**Flood Control Project Maintenance
Levee Inspections**

Fall 2013 Levee Maintenance Deficiency Summary Report

Reclamation District No. 2092 Dos Rios

Waterway	Bank	Unit Miles
Unit No. 01 San Joaquin River	Right	3.76

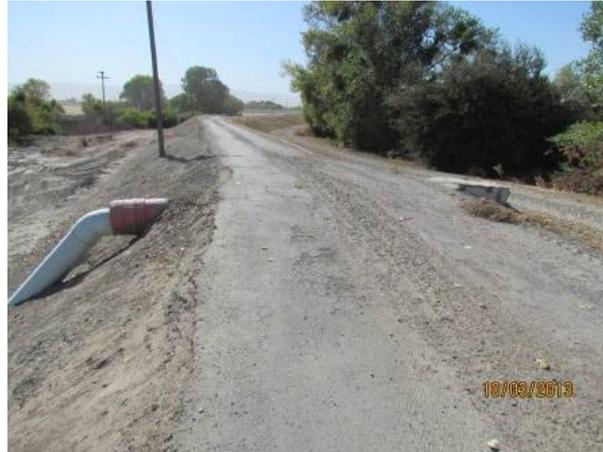
Levee Mile Report Line	4
Start Levee Mile	0.18
End Levee Mile	0.18
Location	Crown
Category	Earthen Levee
Item	Encroachments
<p>A ramp was found on the crown of the levee looking upstream.</p>	
<p>pkazi_f_20131014_930.JPG</p>

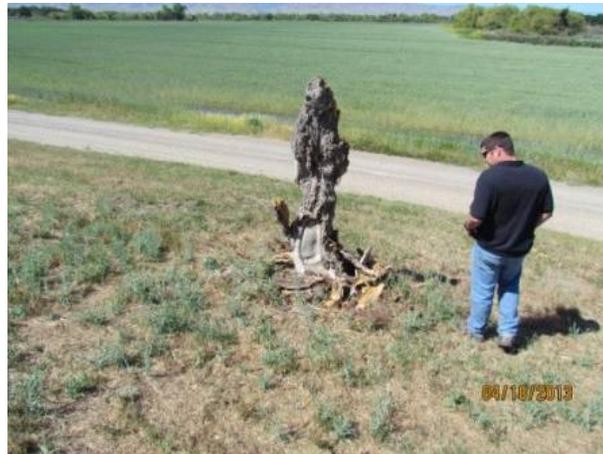
Levee Mile Report Line	5
Start Levee Mile	0.77
End Levee Mile	0.77
Location	Water Side
Category	Earthen Levee
Item	Trim / Thin Trees
<p>A damaged cottonwood was found on the waterside slope of the levee looking upstream. The LMA will be removing the remaining portion of the tree including the stump.</p>	
<p>pkazi_f_20131001_915.JPG</p>

DWR ID: DWR_RD2092_01_f_2013_1		
5	0.77	0.77	Earthen Levee	Trim / Thin Trees	WS	N Ma	T5 : Tree stumps. Inspector Comments: The LMA will remove the tree stump from the waterside slope of the levee.	37.597260 ° -121.168504 °	37.597260 ° -121.168504 °	6 Y
								DWR ID: DWR_RD2092_01_s_2013_6		
6	0.77	1.33	Earthen Levee	Encroachments	LS	M En	DT : Ditch	37.597291 ° -121.168496 °	37.590568 ° -121.164028 °	968 Y
								DWR ID: DWR_RD2092_01_s_2012_968		
7	1.34	1.57	Earthen Levee	Encroachments	LS	M En	DT : Ditch	37.590479 ° -121.163844 °	37.587758 ° -121.162349 °	7 Y
								DWR ID: DWR_RD2092_01_s_2012_7		
8	1.34	1.34	Earthen Levee	Encroachments	LS	A/W Ma	PI : Pipe Inspector Comments: A sand boil appeared on the landside toe of the levee because of an underground pipe leakage. The pipe and boil have been repaired but should be monitored.	37.590467 ° -121.163822 °	37.590467 ° -121.163822 °	10 Y

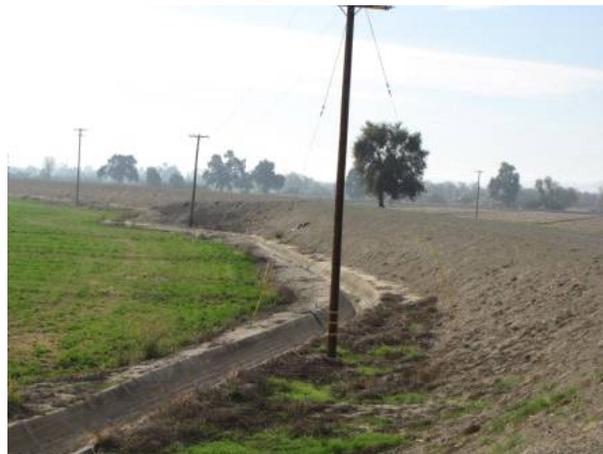
Levee Mile Report Line	6
Start Levee Mile	0.77
End Levee Mile	1.33
Location	Land Side
Category	Earthen Levee
Item	Encroachments
<p>View of agricultural ditch at the landward toe looking upstream.</p>	
<p>pkazi_f_20131001_926.jpg</p>

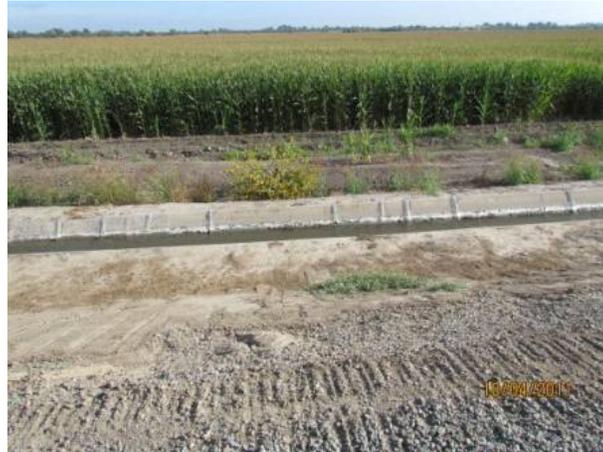
Levee Mile Report Line	7
Start Levee Mile	1.34
End Levee Mile	1.57
Location	Land Side
Category	Earthen Levee
Item	Encroachments
<p>An agricultural ditch was found on the toe of the landside of the levee looking upstream.</p>	
<p>pkazi_f_20131001_916.jpg</p>

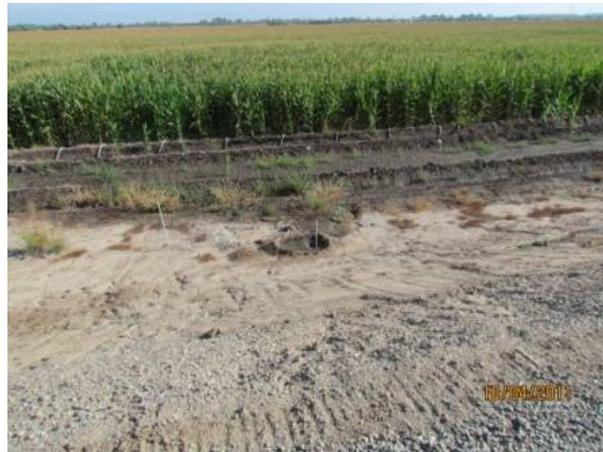
Levee Mile Report Line	8
Start Levee Mile	1.34
End Levee Mile	1.34
Location	Land Side
Category	Earthen Levee
Item	Encroachments
<p>A sand boil was found on the landside of the levee. It was caused by a pipe leak couple of feet below the boil location. LMA was notified to repair it as soon as possible. The picture was taken from the crown looking upstream.</p>	
<p>pkazi_f_20131001_919.jpg</p>

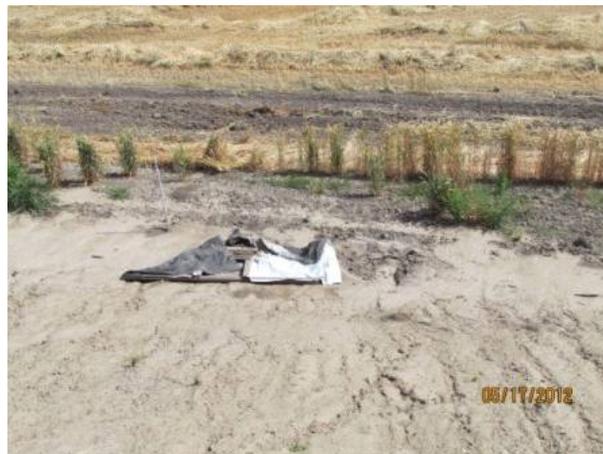
Levee Mile Report Line	8
Start Levee Mile	1.34
End Levee Mile	1.34
Location	Land Side
Category	Earthen Levee
Item	Encroachments
<p>During spring inspection 2012, the sand boil was not active but materials were present on the landside toe of the levee. The sand boil occurred due to an underground irrigation pipe leakage. The picture was taken from the crown looking toward the toe of the levee. The area was repaired but should be monitored.</p>	
<p>pkazi_f_20131001_920.jpg</p>

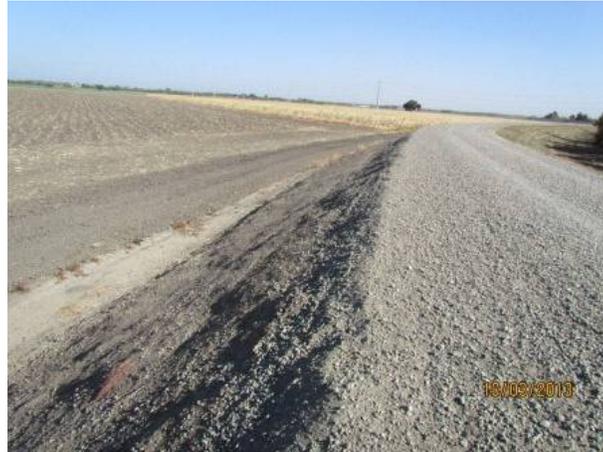
Levee Mile Report Line	10
Start Levee Mile	1.38
End Levee Mile	1.38
Location	Land Side
Category	Earthen Levee
Item	Slope Stability

The slope instability was fixed by the LMA on the landside of the levee looking upstream.

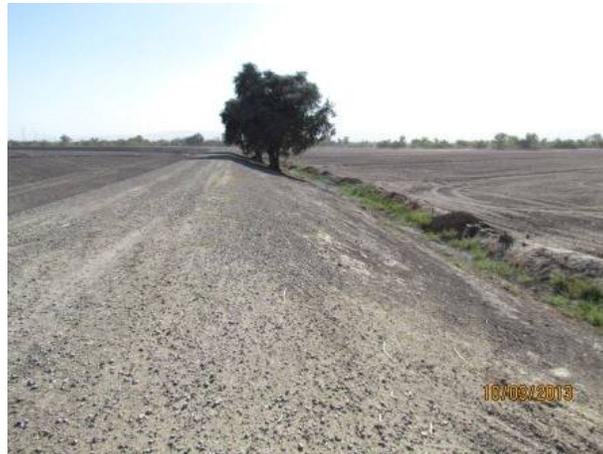
Levee Mile Report Line	11
Start Levee Mile	1.58
End Levee Mile	1.58
Location	Water Side
Category	Earthen Levee
Item	Vegetation

View of the waterside slope of the levee looking upstream.

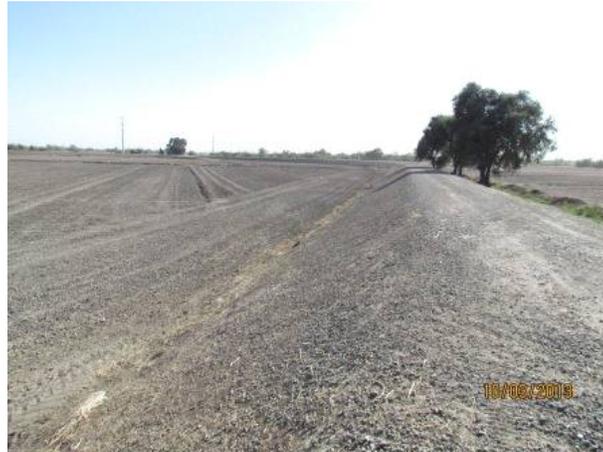
Levee Mile Report Line	12
Start Levee Mile	1.58
End Levee Mile	1.58
Location	Land Side
Category	Earthen Levee
Item	Vegetation

View of the landside slope of the levee looking upstream.

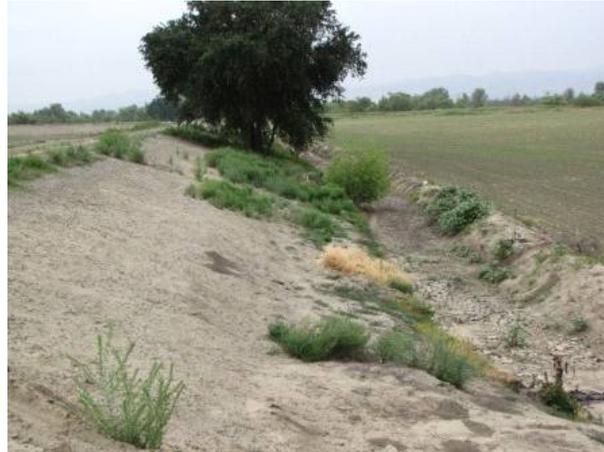
Levee Mile Report Line	13
Start Levee Mile	1.59
End Levee Mile	1.87
Location	Water Side
Category	Earthen Levee
Item	Encroachments

View of an agricultural ditch at the waterward toe of the slope.

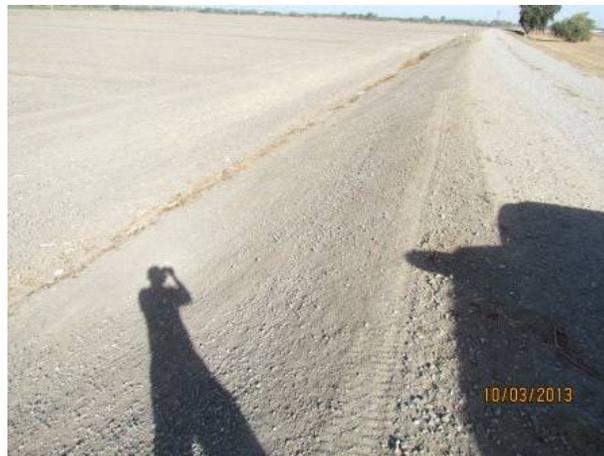
Levee Mile Report Line	14
Start Levee Mile	1.96
End Levee Mile	1.96
Location	Land Side
Category	Earthen Levee
Item	Animal Control

The LMA has repaired the animal holes on the landside slope of the levee looking upstream.

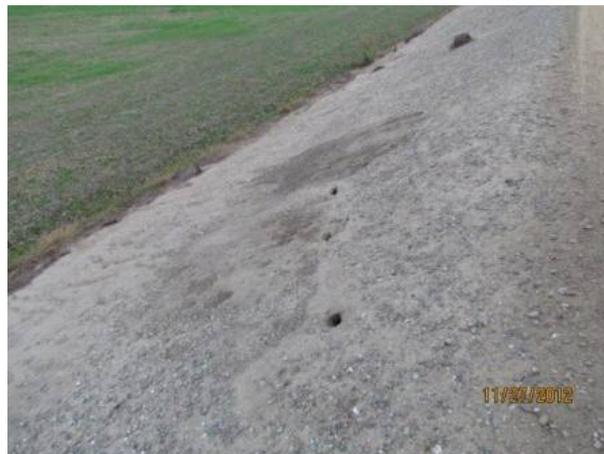
Levee Mile Report Line	18
Start Levee Mile	2.13
End Levee Mile	2.13
Location	Land Side
Category	Earthen Levee
Item	Animal Control

Rodent holes were found on the landside slope of the levee looking upstream.

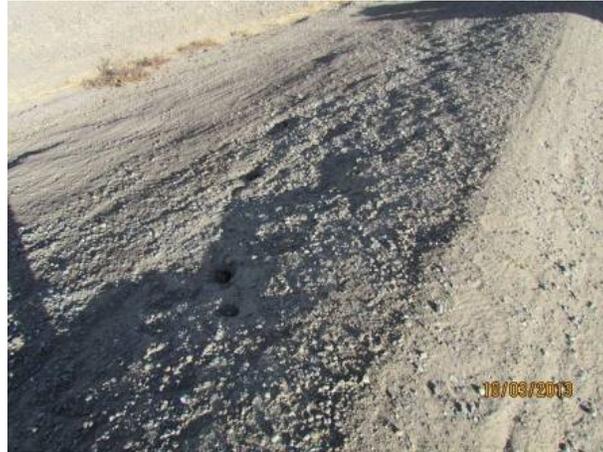
Levee Mile Report Line	18
Start Levee Mile	2.13
End Levee Mile	2.13
Location	Land Side
Category	Earthen Levee
Item	Animal Control
<p>Animal holes were found on the landside of the levee looking upstream during fall 2013 inspection.</p>	
<p>pkazi_f_20131014_935.JPG</p>

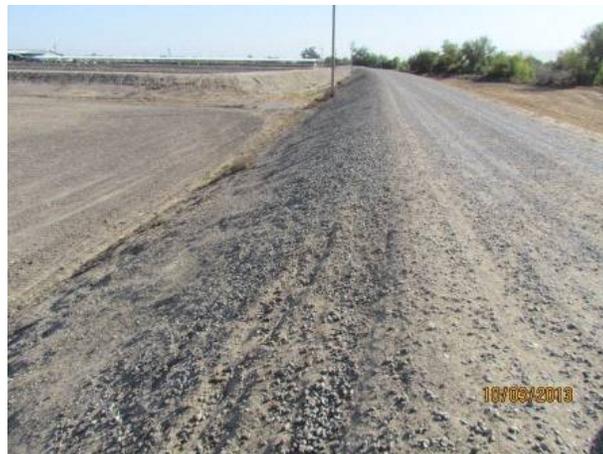
Levee Mile Report Line	19
Start Levee Mile	2.62
End Levee Mile	2.62
Location	Land Side
Category	Earthen Levee
Item	Slope Stability
<p>Slope instability was repaired by the LMA on the landside of the levee looking upstream.</p>	
<p>pkazi_f_20131014_936.JPG</p>

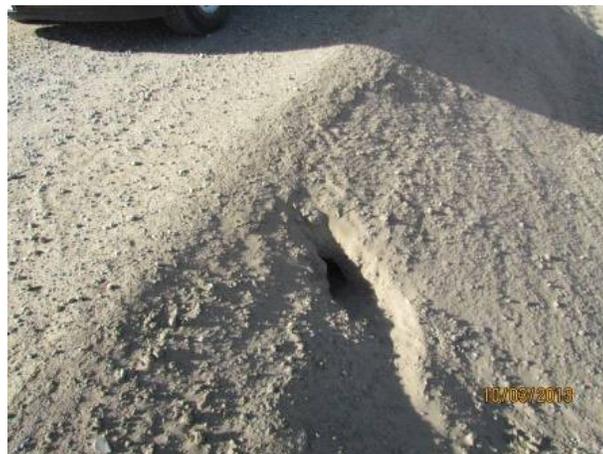
Levee Mile Report Line	21
Start Levee Mile	2.73
End Levee Mile	2.73
Location	Land Side
Category	Earthen Levee
Item	Animal Control
<p>An animal hole was found on the landside shoulder of the levee looking downstream.</p>	
<p>pkazi_f_20131014_937.JPG</p>

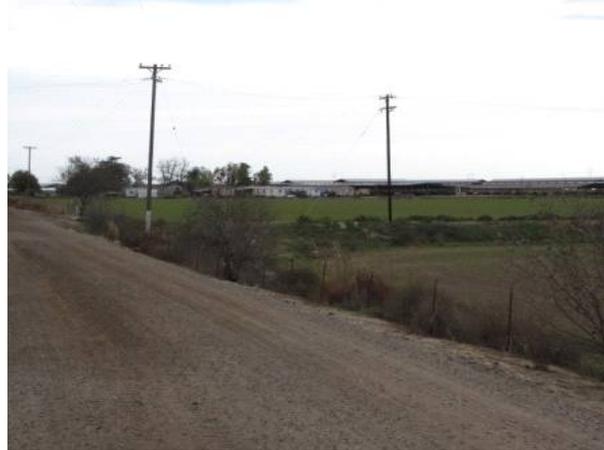
DWR ID: DWR_RD2092_01_f_2013_17										
22	2.84	3.09	Earthen Levee	Encroachments	LS En	M	FE : Fence Inspector Comments: Barbed wire fence on landward slope.	37.574973 ° -121.156647 °	37.574001 ° -121.152183 °	972 Y
DWR ID: DWR_RD2092_01_s_2012_972

Levee Mile Report Line	22
Start Levee Mile	2.84
End Levee Mile	3.09
Location	Land Side
Category	Earthen Levee
Item	Encroachments
View of barbed wire fence along the waterward slope looking upstream.	
pkazi_f_20131001_929.jpg
