**Flood Control Project Maintenance
Levee Inspections**

Fall 2014 Levee Maintenance Deficiency Summary Report

Reclamation District No. 2092 Dos Rios

Waterway	Bank	Unit Miles
Unit No. 01 San Joaquin River	Right	3.71

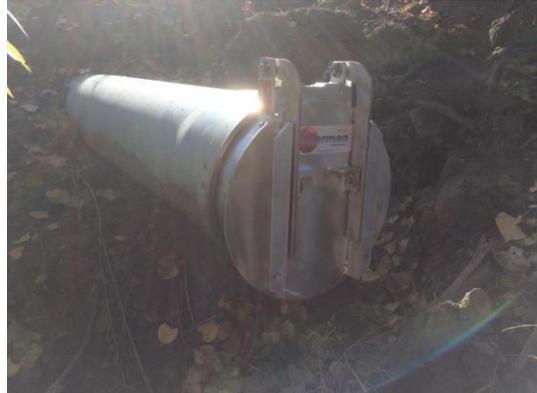
Photo 1 of 2 : FA_2014_RD2092_116_51_20141120_00021.jpg

LM Start	0.17	Rating **	A	Issue No.	51
LM End	0.17	Issue Type +	Ma	Location *	WS
Category	Earthen Levee		GPS Latitude/Longitude		
			Start	End	
Item	Encroachments		37.602073 °	37.602073 °	
			-121.161179 °	-121.161179 °	
DWR ID	DWR_RD2092_01_s_2014_51				
Action/Comments					
Pipe Inspector Comments: A flap gate is installed at the end of the pipe.

A flap gate was installed at the end of the pipe on the waterside of the levee.

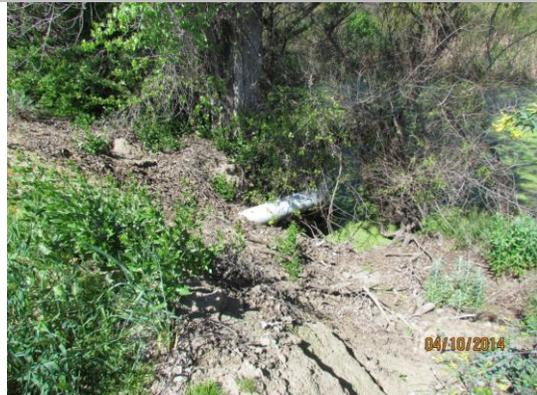
Photo 2 of 2 : FA_2014_RD2092_116_51_20141021_00008.jpg

A flap gate is needed at the end of the pipe on the waterside of the levee.

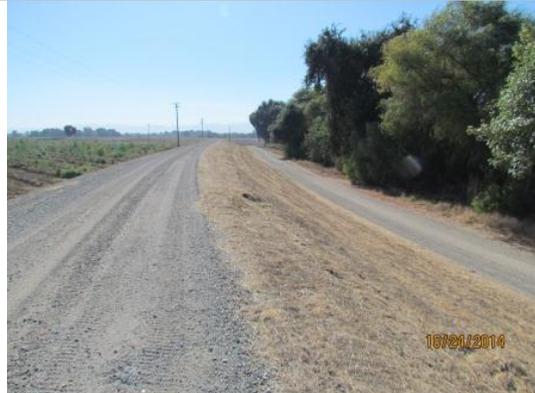
Photo 1 of 1 : FA_2014_RD2092_116_19_20141027_00019.jpg

View of the waterside slope of the levee looking upstream during fall 2014 inspection.

LM Start	0.61	Rating **	A	Issue No.	19
LM End	0.61	Issue Type +	Ma	Location *	WS
Category	Earthen Levee		GPS Latitude/Longitude		
			Start	End	
Item	Vegetation		37.599069 °	37.599069 °	
			-121.167228 °	-121.167228 °	
DWR ID	DWR_RD2092_01_f_2014_19				
Action/Comments					
Control annual grass and weeds on the levee slopes and easements.

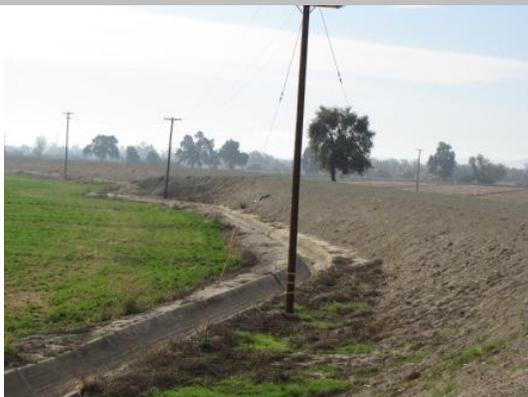
Photo 1 of 1 : FA_2014_RD2092_116_968_20141021_00010.jpg

LM Start	0.77	Rating **	M	Issue No.	968
LM End	1.33	Issue Type +	En	Location *	LS
Category	Earthen Levee		GPS Latitude/Longitude		
			Start	End	
Item	Encroachments		37.597291 °	37.590568 °	
			-121.168496 °	-121.164028 °	
DWR ID	DWR_RD2092_01_s_2012_968				
Action/Comments					
Ditch

View of agricultural ditch at the landward toe looking upstream.

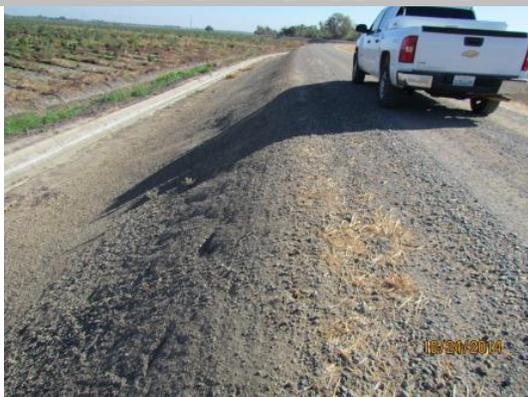
Photo 1 of 2 : FA_2014_RD2092_116_3_20141027_00020.jpg

LMA repaired the rodent holes on the landside shoulder of the levee during fall 2014 inspection.

LM Start	1.07	Rating **	A	Issue No.	3
LM End	1.07	Issue Type +	Ma	Location *	LS
Category	Earthen Levee		GPS Latitude/Longitude		
			Start	End	
Item	Animal Control		37.593403 °	37.593403 °	
			-121.166750 °	-121.166750 °	
DWR ID	DWR_RD2092_01_s_2014_3				
Action/Comments					
No rodents visible, but rodent burrows visible; need to backfill and compact or grout burrows. Inspector Comments: LMA fixed the issue.

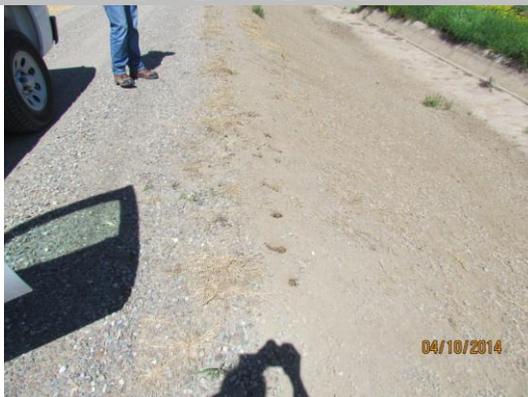
Photo 2 of 2 : FA_2014_RD2092_116_3_20141021_00001.jpg

Rodent holes were found on the landside shoulder of the levee looking downstream.

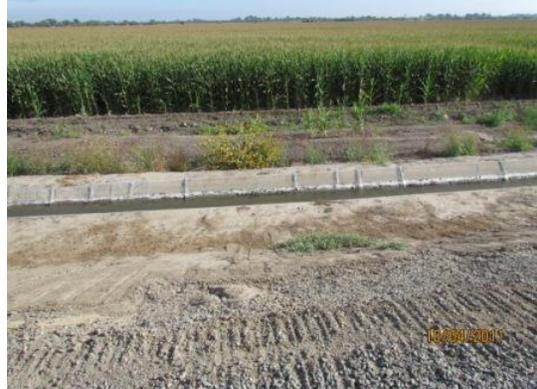
Photo 1 of 1 : FA_2014_RD2092_116_7_20141021_00002.jpg

LM Start	1.34	Rating **	M	Issue No.	7
LM End	1.57	Issue Type +	En	Location *	LS
Category	Earthen Levee		GPS Latitude/Longitude		
			Start	End	
Item	Encroachments		37.590479 °	37.587758 °	
			-121.163844 °	-121.162349 °	
DWR ID	DWR_RD2092_01_s_2012_7				
Action/Comments					
Ditch

An agricultural ditch was found on the toe of the landside of the levee looking upstream.

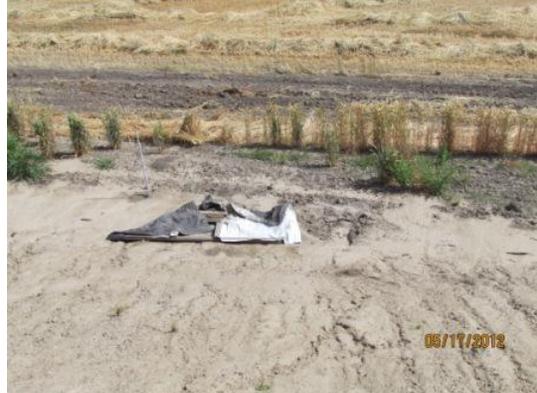
Photo 1 of 2 : FA_2014_RD2092_116_10_20141021_00004.jpg

LM Start	1.34	Rating **	A/W	Issue No.	10
LM End	1.34	Issue Type +	Ma	Location *	LS
Category	Earthen Levee		GPS Latitude/Longitude		
			Start	End	
Item	Encroachments		37.590467 °	37.590467 °	
			-121.163822 °	-121.163822 °	
DWR ID	DWR_RD2092_01_s_2012_10				
Action/Comments					
Pipe					
Inspector Comments: A sand boil appeared on the landside toe of the levee because of an underground pipe leakage. The pipe and boil have been repaired but should be monitored.

During spring inspection 2012, the sand boil was not active but materials were present on the landside toe of the levee. The sand boil occurred due to an underground irrigation pipe leakage. The picture was taken from the crown looking toward the toe of the levee. The area was repaired but should be monitored.

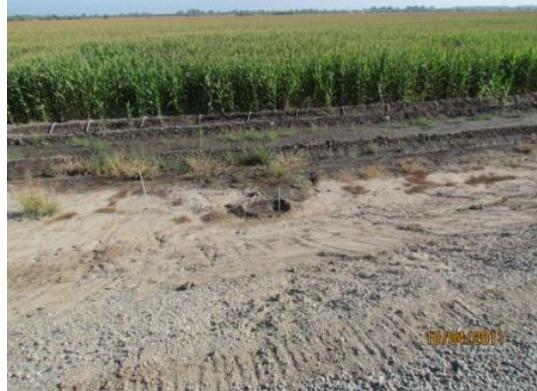
Photo 2 of 2 : FA_2014_RD2092_116_10_20141021_00005.jpg

LM Start	1.34	Rating **	A/W	Issue No.	10 (cont)
LM End	1.34	Issue Type +	Ma	Location *	LS
Category	Earthen Levee		GPS Latitude/Longitude		
			Start	End	
Item	Encroachments		37.590467 °	37.590467 °	
			-121.163822 °	-121.163822 °	
DWR ID	DWR_RD2092_01_s_2012_10				
Action/Comments					
Pipe Inspector Comments: A sand boil appeared on the landside toe of the levee because of an underground pipe leakage. The pipe and boil have been repaired but should be monitored.

A sand boil was found on the landside of the levee. It was caused by a pipe leak couple of feet below the boil location. LMA was notified to repair it as soon as possible. The picture was taken from the crown looking upstream.

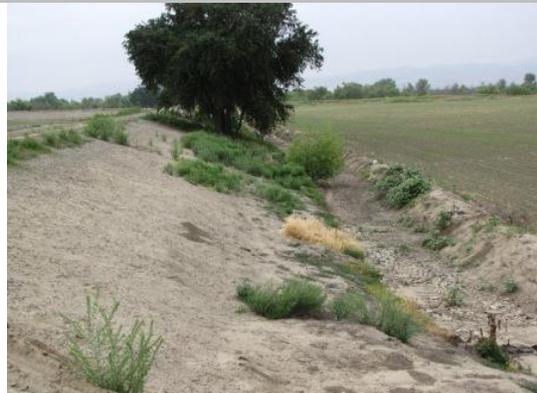
Photo 1 of 1 : FA_2014_RD2092_116_8_20141021_00003.jpg

LM Start	1.59	Rating **	M	Issue No.	8
LM End	1.87	Issue Type +	En	Location *	WS
Category	Earthen Levee		GPS Latitude/Longitude		
			Start	End	
Item	Encroachments		37.587575 °	37.584057 °	
			-121.162454 °	-121.162387 °	
DWR ID	DWR_RD2092_01_s_2012_8				
Action/Comments					
Ditch

View of an agricultural ditch at the waterward toe of the slope.

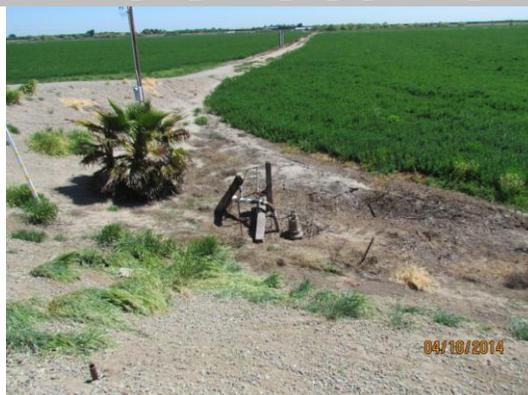
Photo 1 of 1 : FA_2014_RD2092_116_53_20141021_00009.jpg

LM Start	2.43	Rating **	M	Issue No.	53
LM End	2.43	Issue Type +	En	Location *	LS
Category	Earthen Levee		GPS Latitude/Longitude		
			Start	End	
Item	Encroachments		37.580436 °	37.580436 °	
			-121.156783 °	-121.156783 °	
DWR ID	DWR_RD2092_01_s_2014_53				
Action/Comments					
Pipe Inspector Comments: Pump and abandoned pipe was found.

A pump and an abandon pipe was found on the landside toe of the levee looking downstream.

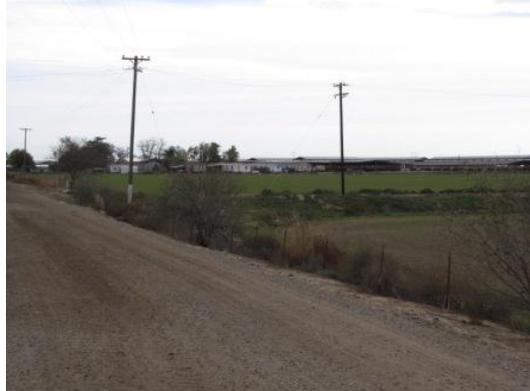
Photo 1 of 1 : FA_2014_RD2092_116_972_20141021_00011.jpg

LM Start	2.84	Rating **	M	Issue No.	972
LM End	3.09	Issue Type +	En	Location *	WS
Category	Earthen Levee		GPS Latitude/Longitude		
			Start	End	
Item	Encroachments		37.574973 °	37.574001 °	
			-121.156647 °	-121.152183 °	
DWR ID	DWR_RD2092_01_s_2012_972				
Action/Comments					
Fence Inspector Comments: Barbed wire fence on waterside toe of the levee.

View of barbed wire fence along the waterward slope looking upstream.
