**Flood Control Project Maintenance
Levee Inspections**

Fall 2015 Levee Maintenance Deficiency Summary Report

San Joaquin River Basin

Reclamation District No. 2092 Dos Rios

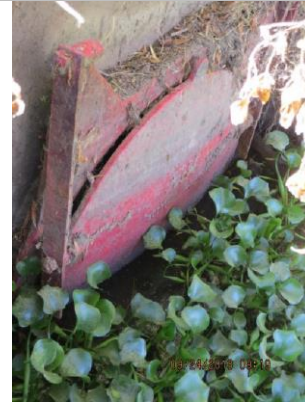
Photo 1 of 3 : UCIP_FA_2015_3390.jpg

Inspector Comments: FS_ID:27123
 DS_ID:20561
 EP_NO: N/A
 FS_HLM: 0.182
 Repair Type: Non-Urgent
 Crossing Status: Found
 UCIP Comments: Pipe rusted through at headwall on LS toe. Good candidate for video inspection.
 FIELD_STRUCT_DESC: 60-inch corrugated metal drainpipe through levee 19.0 feet below crown. Flap gate on the waterward end. Slide gate in 80-inch corrugated metal pipe riser on the waterward slope. Concrete "U" headwalls on both ends. Originally included in the 1961 O&M manual.
 FS Date: 01/16/2014

Flapgate and headwall on WS toe.

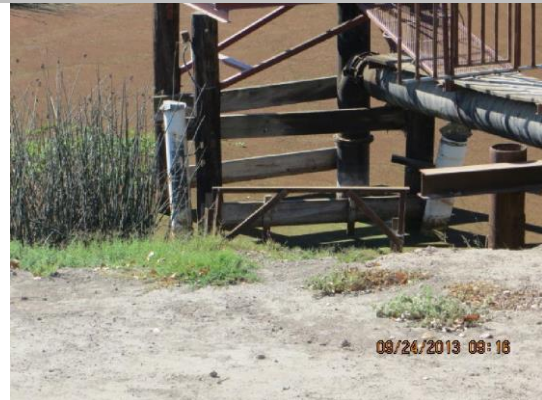
Photo 2 of 3 : UCIP_FA_2015_3391.jpg

Concrete headwall on LS toe in front of pump on pier.

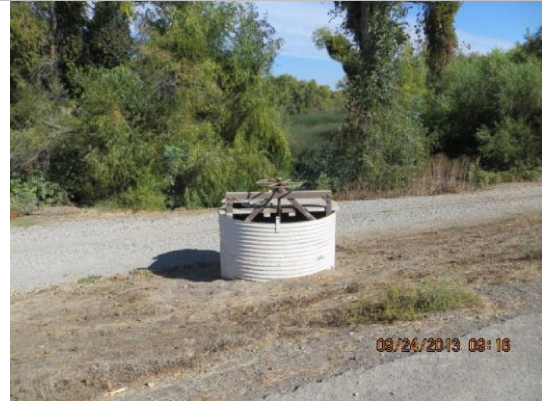
Photo 3 of 3 : UCIP_FA_2015_3392.jpg

Slide gate in 80-inch CMP riser on WS slope.

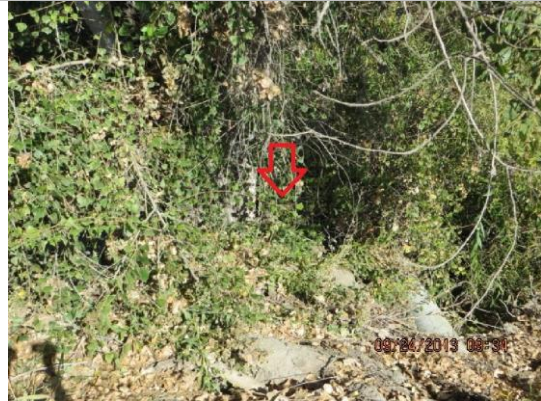
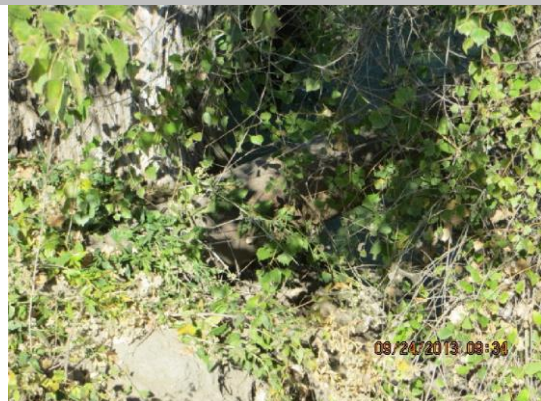
Inspector Comments: FS_ID:20885
 DS_ID:20579
 EP_NO: 6254
 FS_HLM: 0.191
 Repair Type: Non-Urgent
 Crossing Status: Found
 UCIP Comments: Verify pipe has been removed from levee. Pipe visible on WS at riverbank.
 FIELD_STRUCT_DESC: *Abandoned* 16-inch steel pipe over the levee with 3.5 feet of fill on top. Siphon breakers on waterward shoulder. Pad constructed over pipes. This pumping plant was constructed in 1969 during emergency conditions without a permit (Permit No. 6254, 1968).
 FS Date: 09/24/2013

Pipe visible at rivers edge on WS toe.

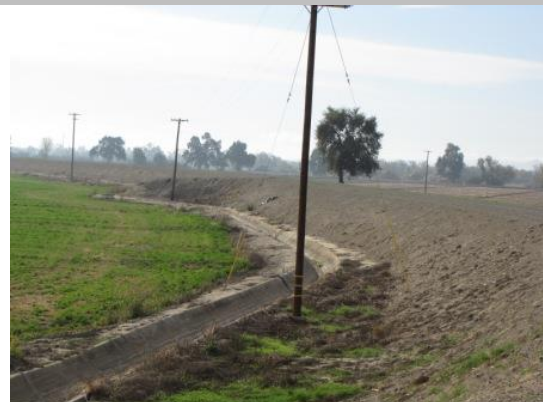
Photo 1 of 1 : FA_2015_RD2092_116_968_20150911_00007.jpg

LM Start	0.76	Rating **	M	Issue No.	968
LM End	1.31	Issue Type +	En	Location *	LS
Category	Earthen Levee			GPS Latitude/Longitude	
				Start	End
Item	Encroachments			37.597291 °	37.590568 °
				-121.168496 °	-121.164028 °
DWR ID	DWR_RD2092_01_s_2012_968				
Action/Comments					
Ditch

View of agricultural ditch at the landward toe looking upstream.

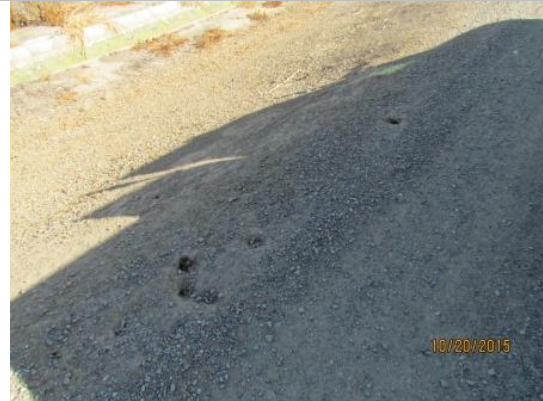
Photo 1 of 1 : FA_2015_RD2092_116_14_20151023_00017.jpg

LM Start	1.20	Rating **	M	Issue No.	14
LM End	1.20	Issue Type +	Ma	Location *	CR
Category	Earthen Levee			GPS Latitude/Longitude	
				Start	End
Item	Animal Control			37.591406 °	37.591406 °
				-121.165624 °	-121.165624 °
DWR ID	DWR_RD2092_01_f_2015_14				
Action/Comments					
No rodents visible, but rodent burrows visible; need to backfill and compact or grout burrows.

A few rodent holes were found on the waterside shoulder of the levee.

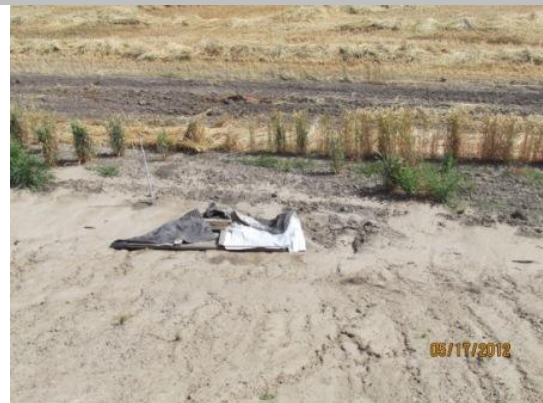
Photo 1 of 2 : FA_2015_RD2092_116_10_20150911_00003.jpg

LM Start	1.32	Rating **	A/W	Issue No.	10
LM End	1.32	Issue Type +	Ma	Location *	LS
Category	Earthen Levee			GPS Latitude/Longitude	
				Start	End
Item	Encroachments			37.590467 °	37.590467 °
				-121.163822 °	-121.163822 °
DWR ID	DWR_RD2092_01_s_2012_10				
Action/Comments					
Pipe Inspector Comments: A sand boil appeared on the landside toe of the levee because of an underground pipe leakage. The pipe and boil have been repaired but should be monitored.

During spring inspection 2012, the sand boil was not active but materials were present on the landside toe of the levee. The sand boil occurred due to an underground irrigation pipe leakage. The picture was taken from the crown looking toward the toe of the levee. The area was repaired but should be monitored.

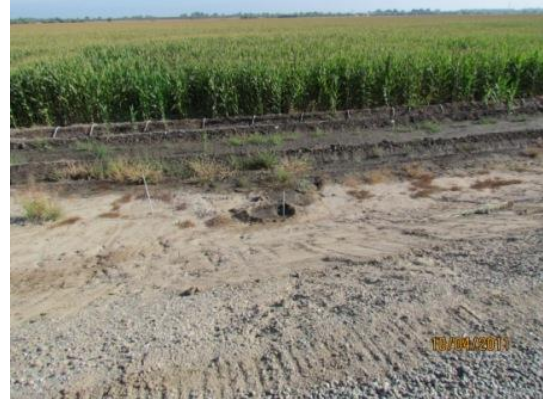
Photo 2 of 2 : FA_2015_RD2092_116_10_20150911_00004.jpg

LM Start	1.32	Rating **	A/W	Issue No.	10 (cont)
LM End	1.32	Issue Type +	Ma	Location *	LS
Category	Earthen Levee			GPS Latitude/Longitude	
				Start	End
Item	Encroachments			37.590467 °	37.590467 °
				-121.163822 °	-121.163822 °
DWR ID	DWR_RD2092_01_s _ 2012_10				
Action/Comments					
Pipe					
Inspector Comments: A sand boil appeared on the landside toe of the levee because of an underground pipe leakage. The pipe and boil have been repaired but should be monitored.

A sand boil was found on the landside of the levee. It was caused by a pipe leak couple of feet below the boil location. LMA was notified to repair it as soon as possible. The picture was taken from the crown looking upstream.

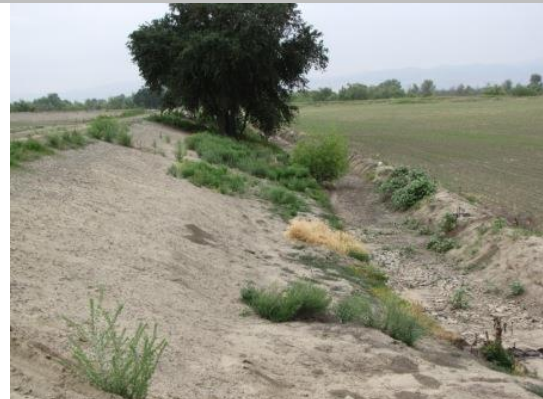
Photo 1 of 1 : FA_2015_RD2092_116_8_20150911_00002.jpg

LM Start	1.56	Rating **	M	Issue No.	8
LM End	1.84	Issue Type +	En	Location *	WS
Category	Earthen Levee			GPS Latitude/Longitude	
				Start	End
Item	Encroachments			37.587575 °	37.584057 °
				-121.162454 °	-121.162387 °
DWR ID	DWR_RD2092_01_s _ 2012_8				
Action/Comments					
Ditch

View of an agricultural ditch at the waterward toe of the slope.

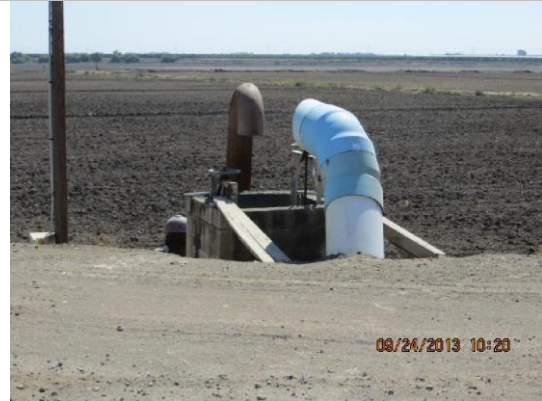
Photo 1 of 3 : UCIP_FA_2015_1890.jpg

Action/Comments					
Inspector Comments: FS_ID:22916					
DS_ID:24680					
EP_NO: N/A					
FS_HLM: 2.376					
Repair Type: Non-Urgent					
Crossing Status: Found					
UCIP Comments: No permit identified for this crossing.					
FIELD_STRUCT_DESC: 21-inch PVC irrigation pipe through the levee					
at an unknown depth below the crown. Pipe discharges into concrete					
distribution box on LS toe. Pump on pier off WS toe.					
FS Date: 09/24/2013

21-inch PVC irrigation pipe visible on LS shoulder.

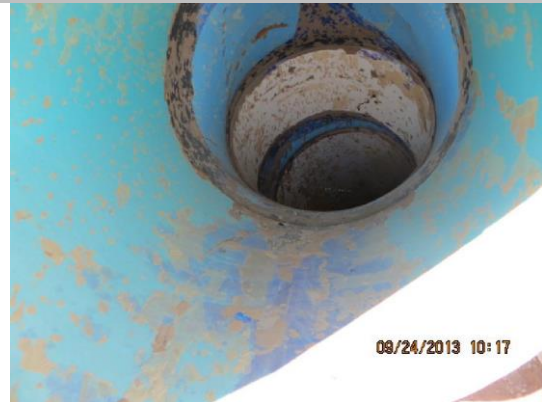
Photo 2 of 3 : UCIP_FA_2015_1910.jpg

Inside of pipe at LS shoulder.

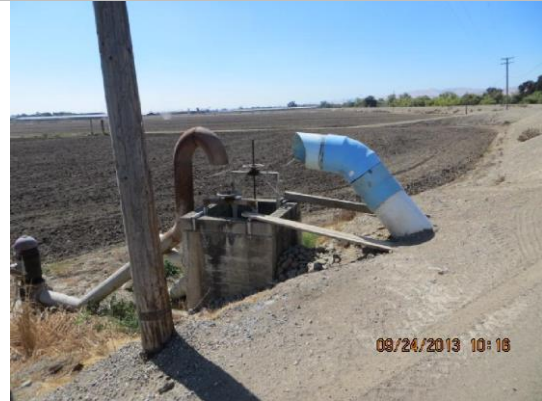
Photo 3 of 3 : UCIP_FA_2015_1911.jpg

21-inch PVC irrigation pipe visible on LS shoulder.

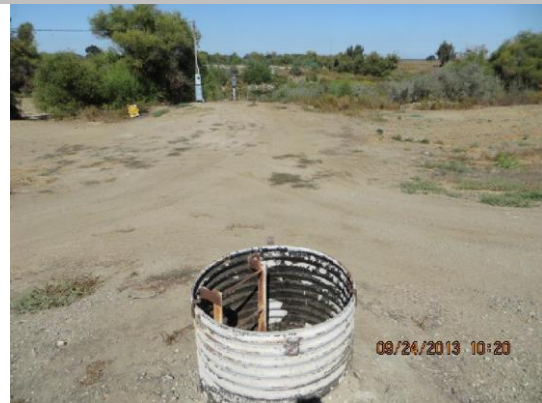
Photo 1 of 3 : UCIP_FA_2015_1631.jpg

LM Start	2.34	Rating **	M	Issue No.	977
LM End	2.34	Issue Type +	En	Location *	LS
Category	Supplemental			GPS Latitude/Longitude	
				Start	End
Item	DWR UCIP Field Study			37.581213 °	37.581213
				-121.156175 °	-121.156175
DWR ID					
Action/Comments					
Inspector Comments: FS_ID:20908 DS_ID:20566 EP_NO: N/A FS_HLM: 2.376 Repair Type: Non-Urgent Crossing Status: Found UCIP Comments: Pipe appears abandoned and needs to be verified as having been done so properly. FIELD_STRUCT_DESC: *ABANDONED* 24-inch corrugated metal pipe through levee 11.0 feet below crown. Slide gate in 36-inch corrugated metal pipe riser on the waterward slope. 5'X5' Concrete distribution box on the landward side. Pump on platform in channel. Pipe filled with concrete on LS toe. Originally included in the 1961 O&M manual. FS Date: 09/24/2013

36-inch CMP riser on WS slope.

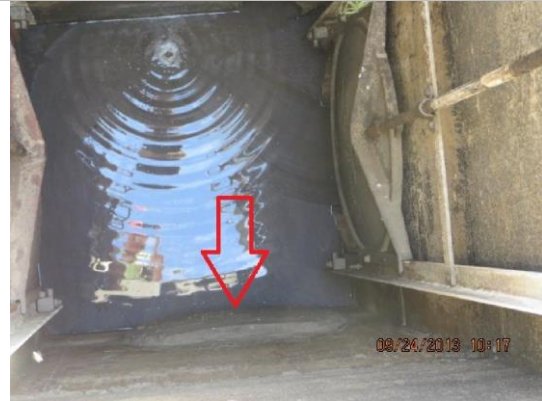
Photo 2 of 3 : UCIP_FA_2015_1632.jpg

Inspector Comments: FS_ID:20908
 DS_ID:20566
 EP_NO: N/A
 FS_HLM: 2.376
 Repair Type: Non-Urgent
 Crossing Status: Found
 UCIP Comments: Pipe appears abandoned and needs to be verified as having been done so properly.
 FIELD_STRUCT_DESC: *ABANDONED* 24-inch corrugated metal pipe through levee 11.0 feet below crown. Slide gate in 36-inch corrugated metal pipe riser on the waterward slope. 5'X5' Concrete distribution box on the landward side. Pump on platform in channel. Pipe filled with concrete on LS toe. Originally included in the 1961 O&M manual.
 FS Date: 09/24/2013

Pipe filled with concrete inside conc. distro box on LS toe.

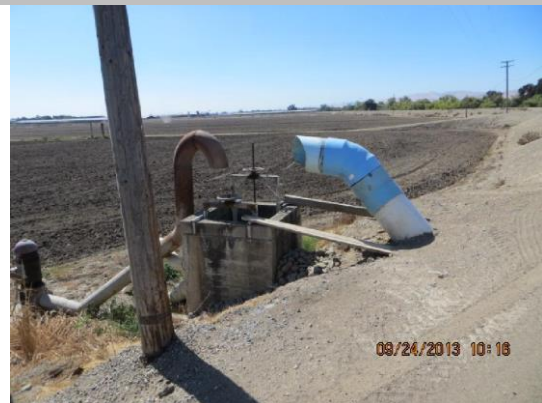
Photo 3 of 3 : UCIP_FA_2015_1633.jpg

5x5 concrete distribuion box on LS toe.

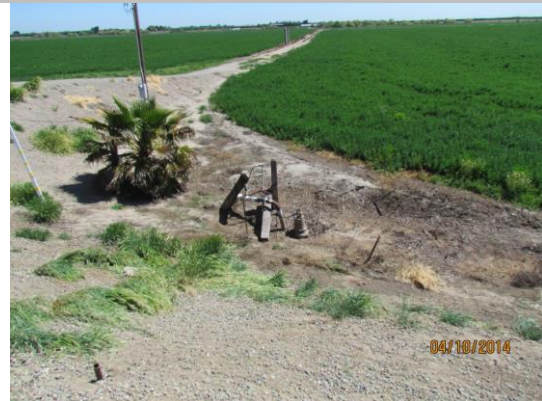
Photo 1 of 1 : FA_2015_RD2092_116_53_20150911_00006.jpg

LM Start	2.40	Rating **	M	Issue No.	53
LM End	2.40	Issue Type +	En	Location *	LS
Category	Earthen Levee			GPS Latitude/Longitude	
				Start	End
Item	Encroachments			37.580436 °	37.580436 °
				-121.156783 °	-121.156783 °
DWR ID	DWR_RD2092_01_s_2014_53				
Action/Comments					
Pipe					
Inspector Comments: Pump and abandoned pipe was found.

A pump and an abandon pipe was found on the landside toe of the levee looking downstream.

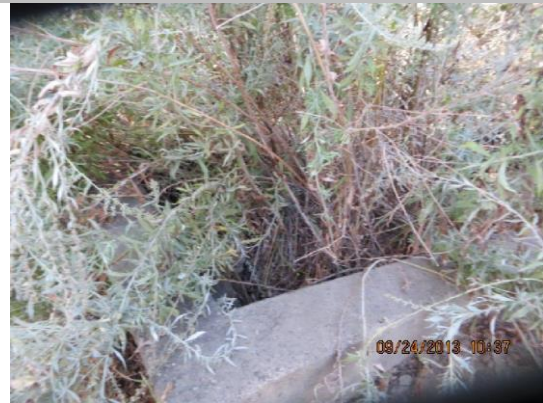
Photo 1 of 2 : UCIP_FA_2015_1634.jpg

Action/Comments					
Inspector Comments: FS_ID:20943 DS_ID:20567 EP_NO: N/A FS_HLM: 2.441 Repair Type: Non-Urgent Crossing Status: Found UCIP Comments: Appears abandoned and if so should be done so properly. FIELD_STRUCT_DESC: 24-inch corrugated metal drain pipe through levee 15.0 feet below crown. Flap gate on the waterward end. Concrete "U" headwall on the waterward end and concrete headwall on LS toe next to pump. Originally included in the 1961 O&M manual. FS Date: 09/24/2013

Concrete U-shaped headwall and flapgate on WS berm.

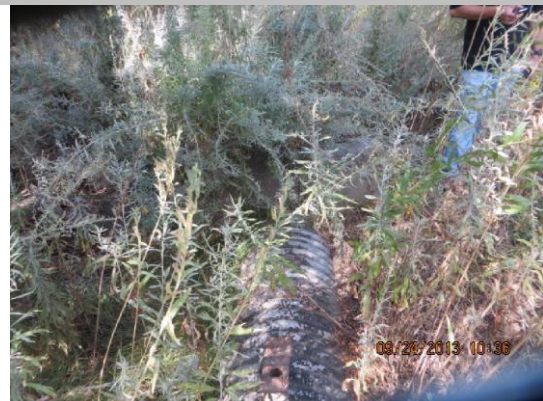
Photo 2 of 2 : UCIP_FA_2015_1635.jpg

24-inch pipe visible on WS berm.

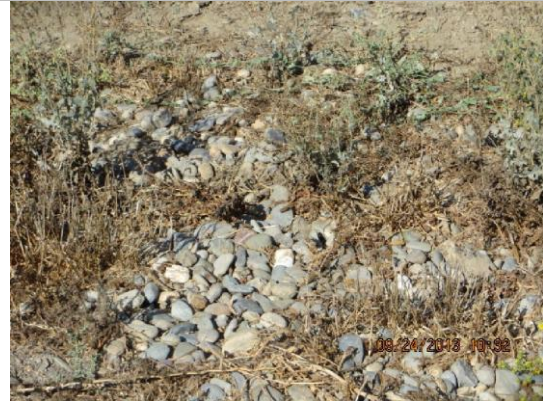
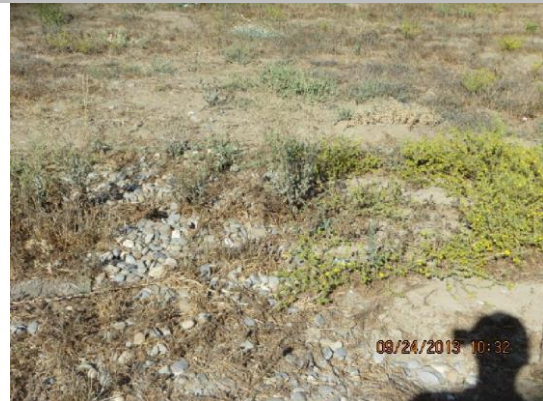
LM Start	2.41	Rating **	M	Issue No.	979
LM End	2.41	Issue Type +	En	Location *	LS
Category	Supplemental			GPS Latitude/Longitude	
				Start	End
Item	DWR UCIP Field Study			37.580405 °	37.580405 °
				-121.156825 °	-121.156825 °
DWR ID					
Action/Comments					
Inspector Comments: FS_ID:20923					
DS_ID:20568					
EP_NO: N/A					
FS_HLM: 2.443					
Repair Type: Non-Urgent					
Crossing Status: Indicator Found

Gravel on WS slope appears to indicate trench.

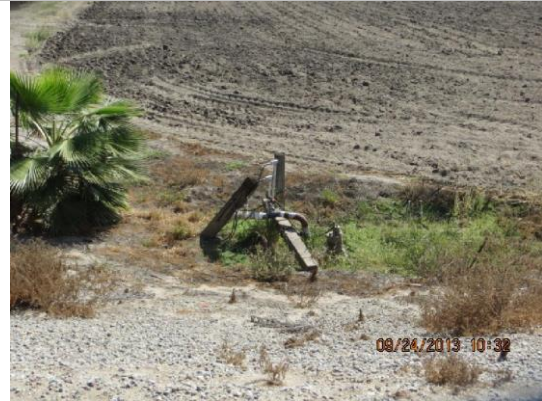
Photo 3 of 3 : UCIP_FA_2015_1851.jpg

Pump and 4-inch pipe visible at LS toe.

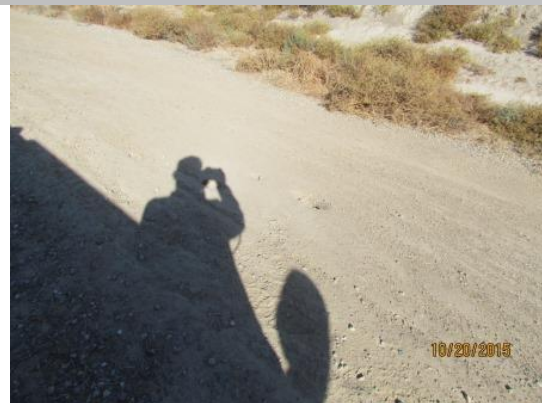
Photo 1 of 1 : FA_2015_RD2092_116_21_20151023_00018.jpg

LM Start	2.66	Rating **	M	Issue No.	21
LM End	2.66	Issue Type +	Ma	Location *	LS
Category	Earthen Levee			GPS Latitude/Longitude	
				Start	End
Item	Animal Control			37.576688 °	37.576688 °
				-121.157197 °	-121.157197 °
DWR ID	DWR_RD2092_01_f_2015_21				
Action/Comments					
No rodents visible, but rodent burrows visible; need to backfill and compact or grout burrows.

An animal hole was found landside slope of the levee.

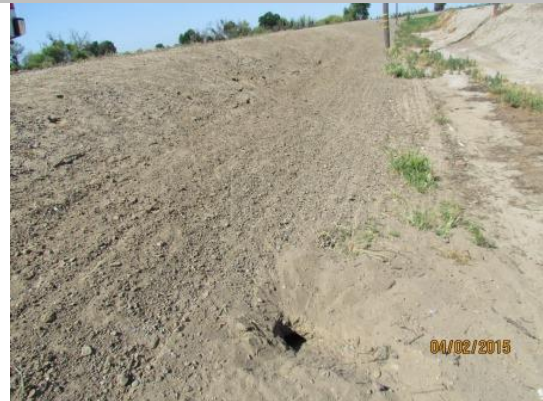
Photo 1 of 1 : FA_2015_RD2092_116_19_20150911_00005.jpg

LM Start	2.70	Rating **	M	Issue No.	19
LM End	2.70	Issue Type +	Ma	Location *	LS
Category	Earthen Levee			GPS Latitude/Longitude	
				Start	End
Item	Animal Control			37.576165 °	37.576165 °
				-121.157230 °	-121.157230 °
DWR ID	DWR_RD2092_01_s_2015_19				
Action/Comments					
No rodents visible, but rodent burrows visible; need to backfill and compact or grout burrows.

A rodent hole was found on the landside toe of the levee looking downstream.

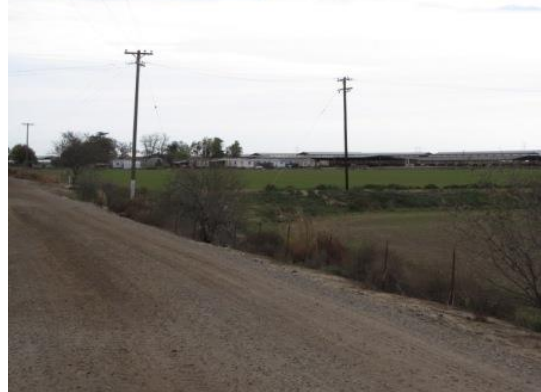
Photo 1 of 1 : FA_2015_RD2092_116_972_20150911_00008.jpg

LM Start	2.79	Rating **	M	Issue No.	972
LM End	3.05	Issue Type +	En	Location *	WS
Category	Earthen Levee			GPS Latitude/Longitude	
				Start	End
Item	Encroachments			37.574973 °	37.574001 °
				-121.156647 °	-121.152183 °
DWR ID	DWR_RD2092_01_s _ 2012_972				
Action/Comments					
Fence					
Inspector Comments: Barbed wire fence on waterside toe of the levee.

View of barbed wire fence along the waterward slope looking upstream.

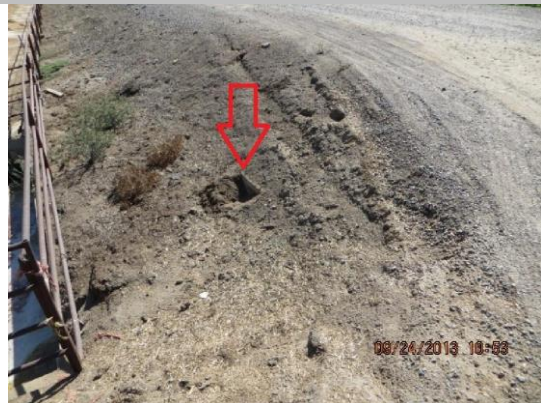
Photo 1 of 1 : UCIP_FA_2015_1636.jpg

LM Start	2.86	Rating **	M	Issue No.	980
LM End	2.86	Issue Type +	En	Location *	WS
Category	Supplemental			GPS Latitude/Longitude	
				Start	End
Item	DWR UCIP Field Study			37.574741 °	37.574741 °
				-121.155495 °	-121.155495 °
DWR ID					
Action/Comments					
Inspector Comments: FS_ID:20944					
DS_ID:20570					
EP_NO: N/A					
FS_HLM: 2.903					
Repair Type: Non-Urgent					
Crossing Status: Indicator Found					
UCIP Comments: Appears abandoned and if so, should be done so properly.					
FIELD_STRUCT_DESC: 24-inch corrugated metal pipe through levee 6.5 feet below crown. Concrete "U" headwall and flap gate on the waterward end. Concrete headwall on LS slope. Originally included in the 1961 O&M manual.					
FS Date: 09/24/2013

Concrete headwall visible on LS slope.

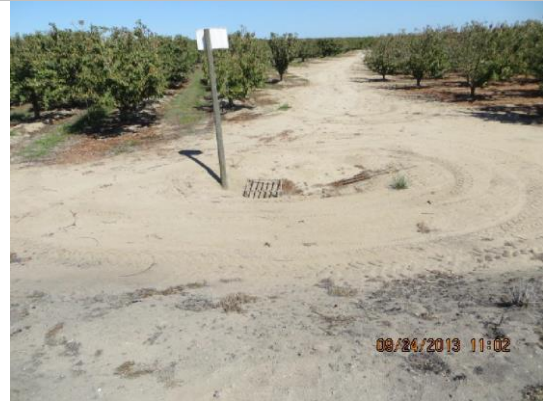
Photo 1 of 2 : UCIP_FA_2015_1638.jpg

Inspector Comments: FS_ID:20945
 DS_ID:20572
 EP_NO: N/A
 FS_HLM: 3.52
 Repair Type: Non-Urgent
 Crossing Status: Found
 UCIP Comments: This pipe appears abandoned and if so, should be done so properly.
 FIELD_STRUCT_DESC: 36-inch corrugated metal pipe through levee 11.0 feet below crown. Slide gate in corrugated metal pipe riser on the waterward slope. Concrete headwalls on both ends. Originally included in the 1961 O&M manual.
 FS Date: 09/24/2013

Grate over sump on LS toe.

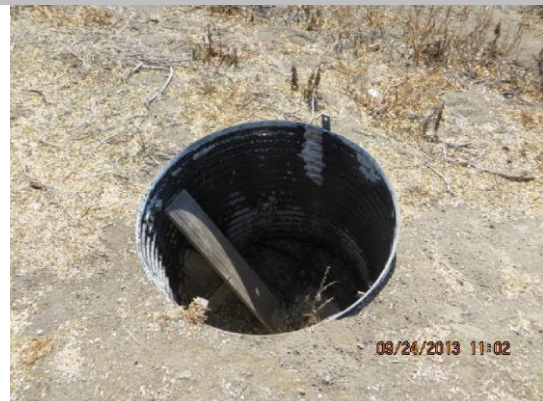
Photo 2 of 2 : UCIP_FA_2015_1639.jpg

48-inch CMP riser on WS slope.
