**Flood Control Project Maintenance
Levee Inspections**

Fall 2016 Levee Maintenance Deficiency Summary Report

Reclamation District No. 2092 Dos Rios

Waterway			Bank	Unit Miles
Unit No. 01 San Joaquin River			Right	3.71
	Spring (March - May)	Summer (June - August)	(September - November) Fall	Winter (December - February)
Unit Maintenance Rating (Fall Only)			A	
Date of Inspection	4/7/2016 - 4/7/2016		10/4/2016 - 10/4/2016	
DWR Inspector	Pavel Kazi		Pavel Kazi	
Accompanied By	Feliciano Degante River Partners		Steve Sheppard River Partner

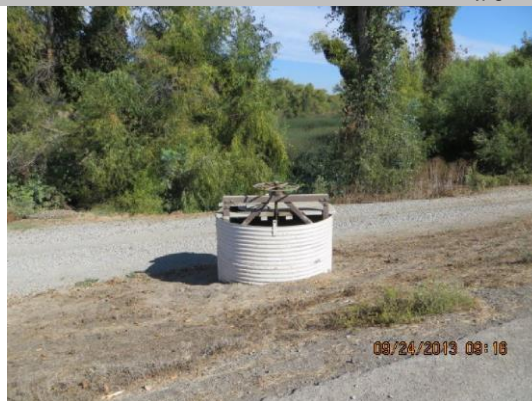
Photo 1 of 2 : UCIP_FA_2016_27123_50242.jpg

LM Start	0.18	Rating **	M	Issue No.	981
LM End	0.18	Issue Type +	En	Location *	N/A
Category	Supplemental			GPS Latitude/Longitude	
				Start	End
Item	DWR UCIP Field Study			37.602031 °	37.602031 °
				-121.161249 °	-121.161249 °
DWR ID					
Comment Code					
Inspector Comment					
FS_ID:27123 DS_ID:20561 EP_NO: N/A Repair Type: Non-Urgent Crossing Status: Found UCIP Comments: Pipe rusted through at headwall on LS toe. Good candidate for video inspection. FIELD_STRUCT_DESC: 60-inch corrugated metal drainpipe through levee 19.0 feet below crown. Flap gate on the waterward end. Slide gate in 80-inch corrugated metal pipe riser on the waterward slope. Concrete "U" headwalls on both ends. Originally included in the 1961 O&M manual. FS Date: 1/16/2014 12:03:14 PM

Slide gate in 80-inch CMP riser on WS slope.

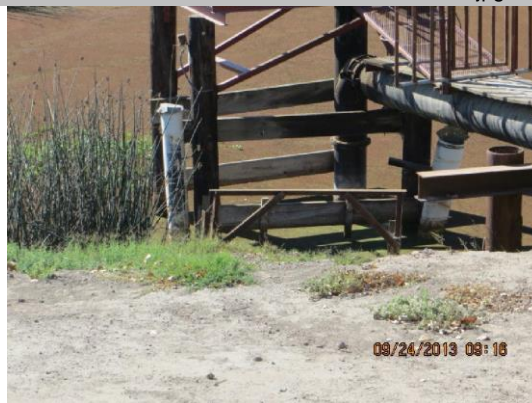
Photo 2 of 2 : UCIP_FA_2016_27123_50241.jpg

Concrete headwall on LS toe in front of pump on pier.

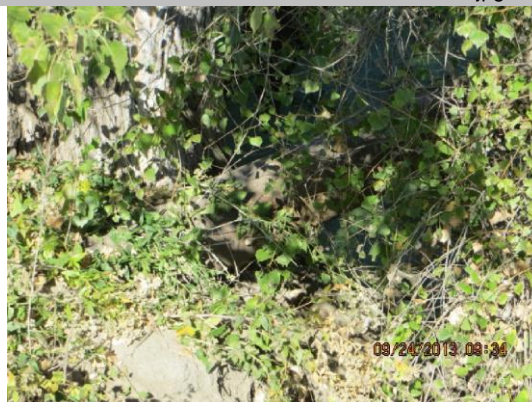
Photo 1 of 2 : UCIP_FA_2016_20885_35205.jpg

LM Start	0.19	Rating **	M	Issue No.	978
LM End	0.19	Issue Type +	En	Location *	N/A
Category	Supplemental			GPS Latitude/Longitude	
				Start	End
Item	DWR UCIP Field Study			37.601976 °	37.601976 °
				-121.161395 °	-121.161395 °
DWR ID					
Comment Code					
Inspector Comment					
FS_ID:20885 DS_ID:20579 EP_NO: 6254 Repair Type: Non-Urgent Crossing Status: Found UCIP Comments: Verify pipe has bee removed from levee. Pipe visible on WS at riverbank. FIELD_STRUCT_DESC: *ABANDONED* 16-inch steel pipe over the levee with 3.5 feet of fill on top. Siphon breakers on waterward shoulder. Pad constructed over pipes. This pumping plant was constructed in 1969 during emergency conditions without a permit (Permit No. 6254, 1968). FS Date: 9/24/2013

Pipe visible at rivers edge on WS toe.

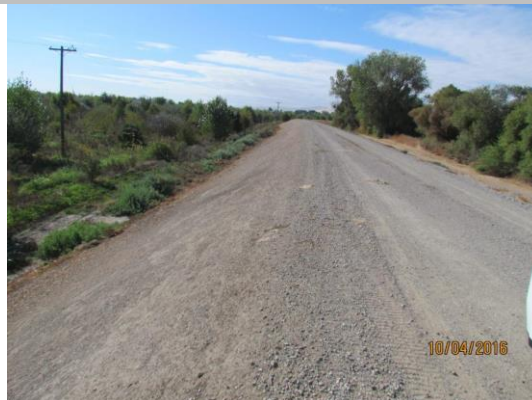
Photo 1 of 1 : FA_2016_RD2092_116_12_20161005_00033.jpg

LM Start	0.40	Rating **	A	Issue No.	12
LM End	0.40	Issue Type +	Ma	Location *	LS
Category	Earthen Levee			GPS Latitude/Longitude	
				Start	End
Item	Vegetation			37.601235 °	37.601235 °
				-121.165117 °	-121.165117 °
DWR ID	DWR_RD2092_01_f_2016_12				
Comment Code					
V1 : Control annual grass and weeds on the levee slopes and easements.					
Inspector Comment					
Acceptable vegetation on the landside of the levee

View of the landside slope of the levee during fall 2016 inspection.

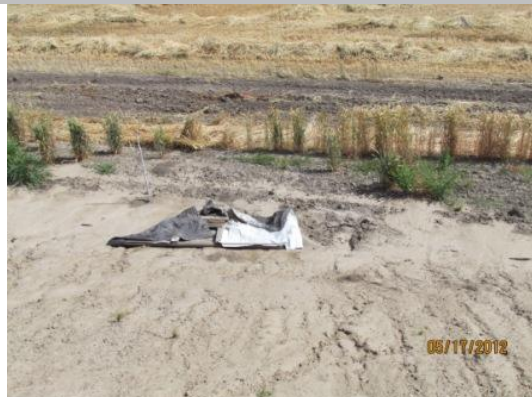
Photo 1 of 2 : FA_2016_RD2092_116_10_20160823_00002.jpg

LM Start	1.32	Rating **	A/W	Issue No.	10
LM End	1.32	Issue Type +	Ma	Location *	LS
Category	Earthen Levee			GPS Latitude/Longitude	
				Start	End
Item	Encroachments			37.590467 °	37.590467 °
				-121.163822 °	-121.163822 °
DWR ID	DWR_RD2092_01_s_2012_10				
Comment Code					
PI : Pipe					
Inspector Comment					
A sand boil appeared on the landside toe of the levee because of an underground pipe leakage. The pipe and boil have been repaired but should be monitored.

During spring inspection 2012, the sand boil was not active but materials were present on the landside toe of the levee. The sand boil occurred due to an underground irrigation pipe leakage. The picture was taken from the crown looking toward the toe of the levee. The area was repaired but should be monitored.

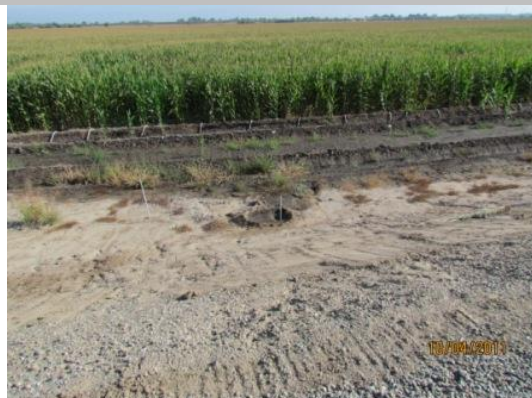
Photo 2 of 2 : FA_2016_RD2092_116_10_20160823_00003.jpg

A sand boil was found on the landside of the levee. It was caused by a pipe leak couple of feet below the boil location. LMA was notified to repair it as soon as possible. The picture was taken from the crown looking upstream.

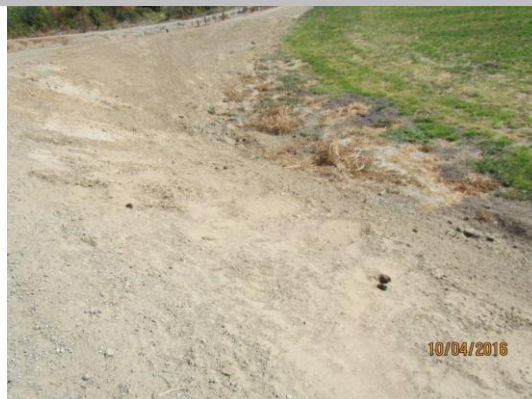
Photo 1 of 1 : FA_2016_RD2092_116_16_20161005_00035.jpg

LM Start	1.56	Rating **	M	Issue No.	16
LM End	1.56	Issue Type +	Ma	Location *	LS
Category	Earthen Levee			GPS Latitude/Longitude	
				Start	End
Item	Animal Control			37.587593 °	37.587593 °
				-121.162431 °	-121.162431 °
DWR ID	DWR_RD2092_01_f_2016_16				
Comment Code					
A3 : No rodents visible, but rodent burrows visible; need to backfill and compact or grout burrows.					
Inspector Comment

View of rodent holes on the landside of the levee looking downstream.

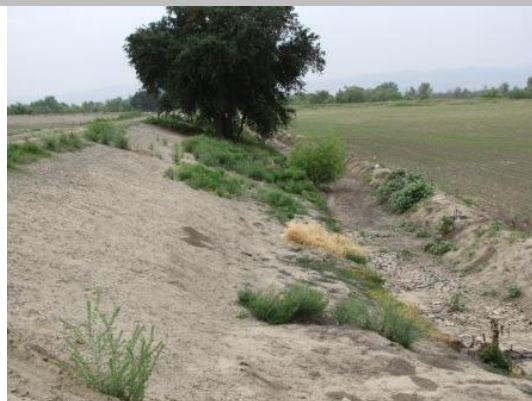
Photo 1 of 1 : FA_2016_RD2092_116_8_20160823_00001.jpg

LM Start	1.56	Rating **	M	Issue No.	8
LM End	1.84	Issue Type +	En	Location *	WS
Category	Earthen Levee			GPS Latitude/Longitude	
				Start	End
Item	Encroachments			37.587575 °	37.584057 °
				-121.162454 °	-121.162387 °
DWR ID	DWR_RD2092_01_s_2012_8				
Comment Code					
DT : Ditch					
Inspector Comment

View of an agricultural ditch at the waterward toe of the slope.

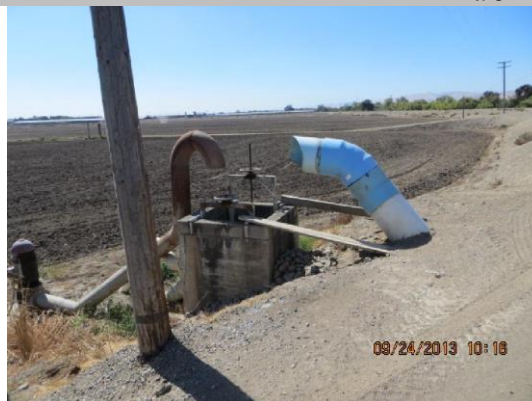
Photo 1 of 2 : UCIP_FA_2016_22916_39046.jpg

LM Start	2.34	Rating **	M	Issue No.	980
LM End	2.34	Issue Type +	En	Location *	WS
Category	Supplemental			GPS Latitude/Longitude	
				Start	End
Item	DWR UCIP Field Study			37.581226 °	37.581226 °
				-121.156175 °	-121.156175 °
DWR ID					
Comment Code					
Inspector Comment					
FS_ID:22916 DS_ID:24680 EP_NO: N/A Repair Type: Non-Urgent Crossing Status: Found UCIP Comments: No permit identified for this crossing. FIELD_STRUCT_DESC: 21-inch PVC irrigation pipe through the levee at an unknown depth below the crown. Pipe discharges into concrete distribution box on LS toe. Pump on pier off WS toe. FS Date: 9/24/2013

21-inch PVC irrigation pipe visible on LS shoulder.

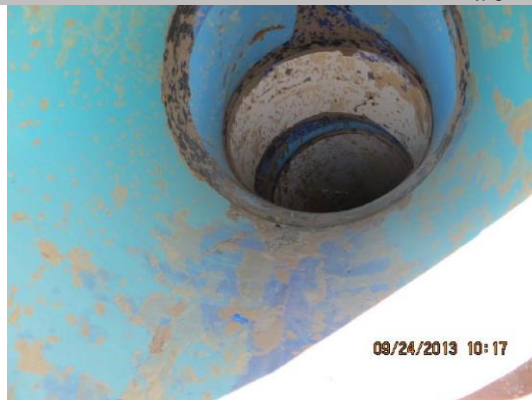
Photo 2 of 2 : UCIP_FA_2016_22916_39045.jpg

Inside of pipe at LS shoulder.

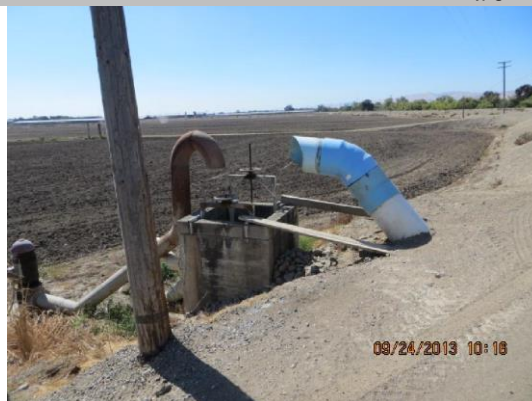
Photo 1 of 2 : UCIP_FA_2016_20908_35229.jpg

LM Start	2.34	Rating **	M	Issue No.	973
LM End	2.34	Issue Type +	En	Location *	WS
Category	Supplemental			GPS Latitude/Longitude	
				Start	End
Item	DWR UCIP Field Study			37.581213 °	37.581213 °
				-121.156175 °	-121.156175 °
DWR ID					
Comment Code					
Inspector Comment					
FS_ID:20908 DS_ID:20566 EP_NO: N/A Repair Type: Non-Urgent Crossing Status: Found UCIP Comments: Pipe appears abandoned and needs to be verified as having been done so properly. FIELD_STRUCT_DESC: *ABANDONED* 24-inch corrugated metal pipe through levee 11.0 feet below crown. Slide gate in 36-inch corrugated metal pipe riser on the waterward slope. 5'X5' Concrete distribution box on the landward side. Pump on platform in channel. Pipe filled with concrete on LS toe. Originally included in the 1961 O&M manual. FS Date: 9/24/2013

5x5 concrete distribuion box on LS toe.

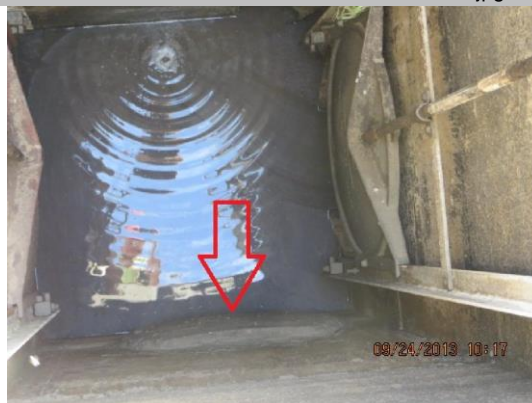
Photo 2 of 2 : UCIP_FA_2016_20908_35227.jpg

Pipe filled with concrete inside conc. distro box on LS toe.

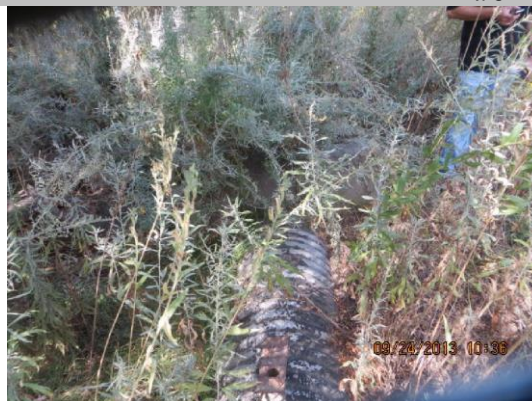
Photo 1 of 2 : UCIP_FA_2016_20943_35251.jpg

LM Start	2.40	Rating **	M	Issue No.	974
LM End	2.40	Issue Type +	En	Location *	LS
Category	Supplemental			GPS Latitude/Longitude	
				Start	End
Item	DWR UCIP Field Study			37.580426 °	37.580426 °
				-121.156798 °	-121.156798 °
DWR ID					
Comment Code					
Inspector Comment					
FS_ID:20943 DS_ID:20567 EP_NO: N/A Repair Type: Non-Urgent Crossing Status: Found UCIP Comments: Appears abandoned and if so should be done so properly. FIELD_STRUCT_DESC: *ABANDONED* 24-inch corrugated metal drain pipe through levee 15.0 feet below crown. Flap gate on the waterward end. Concrete "U" headwall on the waterward end and concrete headwall on LS toe next to pump. Originally included in the 1961 O&M manual. FS Date: 9/24/2013

24-inch pipe visible on WS berm.

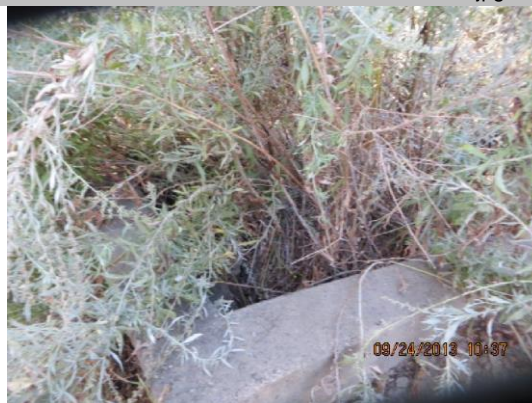
Photo 2 of 2 : UCIP_FA_2016_20943_35250.jpg

Concrete U-shaped headwall and flapgate on WS berm.

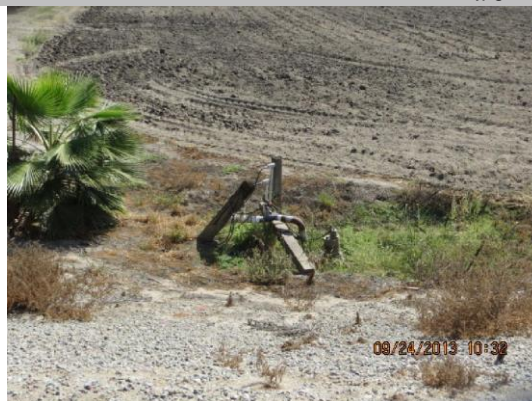
Photo 1 of 2 : UCIP_FA_2016_20923_35234.jpg

FS_ID:20923
DS_ID:20568
EP_NO: N/A
Repair Type: Non-Urgent
Crossing Status: Indicator Found
UCIP Comments: Pipe abandoned and should be verified as having been removed from the levee.
FIELD_STRUCT_DESC: *ABANDONED* 4-inch pipe through levee 1.0 foot below crown. Pump on sump at LS toe. Roadway extending to the landward pump.
FS Date: 9/24/2013

Pump and 4-inch pipe visible at LS toe.

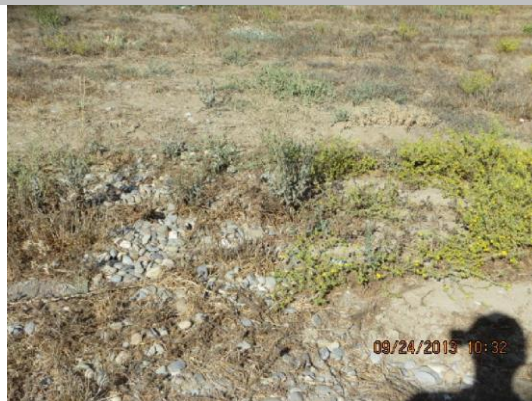
Photo 2 of 2 : UCIP_FA_2016_20923_35233.jpg

Gravel on WS slope appears to indicate trench.

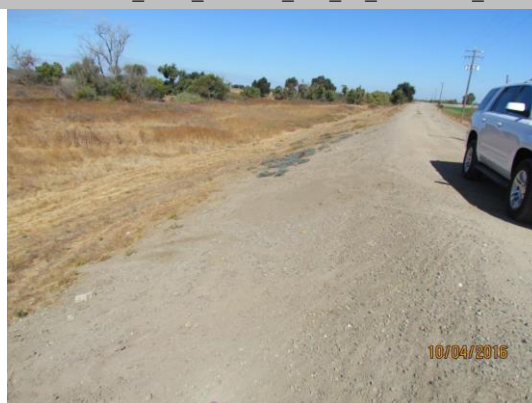
Photo 1 of 2 : FA_2016_RD2092_116_30_20161005_00036.jpg

LM Start	2.73	Rating **	A	Issue No.	30
LM End	2.73	Issue Type +	Ma	Location *	WS
Category	Earthen Levee			GPS Latitude/Longitude	
				Start	End
Item	Animal Control			37.575743 °	37.575743 °
				-121.157237 °	-121.157237 °
DWR ID	DWR_RD2092_01_s_2016_30				
Comment Code					
A3 : No rodents visible, but rodent burrows visible; need to backfill and compact or grout burrows.					
Inspector Comment					
LMA has repaired the rodent holes at this location.

LMA has repaired the rodent holes on the waterside of the levee looking downstream. Fall 2016.

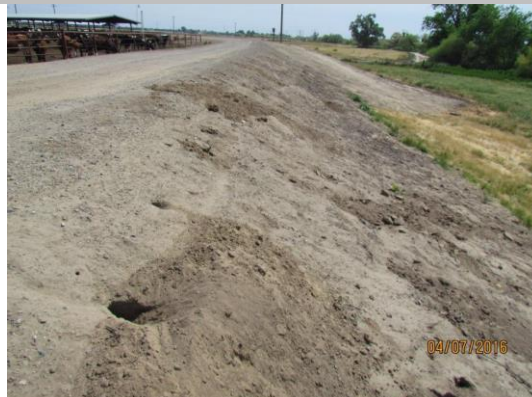
Photo 2 of 2 : FA_2016_RD2092_116_30_20160823_00009.jpg

View of multiple rodent holes on the waterside of the levee looking upstream. Spring 2016.

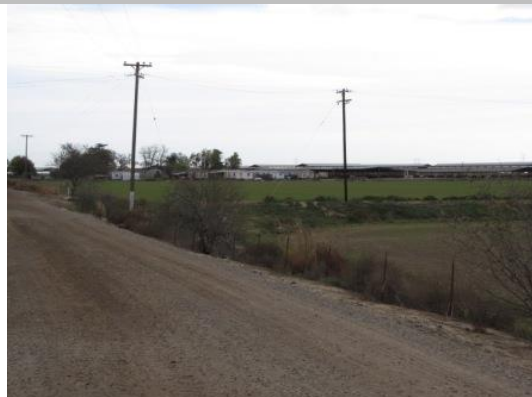
Photo 1 of 1 : FA_2016_RD2092_116_972_20160823_00011.jpg

LM Start	2.79	Rating **	M	Issue No.	972
LM End	3.05	Issue Type +	En	Location *	WS
Category	Earthen Levee			GPS Latitude/Longitude	
				Start	End
Item	Encroachments			37.574973 °	37.574001 °
				-121.156647 °	-121.152183 °
DWR ID	DWR_RD2092_01_s_2012_972				
Comment Code					
FE : Fence					
Inspector Comment					
Barbed wire fence on waterside toe of the levee.

View of barbed wire fence along the waterward slope looking upstream.

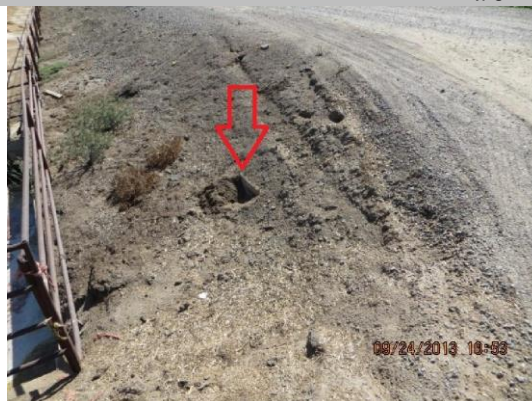
Photo 1 of 1 : UCIP_FA_2016_20944_35255.jpg

LM Start	2.86	Rating **	M	Issue No.	975
LM End	2.86	Issue Type +	En	Location *	WS
Category	Supplemental			GPS Latitude/Longitude	
				Start	End
Item	DWR UCIP Field Study			37.574741 °	37.574741 °
				-121.155495 °	-121.155495 °
DWR ID					
Comment Code					
Inspector Comment					
FS_ID:20944					
DS_ID:20570					
EP_NO: N/A					
Repair Type: Non-Urgent					
Crossing Status: Indicator Found					
UCIP Comments: Appears abandoned and if so, should be done so properly.					
FIELD_STRUCT_DESC: *ABANDONED* 24-inch corrugated metal pipe through levee 6.5 feet below crown. Concrete "U" headwall and flap gate on the waterward end. Concrete headwall on LS slope. Originally included in the 1961 O&M manual.					
FS Date: 9/24/2013

Concrete headwall visible on LS slope.

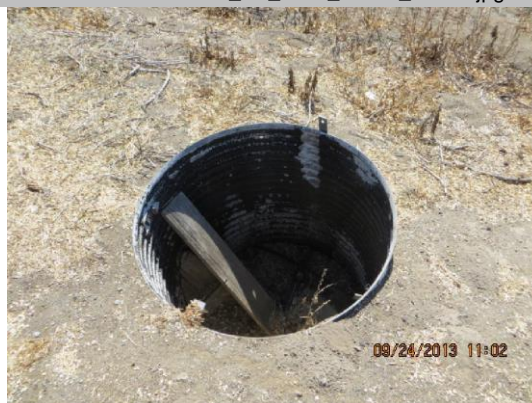
Photo 1 of 2 : UCIP_FA_2016_20945_35261.jpg

LM Start	3.47	Rating **	M	Issue No.	976
LM End	3.47	Issue Type +	En	Location *	WS
Category	Supplemental			GPS Latitude/Longitude	
				Start	End
Item	DWR UCIP Field Study			37.573304 °	37.573304 °
				-121.144747 °	-121.144747 °
DWR ID					
Comment Code					
Inspector Comment					
FS_ID:20945					
DS_ID:20572					
EP_NO: N/A					
Repair Type: Non-Urgent					
Crossing Status: Found					
UCIP Comments: This pipe appears abandoned and if so, should be done so properly.					
FIELD_STRUCT_DESC: *ABANDONED* 36-inch corrugated metal pipe through levee 11.0 feet below crown. Slide gate in corrugated metal pipe riser on the waterward slope. Concrete headwalls on both ends. Originally included in the 1961 O&M manual.					
FS Date: 9/24/2013

48-inch CMP riser on WS slope.

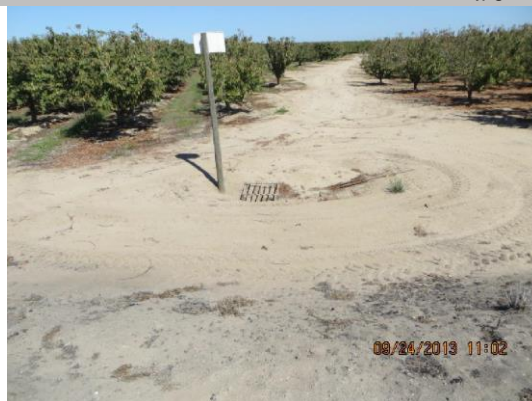
Photo 2 of 2 : UCIP_FA_2016_20945_35260.jpg

Grate over sump on LS toe.
