**Flood Control Project Maintenance
Levee Inspections**

Fall 2017 Levee Maintenance Deficiency Summary Report

Reclamation District No. 2092 Dos Rios

Fall 2017 Levee Inspection Results

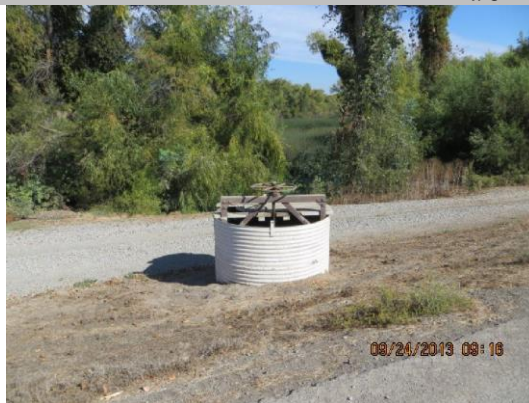
Photo 1 of 3 : UCIP_FA_2017_27123_50242.jpg

LM Start	0.18	Rating **	M	Issue No.	973
LM End	0.18	Issue Type +	Ma	Location *	
Category	Supplemental			GPS Latitude/Longitude	
				Start	End
Item	DWR UCIP LMA Responsibility			37.602031 °	37.602031 °
				-121.161249 °	-121.161249 °
DWR ID					
Comment Code					
Inspector Comment					
FS_ID:27123 DS_ID:20561 EP_NO: N/A Repair Type: Non-Urgent Crossing Status: Found UCIP Comments: Pipe rusted through at headwall on LS toe. Good candidate for video inspection. FIELD_STRUCT_DESC: 60-inch corrugated metal drainage pipe through the levee, 19 feet below the crown. Flap gate on the waterside (WS) end. Slide gate in an 80-inch corrugated metal pipe (CMP) riser on the WS slope. Concrete U-shaped headwalls on both ends. [Additional Reference(s): DWR Levee Log, 2005. USACE San Joaquin O&M Manual 5, August 1961, (HLM 0.18)]. FS Date: 1/16/2014 12:03:14 PM

Slide gate in 80-inch CMP riser on WS slope.

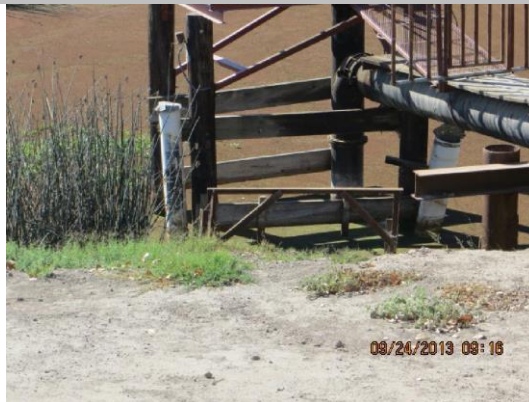
Photo 2 of 3 : UCIP_FA_2017_27123_50241.jpg

Concrete headwall on LS toe in front of pump on pier.

Comment Code						
Inspector Comment						
FS_ID:27123						
DS_ID:20561						
EP_NO: N/A						
Repair Type: Non-Urgent						
Crossing Status: Found						
UCIP Comments: Pipe rusted through at headwall on LS toe. Good candidate for video inspection.						
FIELD_STRUCT_DESC: 60-inch corrugated metal drainage pipe through the levee, 19 feet below the crown. Flap gate on the waterside (WS) end. Slide gate in an 80-inch corrugated metal pipe (CMP) riser on the WS slope. Concrete U-shaped headwalls on both ends.						
[Additional Reference(s): DWR Levee Log, 2005. USACE San Joaquin O&M Manual 5, August 1961, (HLM 0.18)].						
FS Date: 1/16/2014 12:03:14 PM

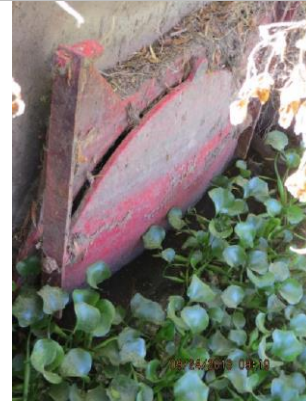
Photo 3 of 3 : UCIP_FA_2017_27123_50240.jpg

Flapgate and headwall on WS toe.

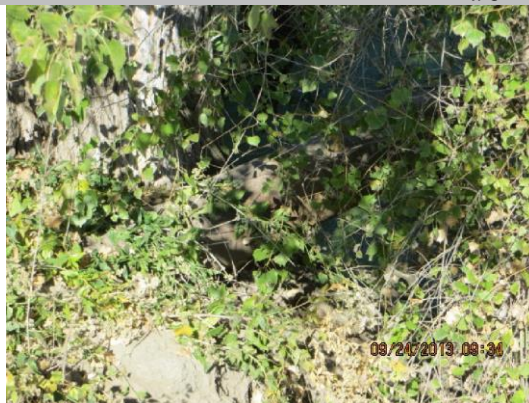
Photo 1 of 2 : UCIP_FA_2017_20885_35205.jpg

Comment Code						
Inspector Comment						
FS_ID:20885						
DS_ID:20579						
EP_NO: 6254						
Repair Type: Non-Urgent						
Crossing Status: Found						
UCIP Comments: Verify pipe has bee removed from levee. Pipe visible on WS at riverbank.						
FIELD_STRUCT_DESC: *ABANDONED* 16-inch steel drainage pipe over the levee with 3.5 feet of the fill on the top. Siphon breakers on the waterside (WS) shoulder. Pad constructed over pipes. This pumping plant was constructed in 1969 during emergency conditions without a permit. (Permit No. 6254, 1968 - John and Robert Bogetti). [Additional Reference(s): DWR Levee Log, 2005].						
FS Date: 9/24/2013

Pipe visible at rivers edge on WS toe.

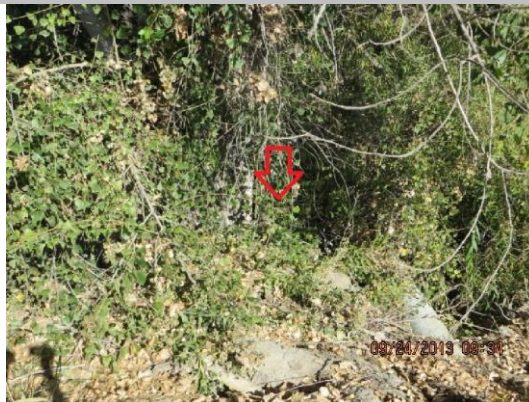
Photo 2 of 2 : UCIP_FA_2017_20885_35204.jpg

Pipe visible at rivers edge on WS toe.

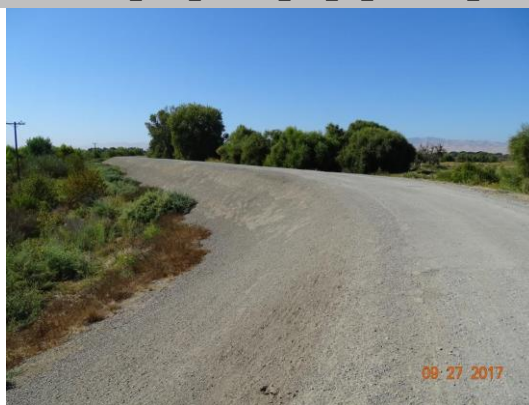
Photo 1 of 1 : FA_2017_RD2092_116_17_20170928_00058.jpg

View of the landside slope of the levee looking upstream. Fall 2017

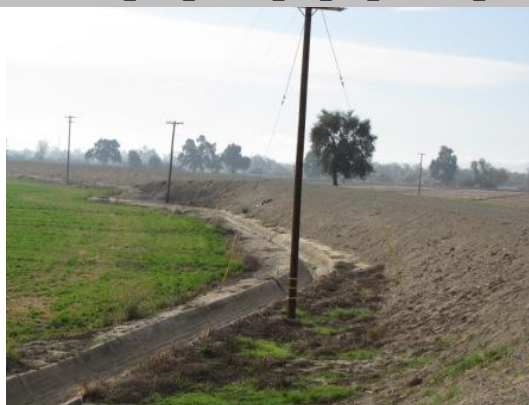
Photo 1 of 1 : FA_2017_RD2092_116_968_20170921_00012.jpg

LM Start	0.76	Rating **	M	Issue No.	968
LM End	1.31	Issue Type +	En	Location *	LS
Category	Earthen Levee			GPS Latitude/Longitude	
				Start	End
Item	Encroachments			37.597291 °	37.590568 °
				-121.168496 °	-121.164028 °
DWR ID	DWR_RD2092_01_s_2012_968				
Comment Code					
DT : Ditch					
Inspector Comment

View of agricultural ditch at the landward toe looking upstream.

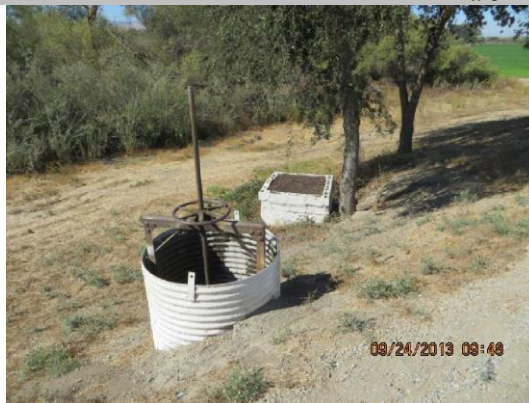
Photo 1 of 2 : UCIP_FA_2017_20889_35213.jpg

LM Start	1.30	Rating **	A/W	Issue No.	976
LM End	1.30	Issue Type +	Ma	Location *	
Category	Supplemental			GPS Latitude/Longitude	
				Start	End
Item	DWR UCIP LMA Responsibility			37.590603 °	37.590603 °
				-121.164111 °	-121.164111 °
DWR ID					
Comment Code					
Inspector Comment					
FS_ID:20889 DS_ID:20562 EP_NO: N/A Repair Type: No Action Needed Crossing Status: Found UCIP Comments: FIELD_STRUCT_DESC: 36-inch corrugated metal drainage pipe through the levee, 15 feet below the crown. Slide gate in a 48-inch corrugated metal pipe (CMP) riser on the waterside (WS) slope. 4-foot by 6-foot concrete distribution box on the landside (LS) toe. 5-foot by 5-foot concrete riser on the WS toe. [Additional Reference(s): DWR Levee Log, 2005. USACE San Joaquin O&M Manual 5, August 1961, (HLM 1.31)]. FS Date: 9/24/2013

Slide gate in 48-inch CMP riser on WS slope.

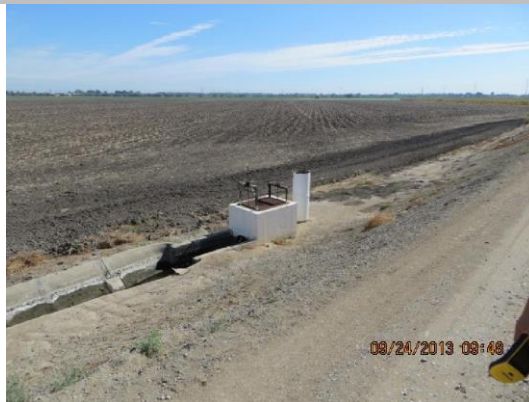
Photo 2 of 2 : UCIP_FA_2017_20889_35212.jpg

Concrete distribution box at concrete canal on LS toe.

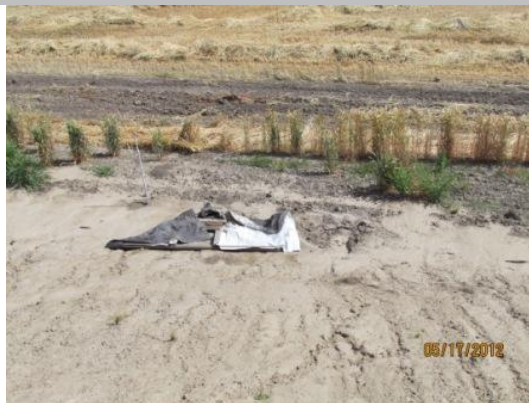
Photo 1 of 2 : FA_2017_RD2092_116_10_20170921_00002.jpg

LM Start	1.32	Rating **	A/W	Issue No.	10
LM End	1.32	Issue Type +	Ma	Location *	LS
Category	Earthen Levee			GPS Latitude/Longitude	
				Start	End
Item	Encroachments			37.590467 °	37.590467 °
				-121.163822 °	-121.163822 °
DWR ID	DWR_RD2092_01_s_2012_10				
Comment Code					
PI : Pipe					
Inspector Comment					
A sand boil appeared on the landside toe of the levee because of an underground pipe leakage. The pipe and boil have been repaired but should be monitored.

During spring inspection 2012, the sand boil was not active but materials were present on the landside toe of the levee. The sand boil occurred due to an underground irrigation pipe leakage. The picture was taken from the crown looking toward the toe of the levee. The area was repaired but should be monitored.

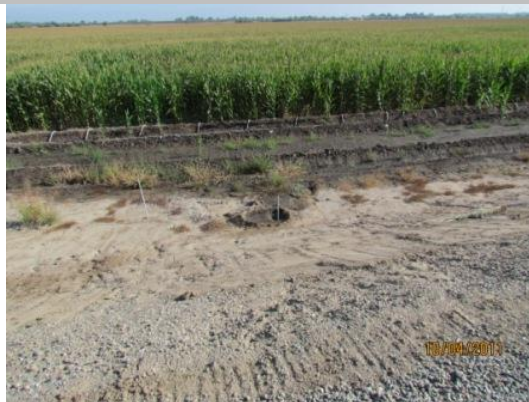
Photo 2 of 2 : FA_2017_RD2092_116_10_20170921_00003.jpg

A sand boil was found on the landside of the levee. It was caused by a pipe leak couple of feet below the boil location. LMA was notified to repair it as soon as possible. The picture was taken from the crown looking upstream.

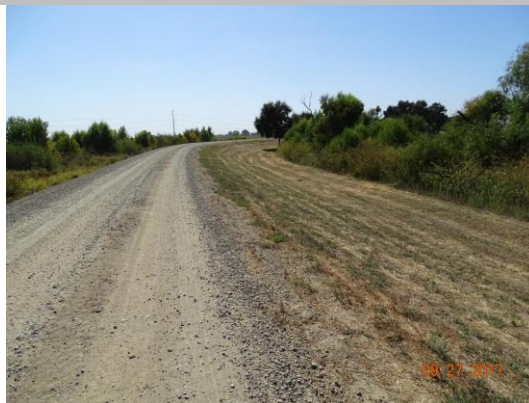
Photo 1 of 1 : FA_2017_RD2092_116_19_20170928_00059.jpg

View of the vegetation on the waterside slope of the levee looking upstream. Fall 2017

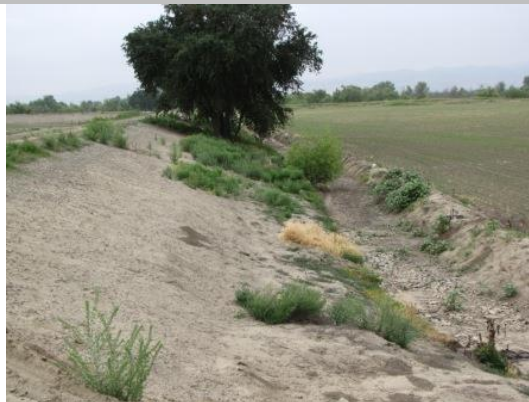
Photo 1 of 1 : FA_2017_RD2092_116_8_20170921_00001.jpg

View of an agricultural ditch at the waterward toe of the slope.

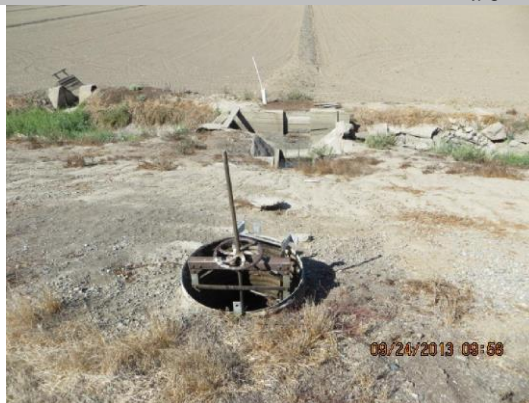
Photo 1 of 3 : UCIP_FA_2017_20891_35216.jpg

LM Start	1.69	Rating **	A/W	Issue No.	977
LM End	1.69	Issue Type +	Ma	Location *	
Category	Supplemental			GPS Latitude/Longitude	
				Start	End
Item	DWR UCIP LMA Responsibility			37.585938 °	37.585938 °
				-121.163348 °	-121.163348 °
DWR ID					
Comment Code					
Inspector Comment					
FS_ID:20891					
DS_ID:20563					
EP_NO: N/A					
Repair Type: No Action Needed					
Crossing Status: Found					
UCIP Comments:					
FIELD_STRUCT_DESC: 24-inch corrugated metal drainage pipe through the levee, 14 feet below the crown. Slide gate in a corrugated metal pipe (CMP) riser on the waterside (WS) slope. Concrete U-shaped headwall at the landside (LS) toe. [Additional Reference(s): DWR Levee Log, 2005. USACE San Joaquin O&M Manual 5, August 1961, (HLM 1.71)].					
FS Date: 9/24/2013

Slide gate in 36-inch CMP riser on WS slope.

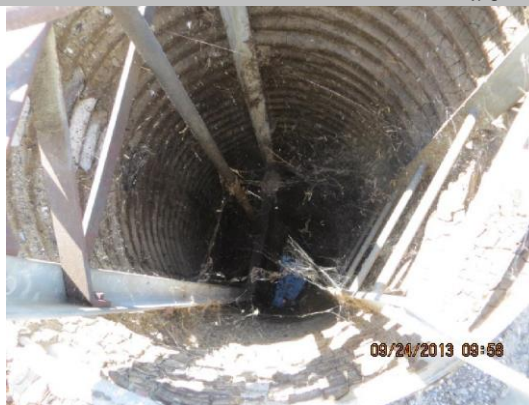
Photo 2 of 3 : UCIP_FA_2017_20891_35215.jpg

Slide gate in 36-inch CMP riser on WS slope.

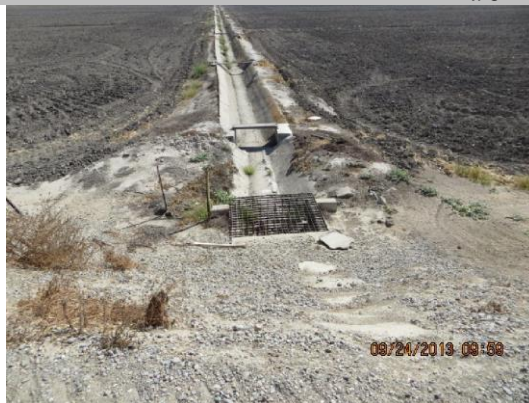
Photo 3 of 3 : UCIP_FA_2017_20891_35214.jpg

Concrete headwall at base of LS toe.

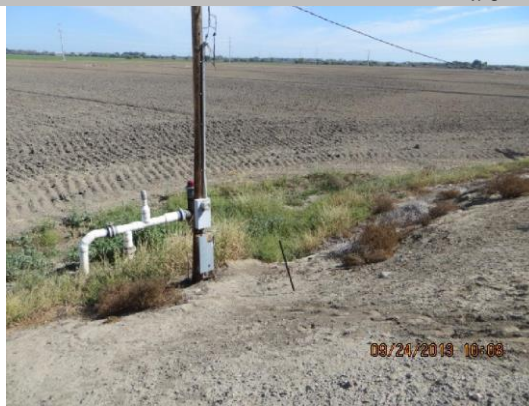
Photo 1 of 2 : UCIP_FA_2017_20904_35221.jpg

LM Start	2.07	Rating **	A/W	Issue No.	978
LM End	2.07	Issue Type +	Ma	Location *	
Category	Supplemental			GPS Latitude/Longitude	
				Start	End
Item	DWR UCIP LMA Responsibility			37.584212 °	37.584212 °
				-121.158347 °	-121.158347 °
DWR ID					
Comment Code					
Inspector Comment					
FS_ID:20904 DS_ID:20564 EP_NO: N/A Repair Type: No Action Needed Crossing Status: Found UCIP Comments: FIELD_STRUCT_DESC: *ABANDONED* 30-inch corrugated metal drainage pipe through the levee, 15 feet below the crown. Flap gate on the waterside (WS) end. Concrete U-shaped headwalls on both ends. Filled with concrete on the landside (LS) toe. [Additional Reference(s): DWR Levee Log, 2005. USACE San Joaquin O&M Manual 5, August 1961, (HLM 2.10), 36-inch pipe listed]. FS Date: 9/24/2013

Pipe and concrete headwall visible on LS toe to right of powerpole.

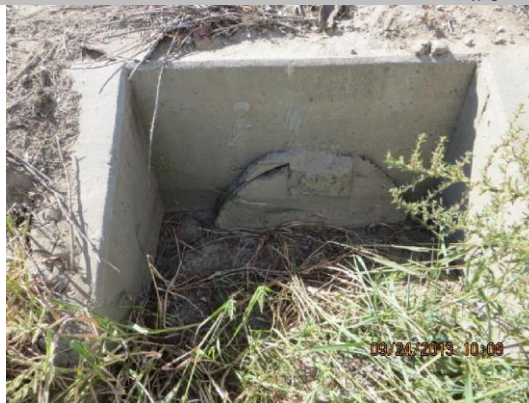
Photo 2 of 2 : UCIP_FA_2017_20904_35220.jpg

Pipe and concrete headwall visible on LS toe.

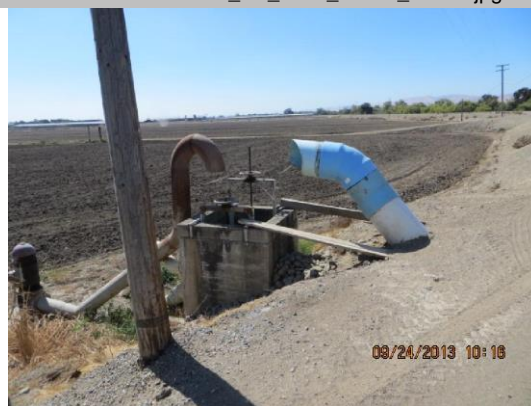
Photo 1 of 3 : UCIP_FA_2017_22916_39046.jpg

LM Start	2.34	Rating **	M	Issue No.	979	
LM End	2.34	Issue Type +	En	Location *		
Category	Supplemental			GPS Latitude/Longitude		
				Start	End	
Item	DWR UCIP Field Study			37.581226°	37.581226°	
				-121.156175°	-121.156175°	
DWR ID						
Comment Code						
Inspector Comment						
FS_ID:22916						
DS_ID:24680						
EP_NO: N/A						
Repair Type: Non-Urgent						
Crossing Status: Found						
UCIP Comments: No permit identified for this crossing.						
FIELD_STRUCT_DESC: 21-inch polyvinyl chloride (PVC) irrigation pipe						
through the levee, at an unknown depth. Pipe discharges into a						
concrete distribution box on the landside (LS) toe. Pump on pier off the						
waterside (WS) toe. [Additional Reference(s): DWR Levee Log, 2005].						
FS Date: 9/24/2013

21-inch PVC irrigation pipe visible on LS shoulder.

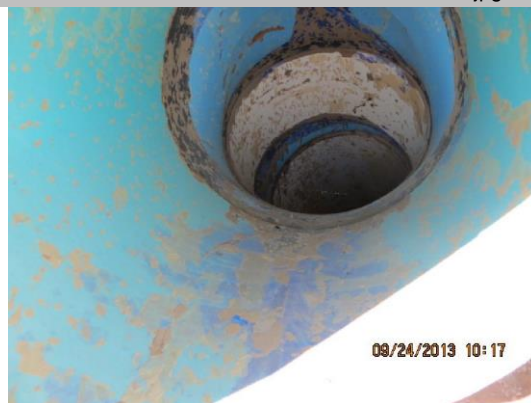
Photo 2 of 3 : UCIP_FA_2017_22916_39045.jpg

Inside of pipe at LS shoulder.

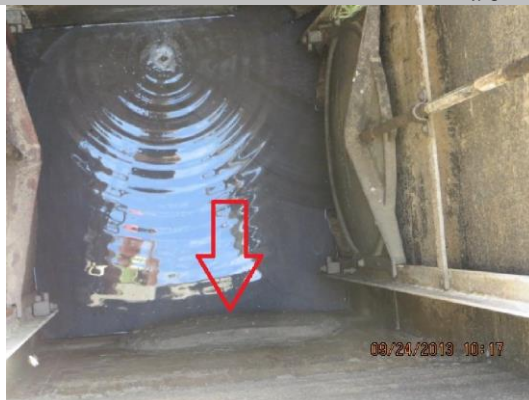
Photo 2 of 3 : UCIP_FA_2017_20908_35227.jpg

Comment Code						
Inspector Comment						
FS_ID:20908 DS_ID:20566 EP_NO: N/A Repair Type: Non-Urgent Crossing Status: Found UCIP Comments: Pipe appears abandoned and needs to be verified as having been done so properly. FIELD_STRUCT_DESC: *ABANDONED* 24-inch corrugated metal irrigation pipe through the levee, 11 feet below the crown. Slide gate in a 36-inch corrugated metal pipe (CMP) riser on the waterside (WS) slope. 5-foot by 5-foot concrete distribution box on the landside (LS). Pump on platform in the channel. Pipe filled with concrete on the LS toe. [Additional Reference(s): DWR Levee Log, 2005. USACE San Joaquin O&M Manual 5, August 1961, (HLM 2.38)]. FS Date: 9/24/2013

Pipe filled with concrete inside conc. distro box on LS toe.

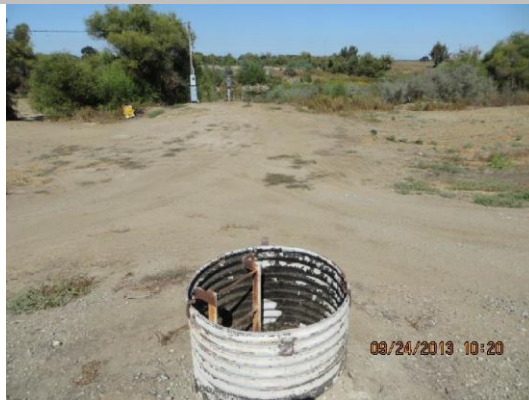
Photo 3 of 3 : UCIP_FA_2017_20908_35223.jpg

36-inch CMP riser on WS slope.

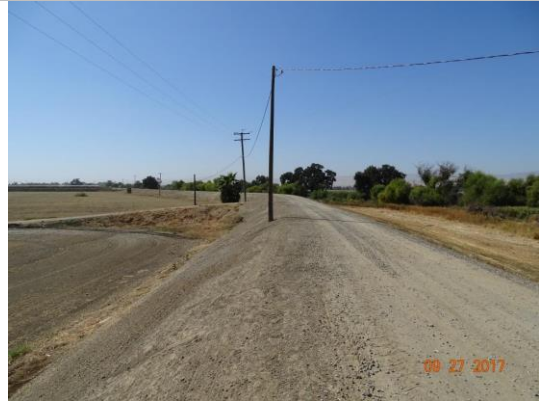
Photo 1 of 1 : FA_2017_RD2092_116_20_20170928_00060.jpg

View of the pole on the landside slope of the levee looking upstream.

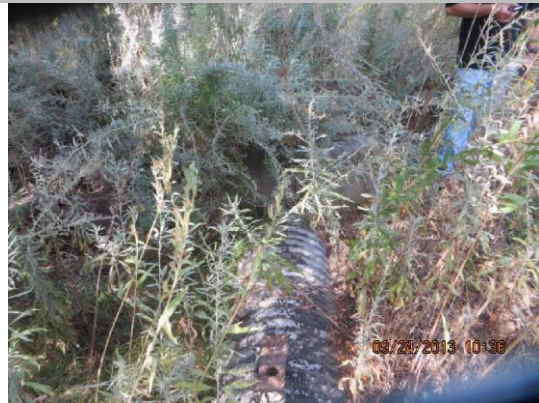
Photo 1 of 3 : UCIP_FA_2017_20943_35251.jpg

LM Start	2.40	Rating **	M	Issue No.	981
LM End	2.40	Issue Type +	Ma	Location *	
Category	Supplemental			GPS Latitude/Longitude	
				Start	End
Item	DWR UCIP LMA Responsibility			37.580426 °	37.580426 °
				-121.156798 °	-121.156798 °
DWR ID					
Comment Code					
Inspector Comment					
FS_ID:20943 DS_ID:20567 EP_NO: N/A Repair Type: Non-Urgent Crossing Status: Found UCIP Comments: Appears abandoned and if so should be done so properly. FIELD_STRUCT_DESC: *ABANDONED* 24-inch corrugated metal drainage pipe through the levee, 15 feet below the crown. Flap gate on the waterside (WS) end. Concrete U-shaped headwall on the WS end. Concrete headwall on the landside (LS) toe next to pump. [Additional Reference(s): DWR Levee Log, 2005. USACE San Joaquin O&M Manual 5, August 1961, (HLM 2.44)]. FS Date: 9/24/2013

24-inch pipe visible on WS berm.

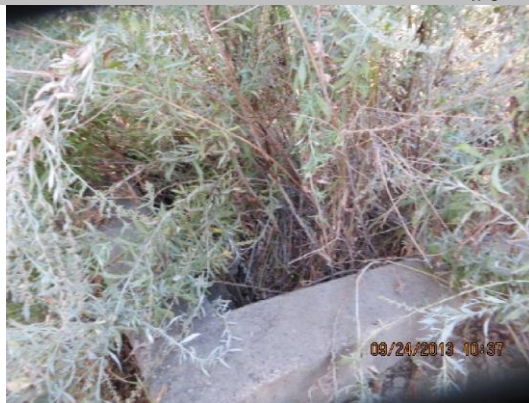
Photo 2 of 3 : UCIP_FA_2017_20943_35250.jpg

Concrete U-shaped headwall and flapgate on WS berm.

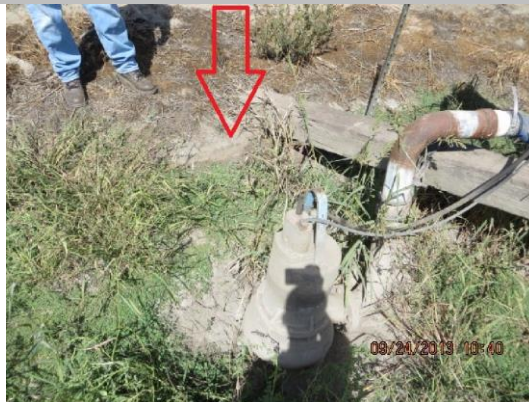
Photo 3 of 3 : UCIP_FA_2017_20943_35252.jpg

Concrete headwall next to pump on WS toe.

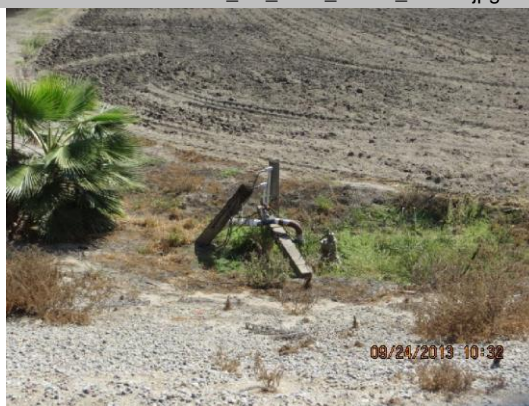
Photo 1 of 3 : UCIP_FA_2017_20923_35234.jpg

LM Start	2.41	Rating **	M	Issue No.	982
LM End	2.41	Issue Type +	En	Location *	
Category	Supplemental			GPS Latitude/Longitude	
				Start	End
Item	DWR UCIP Field Study			37.580405 °	37.580405 °
				-121.156825 °	-121.156825 °
DWR ID					
Comment Code					
Inspector Comment					
FS_ID:20923					
DS_ID:20568					
EP_NO: N/A					
Repair Type: Non-Urgent					
Crossing Status: Indicator Found					
UCIP Comments: Pipe abandoned and should be verified as having been removed from the levee.					
FIELD_STRUCT_DESC: *ABANDONED* 4-inch drainage pipe of an unknown material through the levee, 1 foot below the crown. Pump on sump at the landside (LS) toe. Roadway extending to the LS pump.					
[Additional Reference(s): DWR Levee Log, 2005].					
FS Date: 9/24/2013

Pump and 4-inch pipe visible at LS toe.

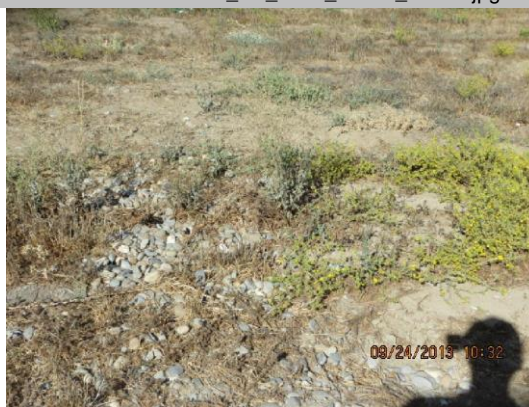
Photo 2 of 3 : UCIP_FA_2017_20923_35233.jpg

Gravel on WS slope appears to indicate trench.

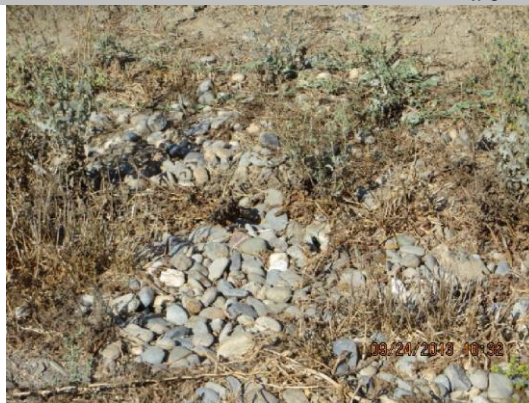
Photo 3 of 3 : UCIP_FA_2017_20923_35232.jpg

Gravel on WS slope appears to indicate trench.

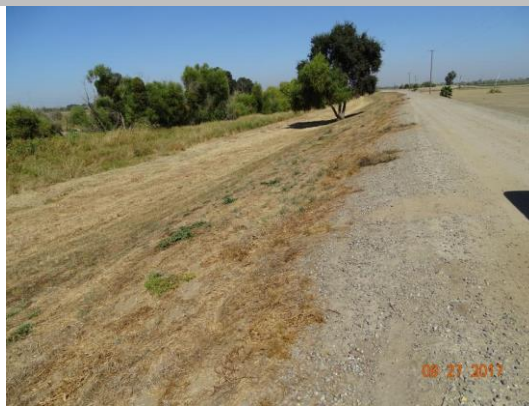
Photo 1 of 2 : FA_2017_RD2092_116_36_20170928_00062.jpg

LM Start	2.61	Rating **	A	Issue No.	36
LM End	2.61	Issue Type +	Ma	Location *	WS
Category	Earthen Levee			GPS Latitude/Longitude	
				Start	End
Item	Animal Control			37.577522°	37.577522°
				-121.157126°	-121.157126°
DWR ID	DWR_RD2092_01_s_2017_36				
Comment Code					
A3 : No rodents visible, but rodent burrows visible; need to backfill and compact or grout burrows.					
Inspector Comment					
LMA repaired the rodent hole at this location.

LMA repaired a few rodent holes on the waterside slope of the levee looking downstream. Fall 2017

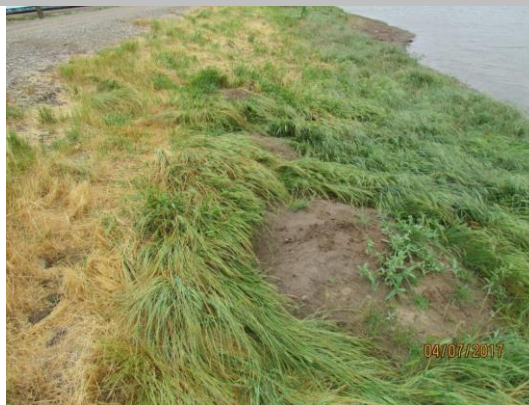
Photo 2 of 2 : FA_2017_RD2092_116_36_20170921_00010.jpg

View of a rodent hole on the waterside slope of the levee.

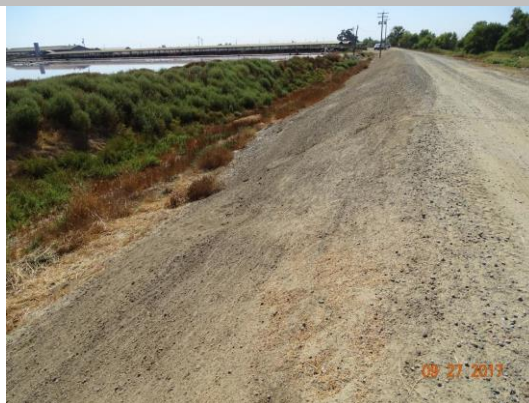
Photo 1 of 2 : FA_2017_RD2092_116_34_20170928_00061.jpg

LM Start	2.62	Rating **	A	Issue No.	34
LM End	2.62	Issue Type +	Ma	Location *	LS
Category	Earthen Levee			GPS Latitude/Longitude	
				Start	End
Item	Animal Control			37.577364 °	37.577364 °
				-121.157131 °	-121.157131 °
DWR ID	DWR_RD2092_01_s_2017_34				
Comment Code					
A3 : No rodents visible, but rodent burrows visible; need to backfill and compact or grout burrows.					
Inspector Comment					
LMA repaired the rodent holes at this location.

View of the landside slope of the levee where the LMA repaired a few rodent holes. Fall 2017

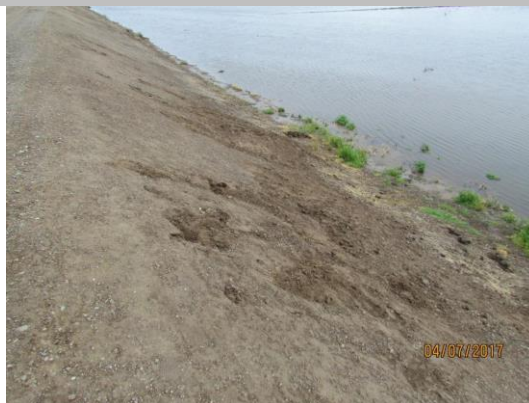
Photo 2 of 2 : FA_2017_RD2092_116_34_20170921_00008.jpg

View of rodent holes on the landside slope of the levee looking downstream. Spring 2017

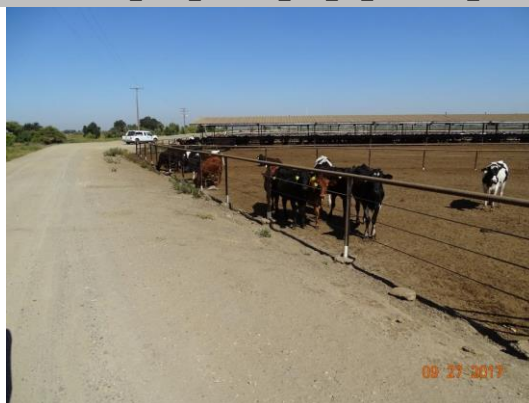
Photo 1 of 1 : FA_2017_RD2092_116_27_20170928_00063.jpg

View of a fence on the landside toe of the levee looking downstream.

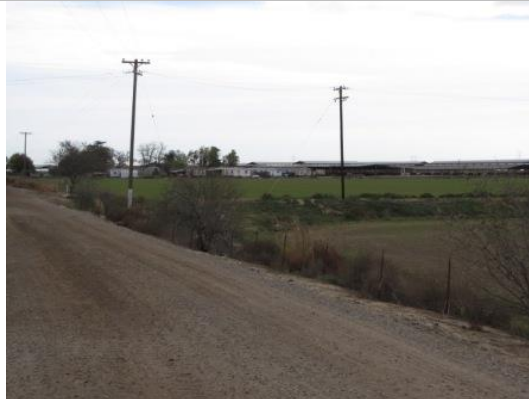
Photo 1 of 1 : FA_2017_RD2092_116_972_20170921_00013.jpg

View of barbed wire fence along the waterward slope looking upstream.

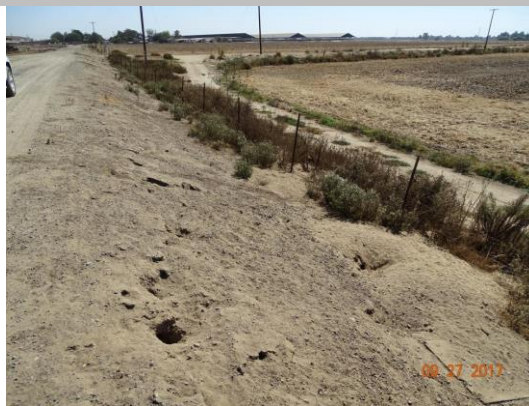
Photo 1 of 2 : FA_2017_RD2092_116_35_20170928_00064.jpg

Updated picture of the rodent holes on the waterside of the levee looking upstream. Fall 2017

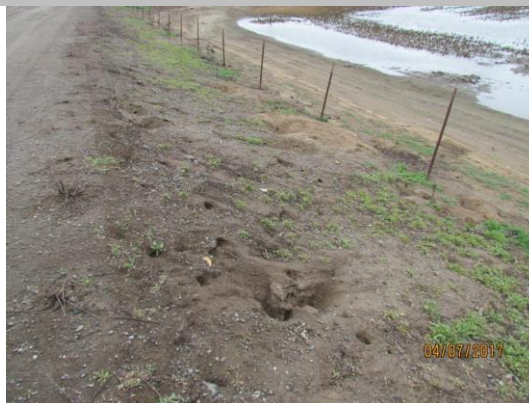
Photo 2 of 2 : FA_2017_RD2092_116_35_20170921_00009.jpg

View of multiple rodent holes on the waterside slope of the levee. Spring 2017

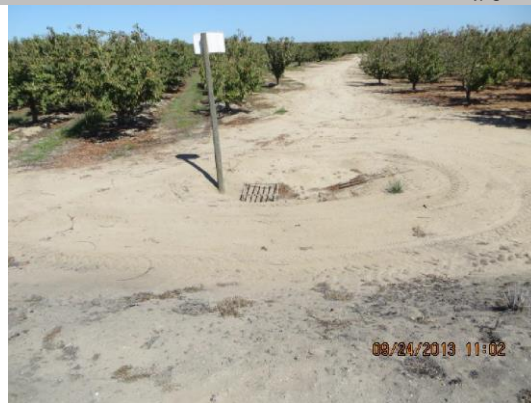
Photo 2 of 3 : UCIP_FA_2017_20945_35260.jpg

LM Start	3.47	Rating **	M	Issue No.	984 (cont)	
LM End	3.47	Issue Type +	Ma	Location *		
Category	Supplemental			GPS Latitude/Longitude		
				Start		End
Item	DWR UCIP LMA Responsibility			37.573304 °	37.573304 °	
				-121.144747 °	-121.144747 °	
DWR ID						
Comment Code						
Inspector Comment						
FS_ID:20945 DS_ID:20572 EP_NO: N/A Repair Type: Non-Urgent Crossing Status: Found UCIP Comments: This pipe appears abandoned and if so, should be done so properly. FIELD_STRUCT_DESC: *ABANDONED* 36-inch corrugated metal drainage pipe through the levee, 11 feet below the crown. Slide gate in a corrugated metal pipe (CMP) riser on the waterside (WS) slope. Concrete headwalls on both ends. [Additional Reference(s): DWR Levee Log, 2005. USACE San Joaquin O&M Manual 5, August 1961, (HLM 3.52)]. FS Date: 9/24/2013

Grate over sump on LS toe.

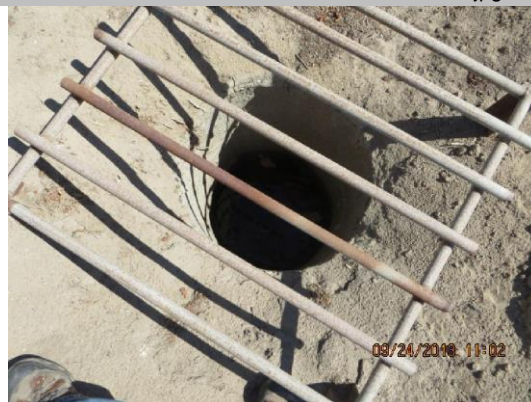
Photo 3 of 3 : UCIP_FA_2017_20945_35262.jpg

Grate over sump on LS toe.
