**Flood Control Project Maintenance
Levee Inspections**

Fall 2019 Levee Maintenance Deficiency Summary Report

San Joaquin River Basin

Reclamation District No. 2092 Dos Rios

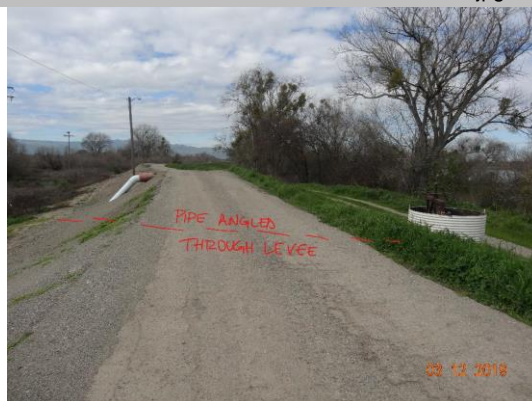
Photo 1 of 3 : UCIP_FA_2019_53799_79055.jpg

Comment Code						
Inspector Comment						
DS_ID:20561 FS_ID:53799 EP_NO: N/A Repair Type: Urgent Crossing Status: Found UCIP Comments: 03/12/2019 A thorough internal evaluation of this crossing is necessary. Pipe shows evidence of pipe integrity (LS) issues (pipe wall sections missing on LS inlet) and levee integrity issues (sink hole visible along LS pipe alignment). Internal inspection is recommended for this crossing to determine the extent of pipe damage through the levee. Pipe crosses the levee at an angle at a depth of about 19 feet. Recommend caution be taken at this crossing when driving over levee until additional information becomes available to determine condition of pipe through levee. Recommend cover be placed on riser to address safety concern (riser is 80 inches in diameter and about 19 feet deep). Slide gate appears to be blocked by sediment/debris preventing slide gate to work properly. Unable to confirm if the flap gate located on the WS is still broken (see photo from 2017). (O. Magana - DWR UCIP)09/24/2013 Pipe rusted through at headwall on LS toe. Good candidate for video inspection. (W. Wylie - DWR UCIP) FIELD_STRUCT_DESC: 60-inch corrugated metal drainage pipe through the levee, 19 feet below the crown. Flap gate on the waterside (WS) end. Slide gate in an 80-inch corrugated metal pipe (CMP) riser on the WS slope. Concrete U-shaped headwalls on both ends. [Additional Reference(s): DWR Levee Log, 2005. USACE San Joaquin O&M Manual 5, August 1961, (HLM 0.18)]. FS Date: 3/12/2019 12:05:00 PM

Overview of levee with approximate pipe alignment (pipe angled through levee).

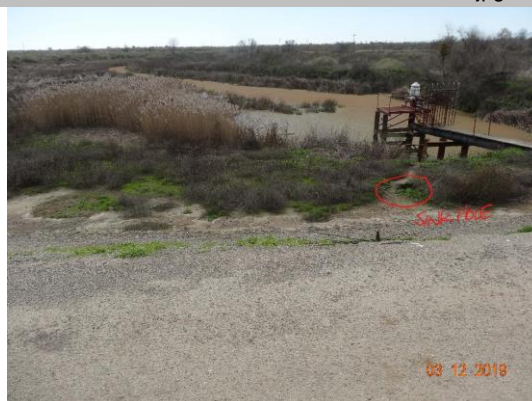
Photo 2 of 3 : UCIP_FA_2019_53799_79054.jpg

Comment Code						
Inspector Comment						
DS_ID:20561 FS_ID:53799 EP_NO: N/A Repair Type: Urgent Crossing Status: Found UCIP Comments: 03/12/2019 A thorough internal evaluation of this crossing is necessary. Pipe shows evidence of pipe integrity (LS) issues (pipe wall sections missing on LS inlet) and levee integrity issues (sink hole visible along LS pipe alignment). Internal inspection is recommended for this crossing to determine the extent of pipe damage through the levee. Pipe crosses the levee at an angle at a depth of about 19 feet. Recommend caution be taken at this crossing when driving over levee until additional information becomes available to determine condition of pipe through levee. Recommend cover be placed on riser to address safety concern (riser is 80 inches in diameter and about 19 feet deep). Slide gate appears to be blocked by sediment/debris preventing slide gate to work properly. Unable to confirm if the flap gate located on the WS is still broken (see photo from 2017). (O. Magana - DWR UCIP)09/24/2013 Pipe rusted through at headwall on LS toe. Good candidate for video inspection. (W. Wylie - DWR UCIP) FIELD_STRUCT_DESC: 60-inch corrugated metal drainage pipe through the levee, 19 feet below the crown. Flap gate on the waterside (WS) end. Slide gate in an 80-inch corrugated metal pipe (CMP) riser on the WS slope. Concrete U-shaped headwalls on both ends. [Additional Reference(s): DWR Levee Log, 2005. USACE San Joaquin O&M Manual 5, August 1961, (HLM 0.18)]. FS Date: 3/12/2019 12:05:00 PM

LS view: overview of LS with sink hole visible along pipe alignment.

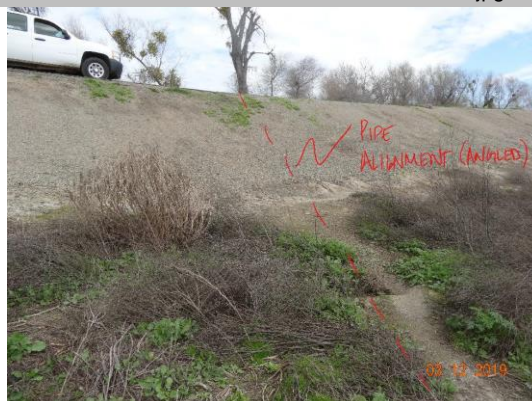
Photo 3 of 3 : UCIP_FA_2019_53799_79058.jpg

Comment Code						
Inspector Comment						
DS_ID:20561 FS_ID:53799 EP_NO: N/A Repair Type: Urgent Crossing Status: Found UCIP Comments: 03/12/2019 A thorough internal evaluation of this crossing is necessary. Pipe shows evidence of pipe integrity (LS) issues (pipe wall sections missing on LS inlet) and levee integrity issues (sink hole visible along LS pipe alignment). Internal inspection is recommended for this crossing to determine the extent of pipe damage through the levee. Pipe crosses the levee at an angle at a depth of about 19 feet. Recommend caution be taken at this crossing when driving over levee until additional information becomes available to determine condition of pipe through levee. Recommend cover be placed on riser to address safety concern (riser is 80 inches in diameter and about 19 feet deep). Slide gate appears to be blocked by sediment/debris preventing slide gate to work properly. Unable to confirm if the flap gate located on the WS is still broken (see photo from 2017). (O. Magana - DWR UCIP)09/24/2013 Pipe rusted through at headwall on LS toe. Good candidate for video inspection. (W. Wylie - DWR UCIP) FIELD_STRUCT_DESC: 60-inch corrugated metal drainage pipe through the levee, 19 feet below the crown. Flap gate on the waterside (WS) end. Slide gate in an 80-inch corrugated metal pipe (CMP) riser on the WS slope. Concrete U-shaped headwalls on both ends. [Additional Reference(s): DWR Levee Log, 2005. USACE San Joaquin O&M Manual 5, August 1961, (HLM 0.18)]. FS Date: 3/12/2019 12:05:00 PM

LS view: pipe crosses levee at angle, approximate alignment on LS.

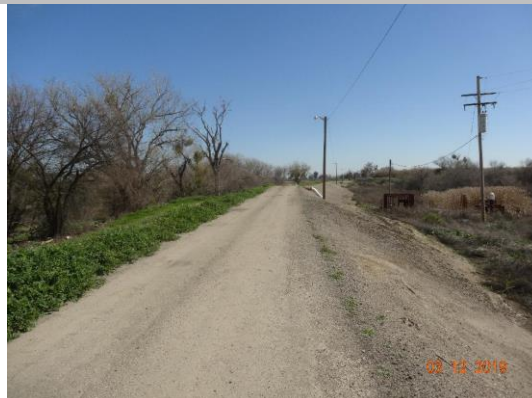
Photo 1 of 3 : UCIP_FA_2019_53815_79066.jpg

Comment Code					
Inspector Comment					
DS_ID:20581 FS_ID:53815 EP_NO: 6254A Repair Type: Non-Urgent Crossing Status: Found UCIP Comments: 03/12/2019 Pipe has been altered on both WS and LS. A PVC pipe has been sleeved through an existing 22-inch pipe, no records have been found approving modification. This crossing appears abandoned, power source and power meter have been disconnected. Need to coordinate with CVFPB and owner. Crossing should be removed/abandoned properly per Title 23. (O. Magana - DWR UCIP) FIELD_STRUCT_DESC: *ABANDONED* 22-inch steel drainage pipe through the levee, 0.5 feet below the crown. 18-inch polyvinyl chloride (PVC) pipe sleeved through the 22-inch steel pipe. 6-inch pad constructed over the pipes. This pumping plant was constructed in 1969 during emergency conditions without a permit. Replaced a 20-inch pipe at the same location. [Additional Reference(s): DWR Levee Log, 2005]. FS Date: 3/12/2019 12:05:00 PM

Overview of levee looking d/s towards crossing.

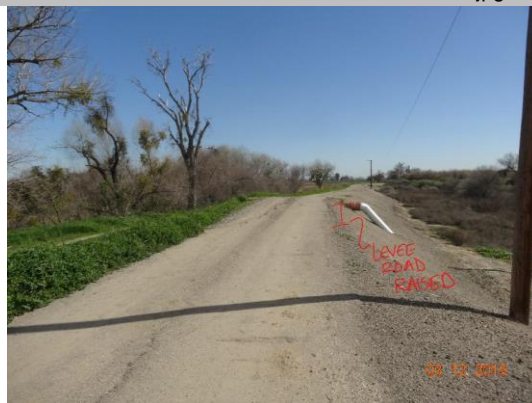
Photo 2 of 3 : UCIP_FA_2019_53815_79067.jpg

Crown view: levee section raised at pipe crossing.

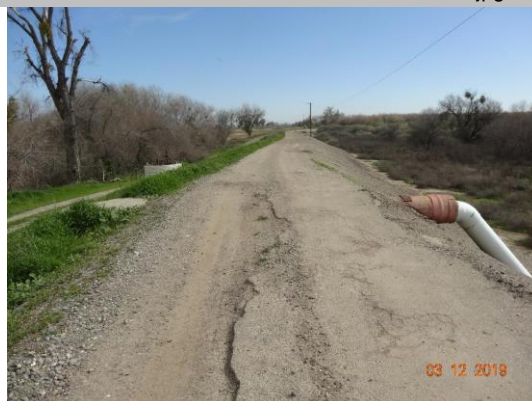
Photo 3 of 3 : UCIP_FA_2019_53815_79064.jpg

Comment Code						
Inspector Comment						
DS_ID:20581 FS_ID:53815 EP_NO: 6254A Repair Type: Non-Urgent Crossing Status: Found UCIP Comments: 03/12/2019 Pipe has been altered on both WS and LS. A PVC pipe has been sleeved through an existing 22-inch pipe, no records have been found approving modification. This crossing appears abandoned, power source and power meter have been disconnected. Need to coordinate with CVFPB and owner. Crossing should be removed/abandoned properly per Title 23. (O. Magana - DWR UCIP) FIELD_STRUCT_DESC: *ABANDONED* 22-inch steel drainage pipe through the levee, 0.5 feet below the crown. 18-inch polyvinyl chloride (PVC) pipe sleeved through the 22-inch steel pipe. 6-inch pad constructed over the pipes. This pumping plant was constructed in 1969 during emergency conditions without a permit. Replaced a 20-inch pipe at the same location. [Additional Reference(s): DWR Levee Log, 2005]. FS Date: 3/12/2019 12:05:00 PM

Overview of levee crown at pipe crossing, photo taking looking d/s.

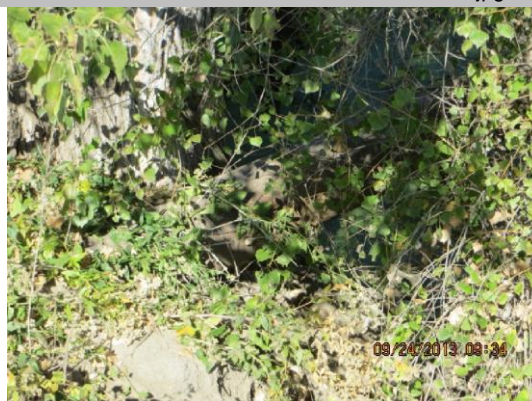
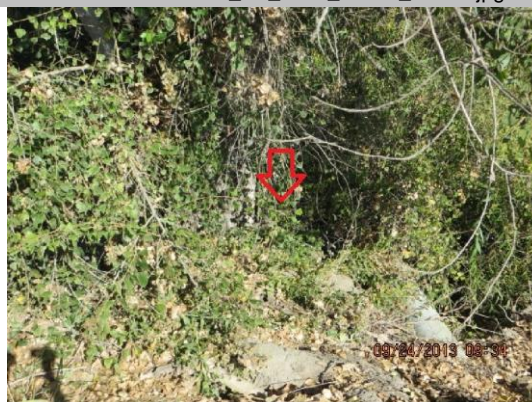
Comment Code						
Inspector Comment						
DS_ID:20579 FS_ID:53830 EP_NO: 6254 Repair Type: Non-Urgent Crossing Status: Not Found UCIP Comments: 03/12/2019 Need to confirm the status of the crossing through levee section. Levee logs indicate 14-inch pipe was removed in 2003 however, no documentation detailing extent of removal is available. Potential evidence of pipe recorded by UCIP Inspector W. Wylie in 2013. Unable to access WS toe due to high water, recommend inspecting crossing in early fall. (O. Magana - DWR UCIP) 09/24/2013 Verify pipe has been removed from levee. Pipe visible on WS at riverbank. (W. Wylie - DWR UCIP) FIELD_STRUCT_DESC: *ABANDONED* 16-inch steel drainage pipe over the levee with 3.5 feet of the fill on the top. Siphon breakers on the waterside (WS) shoulder. Pad constructed over pipes. This pumping plant was constructed in 1969 during emergency conditions without a permit. (20-inch pipe authorized to replace unauthorized 20-inch pipe and the removal of existing 12-inch and 14-inch pipe from levee section, work authorized under Permit No. 6254, 1968 - John and Robert Bogetti). [Additional Reference(s): DWR Levee Log, 2005]. FS Date: 3/12/2019 12:06:00 PM

Pipe visible at rivers edge on WS toe.

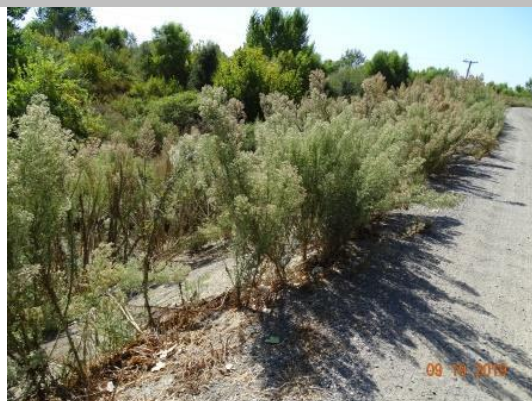
Photo 1 of 1 : FA_2019_RD2092_116_41_20190924_00067.jpg

View of vegetation along landside slope looking upstream. (Fall 2019)

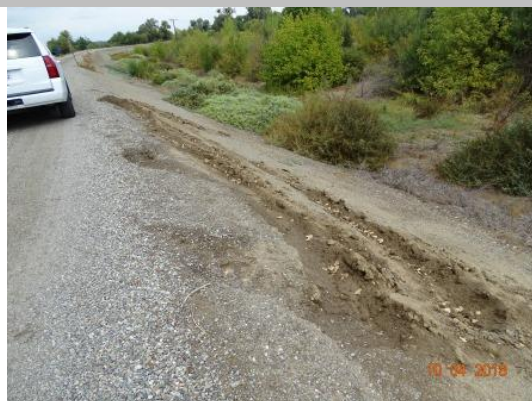
Photo 1 of 1 : FA_2019_RD2092_116_40_20190912_00017.jpg

LM Start	0.59	Rating **	M	Issue No.	40
LM End	0.59	Issue Type +	Ma	Location *	LS
Category	Earthen Levee			GPS Latitude/Longitude	
				Start	End
Item	Slope Stability			37.599406 °	37.599406 °
				-121.167083 °	-121.167083 °
DWR ID	DWR_RD2092_01_f_2018_40				
Comment Code					
S3 : Repair the levee slope damaged by vehicle traffic and prevent access where possible.					
Inspector Comment					
Vehicle tracks on the landside slope should be repaired.

Vehicle tracks on landside slope approximately 6" deep perpendicular to the slope. (Fall 2018)

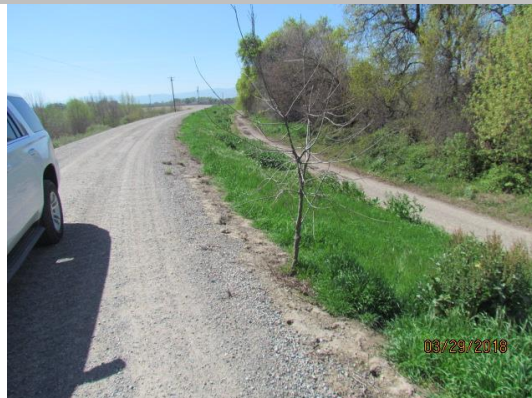
Photo 1 of 1 : FA_2019_RD2092_116_21_20190912_00009.jpg

Looking downstream at small tree on waterward slope. (Spring 2018)

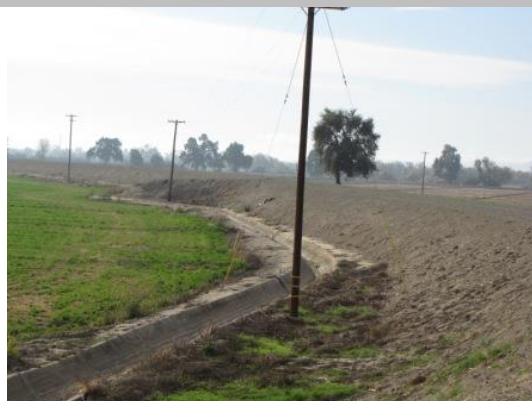
Photo 1 of 1 : FA_2019_RD2092_116_968_20190912_00023.jpg

LM Start	0.76	Rating **	M	Issue No.	968
LM End	1.31	Issue Type +	En	Location *	LS
Category	Earthen Levee			GPS Latitude/Longitude	
				Start	End
Item	Encroachments			37.597291 °	37.590568 °
				-121.168496 °	-121.164028 °
DWR ID	DWR_RD2092_01_s_2012_968				
Comment Code					
DT : Ditch					
Inspector Comment

View of agricultural ditch at the landward toe looking upstream.

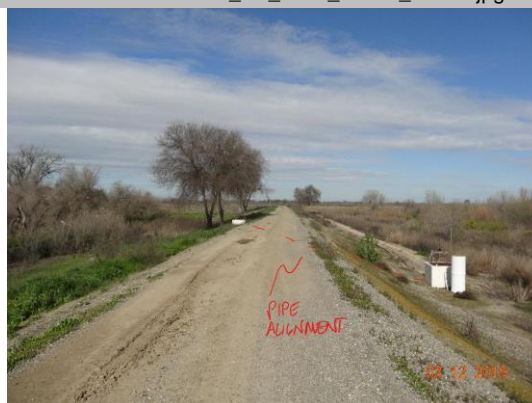
Photo 1 of 3 : UCIP_FA_2019_53820_79073.jpg

Comment Code						
Inspector Comment						
DS_ID:20562 FS_ID:53820 EP_NO: N/A Repair Type: Non-Urgent Crossing Status: Found UCIP Comments: 03/12/2019 During UCIP visual inspection, no pipe or levee integrity issues were observed. Distribution box located on the WS is falling apart (bricks missing). This crossing is an active crossing however, no permit has been found authorizing crossing. Need to determine who maintains and operates this crossing. (O. Magana - DWR UCIP) FIELD_STRUCT_DESC: 36-inch corrugated metal drainage pipe through the levee, 15 feet below the crown. Slide gate in a 48-inch corrugated metal pipe (CMP) riser on the waterside (WS) slope. 4-foot by 6-foot concrete distribution box on the landside (LS) toe. 5-foot by 5-foot concrete riser on the WS toe. [Additional Reference(s): DWR Levee Log, 2005. USACE San Joaquin O&M Manual 5, August 1961, (HLM 1.31)]. FS Date: 3/12/2019 12:06:00 PM

Overview of pipe alignment through levee, photo taking looking d/s toward crossing.

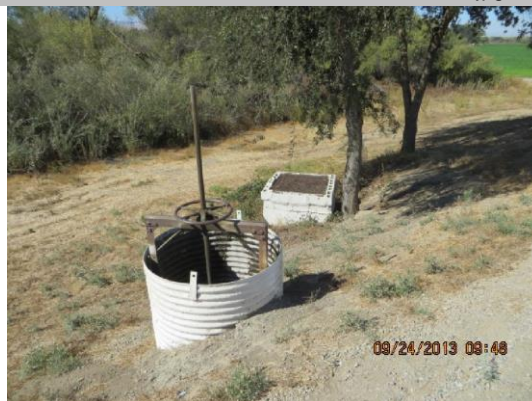
Photo 3 of 3 : UCIP_FA_2019_53820_35213.jpg

Slide gate in 48-inch CMP riser on WS slope.

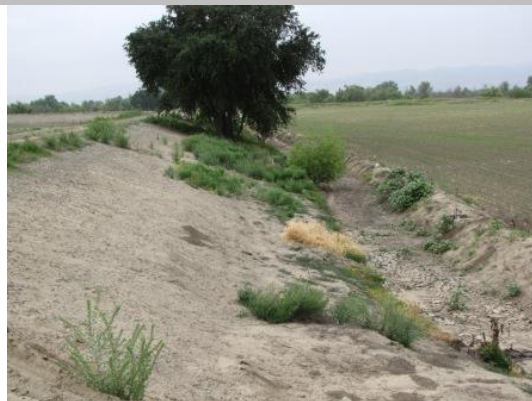
Photo 1 of 1 : FA_2019_RD2092_116_8_20190912_00001.jpg

View of an agricultural ditch at the waterward toe of the slope.

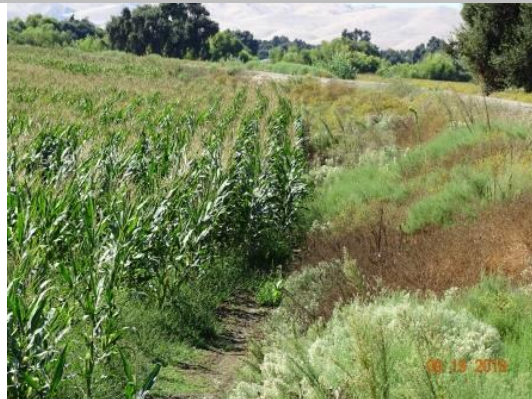
Photo 1 of 2 : FA_2019_RD2092_116_47_20190924_00068.jpg

LM Start	1.59	Rating **	U	Issue No.	47
LM End	2.15	Issue Type +	En	Location *	LS
Category	Earthen Levee			GPS Latitude/Longitude	
				Start	End
Item	Encroachments			37.587182°	37.583542°
				-121.162688°	-121.157028°
DWR ID	DWR_RD2092_01_f_2019_47				
Comment Code					
CR : Crops					
Inspector Comment

View of corn plant in landside easement along the levee toe. (Fall 2019)

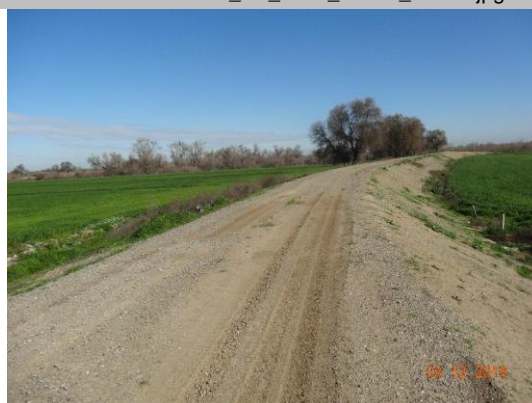
Photo 1 of 3 : UCIP_FA_2019_53817_79086.jpg

Comment Code					
Inspector Comment					
DS_ID:20563 FS_ID:53817 EP_NO: N/A Repair Type: Urgent Crossing Status: Found UCIP Comments: 03/12/2019 A thorough internal evaluation of this crossing is required, pipe shows evidence of pipe integrity (LS) issues (pipe wall sections missing on WS outlet). Internal inspection is recommended for this crossing to determine the extent of pipe damage through the levee. Maintenance issues identified at this crossing include: flap gate missing on WS, debris found inside concrete distribution box, and missing cover on riser. No permit has been identified for this crossing. Need to determine who maintains crossing; crossing appears functional. (O. Magana - DWR UCIP) FIELD_STRUCT_DESC: 24-inch corrugated metal drainage pipe through the levee, 14 feet below the crown. Slide gate in a corrugated metal pipe (CMP) riser on the waterside (WS) slope. Concrete U-shaped headwall at the landside (LS) toe. [Additional Reference(s): DWR Levee Log, 2005. USACE San Joaquin O&M Manual 5, August 1961, (HLM 1.71)]. FS Date: 3/12/2019 12:07:00 PM

Overview of levee crown looking d/s towards pipe crossing.

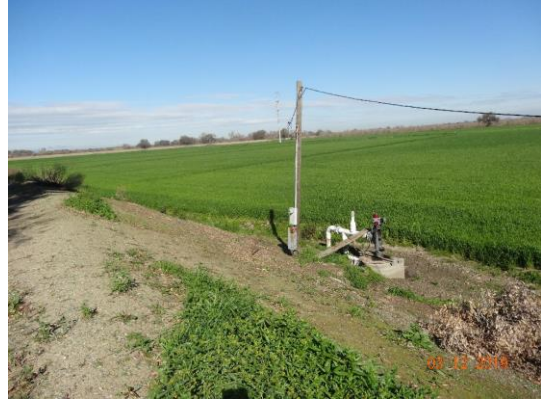
Photo 3 of 3 : UCIP_FA_2019_53814_79093.jpg

Comment Code						
Inspector Comment						
DS_ID:20564 FS_ID:53814 EP_NO: N/A Repair Type: Non-Urgent Crossing Status: Found UCIP Comments: 03/12/2019 Concrete headwall found on LS toe. Pipe appears to have been grouted through. No other appurtenances were found during inspection. WS outlet was not found. Need to coordinate with the CVFPB to determine if additional steps are needed to comply with Title 23. (O. Magana - DWR UCIP) FIELD_STRUCT_DESC: *ABANDONED* 30-inch corrugated metal drainage pipe through the levee, 15 feet below the crown. Flap gate on the waterside (WS) end. Concrete U-shaped headwalls on both ends. Filled with concrete on the landside (LS) toe. [Additional Reference(s): DWR Levee Log, 2005. USACE San Joaquin O&M Manual 5, August 1961, (HLM 2.10), 36-inch pipe listed]. FS Date: 3/12/2019 12:08:00 PM

LS view: concrete riser, power pole, and groundwater pump station.

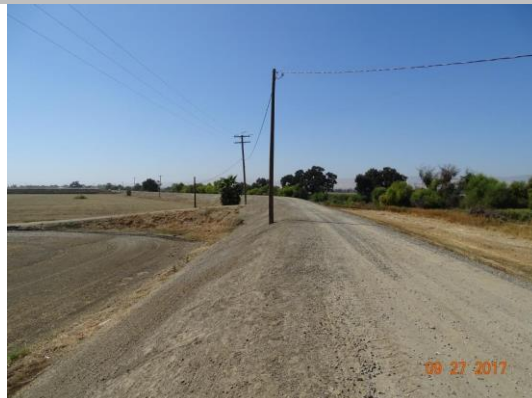
Photo 1 of 1 : FA_2019_RD2092_116_20_20190912_00008.jpg

View of the pole on the landside slope of the levee looking upstream.

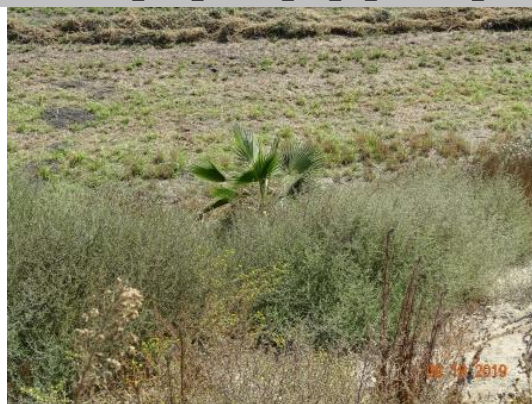
Photo 1 of 1 : FA_2019_RD2092_116_50_20190924_00071.jpg

View of palm tree in landside slope. (Fall 2019)

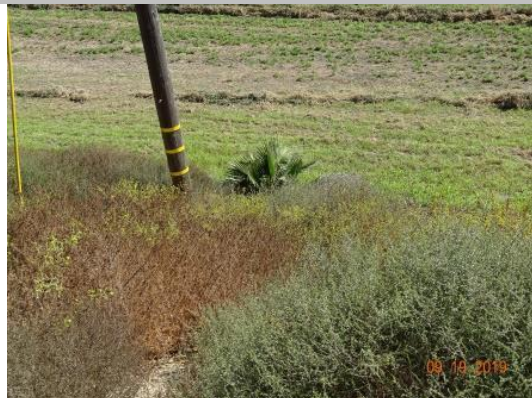
Photo 1 of 1 : FA_2019_RD2092_116_51_20190924_00072.jpg

View of palm tree growing in landside toe. (Fall 2019)

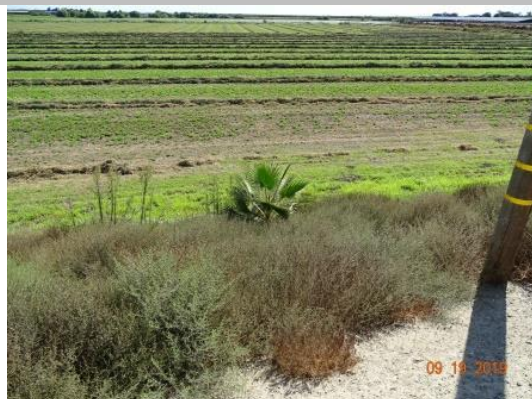
Photo 1 of 2 : FA_2019_RD2092_116_19_20190926_00076.jpg

View of palm tree growing on landside slope. (Fall 2019)

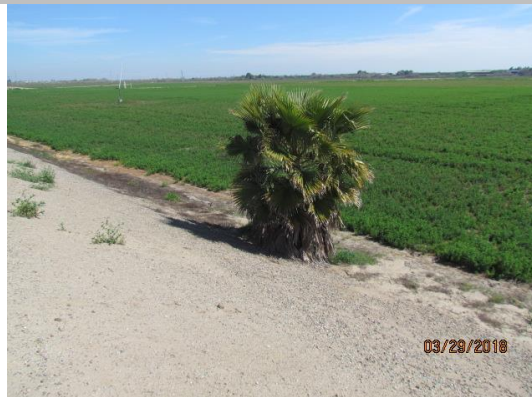
Photo 2 of 2 : FA_2019_RD2092_116_19_20190912_00007.jpg

Looking at Palm tree at landward toe. (Spring 2018)

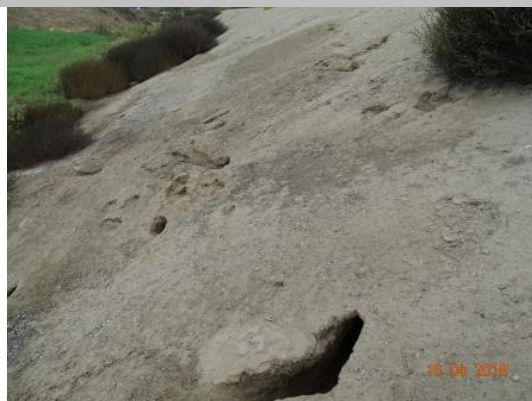
Photo 1 of 1 : FA_2019_RD2092_116_44_20190912_00020.jpg

View of animal burrows looking upstream. (Fall 2018)

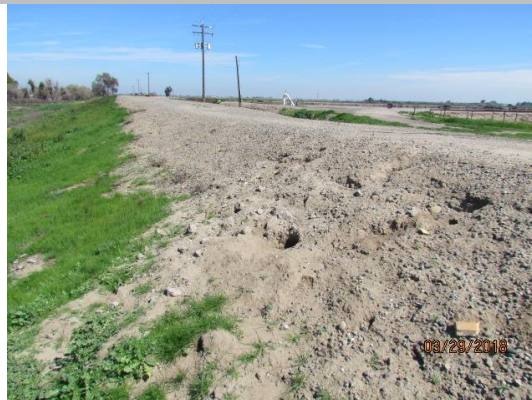
Photo 1 of 4 : FA_2019_RD2092_116_17_20190912_00003.jpg

Looking upstream on waterward slope at several large rodent holes.
(Spring 2018)

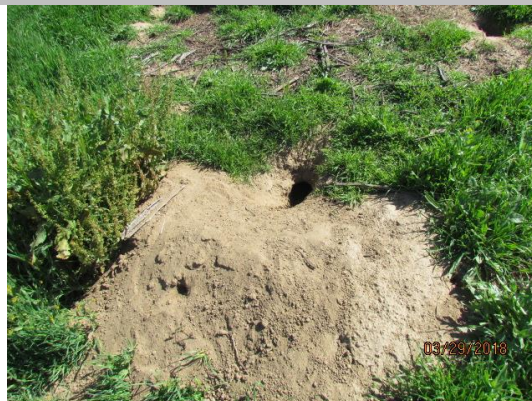
Photo 2 of 4 : FA_2019_RD2092_116_17_20190912_00004.jpg

Looking at typical large rodent holes on waterward slope. (Spring 2018)

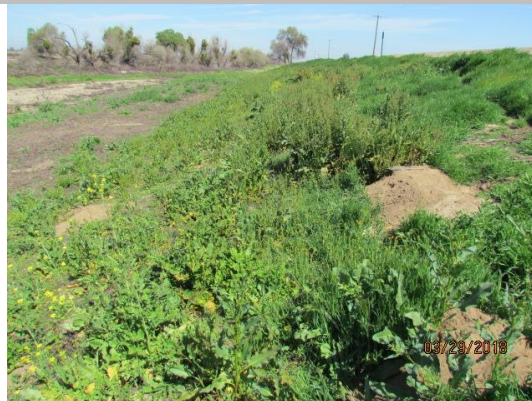
Photo 3 of 4 : FA_2019_RD2092_116_17_20190912_00005.jpg

Looking upstream at large rodent holes on waterward slope. (Spring 2018)

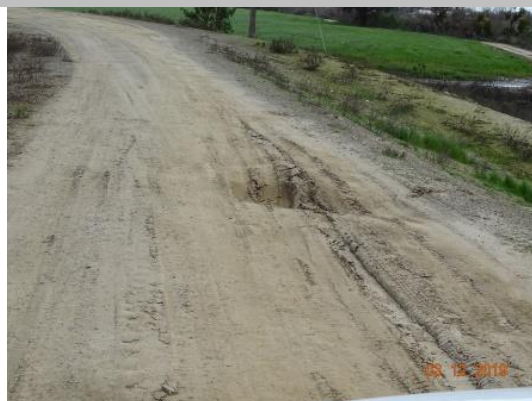
Photo 2 of 2 : FA_2019_RD2092_116_45_20190912_00022.jpg

View of depression in levee crown. (Spring 2019)

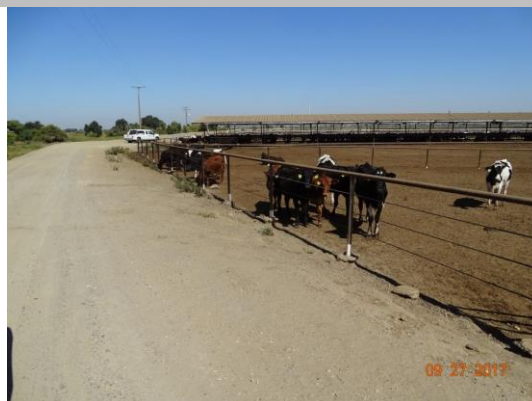
Photo 1 of 1 : FA_2019_RD2092_116_27_20190912_00010.jpg

View of a fence on the landside toe of the levee looking downstream.

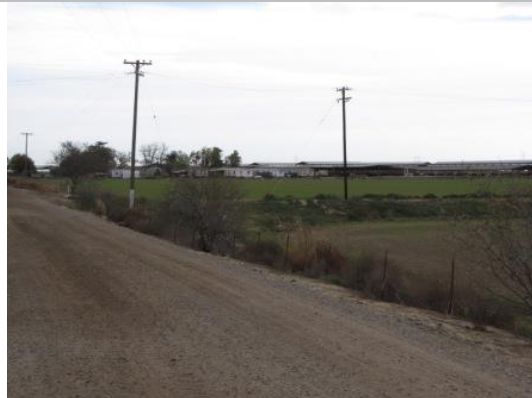
Photo 1 of 1 : FA_2019_RD2092_116_972_20190912_00024.jpg

View of barbed wire fence along the waterward slope looking upstream.

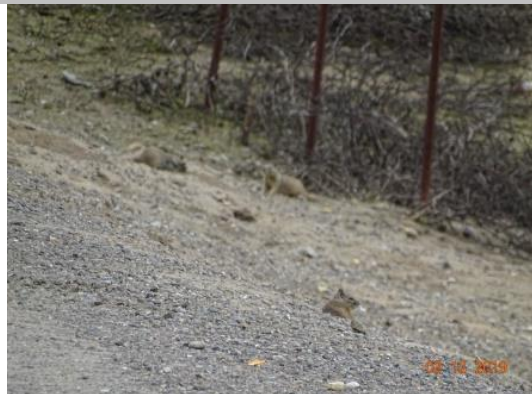
Photo 1 of 3 : FA_2019_RD2092_116_35_20190912_00012.jpg

Squirrels observed along waterside slope. (Spring 2019)

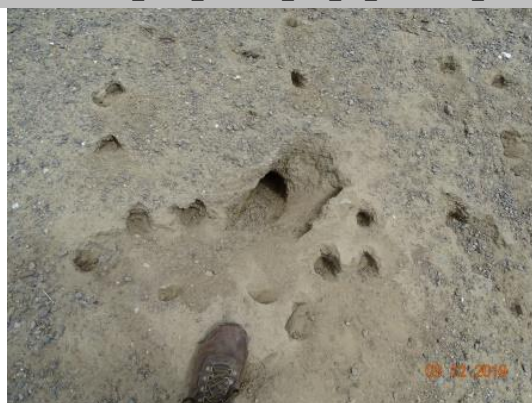
Photo 2 of 3 : FA_2019_RD2092_116_35_20190912_00013.jpg

View of typical rodent holes. (Spring 2019)

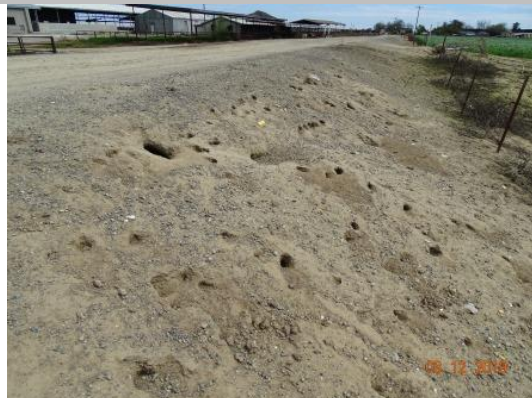
Photo 3 of 3 : FA_2019_RD2092_116_35_20190912_00014.jpg

View of several rodent burrows along waterside slope. (Spring 2019)

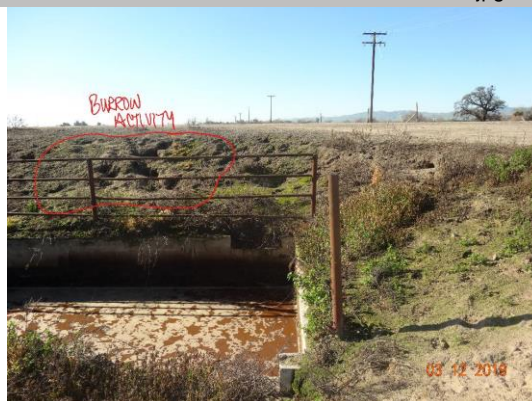
Photo 3 of 3 : UCIP_FA_2019_53810_79140.jpg

LS view: heavy burrow activity observed on LS slope.
