Flood Control Project Maintenance Levee Inspections

Fall 2020 Levee Maintenance Deficiency Summary Report

San Joaquin River Basin

Reclamation District No. 2092 Dos Rios

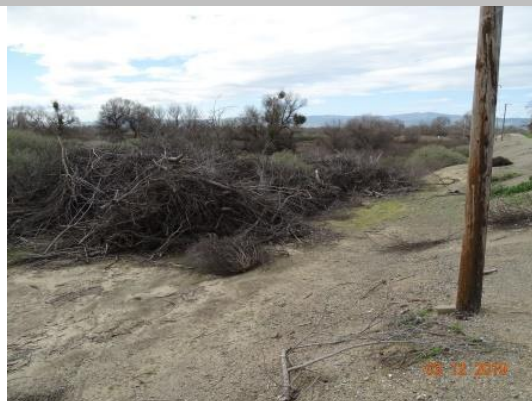
Photo 1 of 1 : FA_2020_RD2092_116_15_20200901_00003.jpg

Large pruning pile along levee slope and toe. (Spring 2019)

LM Start	0.09	Rating **	M	Issue No.	32
LM End	0.80	Issue Type +	Ma	Location *	WS
Category	Earthen Levee			GPS Latitude/Longitude	
				Start	End
Item	Vegetation			37.602481 °	37.596641 °
				-121.159705 °	-121.168440 °
DWR ID	DWR_RD2092_01_f_2020_32				
Comment Code					
V1 : Control annual grass and weeds on the levee slopes and easements.					
Inspector Comment

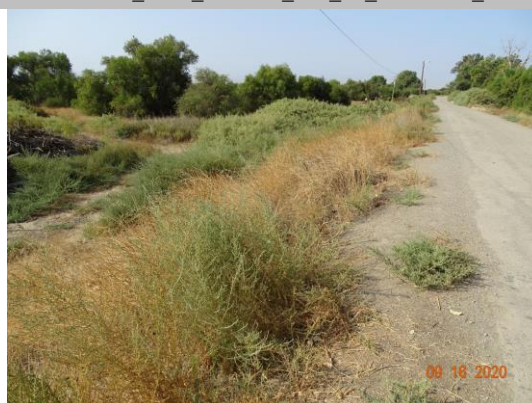
Photo 1 of 1 : FA_2020_RD2092_116_30_20200918_00073.jpg

Looking upstream along the landside slope. (Fall 2020)

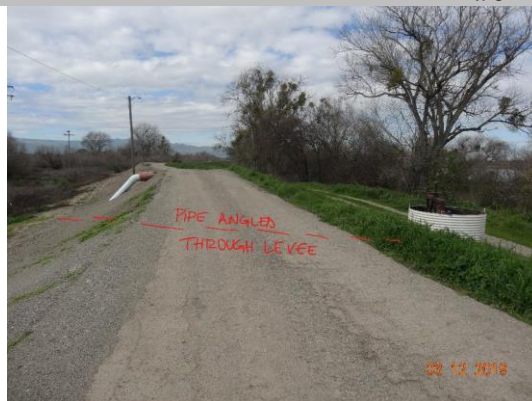
Photo 1 of 3 : UCIP_FA_2020_53799_79055.jpg

DS_ID:20561
FS_ID:53799
EP_NO: N/A
Repair Type: Urgent
EVAL Issue: Pipe Integrity
Crossing Status: Found
UCIP Comments: 03/12/2019 A thorough internal evaluation of this crossing is necessary. Pipe shows evidence of pipe integrity (LS) issues (pipe wall sections missing on LS inlet) and levee integrity issues (sink hole visible along LS pipe alignment). Internal inspection is recommended for this crossing to determine the extent of pipe damage through the levee. Pipe crosses the levee at an angle at a depth of about 19 feet. Recommend caution be taken at this crossing when driving over levee until additional information becomes available to determine condition of pipe through levee. Recommend cover be placed on riser to address safety concern (riser is 80 inches in diameter and about 19 feet deep). Slide gate appears to be blocked by sediment/debris preventing slide gate to work properly. Unable to confirm if the flap gate located on the WS is still broken (see photo from 2017). (O. Magana - DWR UCIP)09/24/2013 Pipe rusted through at headwall on LS toe. Good candidate for video inspection. (W. Wylie - DWR UCIP)

Overview of levee with approximate pipe alignment (pipe angled through levee).

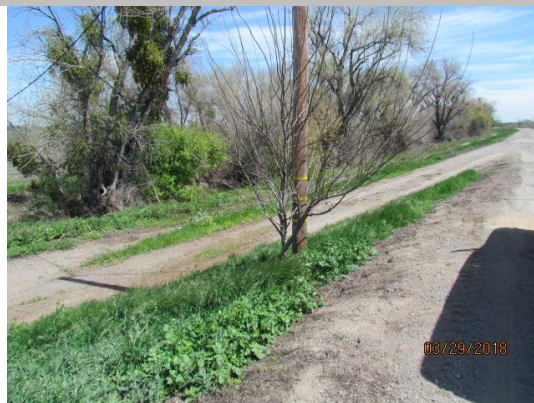
Photo 1 of 1 : FA_2020_RD2092_116_31_20200901_00014.jpg

Looking upstream at small tree on waterward should next to pole.
(Spring 2018)

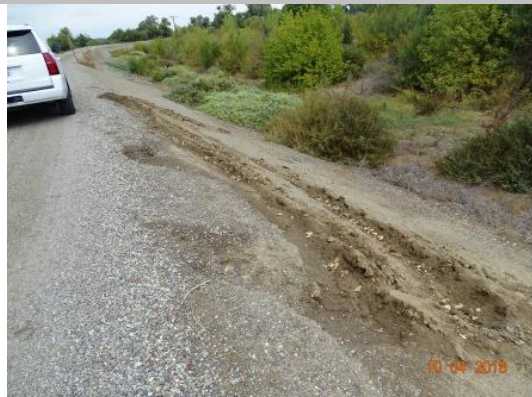
Photo 1 of 1 : FA_2020_RD2092_116_40_20200901_00017.jpg

LM Start	0.59	Rating **	M	Issue No.	40
LM End	0.59	Issue Type +	Ma	Location *	LS
Category	Earthen Levee			GPS Latitude/Longitude	
				Start	End
Item	Slope Stability			37.599406 °	37.599406 °
				-121.167083 °	-121.167083 °
DWR ID	DWR_RD2092_01_f_2018_40				
Comment Code					
S3 : Repair the levee slope damaged by vehicle traffic and prevent access where possible.					
Inspector Comment					
Vehicle tracks on the landside slope should be repaired.

Vehicle tracks on landside slope approximately 6" deep perpendicular to the slope. (Fall 2018)

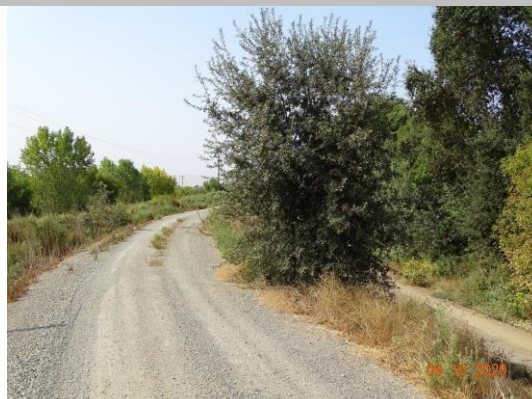
Photo 1 of 1 : FA_2020_RD2092_116_21_20200918_00074.jpg

LM Start	0.61	Rating **	M	Issue No.	21
LM End	0.61	Issue Type +	Ma	Location *	WS
Category	Earthen Levee			GPS Latitude/Longitude	
				Start	End
Item	Trim / Thin Trees			37.599208 °	37.599208 °
				-121.167150 °	-121.167150 °
DWR ID	DWR_RD2092_01_s_2018_21				
Comment Code					
T2 : Thin trees to allow visibility of the ground and room to flood fight.					
Inspector Comment					
Remove small tree on waterward shoulder before tree is established.

Looking upstream at a tree growing in the waterside shoulder. (Fall 2020)

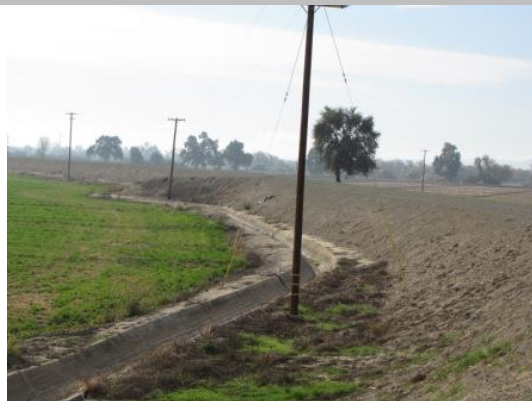
Photo 1 of 1 : FA_2020_RD2092_116_968_20200901_00033.jpg

View of agricultural ditch at the landward toe looking upstream.

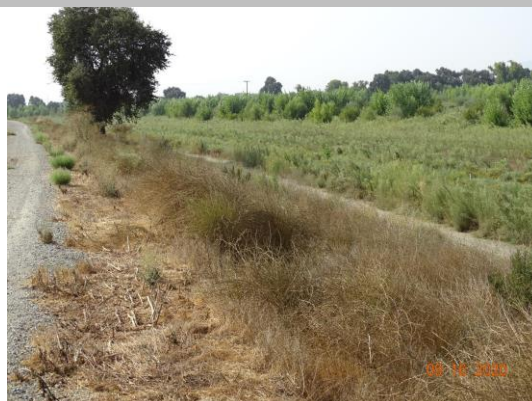
Photo 1 of 1 : FA_2020_RD2092_116_36_20200918_00075.jpg

View of the waterside slope looking upstream. (Fall 2020)

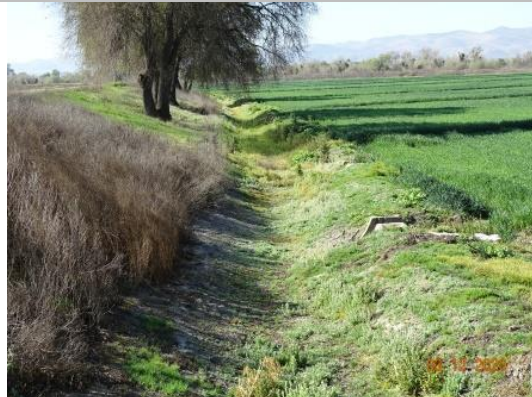
Photo 1 of 1 : FA_2020_RD2092_116_8_20200901_00001.jpg

View of unlined ditch along the waterside toe looking upstream. (Spring 2020)

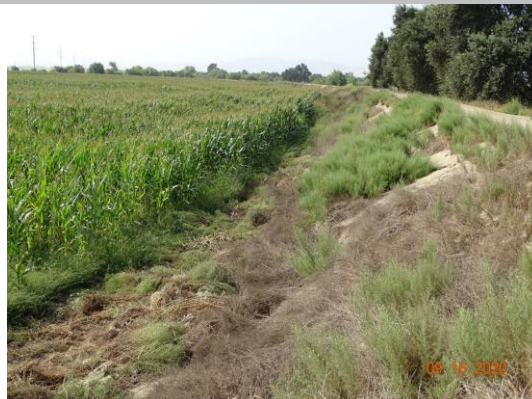
Photo 1 of 1 : FA_2020_RD2092_116_47_20200918_00076.jpg

LM Start	1.59	Rating **	U	Issue No.	47
LM End	2.15	Issue Type +	En	Location *	LS
Category	Earthen Levee			GPS Latitude/Longitude	
				Start	End
Item	Encroachments			37.587182 °	37.583542 °
				-121.162688 °	-121.157028 °
DWR ID	DWR_RD2092_01_f_2019_47				
Comment Code					
CR : Crops					
Inspector Comment

View of corn planted on the landside toe. (Fall 2020)

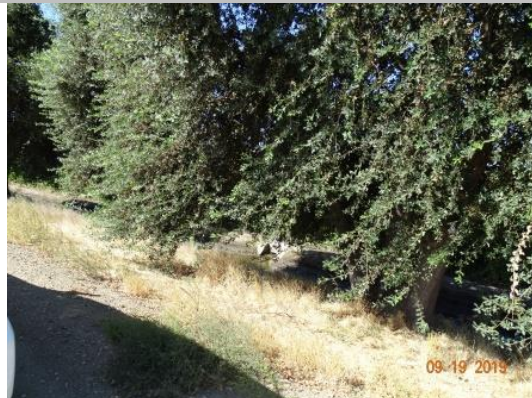
Photo 1 of 1 : FA_2020_RD2092_116_48_20200901_00024.jpg

LM Start	1.60	Rating **	M	Issue No.	48
LM End	1.60	Issue Type +	Ma	Location *	WS
Category	Earthen Levee			GPS Latitude/Longitude	
				Start	End
Item	Trim / Thin Trees			37.587068 °	37.587068 °
				-121.162773 °	-121.162773 °
DWR ID	DWR_RD2092_01_f_2019_48				
Comment Code					
T1 : Trim trees to at least five feet above ground level.					
Inspector Comment

View of branches hanging over waterside slope. (Fall 2019)

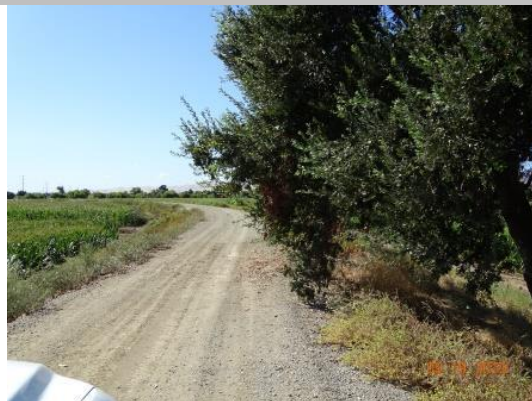
Photo 1 of 1 : FA_2020_RD2092_116_49_20200901_00026.jpg

View of branches hanging over levee crown. (Fall 2019)

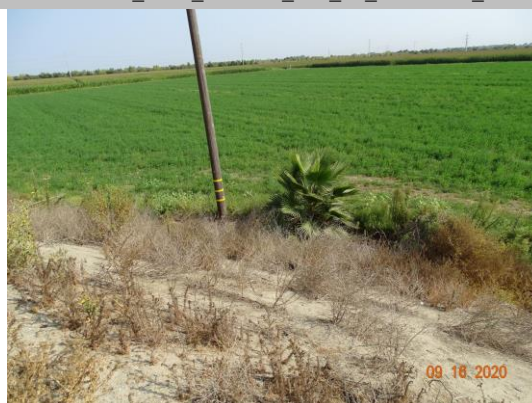
Photo 1 of 1 : FA_2020_RD2092_116_43_20200918_00077.jpg

View of small palm tree growing on the landside toe. (Fall 2020)

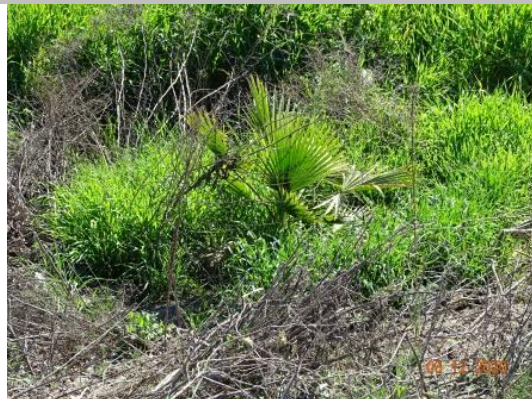
Photo 1 of 1 : FA_2020_RD2092_116_59_20200901_00031.jpg

Upclose view of palm tree growing at the levee toe. (Spring 2020)

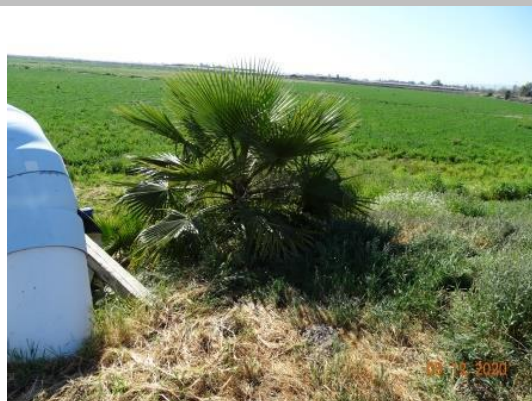
Photo 1 of 1 : FA_2020_RD2092_116_58_20200901_00029.jpg

View of palm tree growing on the landside slope. (Spring 2020)

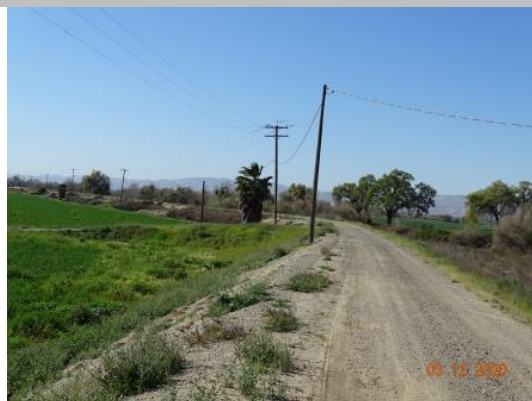
Photo 1 of 1 : FA_2020_RD2092_116_20_20200901_00010.jpg

View of the pole on the landside slope of the levee looking upstream. (Spring 2020)

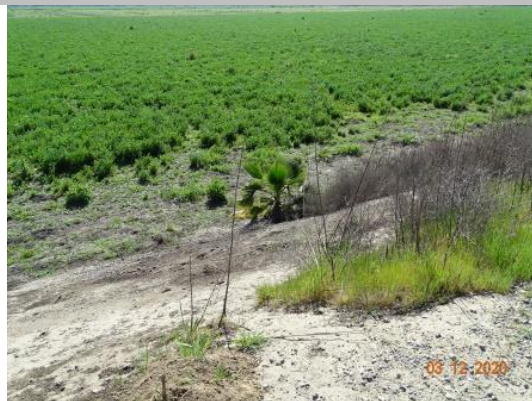
Photo 1 of 1 : FA_2020_RD2092_116_50_20200901_00027.jpg

View of palm tree in the landside slope. (Spring 2020)

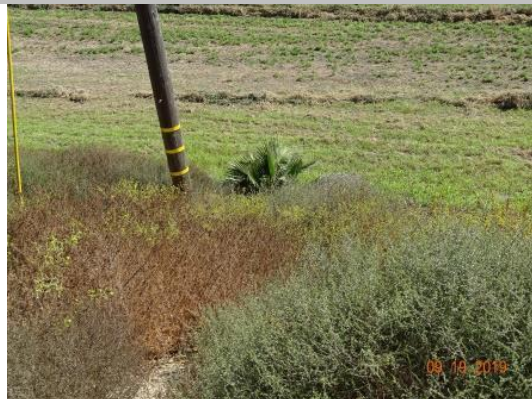
Photo 1 of 1 : FA_2020_RD2092_116_51_20200901_00028.jpg

View of palm tree growing in landside toe. (Fall 2019)

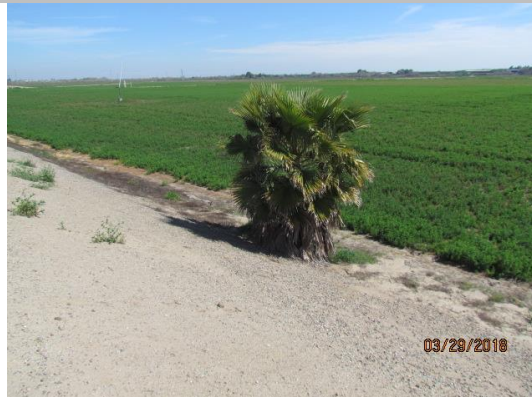
Photo 2 of 2 : FA_2020_RD2092_116_19_20200901_00009.jpg

Looking at Palm tree at landward toe. (Spring 2018)

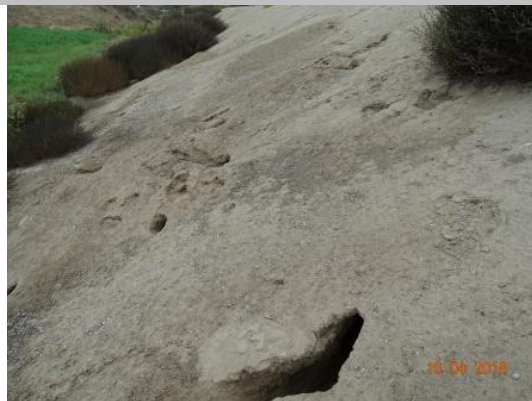
Photo 2 of 2 : FA_2020_RD2092_116_44_20200901_00019.jpg

View of animal burrows looking upstream. (Fall 2018)

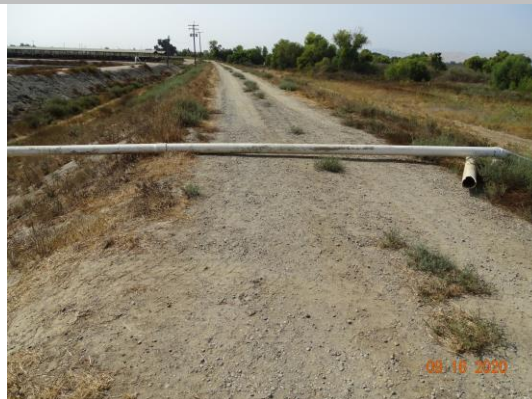
Photo 1 of 1 : FA_2020_RD2092_116_52_20200918_00078.jpg

View of temporary PVC pipe constructed across the levee alignment.
(Fall 2020)

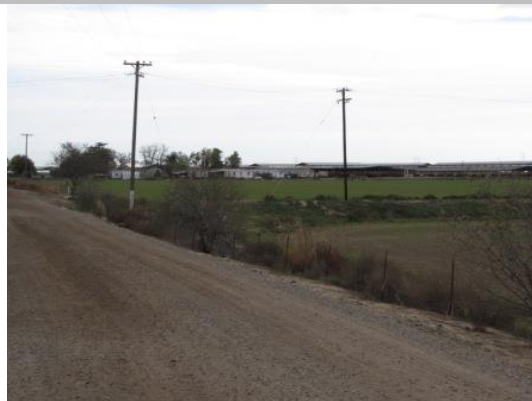
Photo 1 of 1 : FA_2020_RD2092_116_972_20200901_00034.jpg

View of barbed wire fence along the waterward slope looking upstream.

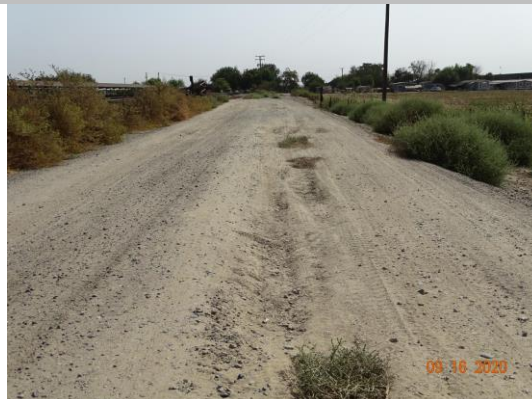
Photo 1 of 1 : FA_2020_RD2092_116_60_20200918_00079.jpg

View of rutting on the levee crown looking downstream. (Fall 2020)

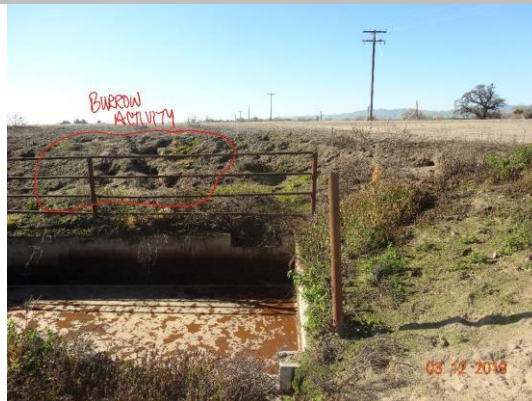
Photo 3 of 3 : UCIP_FA_2020_53810_79140.jpg

LS view: heavy burrow activity observed on LS slope.
