## Flood Control Project Maintenance Levee Inspections

### Fall 2021 Levee Maintenance Deficiency Summary Report

#### San Joaquin River Basin

**Reclamation District No. 2092 Dos Rios**

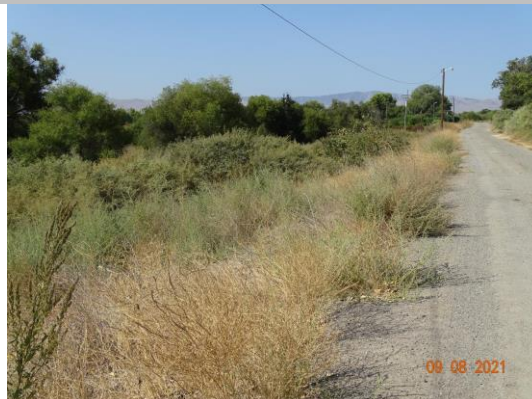
Photo 1 of 1 : FA\_2021\_RD2092\_116\_29\_20210909\_00061.jpg

Looking upstream along the landside slope and shoulder. (Fall 2021)

LM Start	0.12	Rating **	M	Issue No.	30
LM End	0.12	Issue Type +	Ma	Location *	LS
Category	Earthen Levee			GPS Latitude/Longitude	
				Start	End
Item	Vegetation			37.602391 °	37.602391 °
				-121.160191 °	-121.160191 °
DWR ID	DWR_RD2092_01_f_2021_30				
Comment Code					
V4 : Elderberries are blocking visibility and flood fight capability.					
Inspector Comment					
Three elderberry trees growing in the landside slope.

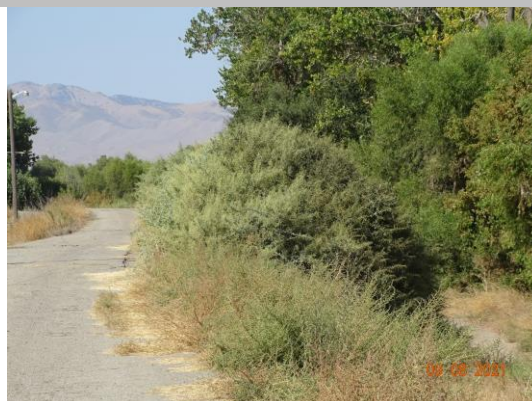
Photo 1 of 1 : FA\_2021\_RD2092\_116\_32\_20210909\_00062.jpg

View of a large shrub growing on the waterside slope and shoulder. (Fall 2021)

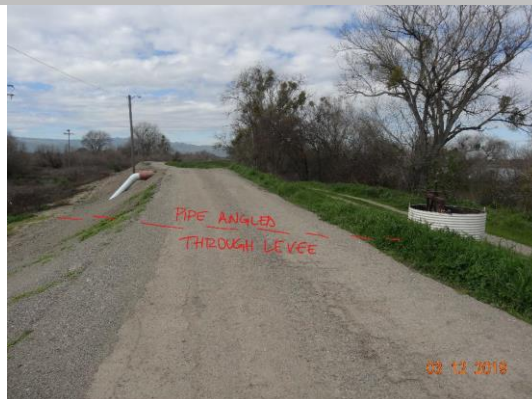
Photo 1 of 3 : UCIP\_FA\_2021\_53799\_79055.jpg

Comment Code						
Inspector Comment						
DS_ID:20561 FS_ID:53799 EP_NO: N/A Repair Type: Urgent EVAL Issue: Pipe Integrity Crossing Status: Found UCIP Comments: 03/12/2019 A thorough internal evaluation of this crossing is necessary. Pipe shows evidence of pipe integrity (LS) issues (pipe wall sections missing on LS inlet) and levee integrity issues (sink hole visible along LS pipe alignment). Internal inspection is recommended for this crossing to determine the extent of pipe damage through the levee. Pipe crosses the levee at an angle at a depth of about 19 feet. Recommend caution be taken at this crossing when driving over levee until additional information becomes available to determine condition of pipe through levee. Recommend cover be placed on riser to address safety concern (riser is 80 inches in diameter and about 19 feet deep). Slide gate appears to be blocked by sediment/debris preventing slide gate to work properly. Unable to confirm if the flap gate located on the WS is still broken (see photo from 2017). (O. Magana - DWR UCIP)09/24/2013 Pipe rusted through at headwall on LS toe. Good candidate for video inspection. (W. Wylie - DWR UCIP) FIELD_STRUCT_DESC: 60-inch corrugated metal drainage pipe through the levee, 19 feet below the crown. Flap gate on the waterside (WS) end. Slide gate in an 80-inch corrugated metal pipe (CMP) riser on the WS slope. Concrete U-shaped headwalls on both ends. [Additional Reference(s): DWR Levee Log, 2005. USACE San Joaquin O&M Manual 5, August 1961, (HLM 0.18)]. FS Date: 3/12/2019 12:05:00 PM

Overview of levee with approximate pipe alignment (pipe angled through levee).

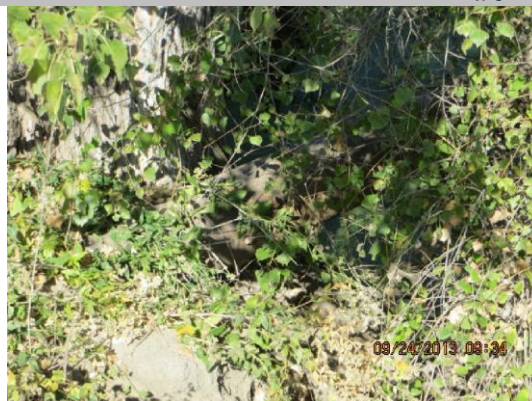
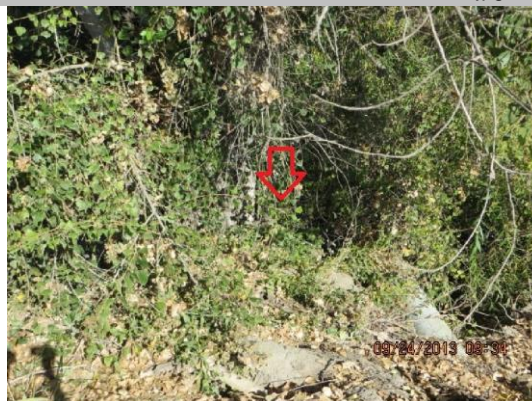
Photo 1 of 2 : UCIP\_FA\_2021\_53830\_35205.jpg

DS\_ID:20579  
FS\_ID:53830  
EP\_NO: 6254  
Repair Type: Non-Urgent  
EVAL Issue: Pipe Not Found  
Crossing Status: Not Found  
UCIP Comments: 03/12/2019 Need to confirm the status of the crossing through levee section. Levee logs indicate 14-inch pipe was removed in 2003 however, no documentation detailing extent of removal is available. Potential evidence of pipe recorded by UCIP Inspector W. Wylie in 2013. Unable to access WS toe due to high water, recommend inspecting crossing in early fall. (O. Magana - DWR UCIP)  
09/24/2013 Verify pipe has been removed from levee. Pipe visible on WS at riverbank. (W. Wylie - DWR UCIP)  
FIELD\_STRUCT\_DESC: \*ABANDONED\* 16-inch steel drainage pipe over the levee with 3.5 feet of the fill on the top. Siphon breakers on the waterside (WS) shoulder. Pad constructed over pipes. This pumping plant was constructed in 1969 during emergency conditions without a permit. (20-inch pipe authorized to replace unauthorized 20-inch pipe and the removal of existing 12-inch and 14-inch pipe from levee section, work authorized under Permit No. 6254, 1968 - John and Robert Bogetti). [Additional Reference(s): DWR Levee Log, 2005].

Pipe visible at rivers edge on WS toe.

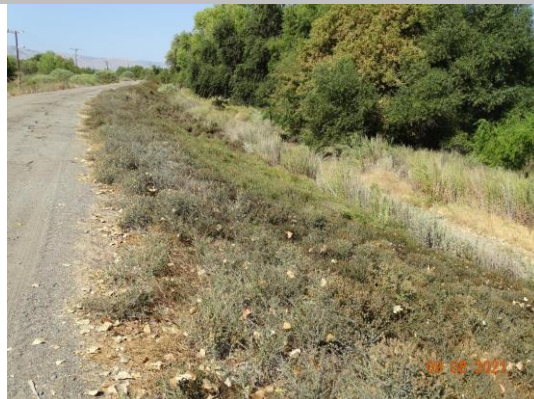
Photo 1 of 1 : FA\_2021\_RD2092\_116\_33\_20210909\_00063.jpg

View of the waterside slope looking upstream. (Fall 2021)

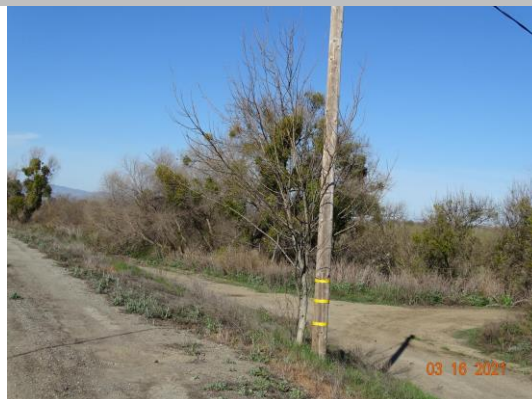
Photo 1 of 1 : FA\_2021\_RD2092\_116\_31\_20210830\_00007.jpg

View of small tree growing on waterside shoulder. (Spring 2021)

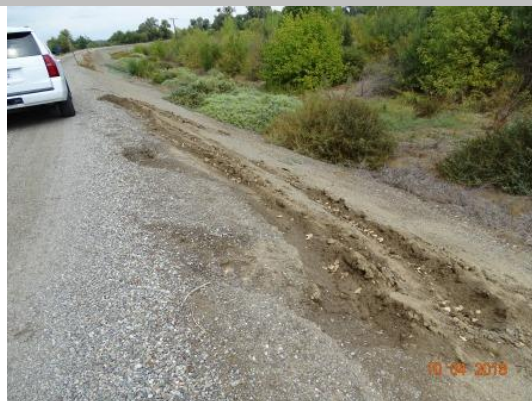
Photo 1 of 1 : FA\_2021\_RD2092\_116\_40\_20210830\_00009.jpg

LM Start	0.59	Rating **	M	Issue No.	40
LM End	0.59	Issue Type +	Ma	Location *	LS
Category	Earthen Levee			GPS Latitude/Longitude	
				Start	End
Item	Slope Stability			37.599406 °	37.599406 °
				-121.167083 °	-121.167083 °
DWR ID	DWR_RD2092_01_f _ 2018_40				
Comment Code					
S3 : Repair the levee slope damaged by vehicle traffic and prevent access where possible.					
Inspector Comment					
Vehicle tracks on the landside slope should be repaired.

Vehicle tracks on landside slope approximately 6" deep perpendicular to the slope. (Fall 2018)

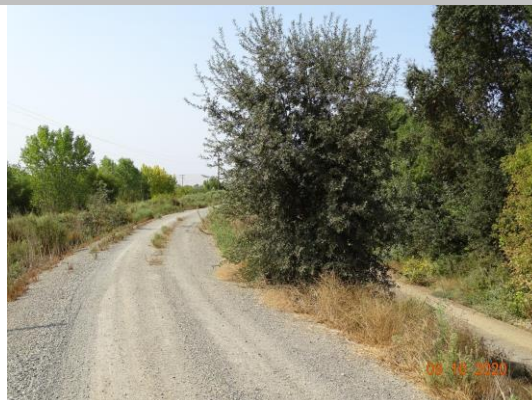
Photo 1 of 1 : FA\_2021\_RD2092\_116\_21\_20210830\_00005.jpg

LM Start	0.61	Rating **	M	Issue No.	21
LM End	0.61	Issue Type +	Ma	Location *	WS
Category	Earthen Levee			GPS Latitude/Longitude	
				Start	End
Item	Trim / Thin Trees			37.599208 °	37.599208 °
				-121.167150 °	-121.167150 °
DWR ID	DWR_RD2092_01_s_2021_21				
Comment Code					
T2 : Thin trees to allow visibility of the ground and room to flood fight.					
Inspector Comment					
Remove small tree on waterward shoulder before tree is established.

Looking upstream at a tree growing in the waterside shoulder. (Fall 2020)

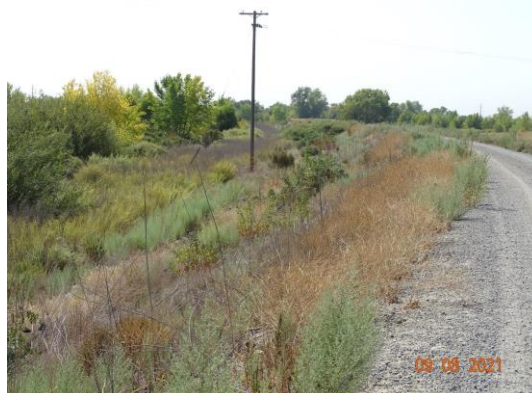
Photo 1 of 1 : FA\_2021\_RD2092\_116\_36\_20210909\_00065.jpg

View of vegetation growing on the landside slope. (Fall 2021)

LM Start	0.99	Rating **	M	Issue No.	54
LM End	1.06	Issue Type +	Ma	Location *	LS
Category	Earthen Levee			GPS Latitude/Longitude	
				Start	End
Item	Vegetation			37.594107 °	37.593265 °
				-121.167300 °	-121.166675 °
DWR ID	DWR_RD2092_01_f_2021_54				
Comment Code					
V4 : Elderberries are blocking visibility and flood fight capability.					
Inspector Comment					
Several elderberry trees should be removed before they can establish.

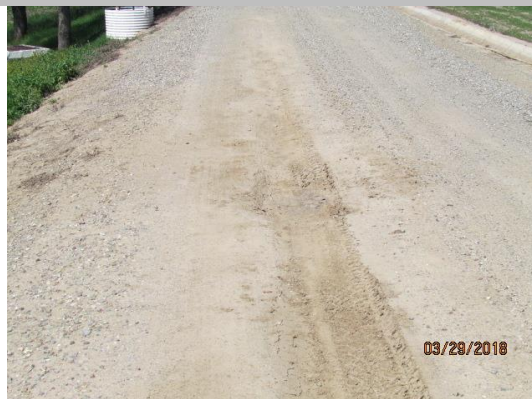
Photo 1 of 1 : FA\_2021\_RD2092\_116\_39\_20210830\_00008.jpg

Looking upstream at rutting and depression on levee crown. (Spring 2018)

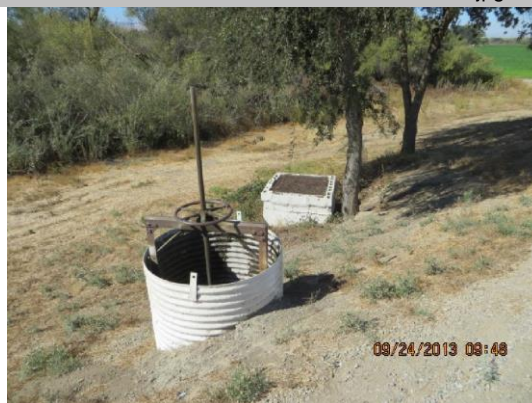
Photo 3 of 3 : UCIP\_FA\_2021\_53820\_35213.jpg

UCIP Comments: 03/12/2019 During UCIP visual inspection, no pipe or levee integrity issues were observed. Distribution box located on the WS is falling apart (bricks missing). This crossing is an active crossing however, no permit has been found authorizing crossing. Need to determine who maintains and operates this crossing. (O. Magana - DWR UCIP)

Slide gate in 48-inch CMP riser on WS slope.

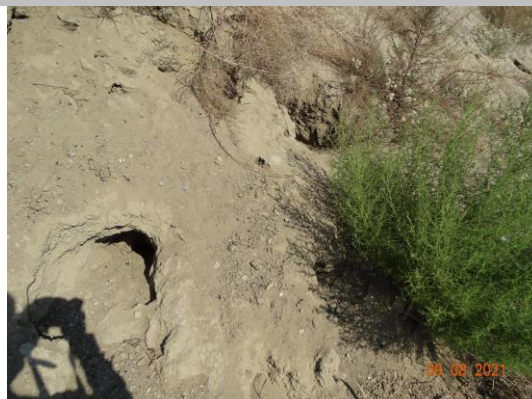
Photo 1 of 1 : FA\_2021\_RD2092\_116\_57\_20210909\_00066.jpg

View of multiple large rodent burrows in the landside slope. (Fall 2021)

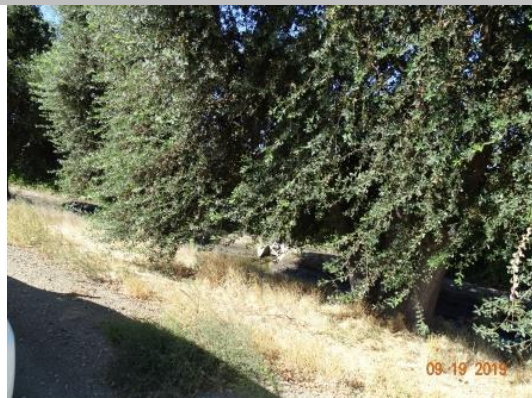
Photo 1 of 1 : FA\_2021\_RD2092\_116\_48\_20210830\_00013.jpg

View of branches hanging over waterside slope. (Fall 2019)

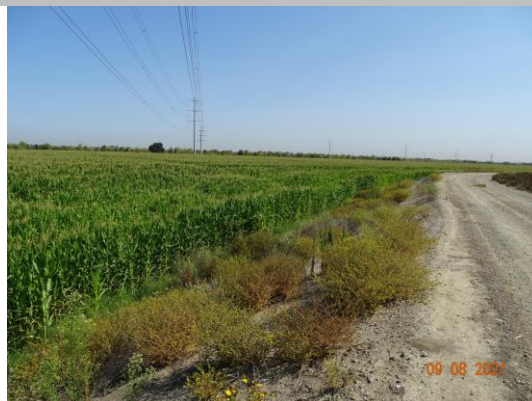
Photo 1 of 1 : FA\_2021\_RD2092\_116\_61\_20210909\_00067.jpg

View of corn plant up to the landside slope. (Fall 2021)

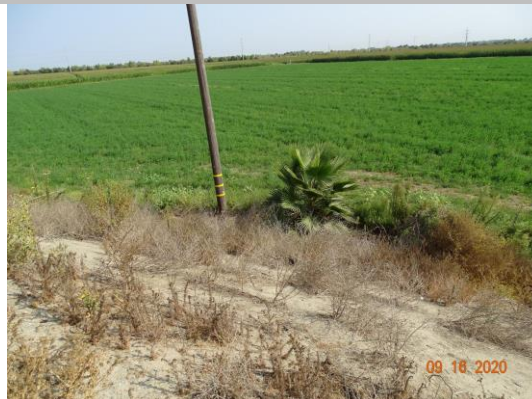
Photo 1 of 1 : FA\_2021\_RD2092\_116\_43\_20210830\_00010.jpg

View of small palm tree growing on the landside toe. (Fall 2020)

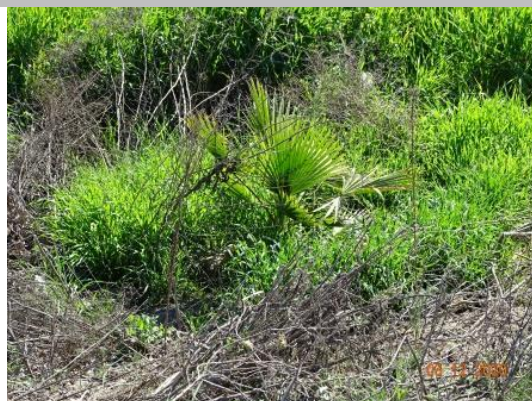
Photo 1 of 1 : FA\_2021\_RD2092\_116\_59\_20210830\_00019.jpg

Upclose view of palm tree growing at the levee toe. (Spring 2020)

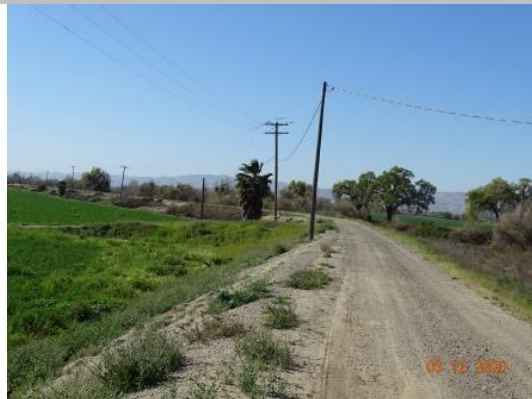
Photo 1 of 1 : FA\_2021\_RD2092\_116\_20\_20210830\_00004.jpg

View of the pole on the landside slope of the levee looking upstream.  
(Spring 2020)

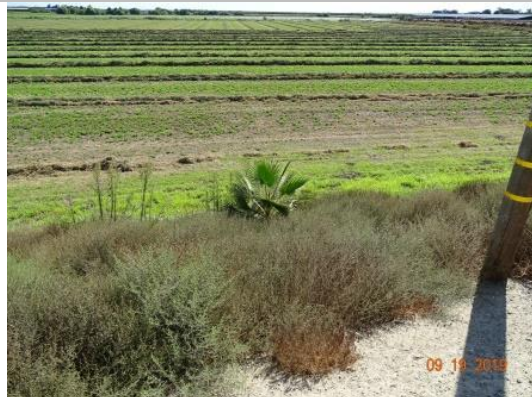
Photo 1 of 1 : FA\_2021\_RD2092\_116\_19\_20210830\_00003.jpg

View of palm tree growing on landside slope. (Fall 2019)

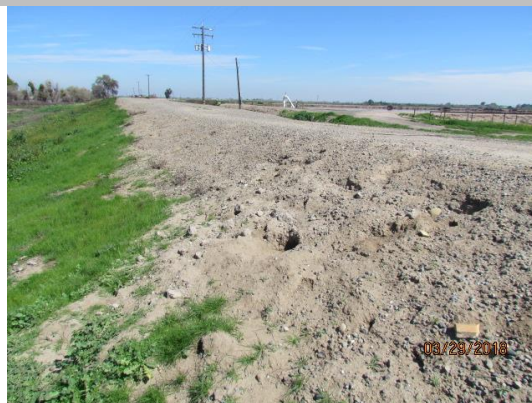
Photo 1 of 1 : FA\_2021\_RD2092\_116\_17\_20210830\_00002.jpg

Looking upstream on waterward slope at several large rodent holes.  
(Spring 2018)

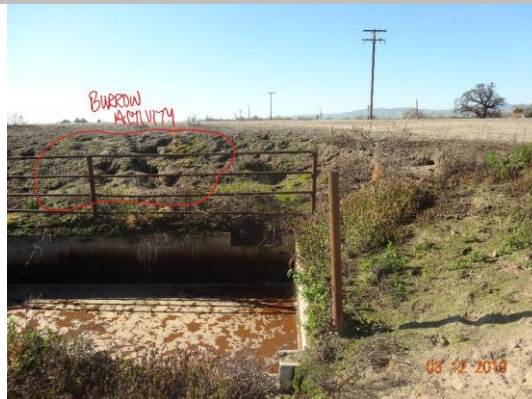
Photo 3 of 3 : UCIP\_FA\_2021\_53810\_79140.jpg

LS view: heavy burrow activity observed on LS slope.

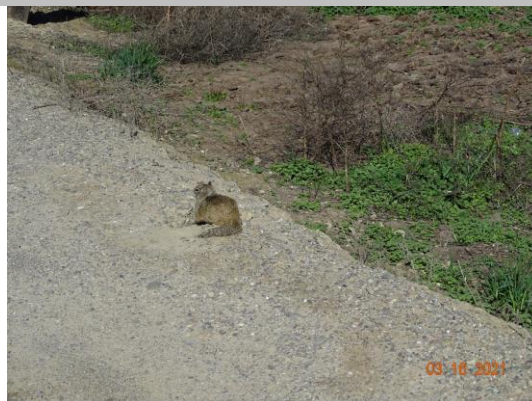
Photo 1 of 1 : FA\_2021\_RD2092\_116\_52\_20210830\_00017.jpg

View of single burrow and rodent observed on landside shoulder. (Spring 2021)
