**Flood Control Project Maintenance
Levee Inspections
Fall 2022 Levee Maintenance Deficiency Summary Report**

San Joaquin River Basin

| RD2092 | Overall LMA Rating | Total LMA Miles | | | | | | |
|---|---|---|---|---|---|---|---|---|
| Reclamation District No. 2092 Dos Rios | U | 3.71 | | | | | | |

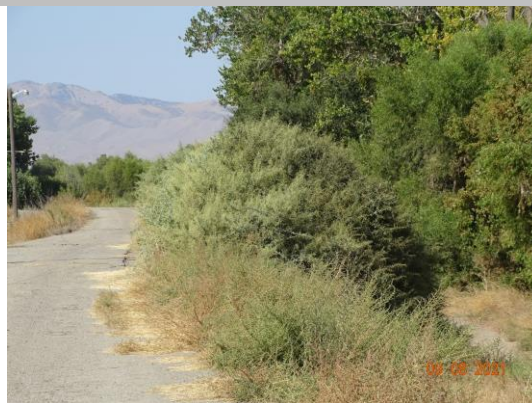
Photo 1 of 1 : FA_2022_RD2092_116_32_20220822_00008.jpg

View of a large shrub growing on the waterside slope and shoulder. (Fall 2021)

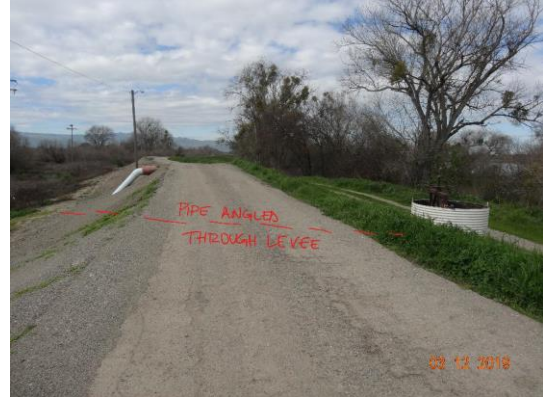
Photo 1 of 3 : UCIP_FA_2022_53799_79055.jpg

| DS_ID:20561 FS_ID:53799 EP_NO: N/A Repair Type: Urgent EVAL Issue: 1, Pipe Integrity Crossing Status: Found UCIP Comments: 03/12/2019 A thorough internal evaluation of this crossing is necessary. Pipe shows evidence of pipe integrity (LS) issues (pipe wall sections missing on LS inlet) and levee integrity issues (sink hole visible along LS pipe alignment). Internal inspection is recommended for this crossing to determine the extent of pipe damage through the levee. Pipe crosses the levee at an angle at a depth of about 19 feet. Recommend caution be taken at this crossing when driving over levee until additional information becomes available to determine condition of pipe through levee. Recommend cover be placed on riser to address safety concern (riser is 80 inches in diameter and about 19 feet deep). Slide gate appears to be blocked by sediment/debris preventing slide gate to work properly. Unable to confirm if the flap gate located on the WS is still broken (see photo from 2017). (O. Magana - DWR UCIP)09/24/2013 Pipe rusted through at headwall on LS toe. Good candidate for video inspection. (W. Wylie - DWR UCIP) FIELD_STRUCT_DESC: 60-inch corrugated metal drainage pipe through the levee, 19 feet below the crown. Flap gate on the waterside (WS) end. Slide gate in an 80-inch corrugated metal pipe (CMP) riser on the WS slope. Concrete U-shaped headwalls on both ends. [Additional Reference(s): DWR Levee Log, 2005. USACE San Joaquin O&M Manual 5, August 1961, (HLM 0.18)]. FS Date: 3/12/2019 12:05:00 PM | | | | | | |

Overview of levee with approximate pipe alignment (pipe angled through levee).

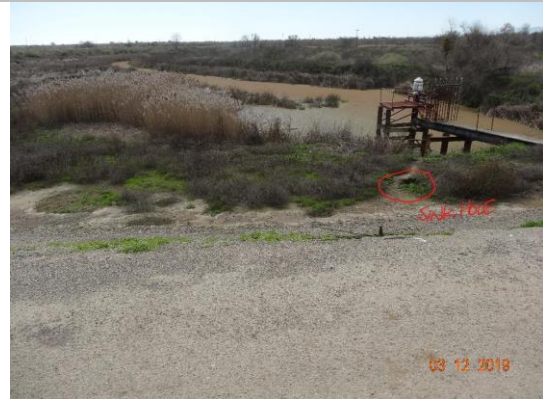
Photo 2 of 3 : UCIP_FA_2022_53799_79054.jpg

LS view: overview of LS with sink hole visible along pipe alignment.

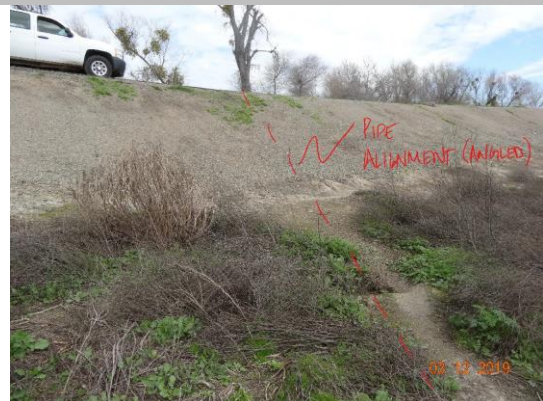
Photo 3 of 3 : UCIP_FA_2022_53799_79058.jpg

LS view: pipe crosses levee at angle, approximate alignment on LS.

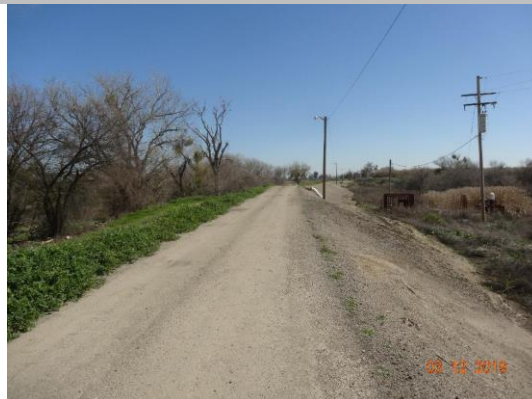
Photo 1 of 3 : UCIP_FA_2022_53815_79066.jpg

| DS_ID:20581 FS_ID:53815 EP_NO: 6254A Repair Type: Non-Urgent EVAL Issue: 10, Unauthorized Modification or Non-Compliant Permit Crossing Status: Found UCIP Comments: 03/12/2019 Pipe has been altered on both WS and LS. A PVC pipe has been sleeved through an existing 22-inch pipe, no records have been found approving modification. This crossing appears abandoned, power source and power meter have been disconnected. Need to coordinate with CVFPB and owner. Crossing should be removed/abandoned properly per Title 23. (O. Magana - DWR UCIP) FIELD_STRUCT_DESC: *ABANDONED* 22-inch steel drainage pipe through the levee, 0.5 feet below the crown. 18-inch polyvinyl chloride (PVC) pipe sleeved through the 22-inch steel pipe. 6-inch pad constructed over the pipes. This pumping plant was constructed in 1969 during emergency conditions without a permit. Replaced a 20-inch pipe at the same location. [Additional Reference(s): DWR Levee Log, 2005]. FS Date: 3/12/2019 12:05:00 PM | | | | | |

Overview of levee looking d/s towards crossing.

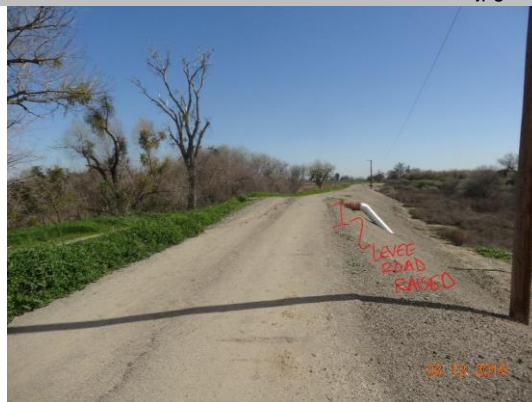
Photo 2 of 3 : UCIP_FA_2022_53815_79067.jpg

Crown view: levee section raised at pipe crossing.

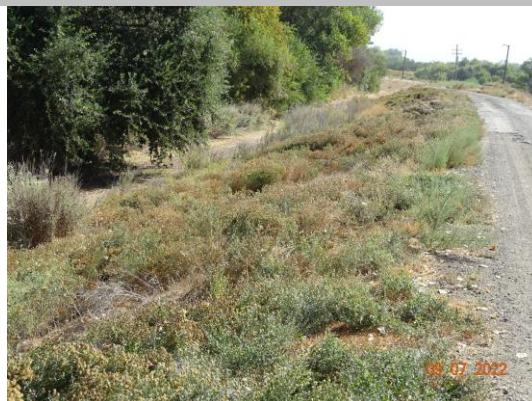
Photo 1 of 1 : FA_2022_RD2092_116_35_20220915_00069.jpg

Looking east along the waterside slope. (Fall 2022)

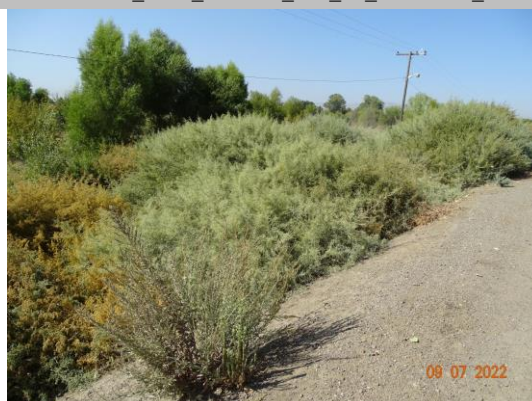
Photo 1 of 1 : FA_2022_RD2092_116_33_20220915_00070.jpg

Several large bushes obstructing view of the landside slope. (Fall 2022)

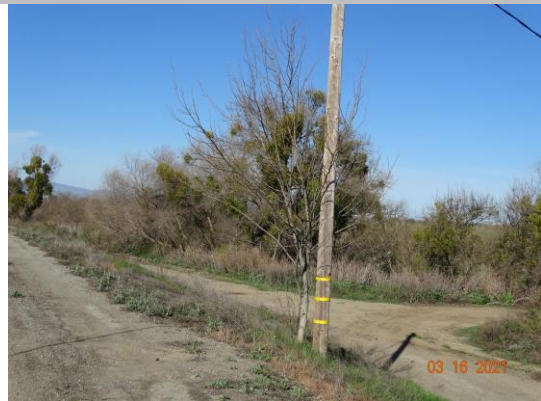
Photo 1 of 1 : FA_2022_RD2092_116_31_20220822_00007.jpg

View of small tree growing on waterside shoulder. (Spring 2021)

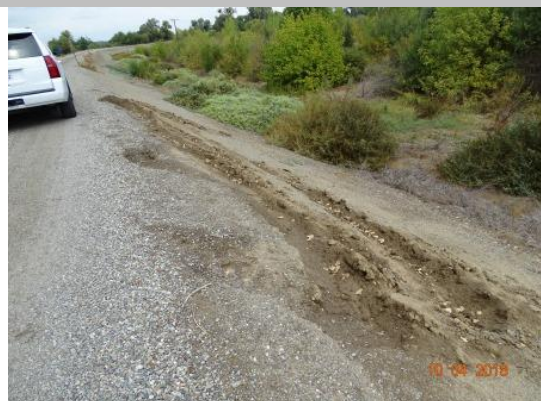
Photo 1 of 1 : FA_2022_RD2092_116_40_20220822_00012.jpg

Vehicle tracks on landside slope approximately 6" deep perpendicular to the slope. (Fall 2018)

| E6 : Repair the levee slope damaged by vehicle traffic and prevent access where possible. | | | | | |
| Vehicle tracks on the landside slope should be repaired. | | | | | |

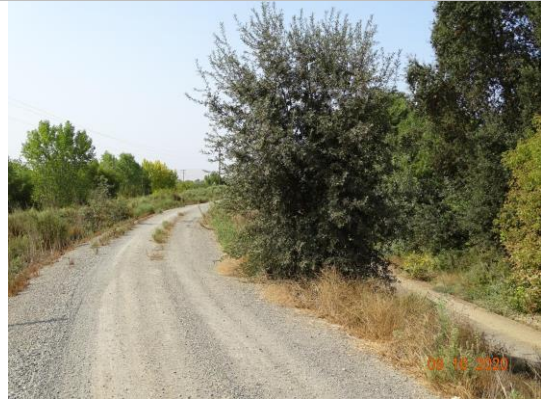
Photo 1 of 1 : FA_2022_RD2092_116_21_20220822_00005.jpg

Looking upstream at a tree growing in the waterside shoulder. (Fall 2020)

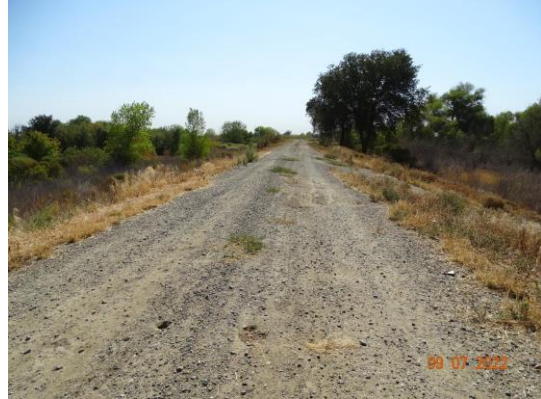
Photo 1 of 1 : FA_2022_RD2092_116_39_20220915_00071.jpg

Looking upstream at rutting and depression on levee crown. (Fall 2022)

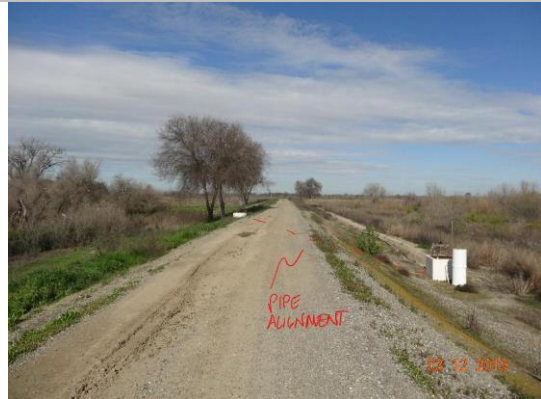
Photo 1 of 3 : UCIP_FA_2022_53820_79073.jpg

| DS_ID:20562 FS_ID:53820 EP_NO: N/A Repair Type: Non-Urgent EVAL Issue: 5, Pipe Damage Crossing Status: Found UCIP Comments: 03/12/2019 DMP internal video inspection has found pipe integrity issues. LOF of crossing is greater than or equal to 4.1 and less than 5. Crossing will be monitored until funding becomes available for rehabilitation. During UCIP visual inspection, no pipe or levee integrity issues were observed. Distribution box located on the WS is falling apart (bricks missing). This crossing is an active crossing however, no permit has been found authorizing crossing. Need to determine who maintains and operates this crossing. (O. Magana - DWR UCIP) FIELD_STRUCT_DESC: 36-inch corrugated metal drainage pipe through the levee, 15 feet below the crown. Slide gate in a 48-inch corrugated metal pipe (CMP) riser on the waterside (WS) slope. 4-foot by 6-foot concrete distribution box on the landside (LS) toe. 5-foot by 5-foot concrete riser on the WS toe. [Additional Reference(s): DWR Levee Log, 2005. USACE San Joaquin O&M Manual 5, August 1961, (HLM 1.31). USACE As-Built Drawing No. 07-04-1555, Sheet 19.3, upstream of STA 260+00, 15 November 1961]. FS Date: 3/12/2019 12:06:00 PM | | | | | |

Overview of pipe alignment through levee, photo taking looking d/s toward crossing.

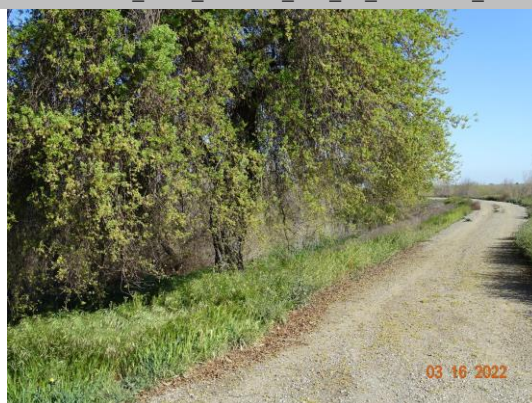
Photo 1 of 1 : FA_2022_RD2092_116_37_20220822_00010.jpg

View of tree branches hanging over the waterside slope and shoulder.
(Spring 2022)

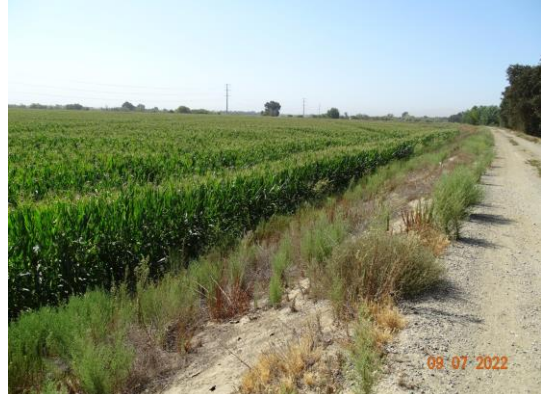
Photo 1 of 1 : FA_2022_RD2092_116_61_20220915_00072.jpg

Crops planted along the landside toe up to the slope. (Fall 2022)

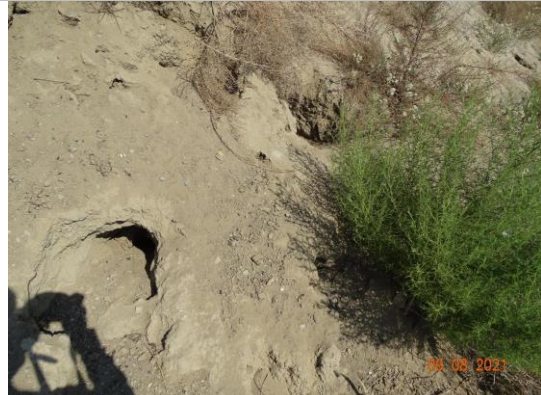
Photo 1 of 1 : FA_2022_RD2092_116_57_20220822_00021.jpg

View of multiple large rodent burrows in the landside slope. (Fall 2021)

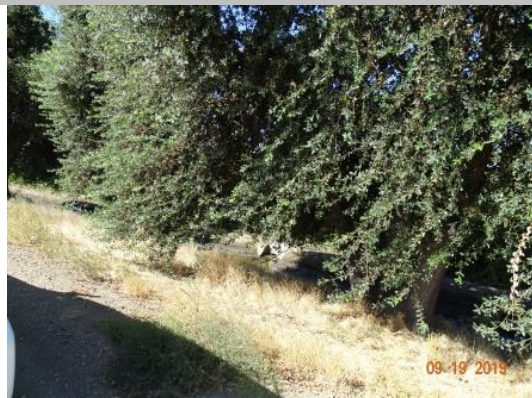
Photo 1 of 1 : FA_2022_RD2092_116_48_20220822_00016.jpg

View of branches hanging over waterside slope. (Fall 2019)

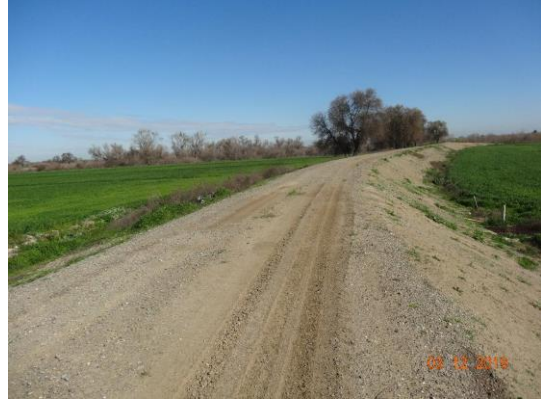
Photo 1 of 3 : UCIP_FA_2022_53817_79086.jpg

| DS_ID:20563 FS_ID:53817 EP_NO: N/A Repair Type: Urgent EVAL Issue: 1, Pipe Integrity Crossing Status: Found UCIP Comments: 03/12/2019 A thorough internal evaluation of this crossing is required, pipe shows evidence of pipe integrity (LS) issues (pipe wall sections missing on WS outlet). Internal inspection is recommended for this crossing to determine the extent of pipe damage through the levee. Maintenance issues identified at this crossing include: flap gate missing on WS, debris found inside concrete distribution box, and missing cover on riser. No permit has been identified for this crossing. Need to determine who maintains crossing; crossing appears functional. (O. Magana - DWR UCIP) FIELD_STRUCT_DESC: 24-inch corrugated metal drainage pipe through the levee, 14 feet below the crown. Slide gate in a corrugated metal pipe (CMP) riser on the waterside (WS) slope. Concrete U-shaped headwall at the landside (LS) toe. [Additional Reference(s): DWR Levee Log, 2005. USACE San Joaquin O&M Manual 5, August 1961, (HLM 1.71)]. FS Date: 3/12/2019 12:07:00 PM | | | | | |

Overview of levee crown looking d/s towards pipe crossing.

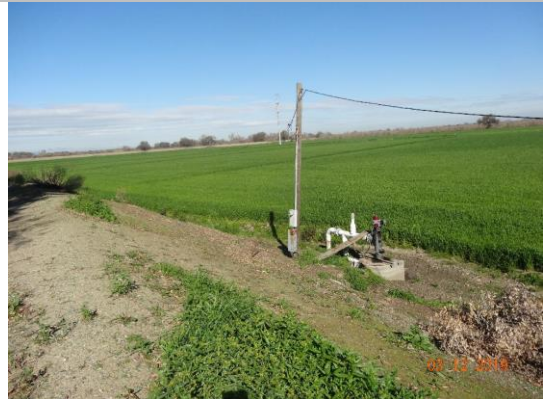
Photo 3 of 3 : UCIP_FA_2022_53814_79093.jpg

| DS_ID:20564 FS_ID:53814 EP_NO: N/A Repair Type: Non-Urgent EVAL Issue: Crossing Status: Found UCIP Comments: 03/12/2019 Concrete headwall found on LS toe. Pipe appears to have been grouted through. No other appurtenances were found during inspection. WS outlet was not found. Need to coordinate with the CVFPB to determine if additional steps are needed to comply with Title 23. (O. Magana - DWR UCIP) FIELD_STRUCT_DESC: *ABANDONED* 30-inch corrugated metal drainage pipe through the levee, 15 feet below the crown. Flap gate on the waterside (WS) end. Concrete U-shaped headwalls on both ends. Filled with concrete on the landside (LS) toe. [Additional Reference(s): DWR Levee Log, 2005. USACE San Joaquin O&M Manual 5, August 1961, (HLM 2.10), 36-inch pipe listed]. FS Date: 3/12/2019 12:08:00 PM | | | | | | |

LS view: concrete riser, power pole, and groundwater pump station.

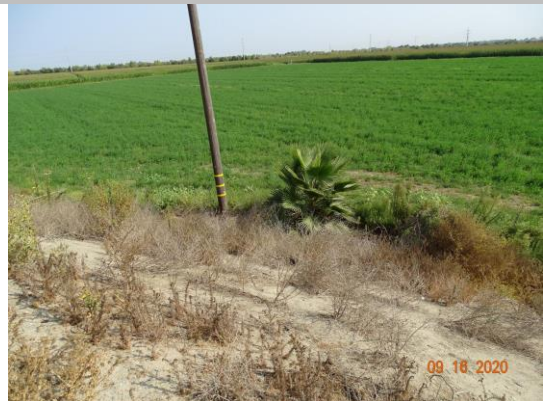
Photo 1 of 1 : FA_2022_RD2092_116_43_20220822_00013.jpg

View of small palm tree growing on the landside toe. (Fall 2020)

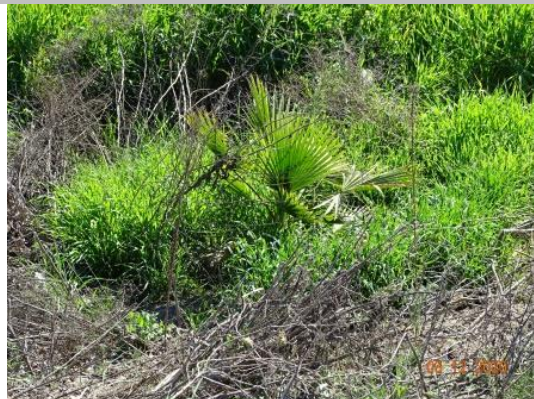
Photo 1 of 1 : FA_2022_RD2092_116_59_20220822_00023.jpg

Upclose view of palm tree growing at the levee toe. (Spring 2020)

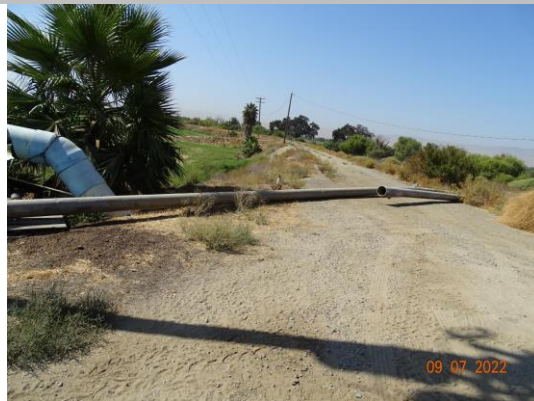
Photo 1 of 1 : FA_2022_RD2092_116_42_20220915_00073.jpg

Temporary pipe crossing placed across levee crown blocking access. (Fall 2022)

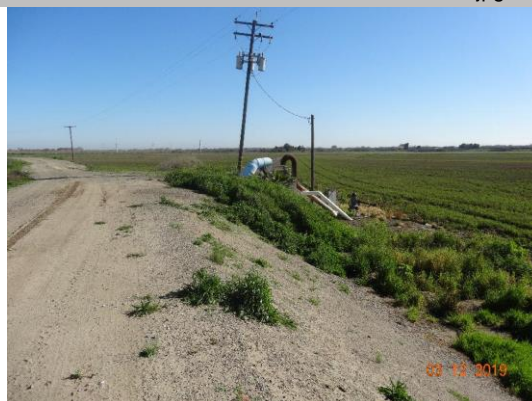
Photo 3 of 3 : UCIP_FA_2022_54051_79110.jpg

DS_ID:20566
 FS_ID:54051
 EP_NO: N/A
 Repair Type: Non-Urgent
 EVAL Issue: 4b, Safety Issue
 Crossing Status: Found
 UCIP Comments: 03/12/2019 Concrete distribution box found on LS with evidence that 24-inch pipe was going through levee. Pipe appears to have been grouted through. Riser is still present on WS however, unable to determine if pipe was grouted all the way through the levee section. Concrete distribution box is currently being used by an unauthorized pipe encroachment (see DSID 24680). Lid missing from CMP riser. Owner needs to add lid to riser to prevent entry in confined space. Need to coordinate with the CVFPB to determine how to address abandoned appurtenances and pipe abandonment. (O. Magana - DWR UCIP)
 09/24/2013 Pipe appears abandoned and needs to be verified as having been done so properly. (W. Wylie - DWR UCIP)
 FIELD_STRUCT_DESC: *ABANDONED* 24-inch corrugated metal irrigation pipe through the levee, 11 feet below the crown. Slide gate in a 36-inch corrugated metal pipe (CMP) riser on the waterside (WS) slope. 5-foot by 5-foot concrete distribution box on the landside (LS). Pump on platform in the channel. Pipe filled with concrete on the LS toe. [Additional Reference(s): DWR Levee Log, 2005. USACE San Joaquin O&M Manual 5, August 1961, (HLM 2.38)].

LS view: overview of LS.

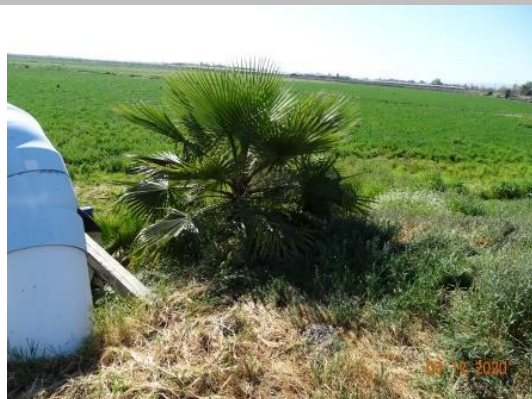
Photo 1 of 1 : FA_2022_RD2092_116_58_20220822_00022.jpg

View of palm tree growing on the landside slope. (Spring 2020)

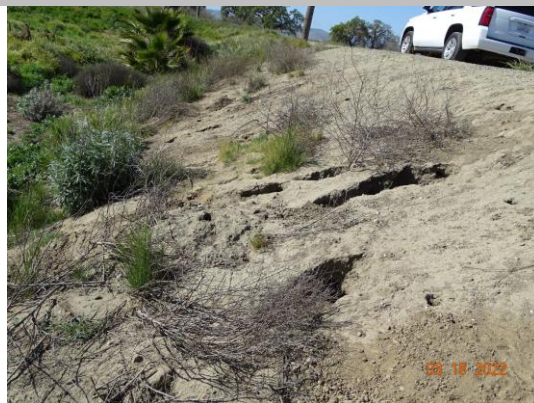
Photo 1 of 1 : FA_2022_RD2092_116_66_20220822_00028.jpg

View of several large rodent holes in the landside slope. (Spring 2022)

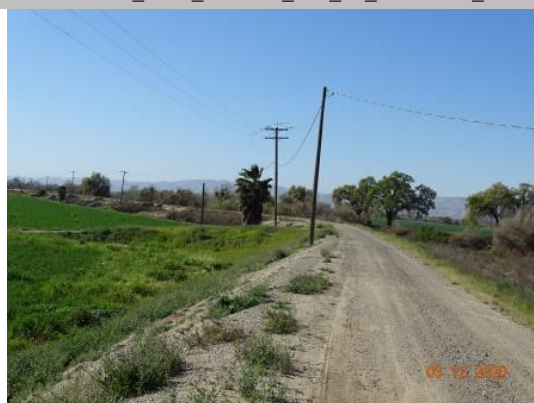
Photo 1 of 1 : FA_2022_RD2092_116_20_20220822_00004.jpg

View of the pole on the landside slope of the levee looking upstream. (Spring 2020)

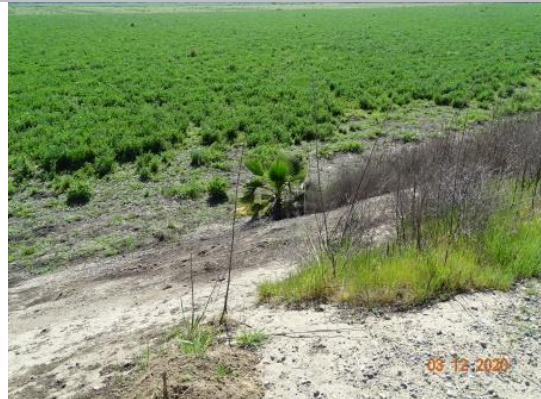
Photo 1 of 1 : FA_2022_RD2092_116_50_20220822_00018.jpg

View of palm tree in the landside slope. (Spring 2020)

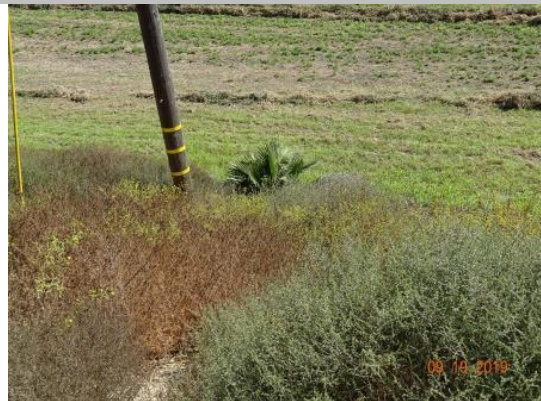
Photo 1 of 1 : FA_2022_RD2092_116_51_20220822_00019.jpg

View of palm tree growing in landside toe. (Fall 2019)

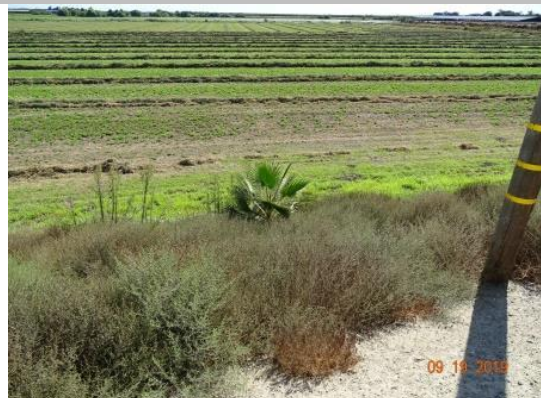
Photo 1 of 1 : FA_2022_RD2092_116_19_20220822_00003.jpg

View of palm tree growing on landside slope. (Fall 2019)

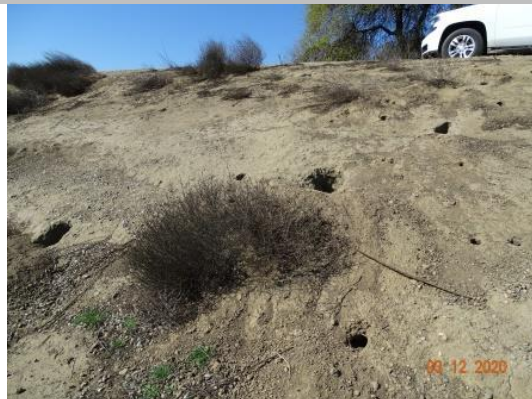
Photo 1 of 1 : FA_2022_RD2092_116_44_20220822_00014.jpg

View of rodent burrows in landside slope. (Spring 2020)

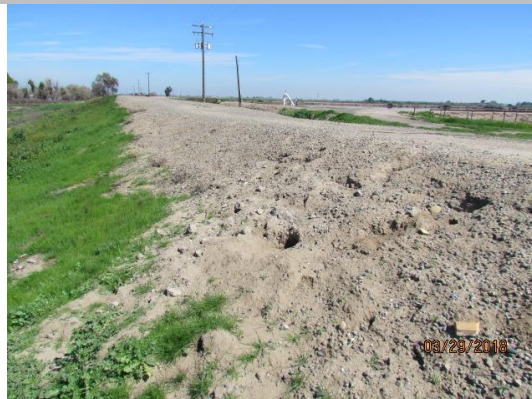
Photo 1 of 1 : FA_2022_RD2092_116_17_20220822_00002.jpg

Looking upstream on waterward slope at several large rodent holes.
(Spring 2018)

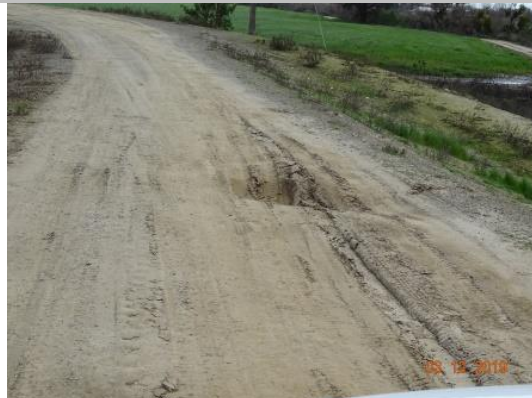
Photo 1 of 1 : FA_2022_RD2092_116_45_20220822_00015.jpg

View of depression in levee crown. (Spring 2019)

| C2 : Repair depressions or ruts in the crown or slope. | | | | | |
| Depression and rutting in levee crown should be repaired. | | | | | |

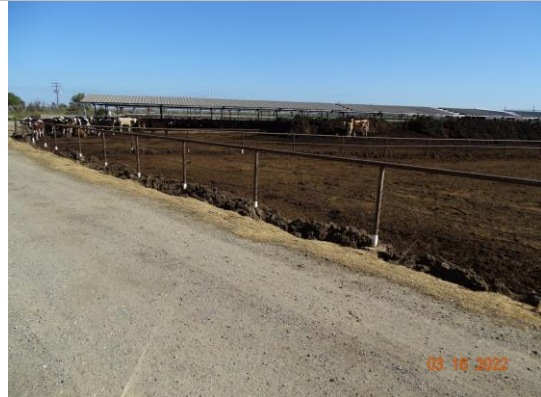
Photo 1 of 1 : FA_2022_RD2092_116_27_20220822_00006.jpg

View of a fence on the landside toe of the levee looking downstream (Spring 2022).

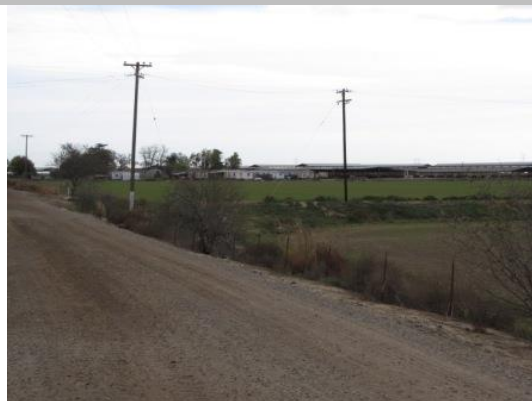
Photo 1 of 1 : FA_2022_RD2092_116_972_20220822_00030.jpg

View of barbed wire fence along the waterward slope looking upstream.

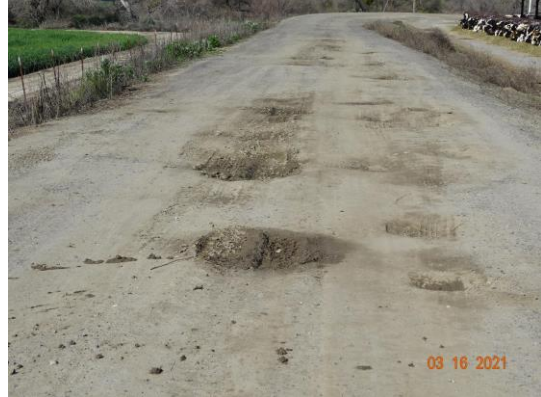
Photo 1 of 1 : FA_2022_RD2092_116_60_20220822_00024.jpg

View of rutting and potholes on levee crown looking downstream.
(Spring 2021)

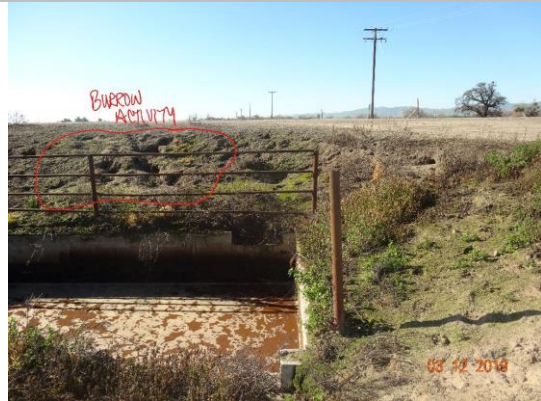
Photo 3 of 3 : UCIP_FA_2022_53810_79140.jpg

LS view: heavy burrow activity observed on LS slope.

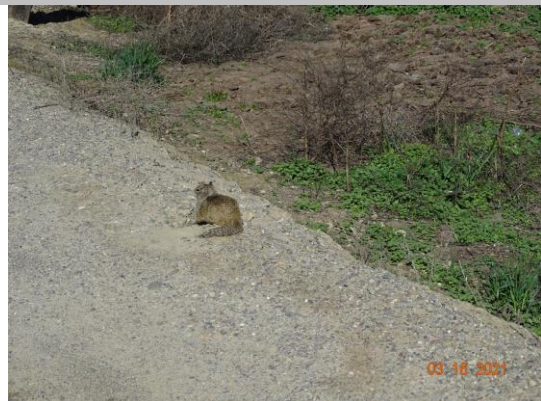
Photo 1 of 1 : FA_2022_RD2092_116_52_20220822_00020.jpg

View of single burrow and rodent observed on landside shoulder. (Spring 2021)
