**Flood Control Project Maintenance  
Levee Inspections  
Fall 2023 Levee Maintenance Deficiency Summary Report**

**San Joaquin River Basin**

**Reclamation District No. 2092 Dos Rios**

Waterway			Bank	Unit Miles
Unit No. 01 San Joaquin River			Right	3.71
	Spring (March - May)	Summer (June - August)	(September - November) Fall	Winter (December - February)
Unit Maintenance Rating (Fall Only)			<b>U</b>	
Date of Inspection	3/1/2023 - 3/1/2023		9/6/2023 - 9/6/2023	
DWR Inspector	Nate Hicks		Nate Hicks	
Accompanied By			Corey Fujitani DWR

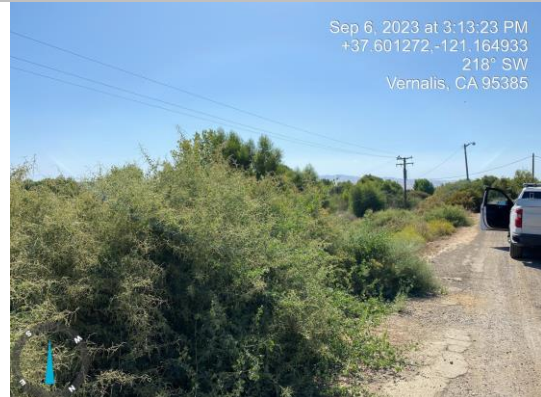
Photo 1 of 1 : FA\_2023\_RD2092\_116\_13\_20230922\_00070.jpg

View of vegetation on the landside slope (Fall 2023).

LM Start	0.00	Rating **	U	Issue No.	14
LM End	3.10	Issue Type +	Ma	Location *	WS
Category	Earthen Levee			GPS Latitude/Longitude	
				Start	End
Item	Vegetation			37.602600°	37.573673°
				-121.158100°	-121.151360°
DWR ID	DWR_RD2092_01_f_2023_14				
Comment Code					
V1 : Control annual grass and weeds on the levee slopes and easements.					
Inspector Comment

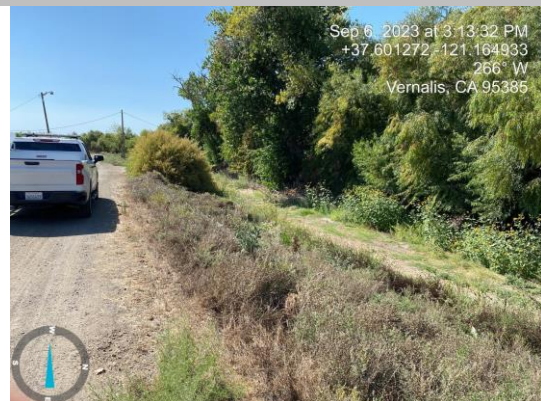
Photo 1 of 1 : FA\_2023\_RD2092\_116\_14\_20230922\_00071.jpg

View of vegetation on the waterside slope (Fall 2023).

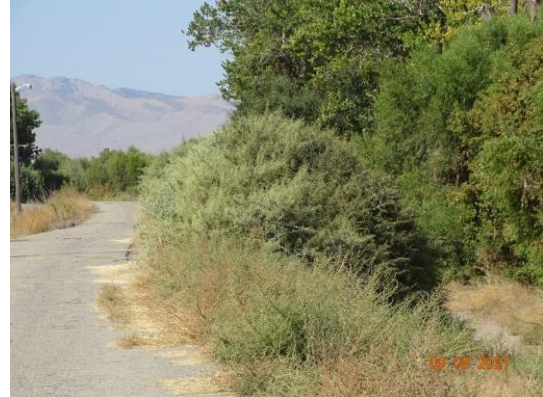
Photo 1 of 1 : FA\_2023\_RD2092\_116\_32\_20230905\_00009.jpg

View of a large shrub growing on the waterside slope and shoulder. (Fall 2021)

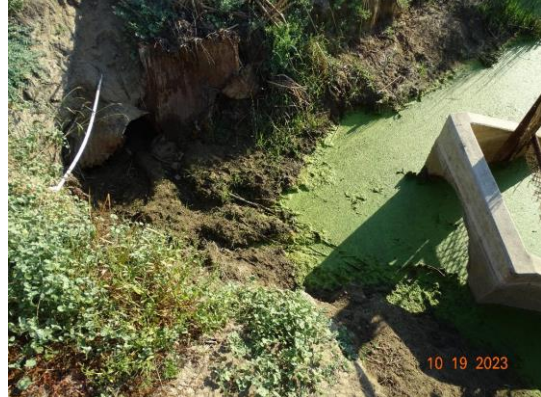
Photo 1 of 3 : UCIP\_FA\_2023\_81387\_117478.jpg

Comment Code					
Inspector Comment					
DS_ID:20561 FS_ID:81387 EP_NO: N/A Repair Type: Urgent EVAL Issue: 1, Pipe Integrity Crossing Status: Found UCIP Comments: 10/19/2023 Record remains Urgent. DMP internal video inspection has found severe pipe defects. Crossing will be monitored until funding becomes available to address the issues. Unable to confirm if flap gate is still broken (from the 2017 inspection) due to it being covered with a tarp. The flap gate hinges are bent causing the flap gate to not close properly; needs to be fixed. LS concrete headwall is completely separated from the pipe. No sink hole along LS pipe alignment (as noted in the 2019 inspection) during this inspection. No cover was present on CMP riser causing a safety hazard. Debris appears to be present at the slide gate which could potentially cause the slide gate to not close properly. (M. Thao - DWR UCIP) 03/12/2019 A thorough internal evaluation of this crossing is necessary. Pipe shows evidence of pipe integrity (LS) issues (pipe wall sections missing on LS inlet) and levee integrity issues (sink hole visible along LS pipe alignment). Internal inspection is recommended for this crossing to determine the extent of pipe damage through the levee. Pipe crosses the levee at an angle at a depth of about 19 feet. Recommend caution be taken at this crossing when driving over levee until additional information becomes available to determine condition of pipe through levee. Recommend cover be placed on riser to address safety concern (riser is 80 inches in diameter and about 19 feet deep). Slide gate appears to be blocked by sediment/debris preventing slide gate to work properly. Unable to confirm if the flap gate located on the WS is still broken (see photo from 2017). (O. Magana - DWR UCIP)09/24/2013 Pipe rusted through at headwall on LS toe. Good candidate for video inspection. (W. Wylie - DWR UCIP) FIELD_STRUCT_DESC: 60-inch corrugated metal drainage pipe through the levee, 19 feet below the crown. Flap gate on the waterside (WS) end. Slide gate in an 80-inch corrugated metal pipe (CMP) riser on the WS slope. Concrete U-shaped headwalls on both ends. [Additional Reference(s): DWR Levee Log, 2005. USACE San Joaquin O&M Manual 5, August 1961, (HLM 0.18)]. FS Date: 10/19/2023 11:40:52 AM

LS view: Headwall (right) completely separated from pipe inlet (left).

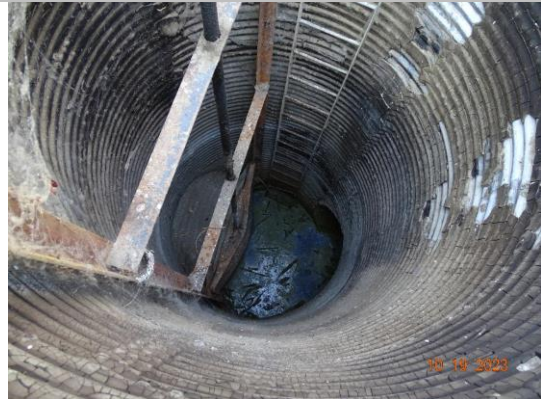
Photo 2 of 3 : UCIP\_FA\_2023\_81387\_117481.jpg

WS view: Slide gate located in CMP riser with debris.

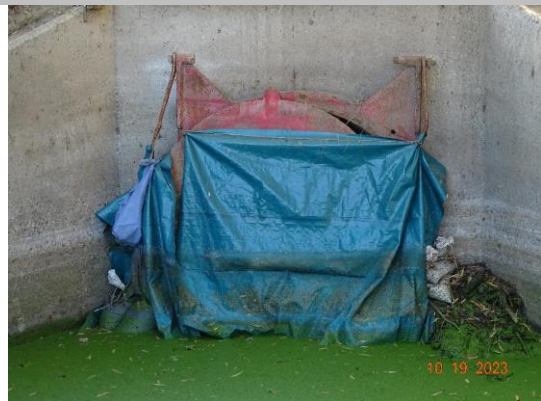
Photo 3 of 3 : UCIP\_FA\_2023\_81387\_117483.jpg

WS view: Close-up view of flap gate covered with tarp; hinge bent so flap gate is not closing properly.

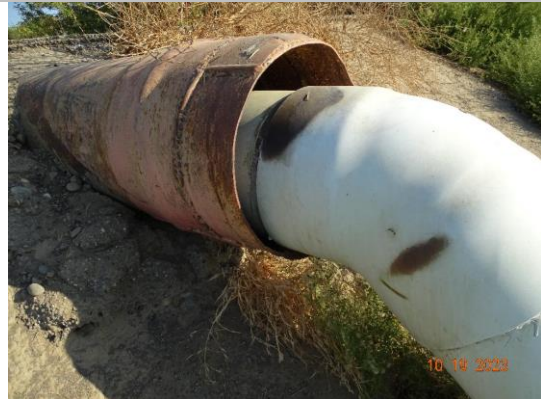
Photo 1 of 1 : UCIP\_FA\_2023\_81509\_117888.jpg

Comment Code					
Inspector Comment					
DS_ID:20581 FS_ID:81509 EP_NO: 6254A Repair Type: Non-Urgent EVAL Issue: 10, Unauthorized Modification or Non-Compliant Permit Crossing Status: Found UCIP Comments: 10/19/2023 Record remains Non-Urgent. Unable to find a permit for modification of the 18-inch PVC pipe sleeved through the existing 20-inch pipe. If crossing is no longer in use, recommend owner to contact CVFPB to abandon or remove pipe from levee. (M. Thao - DWR UCIP) 03/12/2019 Pipe has been altered on both WS and LS. A PVC pipe has been sleeved through an existing 22-inch pipe, no records have been found approving modification. This crossing appears abandoned, power source and power meter have been disconnected. Need to coordinate with CVFPB and owner. Crossing should be removed/abandoned properly per Title 23. (O. Magana - DWR UCIP) FIELD_STRUCT_DESC: 18-inch polyvinyl chloride (PVC) pipe sleeved through 20-inch steel drainage pipe through the levee, 0.5 feet below the crown. 6-inch pad constructed over the pipes. This pumping plant was constructed in 1969 during emergency conditions without a permit. Replaced a 20-inch pipe at the same location. [Additional Reference(s): DWR Levee Log, 2005]. FS Date: 10/19/2023 3:13:00 PM

LS view: 18-inch PVC pipe sleeved through the 22-inch steel pipe.

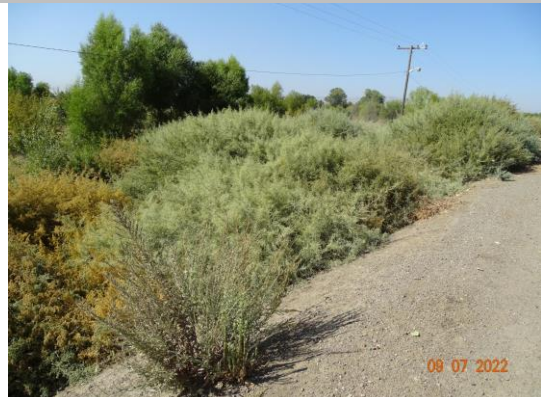
Photo 1 of 1 : FA\_2023\_RD2092\_116\_33\_20230905\_00010.jpg

LM Start	0.35	Rating **	U	Issue No.	33
LM End	0.75	Issue Type +	Ma	Location *	LS
Category	Earthen Levee			GPS Latitude/Longitude	
				Start	End
Item	Vegetation			37.601360°	37.597490°
				-121.164292°	-121.168434°
DWR ID	DWR_RD2092_01_s_2022_33				
Comment Code					
V2 : Remove the wild growth and woody vegetation other than native grasses from the levee slopes.					
Inspector Comment

Several large bushes obstructing view of the landside slope. (Fall 2022)

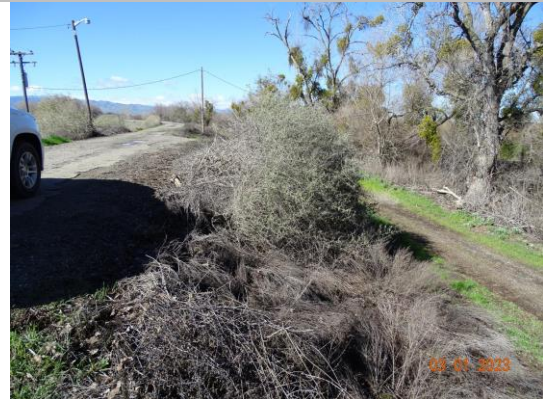
Photo 1 of 1 : FA\_2023\_RD2092\_116\_29\_20230905\_00007.jpg

Woody vegetation on waterside slope (Spring 2023).

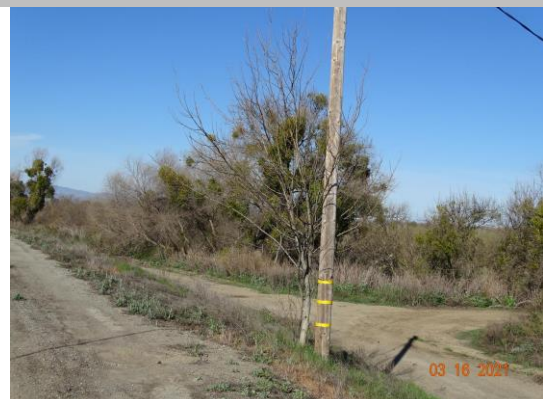
Photo 1 of 1 : FA\_2023\_RD2092\_116\_31\_20230905\_00008.jpg

View of small tree growing on waterside shoulder. (Spring 2021)

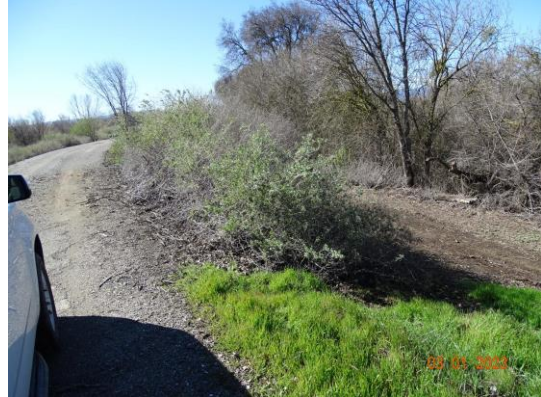
Photo 1 of 1 : FA\_2023\_RD2092\_116\_35\_20230905\_00011.jpg

View of woody vegetation on waterside slope (Spring 2023).

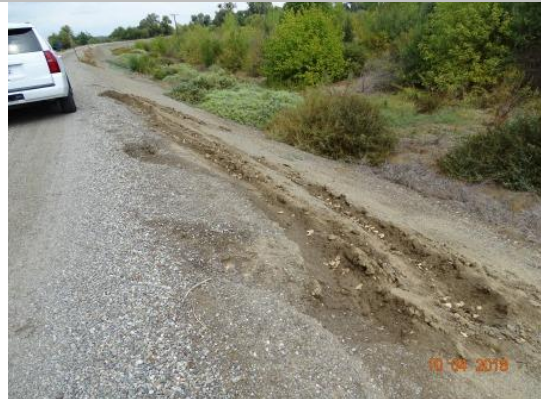
Photo 1 of 1 : FA\_2023\_RD2092\_116\_40\_20230905\_00014.jpg

LM Start	0.59	Rating **	M	Issue No.	40
LM End	0.59	Issue Type +	Ma	Location *	LS
Category	Earthen Levee			GPS Latitude/Longitude	
				Start	End
Item	Erosion / Vehicle Traffic			37.599406°	37.599406°
				-121.167083°	-121.167083°
DWR ID	DWR_RD2092_01_f _ 2018_40				
Comment Code					
E6 : Repair the levee slope damaged by vehicle traffic and prevent access where possible.					
Inspector Comment					
Vehicle tracks on the landside slope should be repaired.

Vehicle tracks on landside slope approximately 6" deep perpendicular to the slope. (Fall 2018)

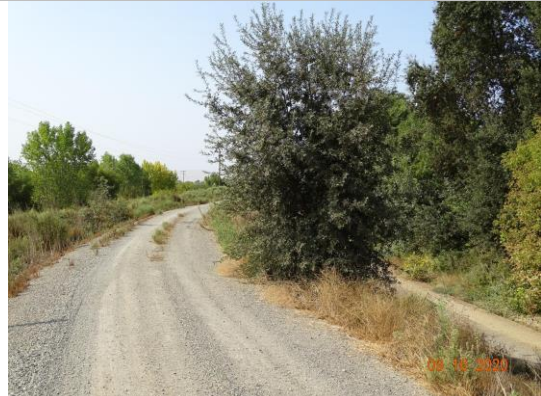
Photo 1 of 1 : FA\_2023\_RD2092\_116\_21\_20230905\_00005.jpg

Looking upstream at a tree growing in the waterside shoulder. (Fall 2020)

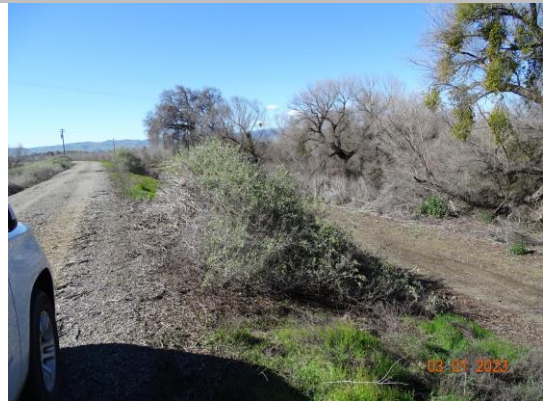
Photo 1 of 1 : FA\_2023\_RD2092\_116\_64\_20230905\_00030.jpg

View of woody vegetation on the waterside slope (Spring 2023).

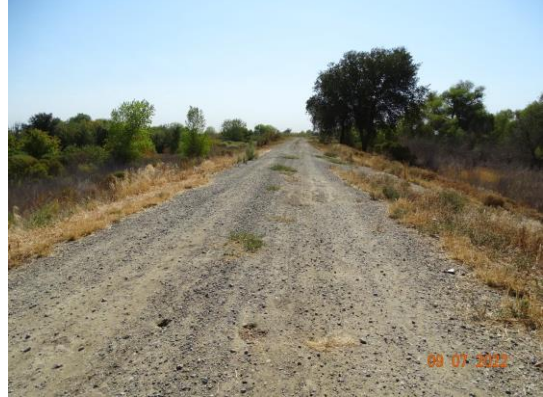
Photo 1 of 1 : FA\_2023\_RD2092\_116\_39\_20230905\_00013.jpg

Looking upstream at rutting and depression on levee crown. (Fall 2022)

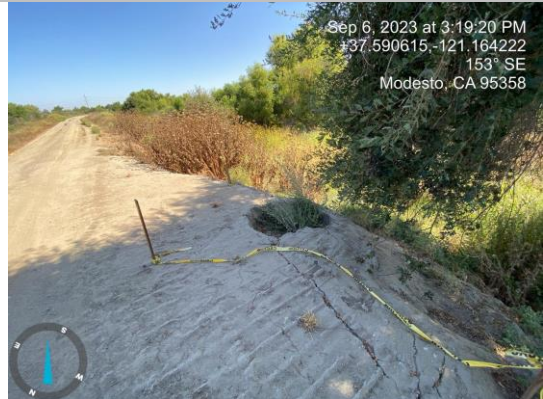
Photo 1 of 1 : FA\_2023\_RD2092\_116\_15\_20230922\_00069.jpg

LM Start	1.29	Rating **	U	Issue No.	15
LM End	1.29	Issue Type +	Ma	Location *	CR
Category	Earthen Levee			GPS Latitude/Longitude	
				Start	End
Item	Erosion / Bank Caving			37.590674°	37.590674°
				-121.164195°	-121.164195°
DWR ID	DWR_RD2092_01_f_2023_15				
Comment Code					
E2 : Schedule repair of erosion site prior to the next inspection.					
Inspector Comment					
A sinkhole has formed on the waterside shoulder and needs to be backfilled and compacted.

View of sinkhole near waterside shoulder (Fall 2023).

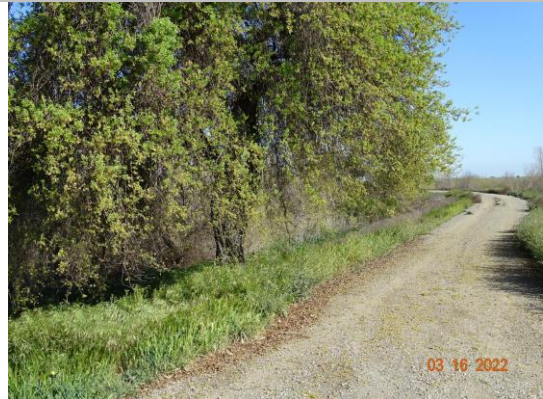
Photo 1 of 1 : FA\_2023\_RD2092\_116\_37\_20230905\_00012.jpg

View of tree branches hanging over the waterside slope and shoulder.  
(Spring 2022)

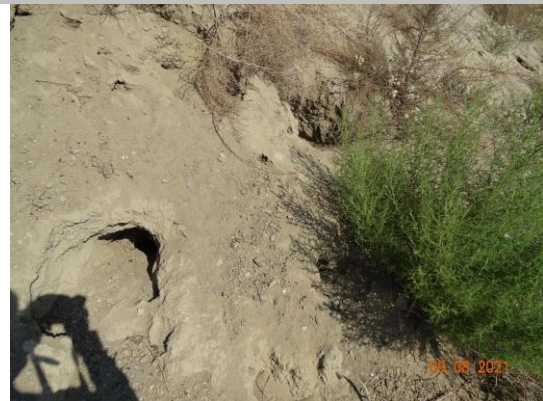
Photo 1 of 1 : FA\_2023\_RD2092\_116\_57\_20230905\_00024.jpg

View of multiple large rodent burrows in the landside slope. (Fall 2021)

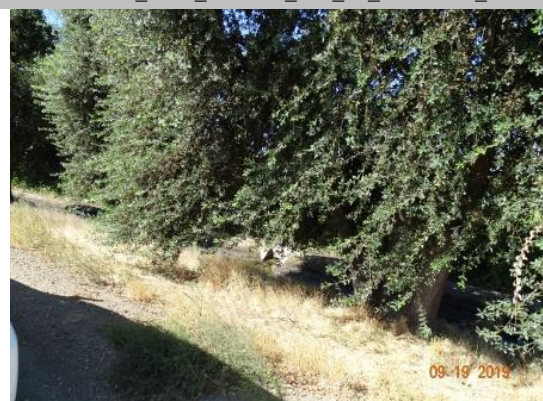
Photo 1 of 1 : FA\_2023\_RD2092\_116\_48\_20230905\_00019.jpg

View of branches hanging over waterside slope. (Fall 2019)

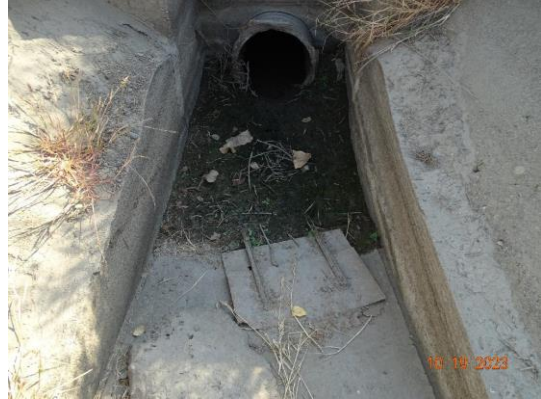
Photo 1 of 2 : UCIP\_FA\_2023\_81556\_117531.jpg

Comment Code					
Inspector Comment					
DS_ID:20563 FS_ID:81556 EP_NO: N/A Repair Type: Urgent EVAL Issue: 3a, Flood Risk Crossing Status: Found UCIP Comments: 10/19/2023 Record remains Urgent. Slide gate on waterside missing potentially allowing uncontrolled flood water from WS to LS. Unable to locate CMP riser on WS slope due to overgrown vegetation. No issues observed on the LS headwall. DMP internal video inspection has found none or minor pipe defects. Recommend next video inspection in 5 years. (M. Thao - DWR UCIP) 03/12/2019 A thorough internal evaluation of this crossing is required, pipe shows evidence of pipe integrity (LS) issues (pipe wall sections missing on WS outlet). Internal inspection is recommended for this crossing to determine the extent of pipe damage through the levee. Maintenance issues identified at this crossing include: flap gate missing on WS, debris found inside concrete distribution box, and missing cover on riser. No permit has been identified for this crossing. Need to determine who maintains crossing; crossing appears functional. (O. Magana - DWR UCIP) FIELD_STRUCT_DESC: 24-inch corrugated metal drainage pipe through the levee, 14 feet below the crown. Slide gate in a corrugated metal pipe (CMP) riser on the waterside (WS) slope. Concrete U-shaped headwall at the landside (LS) toe. [Additional Reference(s): DWR Levee Log, 2005. USACE San Joaquin O&M Manual 5, August 1961, (HLM 1.71)]. FS Date: 10/19/2023 10:15:17 AM

WS view: Pipe outlet at toe with missing flap gate.

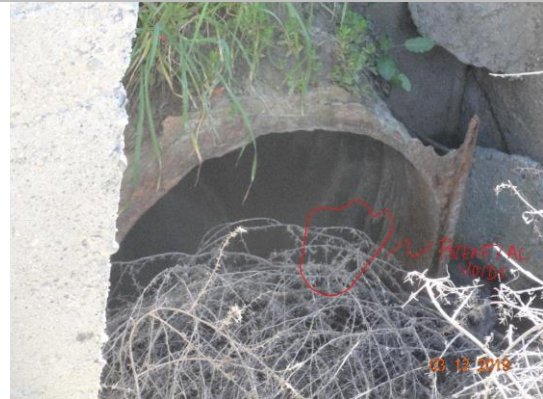
Photo 2 of 2 : UCIP\_FA\_2023\_81556\_79081.jpg

WS view: potential voids visible at pipe outlet.

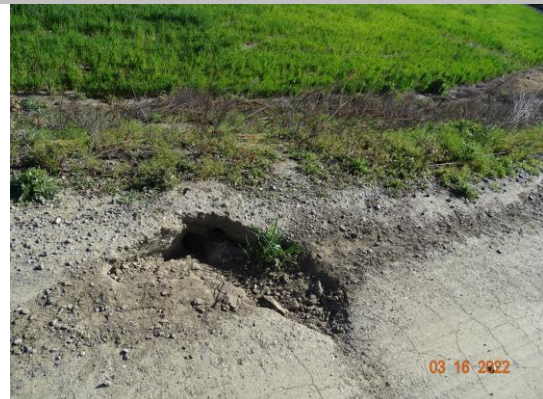
Photo 1 of 1 : FA\_2023\_RD2092\_116\_49\_20230905\_00020.jpg

Levee crown collapsing into a rodent burrow. (Spring 2022)

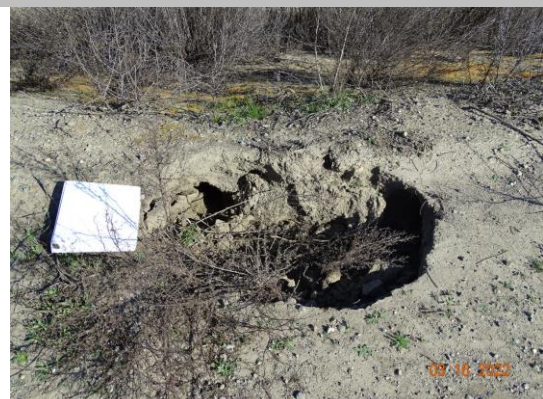
Photo 1 of 1 : FA\_2023\_RD2092\_116\_62\_20230905\_00028.jpg

Large hole in the levee crown from rodent burrows collapsing. (Spring 2022)

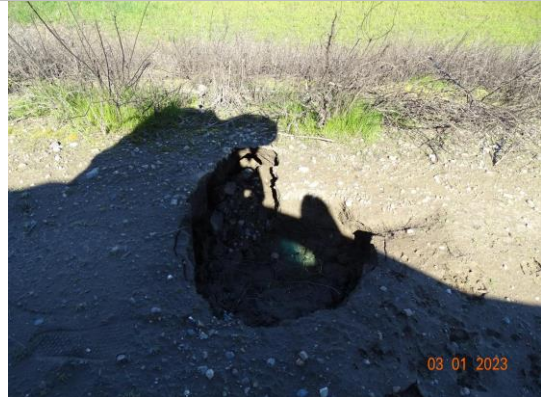
Photo 1 of 1 : FA\_2023\_RD2092\_116\_63\_20230905\_00029.jpg

View of collapsed rodent hole on the crown of the levee (Spring 2023).

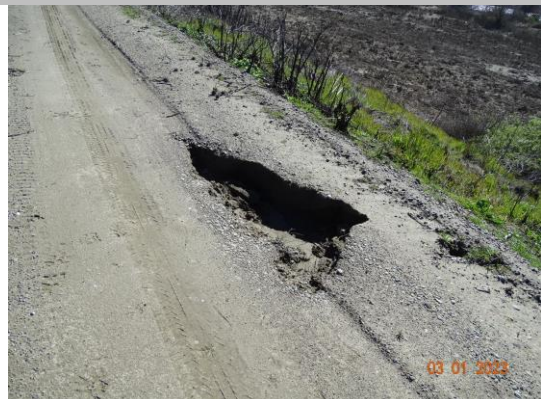
Photo 1 of 1 : FA\_2023\_RD2092\_116\_70\_20230905\_00032.jpg

View of collapsed rodent hole on the crown of the levee (Spring 2023).

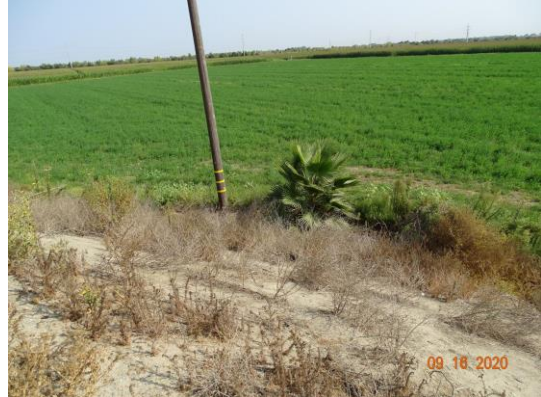
Photo 1 of 1 : FA\_2023\_RD2092\_116\_43\_20230905\_00016.jpg

View of small palm tree growing on the landside toe. (Fall 2020)

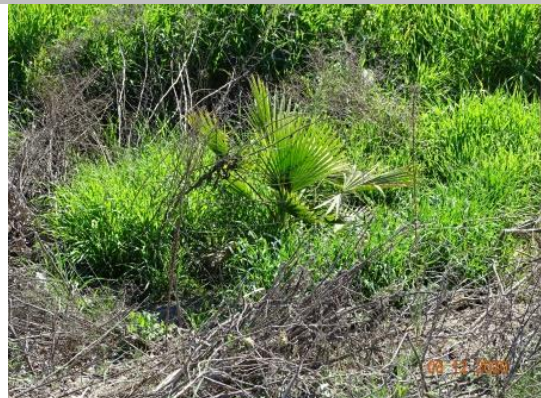
Photo 1 of 1 : FA\_2023\_RD2092\_116\_59\_20230905\_00026.jpg

Up close view of palm tree growing at the levee toe. (Spring 2020)

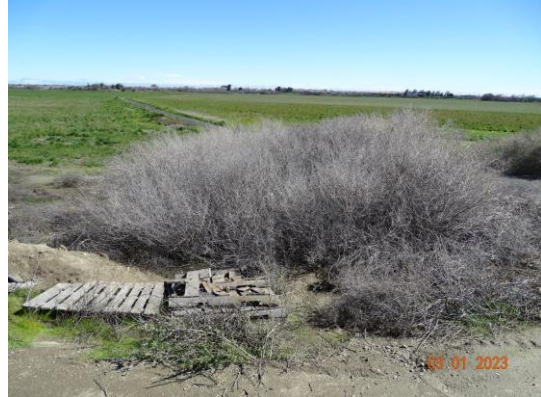
Photo 1 of 1 : FA\_2023\_RD2092\_116\_74\_20230905\_00033.jpg

View of woody vegetation on landside slope (Spring 2023).

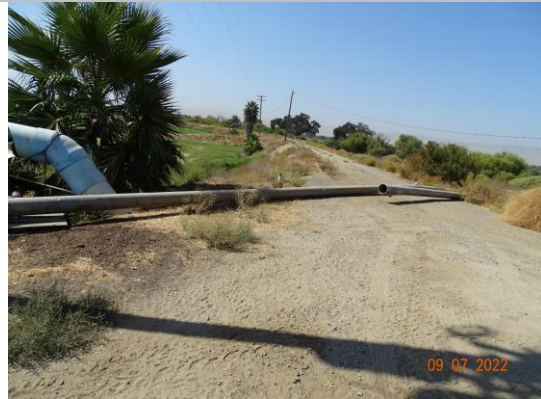
Photo 1 of 1 : FA\_2023\_RD2092\_116\_42\_20230905\_00015.jpg

Temporary pipe crossing placed across levee crown blocking access.  
(Fall 2022)

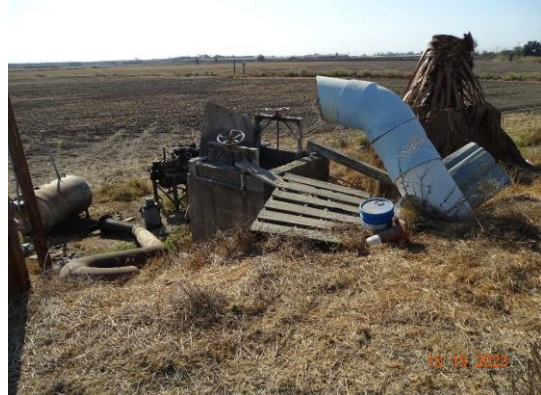
Photo 1 of 2 : UCIP\_FA\_2023\_81555\_117950.jpg

LS view: Looking from crown; concrete distribution box with no cover and unauthorized modified 21-inch PVC irrigation pipe on slope.

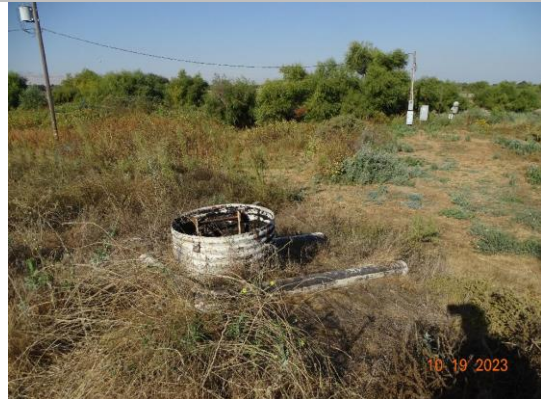
Photo 2 of 2 : UCIP\_FA\_2023\_81555\_117949.jpg

WS view: Looking from crown; CMP riser with no cover on slope and pump on timber pile structure located approximately 120 feet off toe.

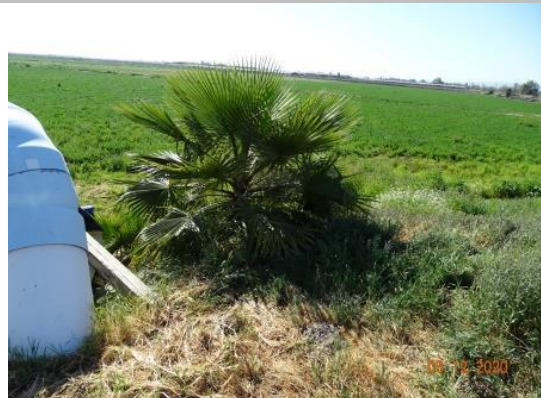
Photo 1 of 1 : FA\_2023\_RD2092\_116\_58\_20230905\_00025.jpg

View of palm tree growing on the landside slope. (Spring 2020)

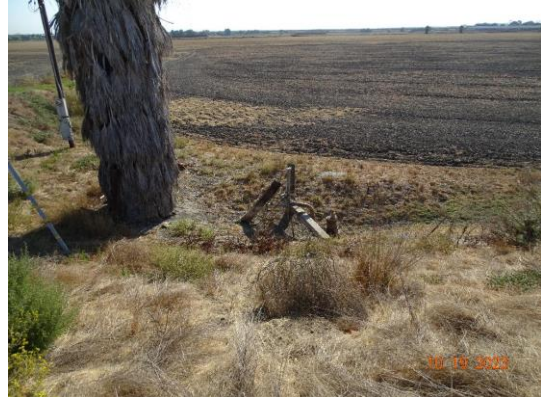
Photo 2 of 3 : UCIP\_FA\_2023\_81503\_117958.jpg

LS view: Looking from crown; no concrete headwall found. Pipe appurtenances associated with a different record (DSID 20568).

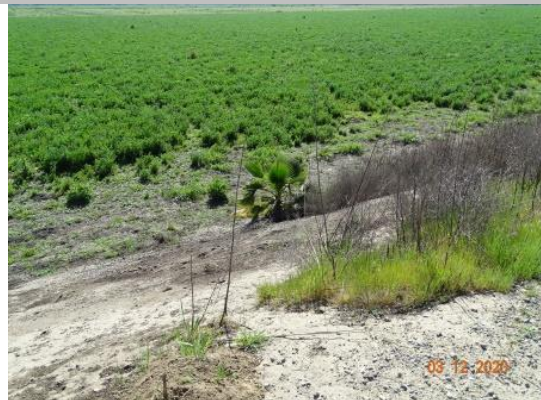
Photo 1 of 1 : FA\_2023\_RD2092\_116\_50\_20230905\_00021.jpg

View of palm tree in the landside slope. (Spring 2020)

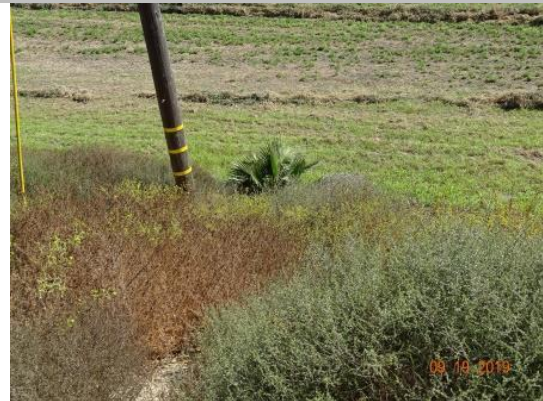
Photo 1 of 1 : FA\_2023\_RD2092\_116\_51\_20230905\_00022.jpg

View of palm tree growing in landside toe. (Fall 2019)

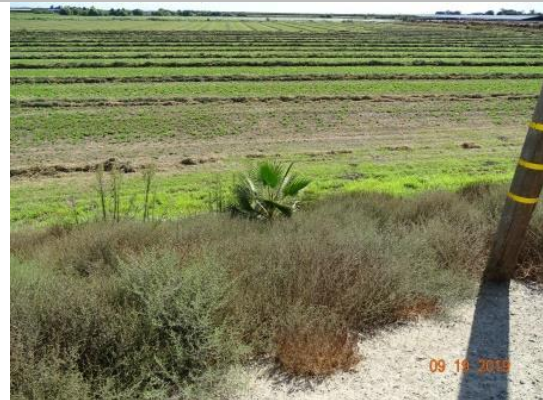
Photo 1 of 1 : FA\_2023\_RD2092\_116\_19\_20230905\_00003.jpg

View of palm tree growing on landside slope. (Fall 2019)

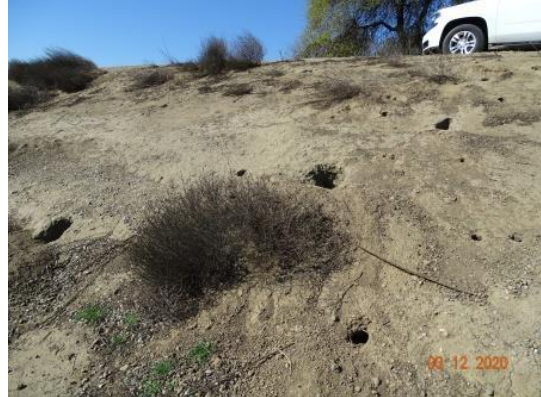
Photo 1 of 1 : FA\_2023\_RD2092\_116\_44\_20230905\_00017.jpg

View of rodent burrows in landside slope. (Spring 2020)

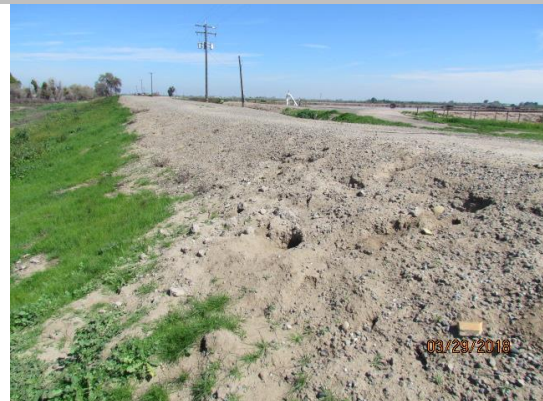
Photo 1 of 1 : FA\_2023\_RD2092\_116\_17\_20230905\_00002.jpg

Looking upstream on waterward slope at several large rodent holes.  
(Spring 2018)

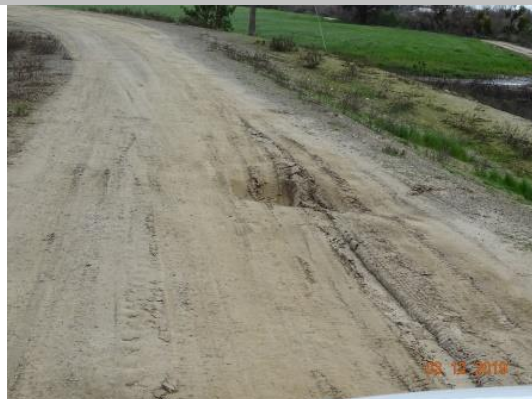
Photo 1 of 1 : FA\_2023\_RD2092\_116\_45\_20230905\_00018.jpg

View of depression in levee crown. (Spring 2019)

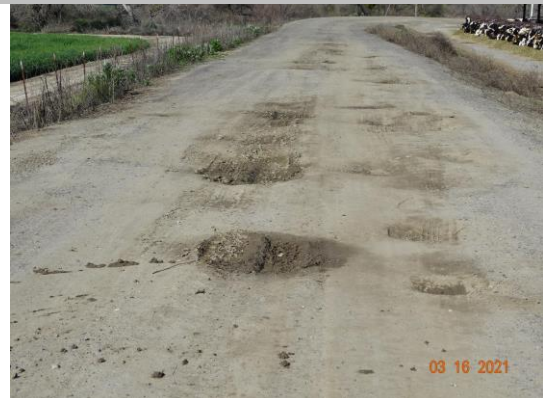
Photo 1 of 1 : FA\_2023\_RD2092\_116\_60\_20230905\_00027.jpg

View of rutting and potholes on levee crown looking downstream. (Spring 2021)

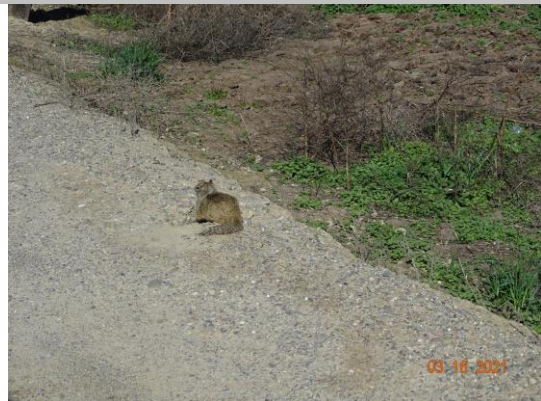
Photo 1 of 1 : FA\_2023\_RD2092\_116\_52\_20230905\_00023.jpg

View of single burrow and rodent observed on landside shoulder. (Spring 2021)

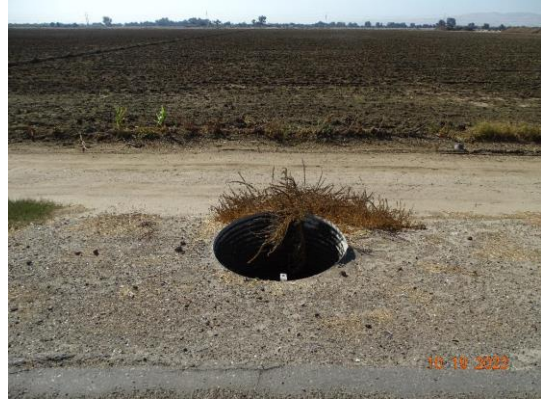
Photo 1 of 2 : UCIP\_FA\_2023\_81482\_117882.jpg

WS view: 48-inch CMP riser with no cover on slope; looking from crown.

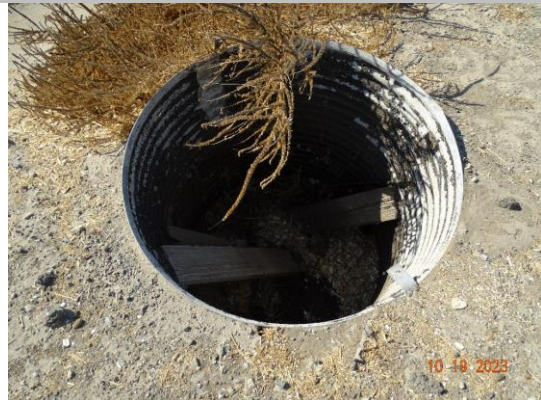
Photo 2 of 2 : UCIP\_FA\_2023\_81482\_117883.jpg

WS view: Debris within 48-inch CMP riser.
