**Flood Control Project Maintenance
Levee Inspections
Fall 2024 Levee Maintenance Deficiency Summary Report**

San Joaquin River Basin

Reclamation District No. 2092 Dos Rios

Waterway			Bank	Unit Miles
Unit No. 01 San Joaquin River			Right	3.71
	Spring (March - May)	Summer (June - August)	(September - November) Fall	Winter (December - February)
Unit Maintenance Rating (Fall Only)			U	
Date of Inspection	4/16/2024 - 4/16/2024		10/15/2024 - 10/15/2024	
DWR Inspector	Nate Hicks		Nate Hicks	
Accompanied By

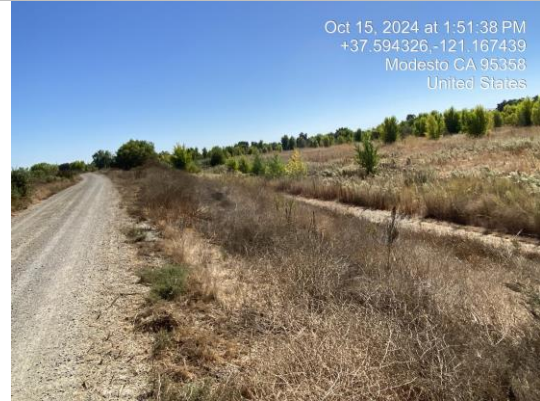
Photo 1 of 1 : FA_2024_RD2092_116_14_20241021_00055.jpg

View of vegetation on the waterside slope (Fall 2024).

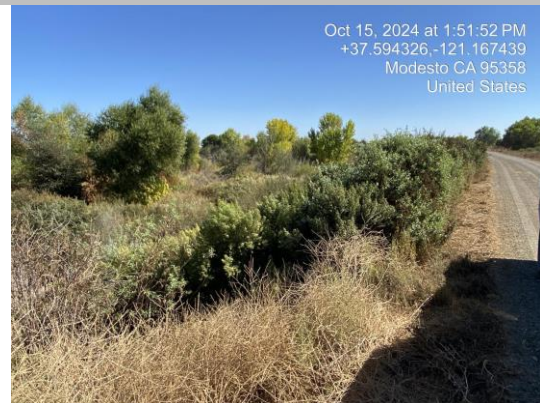
Photo 1 of 1 : FA_2024_RD2092_116_13_20241021_00056.jpg

LM Start	0.05	Rating **	U	Issue No.	13
LM End	2.94	Issue Type +	Ma	Location *	LS
Category	Earthen Levee			GPS Latitude/Longitude	
				Start	End
Item	Vegetation			37.602519 °	37.574428 °
				-121.159001 °	-121.154024 °
DWR ID	DWR_RD2092_01_f_2024_13				
Comment Code					
V1 : Control annual grass and weeds on the levee slopes and easements.					
Inspector Comment

View of vegetation on the landside slope (Fall 2024).

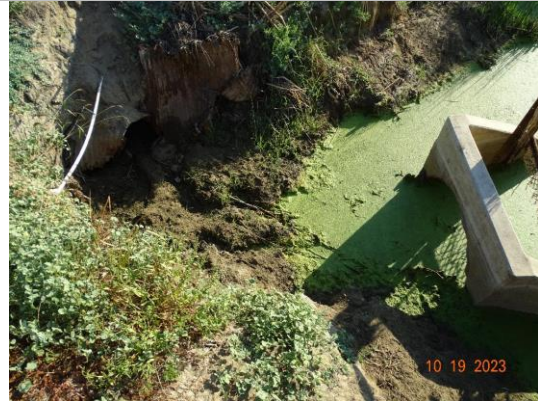
Photo 1 of 3 : UCIP_FA_2024_81387_117478.jpg

DS_ID:20561
FS_ID:81387
EP_NO: N/A
Repair Type: Urgent
EVAL Issue: 1, Pipe Integrity
Crossing Status: Found
UCIP Comments: 10/19/2023 Record remains Urgent. DMP internal video inspection has found severe pipe defects. Crossing will be monitored until funding becomes available to address the issues. Unable to confirm if flap gate is still broken (from the 2017 inspection) due to it being covered with a tarp. The flap gate hinges are bent causing the flap gate to not close properly; needs to be fixed. LS concrete headwall is completely separated from the pipe. No sink hole along LS pipe alignment (as noted in the 2019 inspection) during this inspection. No cover was present on CMP riser causing a safety hazard. Debris appears to be present at the slide gate which could potentially cause the slide gate to not close properly. (M. Thao - DWR UCIP)
03/12/2019 A thorough internal evaluation of this crossing is necessary. Pipe shows evidence of pipe integrity (LS) issues (pipe wall sections missing on LS inlet) and levee integrity issues (sink hole visible along LS pipe alignment). Internal inspection is recommended for this crossing to determine the extent of pipe damage through the levee. Pipe crosses the levee at an angle at a depth of about 19 feet. Recommend caution be taken at this crossing when driving over levee until additional information becomes available to determine condition of pipe through levee. Recommend cover be placed on riser to address safety concern (riser is 80 inches in diameter and about 19 feet deep). Slide gate appears to be blocked by sediment/debris preventing slide gate to work properly. Unable to confirm if the flap gate located on the WS is still broken (see photo from 2017). (O. Magana - DWR UCIP)

09/24/2013 Pipe rusted through at headwall on LS toe. Good candidate for video inspection. (W. Wylie - DWR UCIP)
FIELD_STRUCT_DESC: 60-inch corrugated metal drainage pipe through the levee, 19.0 feet below the crown. Flap gate on the waterside (WS) end. Slide gate in an 80-inch corrugated metal pipe (CMP) riser on the WS slope. Concrete U-shaped headwalls on both landside (LS) and WS end. [Additional Reference(s): DWR Levee Log, 2005 (HLM 0.18). USACE San Joaquin O&M Manual, Unit 5, August 1961, Revised 29 December 2016, (HLM 0.18), listed as 60-inch pipe].
FS Date: 10/19/2023 11:40:52 AM

LS view: Headwall (right) completely separated from pipe inlet (left).

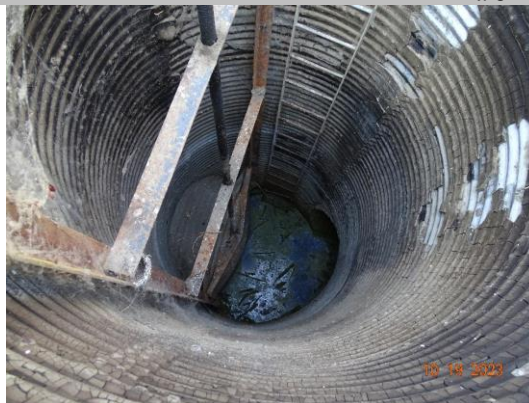
Photo 2 of 3 : UCIP_FA_2024_81387_117481.jpg

WS view: Slide gate located in CMP riser with debris.

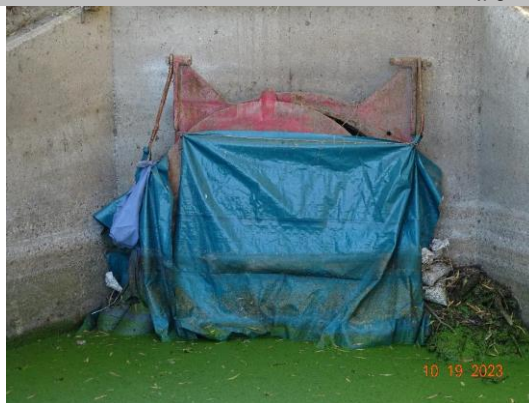
Photo 3 of 3 : UCIP_FA_2024_81387_117483.jpg

WS view: Close-up view of flap gate covered with tarp; hinge bent so flap gate is not closing properly.

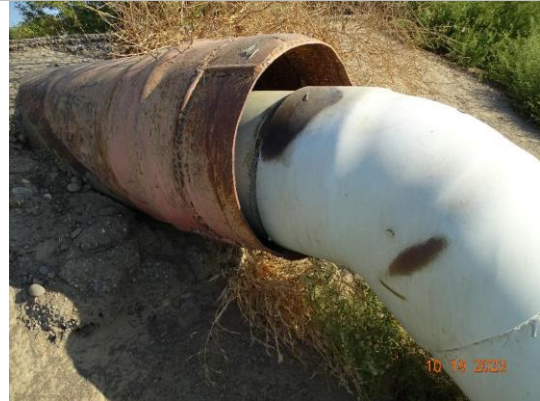
Photo 1 of 1 : UCIP_FA_2024_81509_117888.jpg

Comment Code					
Inspector Comment					
DS_ID:20581 FS_ID:81509 EP_NO: 6254A Repair Type: Non-Urgent EVAL Issue: 10, Unauthorized Modification or Non-Compliant Permit Crossing Status: Found UCIP Comments: 10/19/2023 Record remains Non-Urgent. Unable to find a permit for modification of the 18-inch PVC pipe sleeved through the existing 20-inch pipe. If crossing is no longer in use, recommend owner to contact CVFPB to abandon or remove pipe from levee. (M. Thao - DWR UCIP 03/12/2019) Pipe has been altered on both WS and LS. A PVC pipe has been sleeved through an existing 22-inch pipe, no records have been found approving modification. This crossing appears abandoned, power source and power meter have been disconnected. Need to coordinate with CVFPB and owner. Crossing should be removed/abandoned properly per Title 23. (O. Magana - DWR UCIP) FIELD_STRUCT_DESC: 18-inch polyvinyl chloride (PVC) pipe sleeved through 20-inch steel drainage pipe through the levee, 0.5 feet below the crown. 6-inch pad constructed over the pipes. This pumping plant was constructed in 1969 during emergency conditions without a permit. Replaced a 20-inch pipe at the same location. [Additional Reference(s): DWR Levee Log, 2005]. FS Date: 10/19/2023 3:13:00 PM

LS view: 18-inch PVC pipe sleeved through the 22-inch steel pipe.

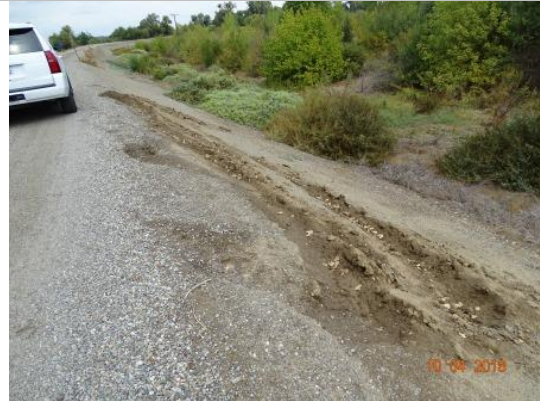
Photo 1 of 1 : FA_2024_RD2092_116_40_20241015_00010.jpg

LM Start	0.59	Rating **	M	Issue No.	40
LM End	0.59	Issue Type +	Ma	Location *	LS
Category	Earthen Levee			GPS Latitude/Longitude	
				Start	End
Item	Erosion / Vehicle Traffic			37.599406°	37.599406°
				-121.167083°	-121.167083°
DWR ID	DWR_RD2092_01_f _ 2018_40				
Comment Code					
E6 : Repair the levee slope damaged by vehicle traffic and prevent access where possible.					
Inspector Comment					
Vehicle tracks on the landside slope should be repaired.

Vehicle tracks on landside slope approximately 6" deep perpendicular to the slope. (Fall 2018)

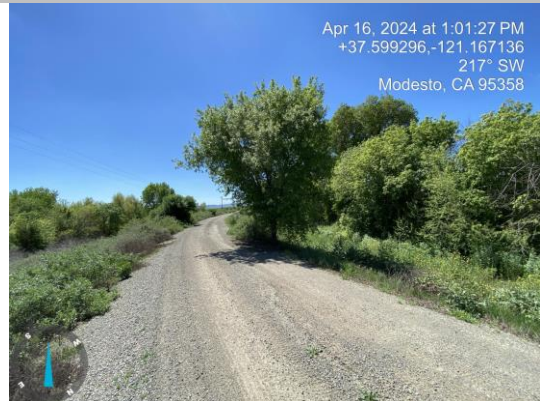
Photo 1 of 1 : FA_2024_RD2092_116_21_20241015_00006.jpg

LM Start	0.61	Rating **	M	Issue No.	21
LM End	0.61	Issue Type +	Ma	Location *	WS
Category	Earthen Levee			GPS Latitude/Longitude	
				Start	End
Item	Trim / Thin Trees			37.599208°	37.599208°
				-121.167150°	-121.167150°
DWR ID	DWR_RD2092_01_s_2024_21				
Comment Code					
T1 : Trim and thin trees to at least five feet above ground level to allow visibility of the ground and room to flood fight.					
Inspector Comment					
Trim tree 5 feet above the ground level.

Looking upstream at a tree growing in the waterside shoulder (Spring 2024).

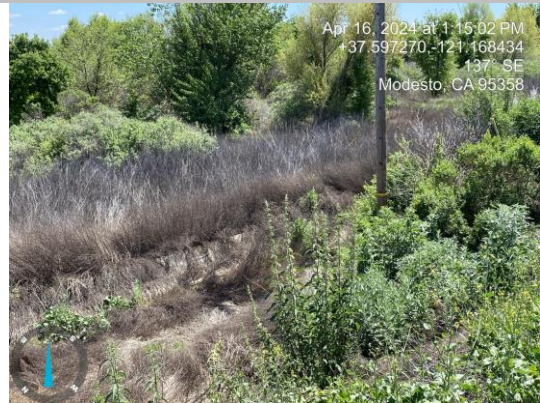
Photo 1 of 1 : FA_2024_RD2092_116_968_20241015_00026.jpg

View of concrete ditch running along the landside toe (Spring 2024).

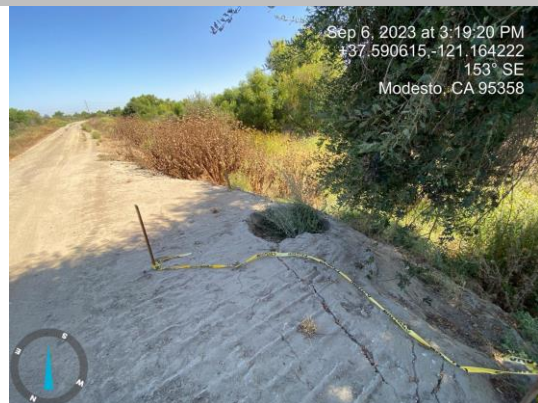
Photo 1 of 1 : FA_2024_RD2092_116_15_20241015_00002.jpg

LM Start	1.29	Rating **	U	Issue No.	15
LM End	1.29	Issue Type +	Ma	Location *	CR
Category	Earthen Levee			GPS Latitude/Longitude	
				Start	End
Item	Erosion / Bank Caving			37.590674 °	37.590674 °
				-121.164195 °	-121.164195 °
DWR ID	DWR_RD2092_01_f_2023_15				
Comment Code					
E2 : Schedule repair of erosion site prior to the next inspection.					
Inspector Comment					
A sinkhole has formed on the waterside shoulder and needs to be backfilled and compacted.

View of sinkhole near waterside shoulder (Fall 2023).

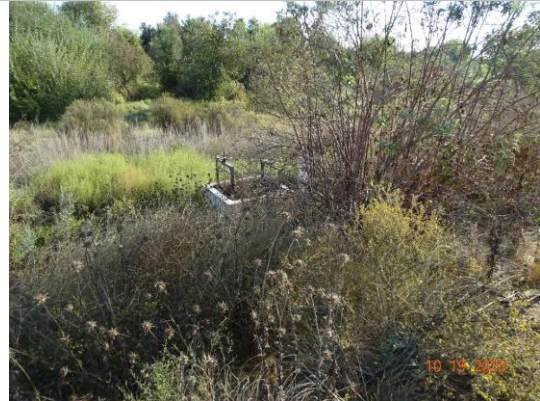
Photo 2 of 3 : UCIP_FA_2024_81554_117508.jpg

Comment Code					
Inspector Comment					
DS_ID:20562 FS_ID:81554 EP_NO: N/A Repair Type: Non-Urgent EVAL Issue: 5, Pipe Damage Crossing Status: Found UCIP Comments: 10/19/2023 Record remains Non-Urgent. DMP internal video inspection has found moderate pipe defects. Crossing will be monitored until funding becomes available for rehabilitation. Slide gate in a 48-inch CMP riser on WS slope not found. Distribution box on WS toe not found. Overgrown vegetation limits inspection of levee at this crossing on LS. (M. Thao - DWR UCIP) 03/12/2019 DMP internal video inspection has found pipe integrity issues. LOF of crossing is greater than or equal to 4.1 and less than 5. Crossing will be monitored until funding becomes available for rehabilitation. During UCIP visual inspection, no pipe or levee integrity issues were observed. Distribution box located on the WS is falling apart (bricks missing). This crossing is an active crossing however, no permit has been found authorizing crossing. Need to determine who maintains and operates this crossing. (O. Magana - DWR UCIP) FIELD_STRUCT_DESC: 36-inch corrugated metal irrigation pipe through the levee, 15 feet below the crown. Slide gate in a 48-inch corrugated metal pipe (CMP) riser on the waterside (WS) slope. 4-foot by 6-foot concrete distribution box on the landside (LS) toe. 5-foot by 5-foot concrete riser on the WS toe. [Additional Reference(s): DWR Levee Log, 2005. USACE San Joaquin O&M Manual 5, August 1961, (HLM 1.31). USACE As-Built Drawing No. 07-04-1555, Sheet 19.3, upstream of STA 260+00, 15 November 1961]. FS Date: 10/19/2023 4:26:48 PM

LS view: Concrete distribution box on toe; looking from crown.

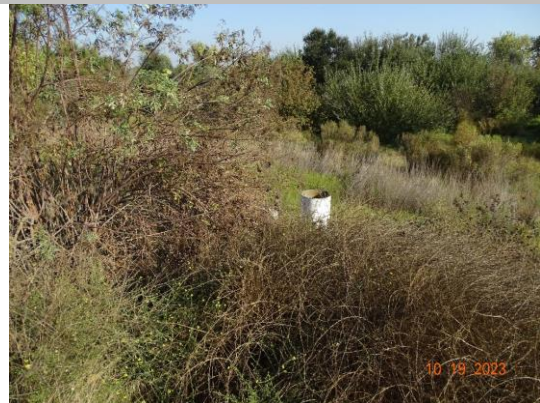
Photo 3 of 3 : UCIP_FA_2024_81554_117510.jpg

LS view: Concrete riser on toe; looking from crown.

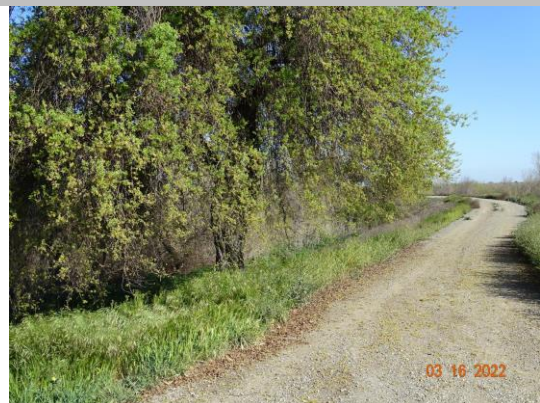
Photo 1 of 1 : FA_2024_RD2092_116_37_20241015_00008.jpg

View of tree branches hanging over the waterside slope and shoulder.
(Spring 2022)

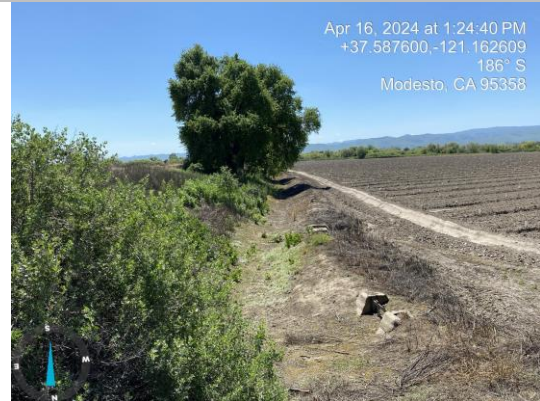
Photo 1 of 1 : FA_2024_RD2092_116_8_20241015_00001.jpg

View of unlined ditch along the waterside toe looking upstream (Spring 2024).

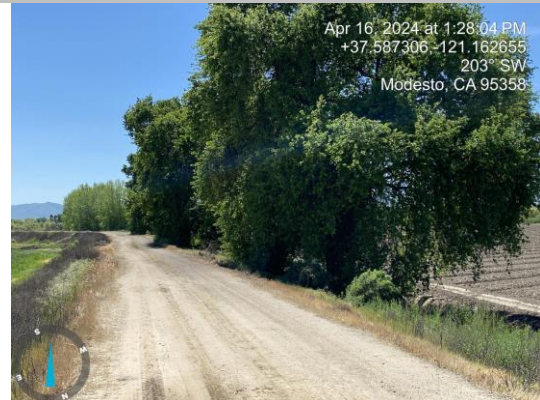
Photo 1 of 1 : FA_2024_RD2092_116_48_20241015_00013.jpg

LM Start	1.60	Rating **	M	Issue No.	48
LM End	1.71	Issue Type +	Ma	Location *	WS
Category	Earthen Levee			GPS Latitude/Longitude	
				Start	End
Item	Trim / Thin Trees			37.587068 °	37.585551 °
				-121.162773 °	-121.163388 °
DWR ID	DWR_RD2092_01_f_2019_48				
Comment Code					
T1 : Trim and thin trees to at least five feet above ground level to allow visibility of the ground and room to flood fight.					
Inspector Comment

View of low hanging tree limbs on the waterside slope (Spring 2024).

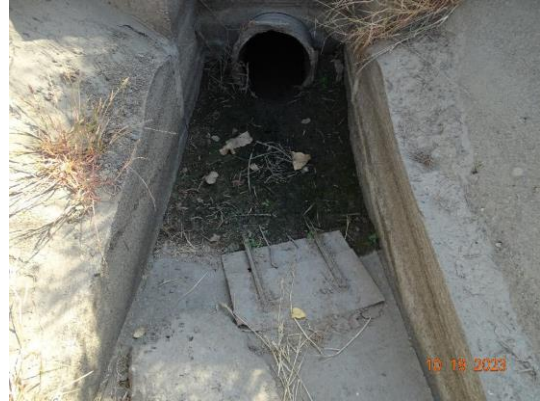
Photo 1 of 2 : UCIP_FA_2024_81556_117531.jpg

Comment Code					
Inspector Comment					
DS_ID:20563 FS_ID:81556 EP_NO: N/A Repair Type: Urgent EVAL Issue: 3a, Flood Risk Crossing Status: Found UCIP Comments: 10/19/2023 Record remains Urgent. Closure device on waterside missing potentially allowing uncontrolled flood water from WS to LS. Unable to locate CMP riser on WS slope due to overgrown vegetation. No issues observed on the LS headwall. DMP internal video inspection has found none or minor pipe defects. Recommend next video inspection in 5 years. (M. Thao - DWR UCIP) 03/12/2019 A thorough internal evaluation of this crossing is required, pipe shows evidence of pipe integrity (LS) issues (pipe wall sections missing on WS outlet). Internal inspection is recommended for this crossing to determine the extent of pipe damage through the levee. Maintenance issues identified at this crossing include: flap gate missing on WS, debris found inside concrete distribution box, and missing cover on riser. No permit has been identified for this crossing. Need to determine who maintains crossing; crossing appears functional. (O. Magana - DWR UCIP) FIELD_STRUCT_DESC: 24-inch corrugated metal drainage pipe through the levee, 14 feet below the crown. Slide gate in a corrugated metal pipe (CMP) riser on the waterside (WS) slope. Concrete U-shaped headwall at the landside (LS) toe. [Additional Reference(s): DWR Levee Log, 2005. USACE San Joaquin O&M Manual 5, August 1961, (HLM 1.71)]. FS Date: 10/19/2023 10:15:17 AM

WS view: Pipe outlet at toe with missing closure device.

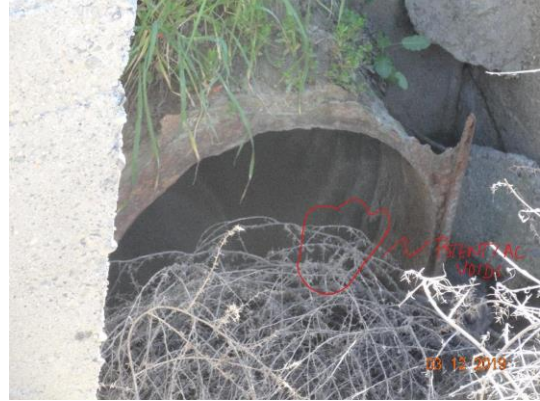
Photo 2 of 2 : UCIP_FA_2024_81556_79081.jpg

WS view: potential voids visible at pipe outlet.

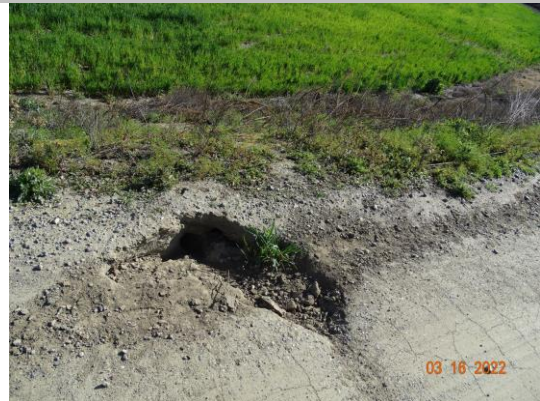
Photo 1 of 1 : FA_2024_RD2092_116_49_20241015_00014.jpg

LM Start	1.81	Rating **	A/W	Issue No.	49
LM End	1.81	Issue Type +	Ma	Location *	CR
Category	Earthen Levee			GPS Latitude/Longitude	
				Start	End
Item	Animal Control			37.584288 °	37.584288 °
				-121.162864 °	-121.162864 °
DWR ID	DWR_RD2092_01_s_2022_49				
Comment Code					
A3 : No rodents visible, but rodent burrows visible; need to backfill and compact or grout burrows.					
Inspector Comment

Levee crown collapsing into a rodent burrow. (Spring 2022)

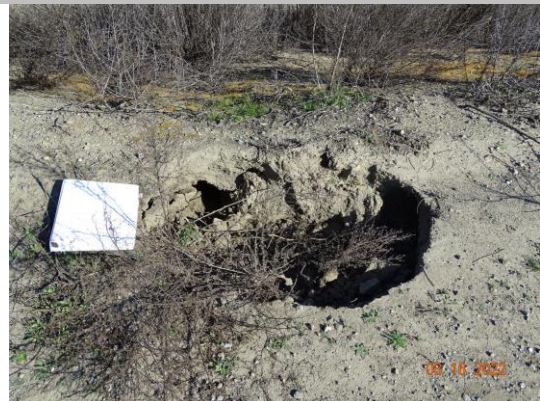
Photo 1 of 1 : FA_2024_RD2092_116_62_20241015_00021.jpg

LM Start	1.88	Rating **	A/W	Issue No.	62
LM End	1.88	Issue Type +	Ma	Location *	CR
Category	Earthen Levee			GPS Latitude/Longitude	
				Start	End
Item	Animal Control			37.584091 °	37.584091 °
				-121.161624 °	-121.161624 °
DWR ID	DWR_RD2092_01_s_2022_62				
Comment Code					
A3 : No rodents visible, but rodent burrows visible; need to backfill and compact or grout burrows.					
Inspector Comment

Large hole in the levee crown from rodent burrows collapsing. (Spring 2022)

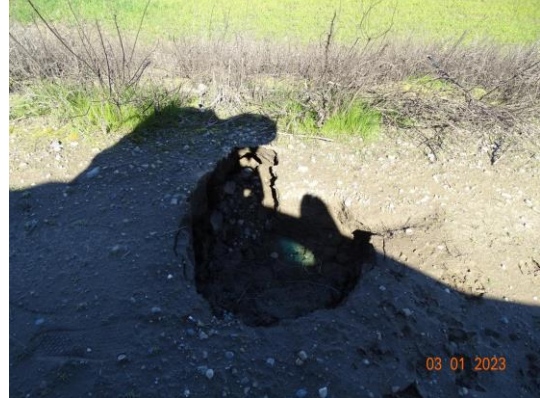
Photo 1 of 1 : FA_2024_RD2092_116_63_20241015_00022.jpg

View of collapsed rodent hole on the crown of the levee (Spring 2023).

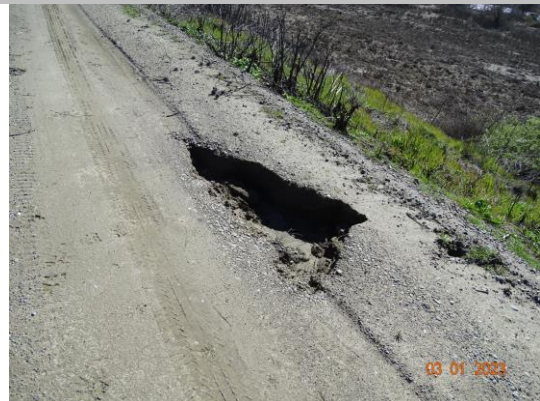
Photo 1 of 1 : FA_2024_RD2092_116_70_20241015_00025.jpg

LM Start	1.95	Rating **	A/W	Issue No.	70
LM End	1.95	Issue Type +	Ma	Location *	CR
Category	Earthen Levee			GPS Latitude/Longitude	
				Start	End
Item	Animal Control			37.584379 °	37.584379 °
				-121.160335 °	-121.160335 °
DWR ID	DWR_RD2092_01_s_2023_70				
Comment Code					
A3 : No rodents visible, but rodent burrows visible; need to backfill and compact or grout burrows.					
Inspector Comment

View of collapsed rodent hole on the crown of the levee (Spring 2023).

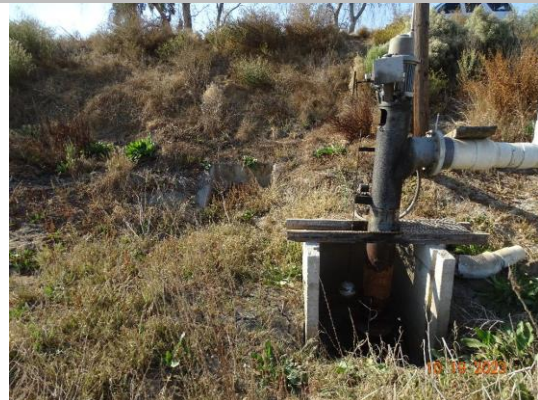
Photo 2 of 3 : UCIP_FA_2024_81477_117866.jpg

Comment Code					
Inspector Comment					
DS_ID:20564 FS_ID:81477 EP_NO: N/A Repair Type: Non-Urgent EVAL Issue: Crossing Status: Found UCIP Comments: 10/19/2023 Record remains Non-Urgent. Crossing appears abandoned; unable to locate a permit and confirm proper pipe abandonment. Overgrown vegetation limits inspection of levee on WS. (M. Thao - DWR UCIP) 03/12/2019 Concrete headwall found on LS toe. Pipe appears to have been grouted through. No other appurtenances were found during inspection. WS outlet was not found. Need to coordinate with the CVFPB to determine if additional steps are needed to comply with Title 23. (O. Magana - DWR UCIP) FIELD_STRUCT_DESC: 30-inch corrugated metal drainage pipe through the levee, 15 feet below the crown. Flap gate on the waterside (WS) end. Concrete U-shaped headwalls on both ends. Filled with concrete on the landside (LS) toe. [Additional Reference(s): DWR Levee Log, 2005. USACE San Joaquin O&M Manual 5, August 1961, (HLM 2.10), 36-inch pipe listed]. FS Date: 10/19/2023 2:50:09 PM

LS view: Concrete headwall and pipe inlet at toe (left); groundwater pump and concrete drop structure approximately 10 feet off toe (right).

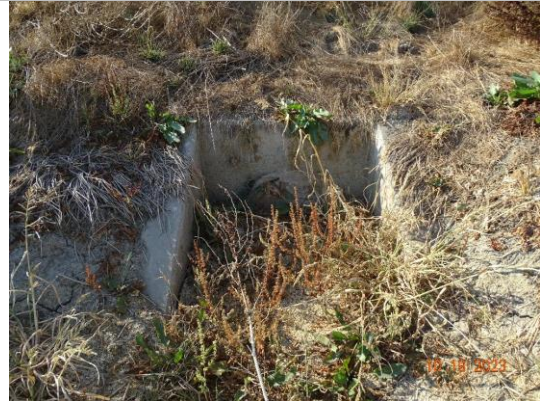
Photo 3 of 3 : UCIP_FA_2024_81477_117867.jpg

LS view: Close-up view of concrete headwall and pipe inlet on toe.

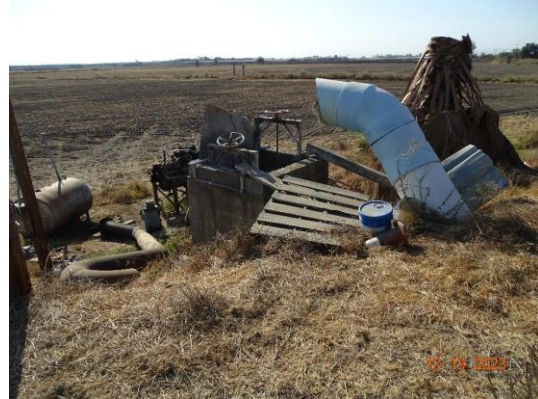
Photo 1 of 2 : UCIP_FA_2024_81501_117898.jpg

Comment Code						
Inspector Comment						
DS_ID:24680 FS_ID:81501 EP_NO: N/A Repair Type: Non-Urgent EVAL Issue: 4b, Safety Issue Crossing Status: Found UCIP Comments: 10/19/2023 Record remains Non-Urgent. Unable to find a permit for modification. New 21-inch PVC pipe seems to be added at this levee section using old appurtenances associated with DSID 20566. Debris present in CMP riser on WS and does not appear to be in use; recommend owner contact CVFPB to authorize modifications and abandon appurtenances no longer in use. No cover was present on concrete distribution box and CMP riser causing a safety hazard; recommend adding a cover to both. (M. Thao - DWR UCIP) 03/12/2019 No permit was found authorizing modifications to existing crossing. New crossing was added at this levee section using the old appurtenances associated with USACE O&M Legacy system Pipe (dsid 20566). The pipe associated with dsid 20566 has been grouted through (see dsid 20566 detail report). Irrigation pipe is functional and pipe is being maintained. Unable to confirm if riser located on WS is being used with this crossing. Need to coordinate with CVFPB to determine owner and if permit was issued for the modifications of this crossing. (O. Magana - DWR UCIP) 09/24/2013 No permit identified for this crossing. (W. Wylie - DWR UCIP) FIELD_STRUCT_DESC: 21-inch polyvinyl chloride (PVC) irrigation pipe through the levee, at an unknown depth. Pipe discharges into a concrete distribution box on the landside (LS) toe. Pump on pier off the waterside (WS) toe. [Additional Reference(s): DWR Levee Log, 2005]. FS Date: 10/19/2023 4:24:54 PM

LS view: General overview looking from crown; concrete distribution box and 21-inch PVC irrigation pipe on slope.

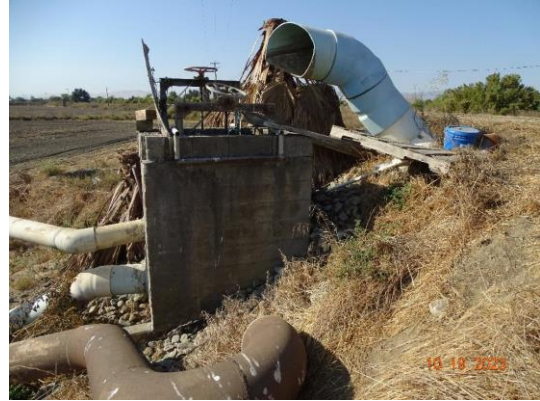
Photo 2 of 2 : UCIP_FA_2024_81501_117899.jpg

LS view: Different angle of concrete distribution box and 21-inch PVC irrigation pipe on slope; looking in upstream direction.

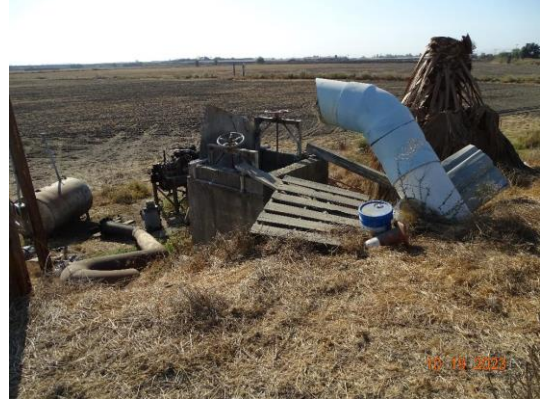
Photo 1 of 2 : UCIP_FA_2024_81555_117950.jpg

Comment Code					
Inspector Comment					
DS_ID:20566 FS_ID:81555 EP_NO: N/A Repair Type: Non-Urgent EVAL Issue: 4b, Safety Issue Crossing Status: Found UCIP Comments: 10/19/2023 Record remains Non-Urgent. Crossing appears to be modified; unable to find a permit for modification. New 21-inch PVC pipe (DSID 24680) seems to be added using appurtenances associated with this crossing. Debris is present in CMP riser on WS and does not appear to be in use. If original pipe is no longer in use, recommend owner contact CVFPB to abandon it properly and permit the modification. No cover was present on concrete distribution box and CMP riser causing a safety hazard; recommend adding a cover to both. (M. Thao - DWR UCIP) 03/12/2019 Concrete distribution box found on LS with evidence that 24-inch pipe was going through levee. Pipe appears to have been grouted through. Riser is still present on WS however, unable to determine if pipe was grouted all the way through the levee section. Concrete distribution box is currently being used by an unauthorized pipe encroachment (see DSID 24680). Lid missing from CMP riser. Owner needs to add lid to riser to prevent entry in confined space. Need to coordinate with the CVFPB to determine how to address abandoned appurtenances and pipe abandonment. (O. Magana - DWR UCIP) 09/24/2013 Pipe appears abandoned and needs to be verified as having been done so properly. (W. Wylie - DWR UCIP) FIELD_STRUCT_DESC: *ABANDONED* 24-inch corrugated metal irrigation pipe through the levee, 11 feet below the crown. Slide gate in a 36-inch corrugated metal pipe (CMP) riser on the waterside (WS) slope. 5-foot by 5-foot concrete distribution box on the landside (LS). Pump on platform in the channel. Pipe filled with concrete on the LS toe. [Additional Reference(s): DWR Levee Log, 2005. USACE San Joaquin O&M Manual 5, August 1961, (HLM 2.38)]. FS Date: 10/19/2023 8:14:32 AM

LS view: Looking from crown; concrete distribution box with no cover and unauthorized modified 21-inch PVC irrigation pipe on slope.

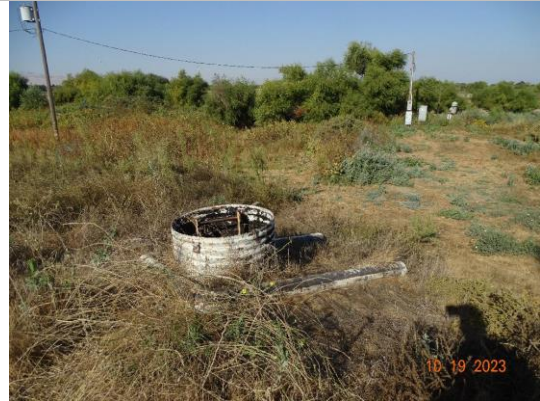
Photo 2 of 2 : UCIP_FA_2024_81555_117949.jpg

WS view: Looking from crown; CMP riser with no cover on slope and pump on timber pile structure located approximately 120 feet off toe.

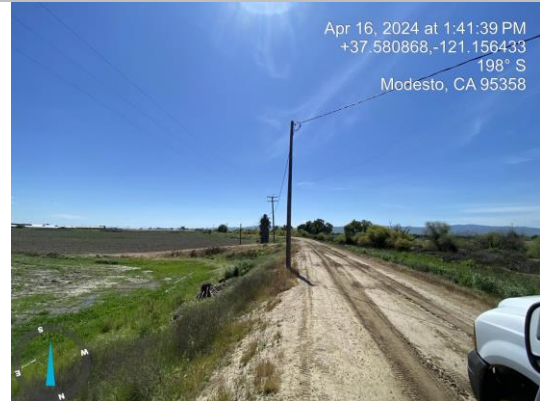
Photo 1 of 1 : FA_2024_RD2092_116_20_20241015_00005.jpg

View of the pole on the landside slope of the levee looking upstream (Spring 2024).

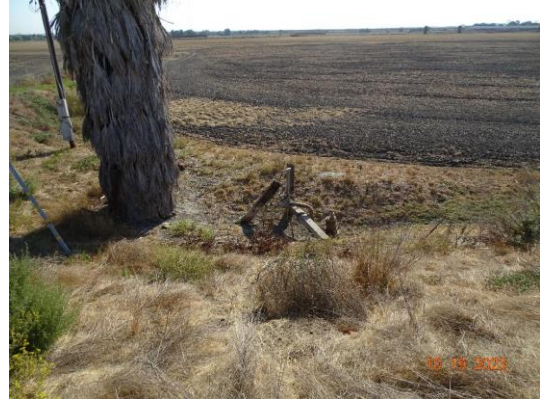
Photo 2 of 3 : UCIP_FA_2024_81503_117958.jpg

LS view: Looking from crown; no concrete headwall found. Pipe appurtenances associated with a different record (DSID 20568).

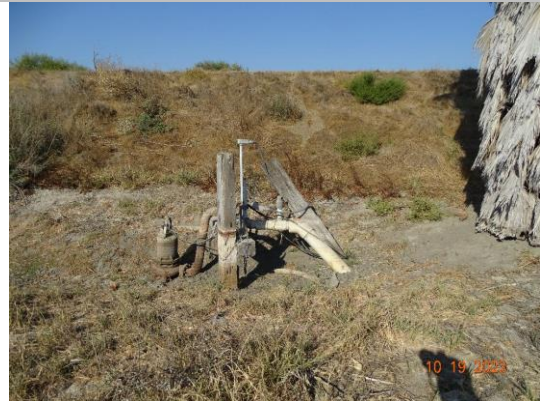
Photo 3 of 3 : UCIP_FA_2024_81503_117959.jpg

LS view: Looking toward levee; no concrete headwall found. Pipe appurtenances associated with a different record (DSID 20568).

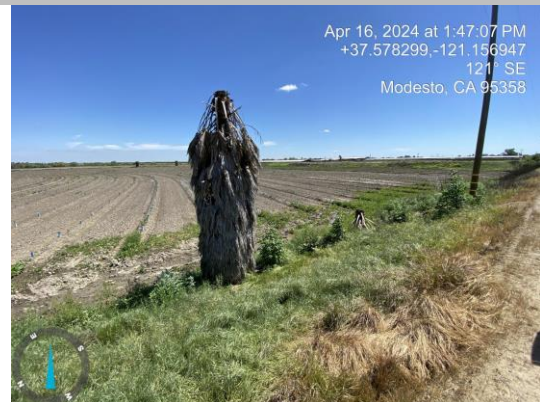
Photo 1 of 1 : FA_2024_RD2092_116_19_20241015_00004.jpg

View of palm tree on the landside slope and toe (Spring 2024).

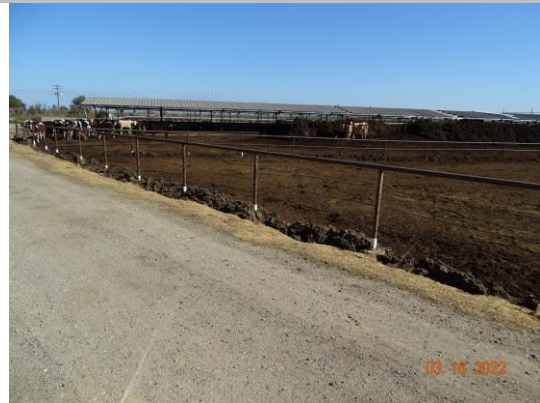
Photo 1 of 1 : FA_2024_RD2092_116_27_20241015_00007.jpg

View of a fence on the landside toe of the levee looking downstream (Spring 2022).

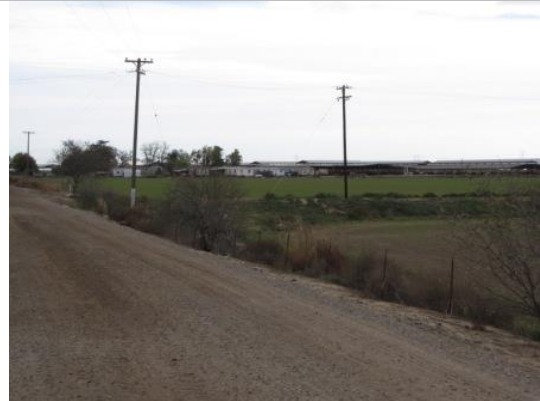
Photo 1 of 1 : FA_2024_RD2092_116_972_20241015_00027.jpg

View of barbed wire fence along the waterward slope looking upstream.

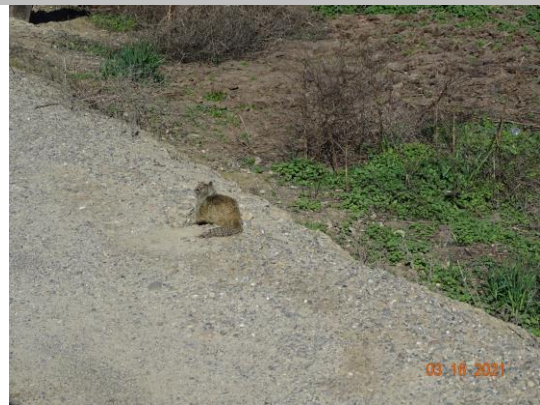
Photo 1 of 1 : FA_2024_RD2092_116_52_20241015_00017.jpg

View of single burrow and rodent observed on landside shoulder. (Spring 2021)

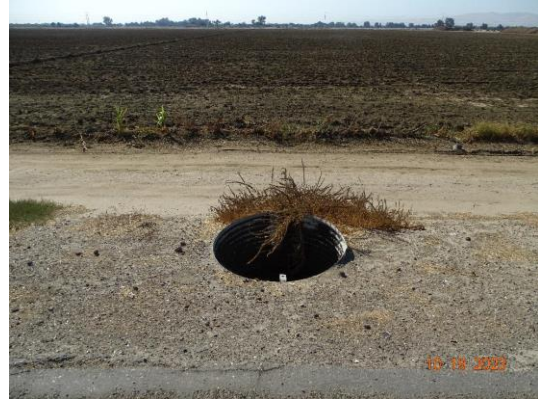
Photo 1 of 2 : UCIP_FA_2024_81482_117882.jpg

WS view: 48-inch CMP riser with no cover on slope; looking from crown.

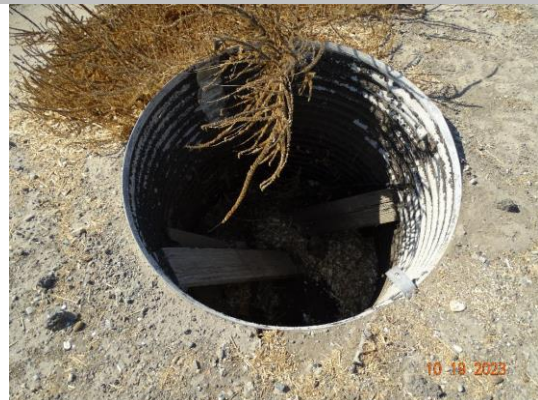
Photo 2 of 2 : UCIP_FA_2024_81482_117883.jpg

WS view: Debris within 48-inch CMP riser.
