**Flood Control Project Maintenance
Levee Inspections
LMA District Cover Sheet
Spring 2013 Levee Inspection Results**

Reclamation District No. 2092 Dos Rios

Levee Inspection Report By Mile - Spring 2013

Waterway	Bank	Unit Miles	Inspection Start/End	Inspector
Unit No. 01 San Joaquin River	Right	3.76	04/18/2013 04/18/2013	Pavel Kazi

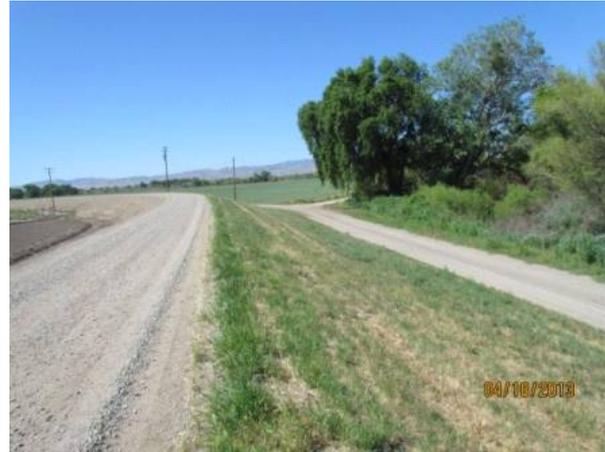
Levee Mile Report Line	5
Start Levee Mile	0.70
End Levee Mile	2.73
Location	Water Side
Category	
Item	Vegetation
Vegetation on the waterside slope of the levee looking upstream.	
pkazi_s_20130419_896.JPG

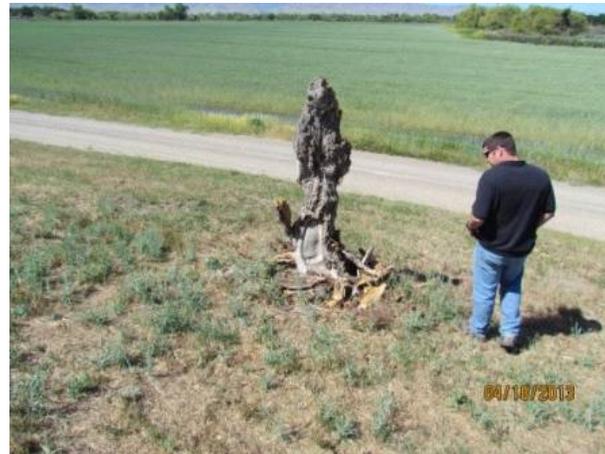
Levee Mile Report Line	6
Start Levee Mile	0.77
End Levee Mile	0.77
Location	Water Side
Category	
Item	Trim / Thin Trees
A damaged cottonwood was found on the waterside slope of the levee looking upstream. The LMA will be removing the remaining portion of the tree including the stump.	
pkazi_s_20130419_897.JPG

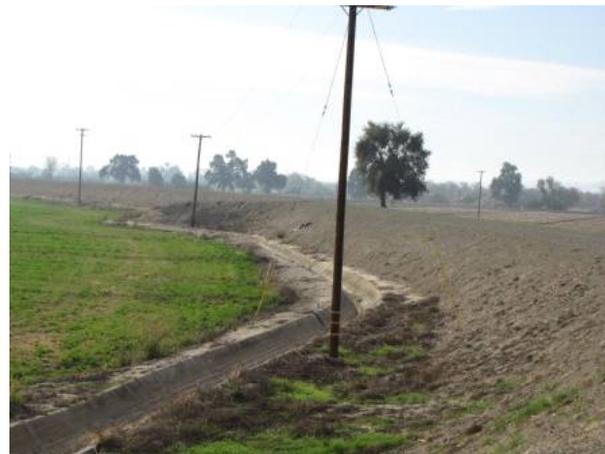
Levee Mile Report Line	7
Start Levee Mile	0.77
End Levee Mile	1.33
Location	Land Side
Category	
Item	Encroachments
View of agricultural ditch at the landward toe looking upstream.	
pkazi_s_20130404_834.jpg

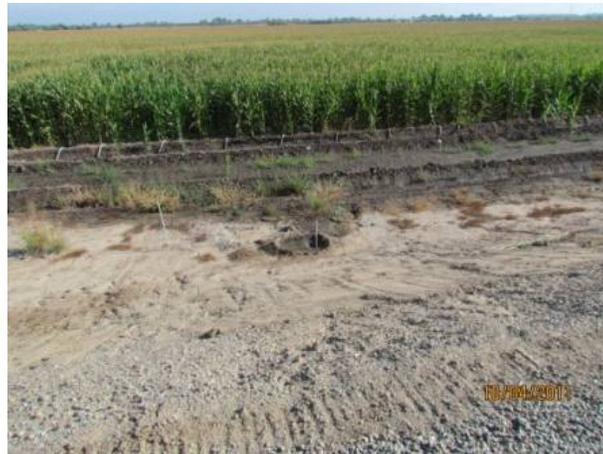
Levee Mile Report Line	10
Start Levee Mile	1.34
End Levee Mile	1.34
Location	Land Side
Category	
Item	Encroachments
<p>A sand boil was found on the landside of the levee. It was caused by a pipe leak couple of feet below the boil location. LMA was notified to repair it as soon as possible. The picture was taken from the crown looking upstream.</p>	
<p>pkazi_s_20130404_828.jpg</p>

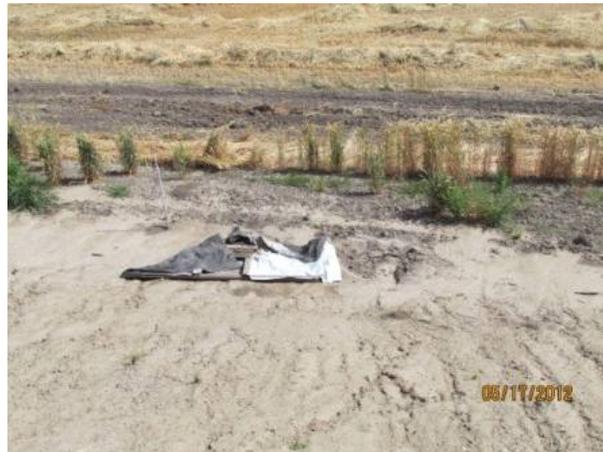
Levee Mile Report Line	10
Start Levee Mile	1.34
End Levee Mile	1.34
Location	Land Side
Category	
Item	Encroachments
<p>During spring inspection 2012, the sand boil was not active but materials were present on the landside toe of the levee. The sand boil occurred due to an underground irrigation pipe leakage. The picture was taken from the crown looking toward the toe of the levee. The area was repaired but should be monitored.</p>	
<p>pkazi_s_20130404_829.jpg</p>

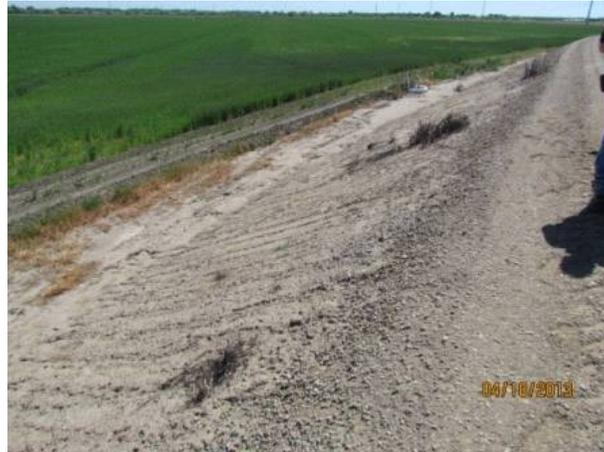
Levee Mile Report Line	11
Start Levee Mile	1.37
End Levee Mile	1.37
Location	Land Side
Category	
Item	Slope Stability
Slope instability was caused by runoff on the landside slope of the levee looking upstream.	
pkazi_s_20130419_898.JPG

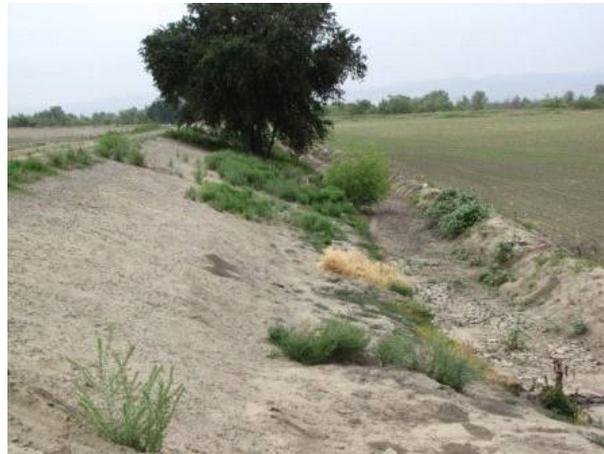
Levee Mile Report Line	13
Start Levee Mile	1.59
End Levee Mile	1.87
Location	Water Side
Category	
Item	Encroachments
View of an agricultural ditch at the waterward toe of the slope.	
pkazi_s_20130404_827.jpg

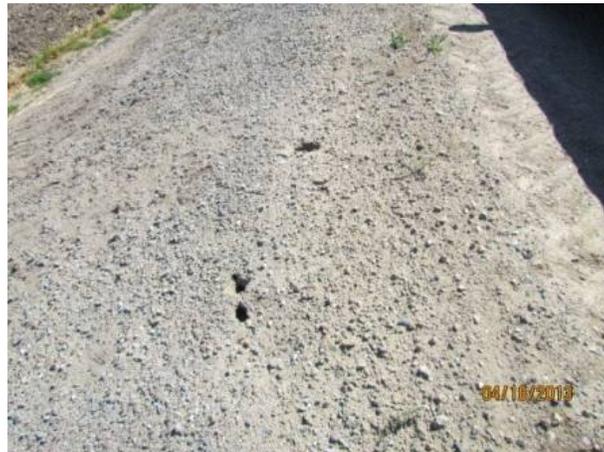
Levee Mile Report Line	14
Start Levee Mile	1.96
End Levee Mile	1.96
Location	Land Side
Category	
Item	Animal Control
Animal holes were found on the landside slope of the levee looking upstream.	
pkazi_s_20130419_899.JPG

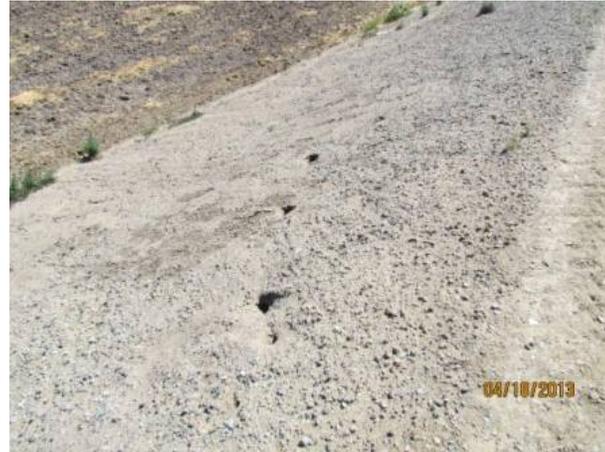
Levee Mile Report Line	14
Start Levee Mile	1.96
End Levee Mile	1.96
Location	Land Side
Category	
Item	Animal Control
Updated picture of the animal holes on the landside slope of the levee looking upstream.	
pkazi_s_20130419_900.JPG

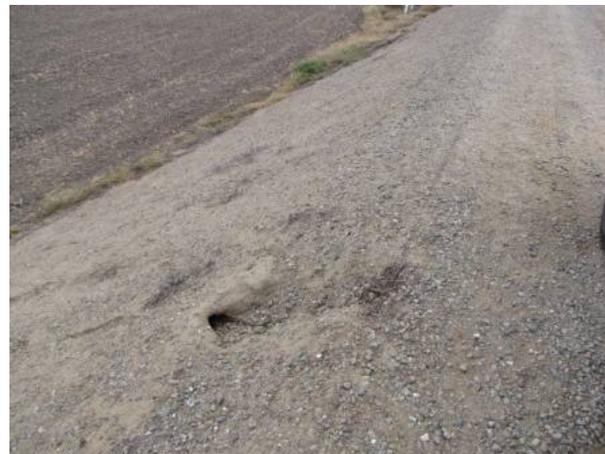
Levee Mile Report Line	15
Start Levee Mile	2.07
End Levee Mile	2.07
Location	Land Side
Category	
Item	Animal Control
View of rodent holes in the landward shoulder looking upstream.	
pkazi_s_20130404_835.jpg

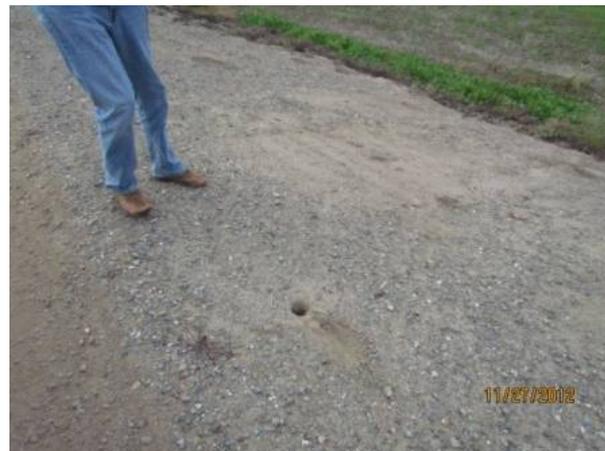
Levee Mile Report Line	15
Start Levee Mile	2.07
End Levee Mile	2.07
Location	Land Side
Category	
Item	Animal Control
View of a rodent hole on the landside shoulder of the levee looking downstream.	
pkazi_s_20130404_836.jpg

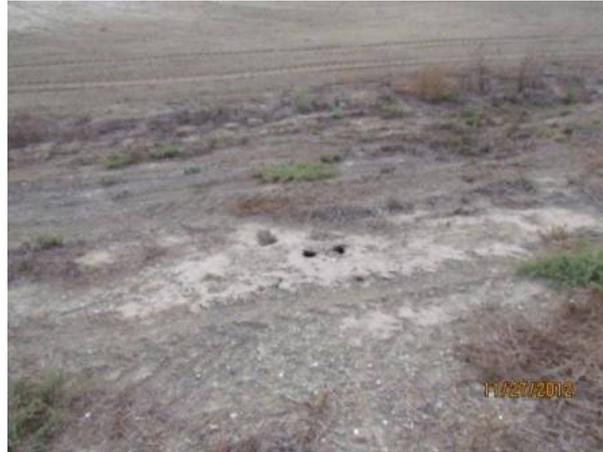
Levee Mile Report Line	16
Start Levee Mile	2.13
End Levee Mile	2.13
Location	Water Side
Category	
Item	Animal Control
Rodent holes were found on the waterside toe of the levee looking upstream.	
pkazi_s_20130404_831.jpg

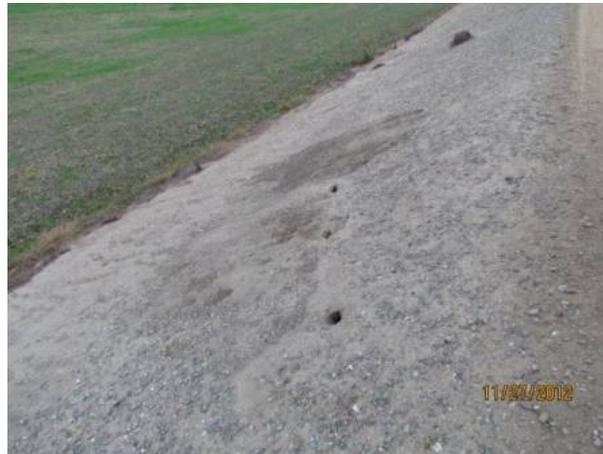
Levee Mile Report Line	17
Start Levee Mile	2.13
End Levee Mile	2.13
Location	Land Side
Category	
Item	Animal Control
Rodent holes were found on the landside slope of the levee looking upstream.	
pkazi_s_20130404_832.jpg

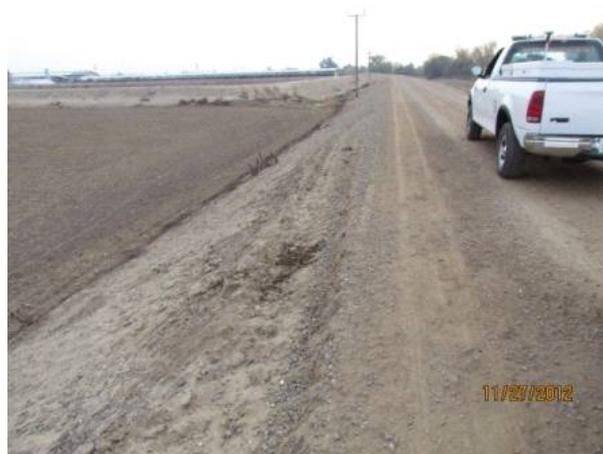
Levee Mile Report Line	18
Start Levee Mile	2.62
End Levee Mile	2.62
Location	Land Side
Category	
Item	Slope Stability
Slope instability was found due to vehicular traffic on the landside shoulder of levee looking upstream.	
pkazi_s_20130404_833.jpg

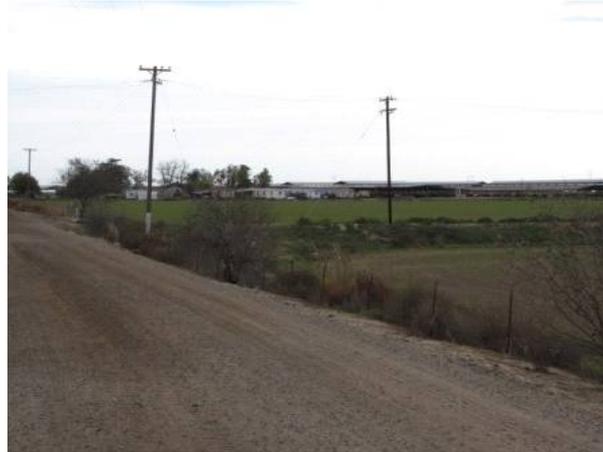
Levee Mile Report Line	19
Start Levee Mile	2.84
End Levee Mile	3.09
Location	Land Side
Category	
Item	Encroachments
View of barbed wire fence along the waterward slope looking upstream.	
pkazi_s_20130404_837.jpg
