**Flood Control Project Maintenance
Levee Inspections**
LMA District Cover Sheet
Spring 2014 Levee Inspection Results

Reclamation District No. 2092 Dos Rios

Waterway		Bank	Unit Miles
Unit No. 01 San Joaquin River		Right	3.76

Levee Inspection Report By Mile - Spring 2014

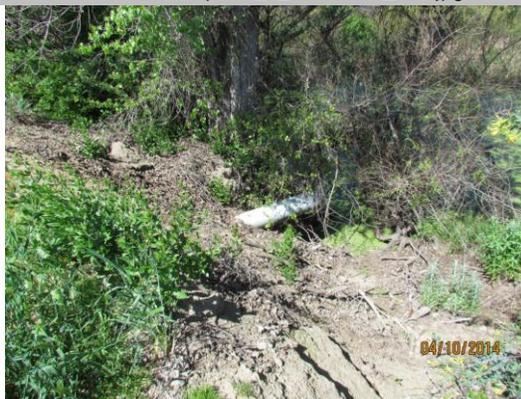
Photo 1 of 1 : pkazi_s_20140411_082.jpg

LM Start	0.17	Rating **	M	Issue No.	51
LM End	0.17	Issue Type +	Ma	Location *	WS
Category	Earthen Levee			GPS Latitude/Longitude	
				Start	End
Item	Encroachments			37.602073 °	37.602073 °
				-121.161179 °	-121.161179 °
DWR ID	DWR_RD2092_01_s_2014_51				
Action/Comments					
Pipe Inspector Comments: A flap gate is needed at the end of the pipe.

A flap gate is needed at the end of the pipe on the waterside of the levee.

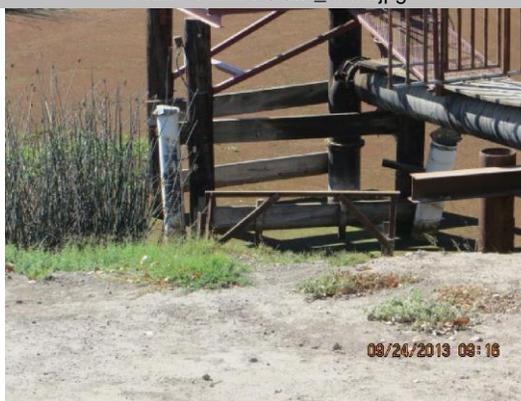
Photo 1 of 1 : UCIP_5384.jpg

LM Start	0.18	Rating **	M	Issue No.	42
LM End	0.18	Issue Type +	En	Location *	WS
Category	Supplemental			GPS Latitude/Longitude	
				Start	End
Item	DWR UCIP Field Study			37.602031 °	37.602031 °
				-121.161249 °	-121.161249 °
DWR ID	DWR_RD2092_01_s_2014_42				
Action/Comments					
Inspector Comments: FS_ID:27123 EP_NO: N/A Repair Type: Crossing Status: UCIP Comments: Pipe rusted through at headwall on LS toe. Good candidate for video inspection. FIELD_STRUCT_DESC: 60-inch corrugated metal drainpipe through levee 19.0 feet below crown. Flap gate on the waterward end. Slide gate in 80-inch corrugated metal pipe riser on the waterward slope. Concrete "U" headwalls on both ends. Originally included in the 1961 O&M manual. FS Date: 1/16/2014 12:03:14 PM

Concrete headwall on LS toe in front of pump on pier.

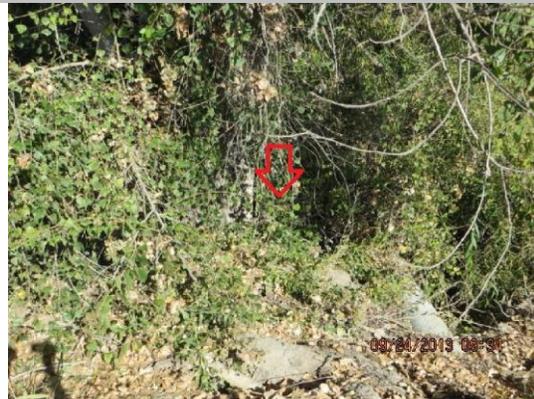
Photo 1 of 1 : UCIP_2368.jpg

LM Start	0.19	Rating **	M	Issue No.	44
LM End	0.19	Issue Type +	En	Location *	WS
Category	Supplemental			GPS Latitude/Longitude	
				Start	End
Item	DWR UCIP Field Study			37.601975 °	37.601975 °
				-121.161395 °	-121.161395 °
DWR ID	DWR_RD2092_01_s_2014_44				
Action/Comments					
Inspector Comments: FS_ID:20885 EP_NO: 6254 Repair Type: Crossing Status: UCIP Comments: Verify pipe has been removed from levee. Pipe visible on WS at riverbank. FIELD_STRUCT_DESC: *Abandoned* 16-inch steel pipe over the levee with 3.5 feet of fill on top. Siphon breakers on waterward shoulder. Pad constructed over pipes. This pumping plant was constructed in 1969 during emergency conditions without a permit (Permit No. 6254, 1968). FS Date: 9/24/2013

Pipe visible at rivers edge on WS toe.

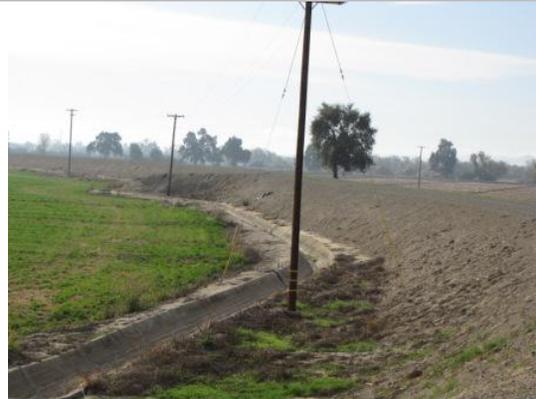
Photo 1 of 1 : pkazi_s_20140328_000.jpg

LM Start	0.77	Rating **	M	Issue No.	968
LM End	1.33	Issue Type +	En	Location *	LS
Category	Earthen Levee		GPS Latitude/Longitude		
			Start	End	
Item	Encroachments		37.597291 °	37.590568 °	
			-121.168496 °	-121.164028 °	
DWR ID	DWR_RD2092_01_s_2012_968				
Action/Comments					
Ditch

View of agricultural ditch at the landward toe looking upstream.

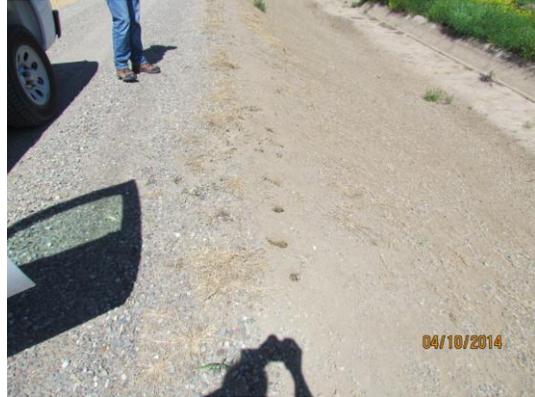
Photo 1 of 1 : pkazi_s_20140411_083.jpg

LM Start	1.07	Rating **	M	Issue No.	3
LM End	1.07	Issue Type +	Ma	Location *	LS
Category	Earthen Levee		GPS Latitude/Longitude		
			Start	End	
Item	Animal Control		37.593403 °	37.593403 °	
			-121.166750 °	-121.166750 °	
DWR ID	DWR_RD2092_01_s_2014_3				
Action/Comments

Rodent holes were found on the landside shoulder of the levee looking downstream.

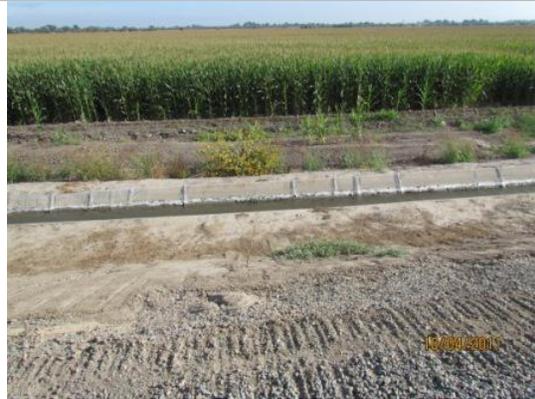
Photo 1 of 1 : pkazi_s_20140328_993.jpg

LM Start	1.34	Rating **	M	Issue No.	7
LM End	1.57	Issue Type +	En	Location *	LS
Category	Earthen Levee		GPS Latitude/Longitude		
			Start	End	
Item	Encroachments		37.590479 °	37.587758 °	
			-121.163844 °	-121.162349 °	
DWR ID	DWR_RD2092_01_s_2012_7				
Action/Comments					
Ditch

An agricultural ditch was found on the toe of the landside of the levee looking upstream.

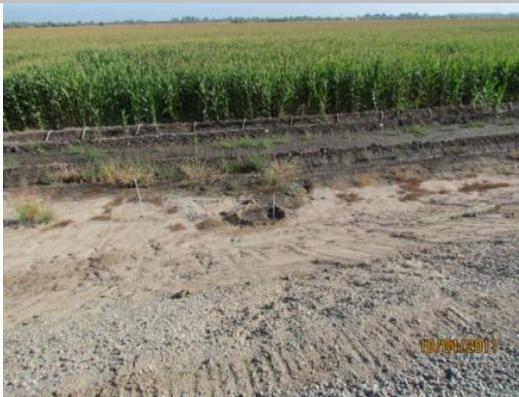
Photo 1 of 2 : pkazi_s_20140328_995.jpg

LM Start	1.34	Rating **	A/W	Issue No.	10
LM End	1.34	Issue Type +	Ma	Location *	LS
Category	Earthen Levee		GPS Latitude/Longitude		
			Start	End	
Item	Encroachments		37.590467 °	37.590467 °	
			-121.163822 °	-121.163822 °	
DWR ID	DWR_RD2092_01_s_2012_10				
Action/Comments					
Pipe Inspector Comments: A sand boil appeared on the landside toe of the levee because of an underground pipe leakage. The pipe and boil have been repaired but should be monitored.

A sand boil was found on the landside of the levee. It was caused by a pipe leak couple of feet below the boil location. LMA was notified to repair it as soon as possible. The picture was taken from the crown looking upstream.

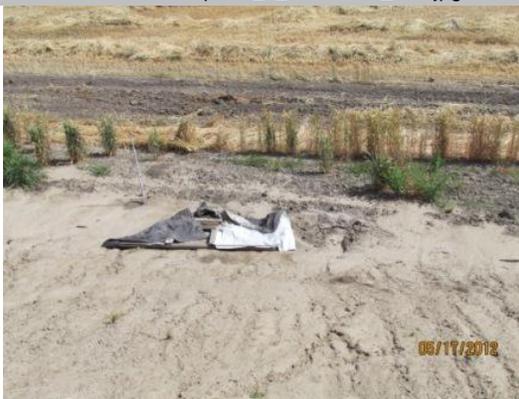
Photo 2 of 2 : pkazi_s_20140328_996.jpg

During spring inspection 2012, the sand boil was not active but materials were present on the landside toe of the levee. The sand boil occurred due to an underground irrigation pipe leakage. The picture was taken from the crown looking toward the toe of the levee. The area was repaired but should be monitored.

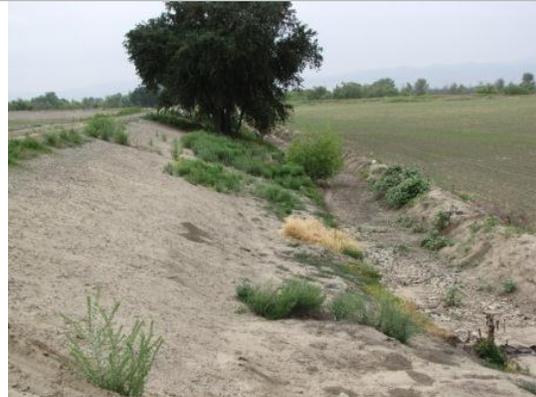
Photo 1 of 1 : pkazi_s_20140328_994.jpg

LM Start	1.59	Rating **	M	Issue No.	8
LM End	1.87	Issue Type +	En	Location *	WS
Category	Earthen Levee		GPS Latitude/Longitude		
			Start	End	
Item	Encroachments		37.587575 °	37.584057 °	
			-121.162454 °	-121.162387 °	
DWR ID	DWR_RD2092_01_s_2012_8				
Action/Comments					
Ditch

View of an agricultural ditch at the waterward toe of the slope.

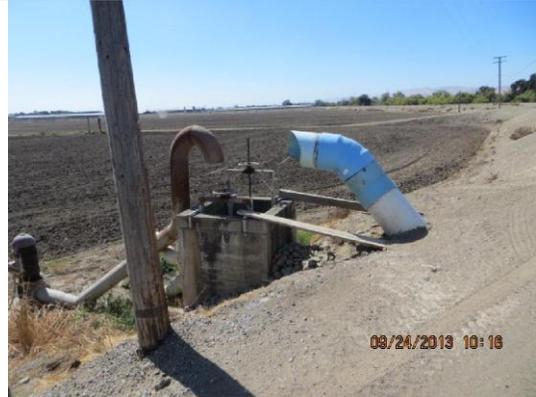
Photo 1 of 1 : UCIP_3268.jpg

LM Start	2.38	Rating **	M	Issue No.	45
LM End	2.38	Issue Type +	En	Location *	LS
Category	Supplemental			GPS Latitude/Longitude	
				Start	End
Item	DWR UCIP Field Study			37.581226 °	37.581226 °
				-121.156175 °	-121.156175 °
DWR ID	DWR_RD2092_01_s_2014_45				
Action/Comments					
Inspector Comments: FS_ID:22916

21-inch PVC irrigation pipe visible on LS shoulder.

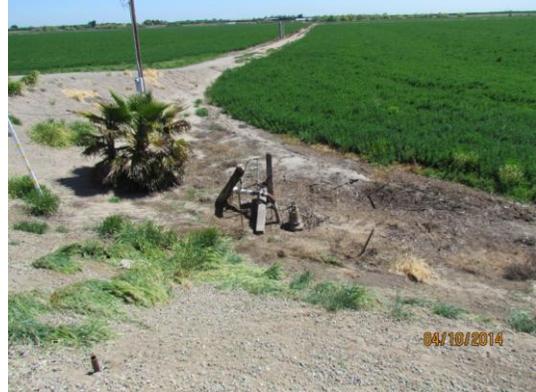
Photo 1 of 1 : pkazi_s_20140411_084.jpg

LM Start	2.43	Rating **	M	Issue No.	53
LM End	2.43	Issue Type +	En	Location *	LS
Category	Earthen Levee			GPS Latitude/Longitude	
				Start	End
Item	Encroachments			37.580436 °	37.580436 °
				-121.156783 °	-121.156783 °
DWR ID	DWR_RD2092_01_s_2014_53				
Action/Comments					
Pipe Inspector Comments: Pump and abandoned pipe was found.

A pump and an abandon pipe was found on the landside toe of the levee looking downstream.

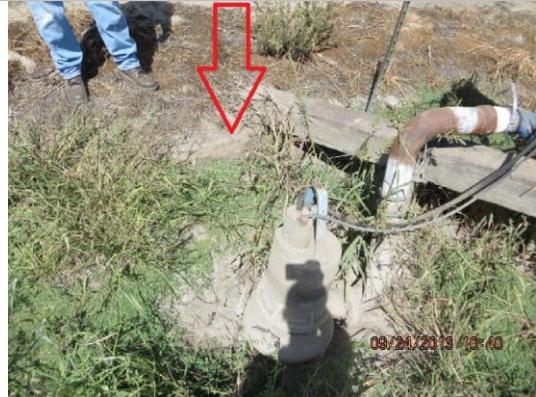
Photo 1 of 1 : UCIP_2382.jpg

LM Start	2.44	Rating **	M	Issue No.	47
LM End	2.44	Issue Type +	En	Location *	LS
Category	Supplemental			GPS Latitude/Longitude	
				Start	End
Item	DWR UCIP Field Study			37.580426 °	37.580426 °
				-121.156798 °	-121.156798 °
DWR ID	DWR_RD2092_01_s_2014_47				
Action/Comments					
Inspector Comments: FS_ID:20943 EP_NO: N/A Repair Type: Crossing Status: UCIP Comments: Appears abandoned and if so should be done so properly. FIELD_STRUCT_DESC: 24-inch corrugated metal drain pipe through levee 15.0 feet below crown. Flap gate on the waterward end. Concrete "U" headwall on the waterward end and concrete headwall on LS toe next to pump. Originally included in the 1961 O&M manual. FS Date: 9/24/2013

Concrete headwall next to pump on WS toe.

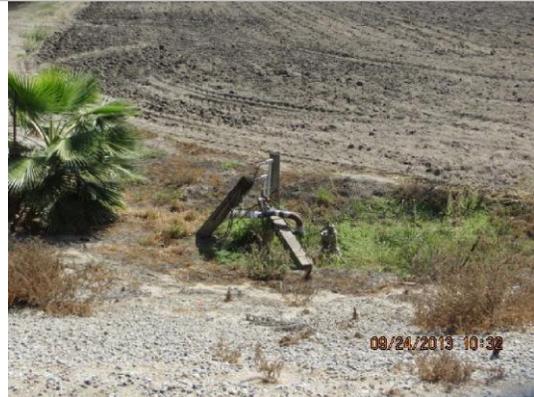
Photo 1 of 1 : UCIP_2376.jpg

LM Start	2.44	Rating **	M	Issue No.	48
LM End	2.44	Issue Type +	En	Location *	LS
Category	Supplemental		GPS Latitude/Longitude		
			Start	End	
Item	DWR UCIP Field Study		37.580404 °	37.580404 °	
			-121.156824 °	-121.156824 °	
DWR ID	DWR_RD2092_01_s_2014_48				
Action/Comments					
Inspector Comments: FS_ID:20923 EP_NO: N/A Repair Type: Crossing Status: UCIP Comments: Pipe abandoned and should be verified as having been removed from the levee. FIELD_STRUCT_DESC: 4-inch pipe through levee 1.0 foot below crown. Pump on sump at LS toe. Roadway extending to the landward pump. FS Date: 9/24/2013

Pump and 4-inch pipe visible at LS toe.

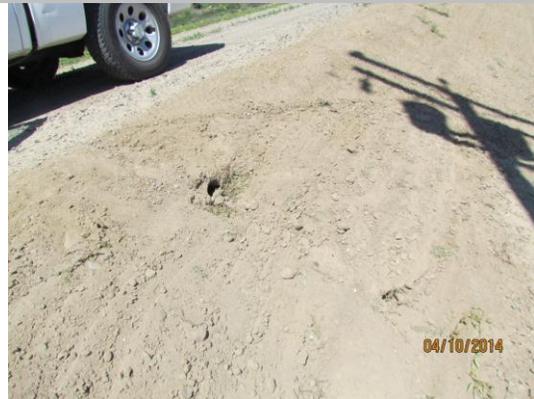
Photo 1 of 2 : pkazi_s_20140411_085.jpg

LM Start	2.73	Rating **	M	Issue No.	17
LM End	2.73	Issue Type +	Ma	Location *	LS
Category	Earthen Levee		GPS Latitude/Longitude		
			Start	End	
Item	Animal Control		37.576383 °	37.576383 °	
			-121.157208 °	-121.157208 °	
DWR ID	DWR_RD2092_01_f_2013_17				
Action/Comments					
No rodents visible, but rodent burrows visible; need to backfill and compact or grout burrows.

Updated picture of the animal hole on the landside of the levee during spring 2014 inspection.

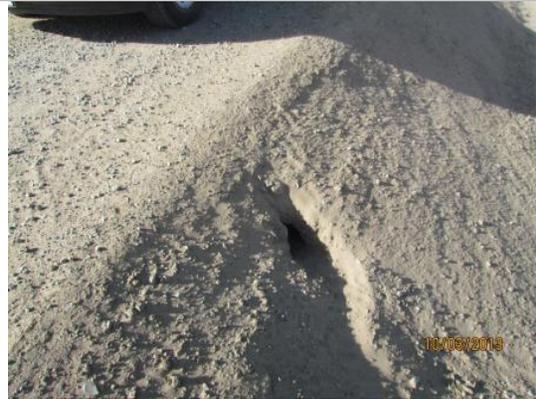
Photo 2 of 2 : pkazi_s_20140328_997.jpg

LM Start	2.73	Rating **	M	Issue No.	17 (cont)
LM End	2.73	Issue Type +	Ma	Location *	LS
Category	Earthen Levee		GPS Latitude/Longitude		
			Start	End	
Item	Animal Control		37.576383 °	37.576383 °	
			-121.157208 °	-121.157208 °	
DWR ID	DWR_RD2092_01_f_2013_17				
Action/Comments					
No rodents visible, but rodent burrows visible; need to backfill and compact or grout burrows.

An animal hole was found on the landside shoulder of the levee looking downstream.

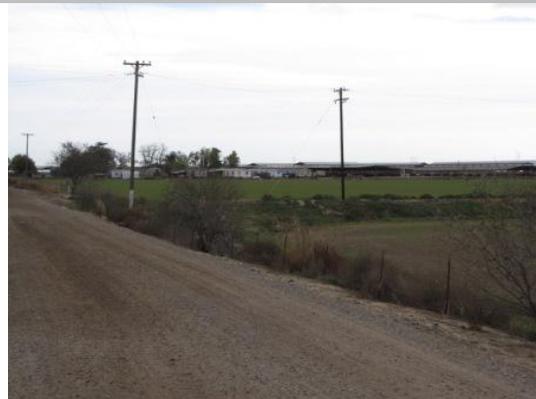
Photo 1 of 1 : pkazi_s_20140328_001.jpg

LM Start	2.84	Rating **	M	Issue No.	972
LM End	3.09	Issue Type +	En	Location *	LS
Category	Earthen Levee		GPS Latitude/Longitude		
			Start	End	
Item	Encroachments		37.574973 °	37.574001 °	
			-121.156647 °	-121.152183 °	
DWR ID	DWR_RD2092_01_s_2012_972				
Action/Comments					
Fence Inspector Comments: Barbed wire fence on landward slope.

View of barbed wire fence along the waterward slope looking upstream.

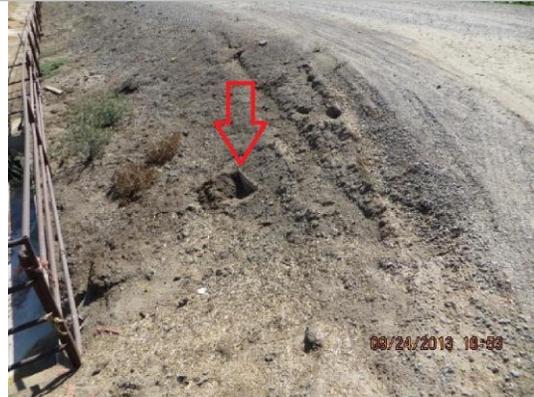
Photo 1 of 1 : UCIP_2384.jpg

LM Start	2.90	Rating **	M	Issue No.	49
LM End	2.90	Issue Type +	En	Location *	LS
Category	Supplemental		GPS Latitude/Longitude		
			Start	End	
Item	DWR UCIP Field Study		37.574741 °	37.574741 °	
			-121.155495 °	-121.155495 °	
DWR ID	DWR_RD2092_01_s_2014_49				
Action/Comments					
Inspector Comments: FS_ID:20944 EP_NO: N/A Repair Type: Crossing Status: UCIP Comments: Appears abandoned and if so, should be done so properly. FIELD_STRUCT_DESC: 24-inch corrugated metal pipe through levee 6.5 feet below crown. Concrete "U" headwall and flap gate on the waterward end. Concrete headwall on LS slope. Originally included in the 1961 O&M manual. FS Date: 9/24/2013

Concrete headwall visible on LS slope.

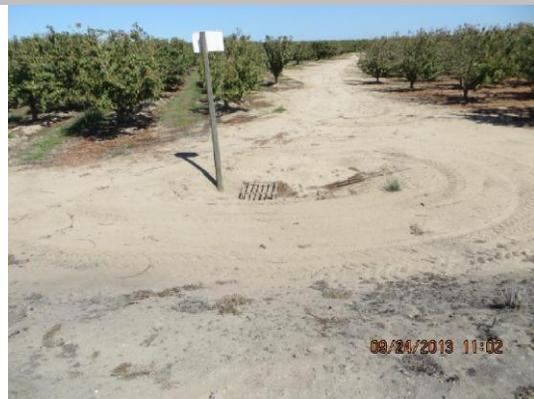
Photo 1 of 1 : UCIP_2386.jpg

LM Start	3.52	Rating **	M	Issue No.	50
LM End	3.52	Issue Type +	En	Location *	LS
Category	Supplemental		GPS Latitude/Longitude		
			Start	End	
Item	DWR UCIP Field Study		37.573304 °	37.573304 °	
			-121.144747 °	-121.144747 °	
DWR ID	DWR_RD2092_01_s_2014_50				
Action/Comments					
Inspector Comments: FS_ID:20945 EP_NO: N/A Repair Type: Crossing Status: UCIP Comments: This pipe appears abandoned and if so, should be done so properly. FIELD_STRUCT_DESC: 36-inch corrugated metal pipe through levee 11.0 feet below crown. Slide gate in corrugated metal pipe riser on the waterward slope. Concrete headwalls on both ends. Originally included in the 1961 O&M manual. FS Date: 9/24/2013

Grate over sump on LS toe.
