**Flood Control Project Maintenance  
Levee Inspections  
LMA District Cover Sheet  
Spring 2015 Levee Inspection Results**

**Reclamation District No. 2092 Dos Rios**

**Spring 2015 Levee Inspection Results**

Waterway		Bank	Unit Miles
Unit No. 01 San Joaquin River		Right	3.71

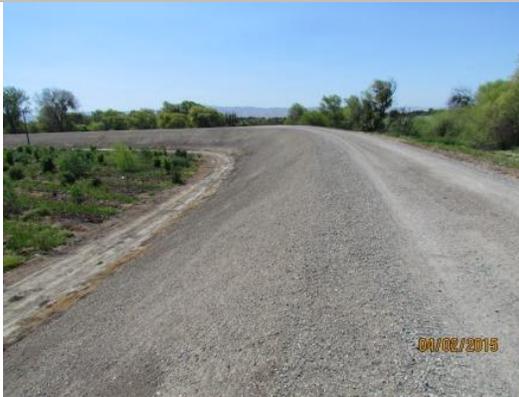
Photo 1 of 1 : SP\_2015\_RD2092\_116\_14\_20150406\_00015.jpg

LM Start	<b>0.44</b>	Rating **	A	Issue No.	<b>14</b>
LM End	<b>0.44</b>	Issue Type +	Ma	Location *	LS
Category	Earthen Levee		GPS Latitude/Longitude		
			Start	End	
Item	Vegetation		37.601192 °	37.601192 °	
			-121.165838 °	-121.165838 °	
DWR ID	DWR_RD2092_01_s_2015_14				
Action/Comments					
Control annual grass and weeds on the levee slopes and easements.

View of the landside slope of the levee looking upstream during spring 2015 inspection.

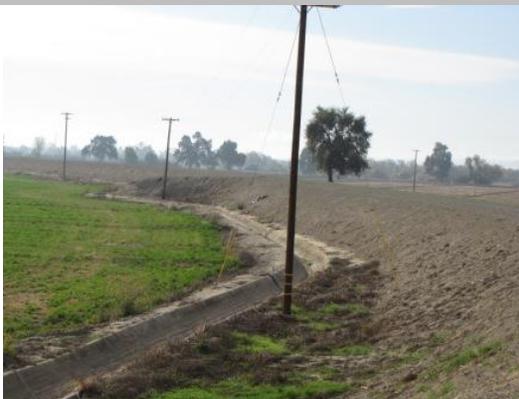
Photo 1 of 1 : SP\_2015\_RD2092\_116\_968\_20150313\_00006.jpg

LM Start	<b>0.76</b>	Rating **	M	Issue No.	<b>968</b>
LM End	<b>1.31</b>	Issue Type +	En	Location *	LS
Category	Earthen Levee		GPS Latitude/Longitude		
			Start	End	
Item	Encroachments		37.597291 °	37.590568 °	
			-121.168496 °	-121.164028 °	
DWR ID	DWR_RD2092_01_s_2012_968				
Action/Comments					
Ditch

View of agricultural ditch at the landward toe looking upstream.

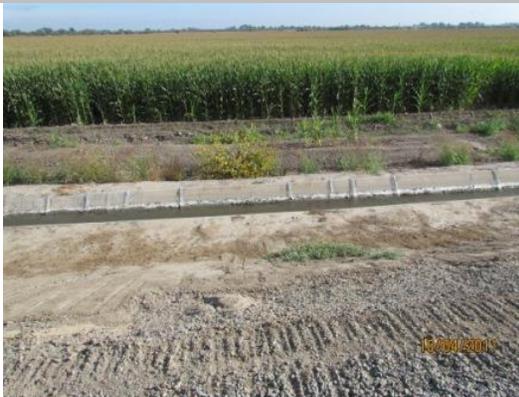
Photo 1 of 1 : SP\_2015\_RD2092\_116\_7\_20150313\_00001.jpg

LM Start	<b>1.32</b>	Rating **	M	Issue No.	<b>7</b>
LM End	<b>1.55</b>	Issue Type +	En	Location *	LS
Category	Earthen Levee		GPS Latitude/Longitude		
			Start	End	
Item	Encroachments		37.590479 °	37.587758 °	
			-121.163844 °	-121.162349 °	
DWR ID	DWR_RD2092_01_s_2012_7				
Action/Comments					
Ditch

An agricultural ditch was found on the toe of the landside of the levee looking upstream.

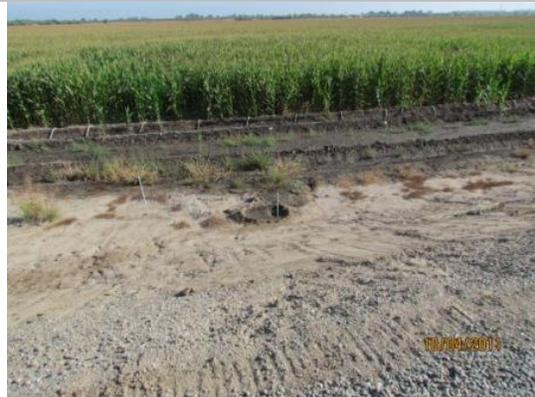
Photo 2 of 2 : SP\_2015\_RD2092\_116\_10\_20150313\_00004.jpg

A sand boil was found on the landside of the levee. It was caused by a pipe leak couple of feet below the boil location. LMA was notified to repair it as soon as possible. The picture was taken from the crown looking upstream.

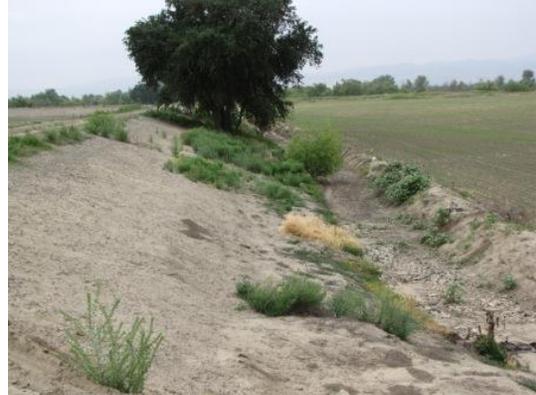
Photo 1 of 1 : SP\_2015\_RD2092\_116\_8\_20150313\_00002.jpg

LM Start	<b>1.56</b>	Rating **	M	Issue No.	<b>8</b>
LM End	<b>1.84</b>	Issue Type +	En	Location *	WS
Category	Earthen Levee		GPS Latitude/Longitude		
			Start	End	
Item	Encroachments		37.587575 °	37.584057 °	
			-121.162454 °	-121.162387 °	
DWR ID	DWR_RD2092_01_s_2012_8				
Action/Comments					
Ditch

View of an agricultural ditch at the waterward toe of the slope.

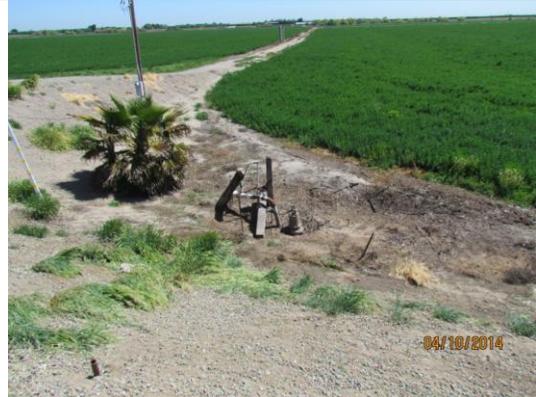
Photo 1 of 1 : SP\_2015\_RD2092\_116\_53\_20150313\_00005.jpg

LM Start	<b>2.40</b>	Rating **	M	Issue No.	<b>53</b>
LM End	<b>2.40</b>	Issue Type +	En	Location *	LS
Category	Earthen Levee			GPS Latitude/Longitude	
				Start	End
Item	Encroachments			37.580436 °	37.580436 °
				-121.156783 °	-121.156783 °
DWR ID	DWR_RD2092_01_s_2014_53				
Action/Comments					
Pipe Inspector Comments: Pump and abandoned pipe was found.

A pump and an abandon pipe was found on the landside toe of the levee looking downstream.

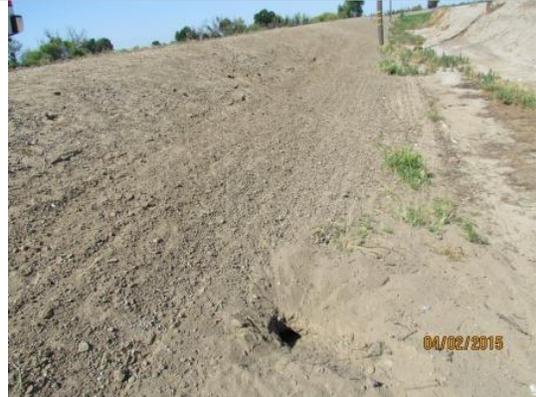
Photo 1 of 1 : SP\_2015\_RD2092\_116\_19\_20150406\_00016.jpg

LM Start	<b>2.70</b>	Rating **	M	Issue No.	<b>19</b>
LM End	<b>2.70</b>	Issue Type +	Ma	Location *	LS
Category	Earthen Levee		GPS Latitude/Longitude		
			Start	End	
Item	Animal Control		37.576165 °	37.576165 °	
			-121.157230 °	-121.157230 °	
DWR ID	DWR_RD2092_01_s_2015_19				
Action/Comments					
No rodents visible, but rodent burrows visible; need to backfill and compact or grout burrows.

A rodent hole was found on the landside toe of the levee looking downstream.

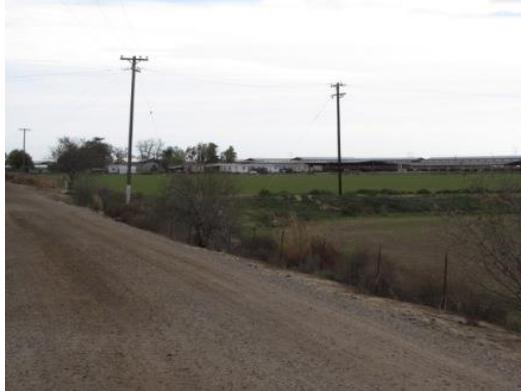
Photo 1 of 1 : SP\_2015\_RD2092\_116\_972\_20150313\_00007.jpg

LM Start	<b>2.79</b>	Rating **	M	Issue No.	<b>972</b>
LM End	<b>3.05</b>	Issue Type +	En	Location *	WS
Category	Earthen Levee		GPS Latitude/Longitude		
			Start	End	
Item	Encroachments		37.574973 °	37.574001 °	
			-121.156647 °	-121.152183 °	
DWR ID	DWR_RD2092_01_s_2012_972				
Action/Comments					
Fence Inspector Comments: Barbed wire fence on waterside toe of the levee.

View of barbed wire fence along the waterward slope looking upstream.
