**Flood Control Project Maintenance
Levee Inspections**

Maintenance Issue Types Only, Levee Inspection Report By Mile - Fall 2014

Reclamation District No. 2092 Dos Rios

Waterway	Bank	Unit Miles	Inspection Start/End	Inspector
Unit No. 01 San Joaquin River	Right	3.71	10/24/2014 10/24/2014	Pavel Kazi

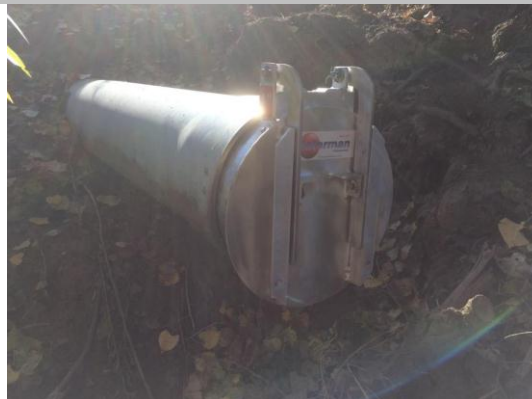
Photo 1 of 2 : FA_2014_RD2092_116_51_20141120_00021.jpg

LM Start	0.17	Rating **	A	Issue No.	51
LM End	0.17	Issue Type +	Ma	Location *	WS
Category	Earthen Levee			GPS Latitude/Longitude	
				Start	End
Item	Encroachments			37.602073 °	37.602073 °
				-121.161179 °	-121.161179 °
DWR ID	DWR_RD2092_01_s_2014_51				
Action/Comments					
Pipe					
Inspector Comments: A flap gate is installed at the end of the pipe.

A flap gate was installed at the end of the pipe on the waterside of the levee.

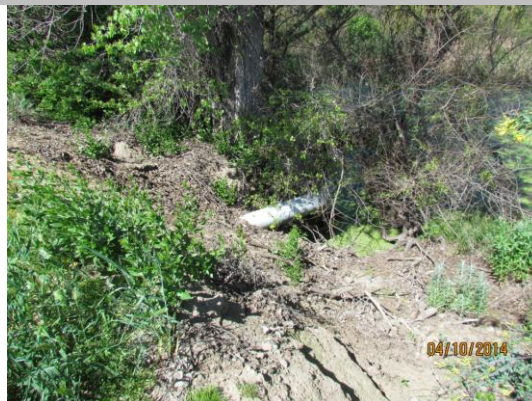
Photo 2 of 2 : FA_2014_RD2092_116_51_20141021_00008.jpg

A flap gate is needed at the end of the pipe on the waterside of the levee.

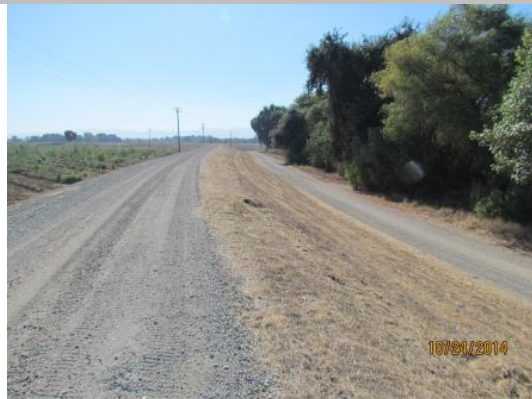
Photo 1 of 1 : FA_2014_RD2092_116_19_20141027_00019.jpg

View of the waterside slope of the levee looking upstream during fall 2014 inspection.

LM Start	0.61	Rating **	A	Issue No.	19
LM End	0.61	Issue Type +	Ma	Location *	WS
Category	Earthen Levee			GPS Latitude/Longitude	
				Start	End
Item	Vegetation			37.599069 °	37.599069 °
				-121.167228 °	-121.167228 °
DWR ID	DWR_RD2092_01_f_2014_19				
Action/Comments					
Control annual grass and weeds on the levee slopes and easements.

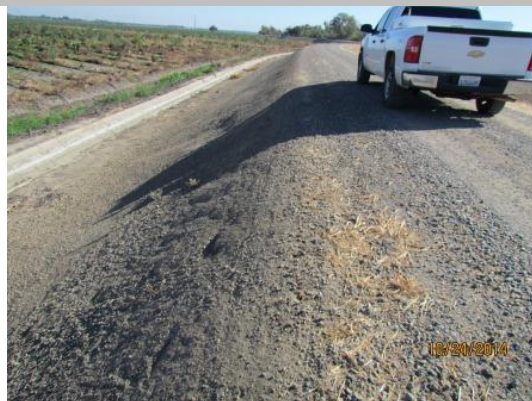
Photo 1 of 2 : FA_2014_RD2092_116_3_20141027_00020.jpg

LMA repaired the rodent holes on the landside shoulder of the levee during fall 2014 inspection.

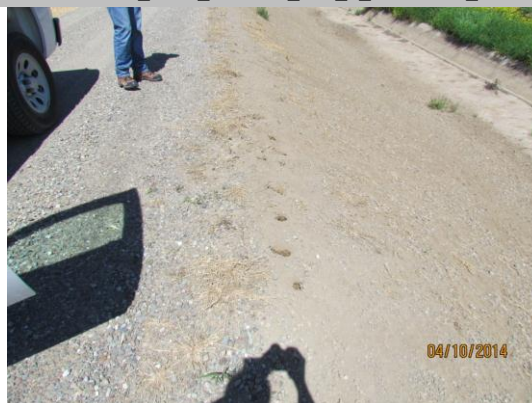
Photo 2 of 2 : FA_2014_RD2092_116_3_20141021_00001.jpg

Rodent holes were found on the landside shoulder of the levee looking downstream.

LM Start	1.07	Rating **	A	Issue No.	3
LM End	1.07	Issue Type +	Ma	Location *	LS
Category	Earthen Levee			GPS Latitude/Longitude	
				Start	End
Item	Animal Control			37.593403 °	37.593403 °
				-121.166750 °	-121.166750 °
DWR ID	DWR_RD2092_01_s_2014_3				
Action/Comments					
No rodents visible, but rodent burrows visible; need to backfill and compact or grout burrows. Inspector Comments: LMA fixed the issue.

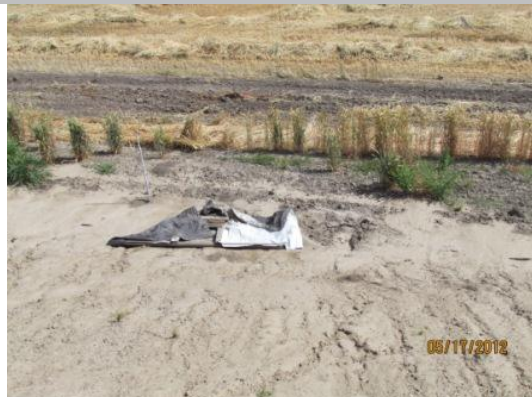
Photo 1 of 2 : FA_2014_RD2092_116_10_20141021_00004.jpg

Inspector Comments: A sand boil appeared on the landside toe of the levee because of an underground pipe leakage. The pipe and boil have been repaired but should be monitored.

During spring inspection 2012, the sand boil was not active but materials were present on the landside toe of the levee. The sand boil occurred due to an underground irrigation pipe leakage. The picture was taken from the crown looking toward the toe of the levee. The area was repaired but should be monitored.

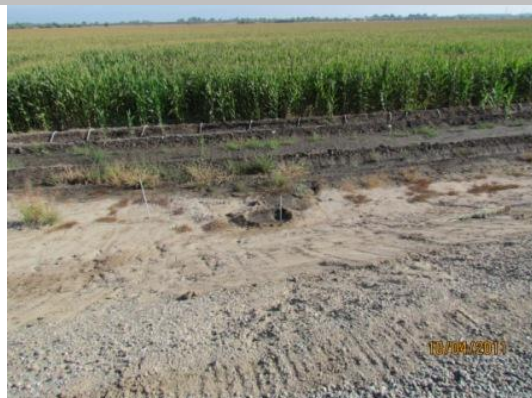
Photo 2 of 2 : FA_2014_RD2092_116_10_20141021_00005.jpg

A sand boil was found on the landside of the levee. It was caused by a pipe leak couple of feet below the boil location. LMA was notified to repair it as soon as possible. The picture was taken from the crown looking upstream.
