**Flood Control Project Maintenance
Levee Inspections**

Maintenance Issue Types Only, Levee Inspection Report By Mile - Fall 2015

Reclamation District No. 2092 Dos Rios

Waterway	Bank	Unit Miles	Inspection Start/End	Inspector
Unit No. 01 San Joaquin River	Right	3.71	10/22/2015 10/22/2015	Pavel Kazi

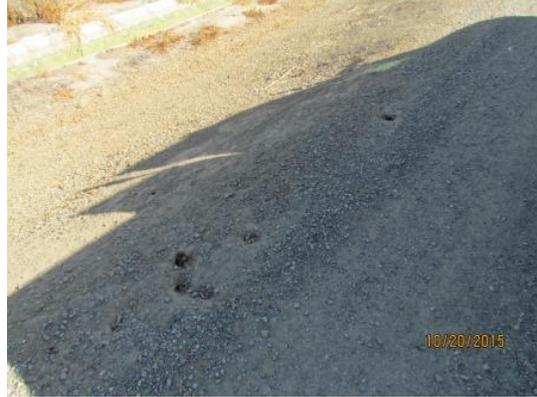
Photo 1 of 1 : FA_2015_RD2092_116_14_20151023_00017.jpg

LM Start	1.20	Rating **	M	Issue No.	14
LM End	1.20	Issue Type +	Ma	Location *	CR
Category	Earthen Levee		GPS Latitude/Longitude		
			Start	End	
Item	Animal Control		37.591406 °	37.591406 °	
			-121.165624 °	-121.165624 °	
DWR ID	DWR_RD2092_01_f_2015_14				
Action/Comments					
No rodents visible, but rodent burrows visible; need to backfill and compact or grout burrows.

A few rodent holes were found on the waterside shoulder of the levee.

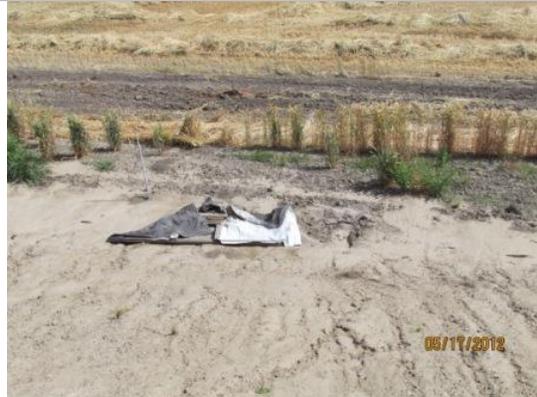
Photo 1 of 2 : FA_2015_RD2092_116_10_20150911_00003.jpg

LM Start	1.32	Rating **	A/W	Issue No.	10
LM End	1.32	Issue Type +	Ma	Location *	LS
Category	Earthen Levee		GPS Latitude/Longitude		
			Start	End	
Item	Encroachments		37.590467 °	37.590467 °	
			-121.163822 °	-121.163822 °	
DWR ID	DWR_RD2092_01_s_2012_10				
Action/Comments					
Pipe Inspector Comments: A sand boil appeared on the landside toe of the levee because of an underground pipe leakage. The pipe and boil have been repaired but should be monitored.

During spring inspection 2012, the sand boil was not active but materials were present on the landside toe of the levee. The sand boil occurred due to an underground irrigation pipe leakage. The picture was taken from the crown looking toward the toe of the levee. The area was repaired but should be monitored.

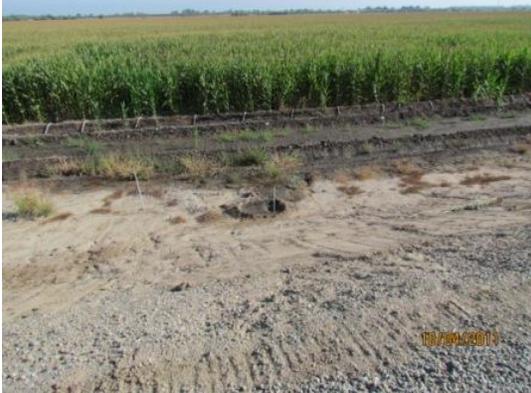
Photo 2 of 2 : FA_2015_RD2092_116_10_20150911_00004.jpg

LM Start	1.32	Rating **	A/W	Issue No.	10 (cont)
LM End	1.32	Issue Type +	Ma	Location *	LS
Category	Earthen Levee		GPS Latitude/Longitude		
			Start	End	
Item	Encroachments		37.590467 °	37.590467 °	
			-121.163822 °	-121.163822 °	
DWR ID	DWR_RD2092_01_s_2012_10				
Action/Comments					
Pipe Inspector Comments: A sand boil appeared on the landside toe of the levee because of an underground pipe leakage. The pipe and boil have been repaired but should be monitored.

A sand boil was found on the landside of the levee. It was caused by a pipe leak couple of feet below the boil location. LMA was notified to repair it as soon as possible. The picture was taken from the crown looking upstream.

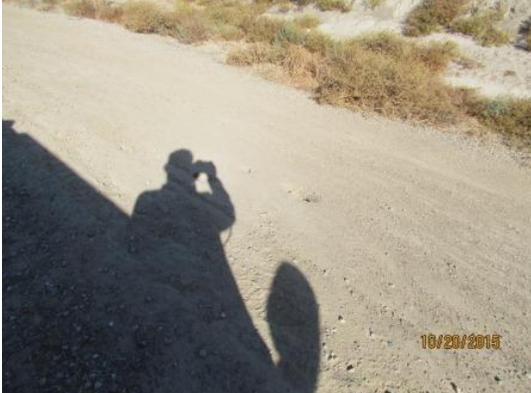
Photo 1 of 1 : FA_2015_RD2092_116_21_20151023_00018.jpg

LM Start	2.66	Rating **	M	Issue No.	21
LM End	2.66	Issue Type +	Ma	Location *	LS
Category	Earthen Levee		GPS Latitude/Longitude		
			Start	End	
Item	Animal Control		37.576688 °	37.576688 °	
			-121.157197 °	-121.157197 °	
DWR ID	DWR_RD2092_01_f_2015_21				
Action/Comments					
No rodents visible, but rodent burrows visible; need to backfill and compact or grout burrows.

An animal hole was found landside slope of the levee.
