**Flood Control Project Maintenance
Levee Inspections**

Maintenance Issue Types Only, Levee Inspection Report By Mile - Fall 2017

Reclamation District No. 2092 Dos Rios

| Waterway | Bank | Unit Miles | Inspection Start/End | Inspector |
|---|---|---|---|---|
| Unit No. 01 San Joaquin River | Right | 3.71 | 09/27/2017 09/27/2017 | Pavel Kazi |

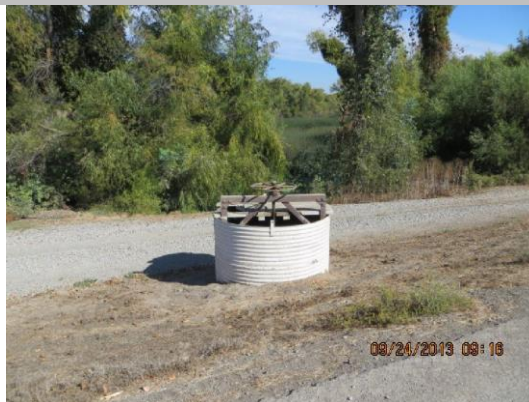
Photo 1 of 3 : UCIP_FA_2017_27123_50242.jpg

| UCIP Comments: Pipe rusted through at headwall on LS toe. Good candidate for video inspection. | | | | | | |

Slide gate in 80-inch CMP riser on WS slope.

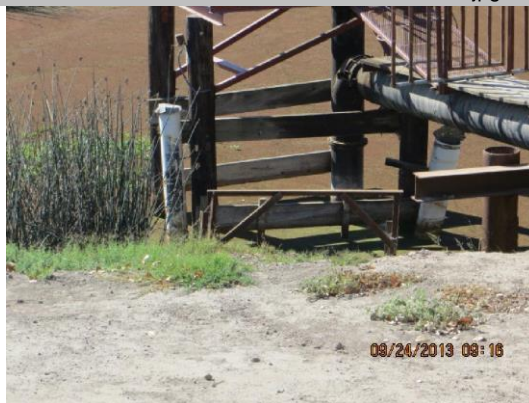
Photo 2 of 3 : UCIP_FA_2017_27123_50241.jpg

| UCIP Comments: Pipe rusted through at headwall on LS toe. Good candidate for video inspection. | | | | | |

Concrete headwall on LS toe in front of pump on pier.

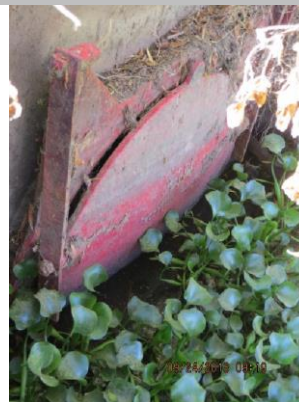
Photo 3 of 3 : UCIP_FA_2017_27123_50240.jpg

Flapgate and headwall on WS toe.

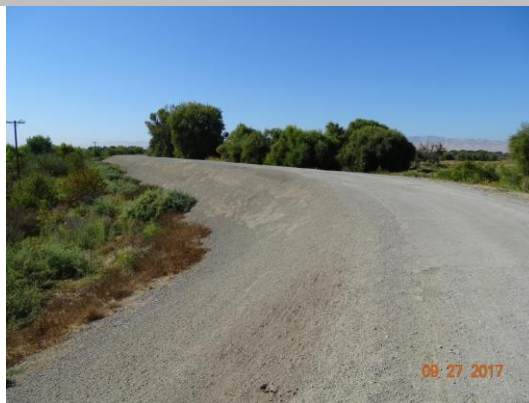
Photo 1 of 1 : FA_2017_RD2092_116_17_20170928_00058.jpg

| Acceptable vegetation. | | | | | |

View of the landside slope of the levee looking upstream. Fall 2017

| V1 : Control annual grass and weeds on the levee slopes and easements. | | | | | |

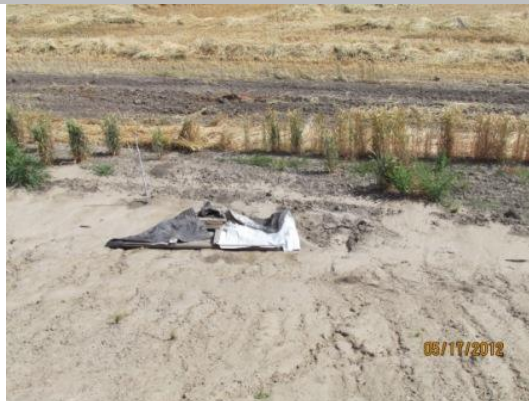
Photo 1 of 2 : FA_2017_RD2092_116_10_20170921_00002.jpg

| A sand boil appeared on the landside toe of the levee because of an underground pipe leakage. The pipe and boil have been repaired but should be monitored. | | | | | |

During spring inspection 2012, the sand boil was not active but materials were present on the landside toe of the levee. The sand boil occurred due to an underground irrigation pipe leakage. The picture was taken from the crown looking toward the toe of the levee. The area was repaired but should be monitored.

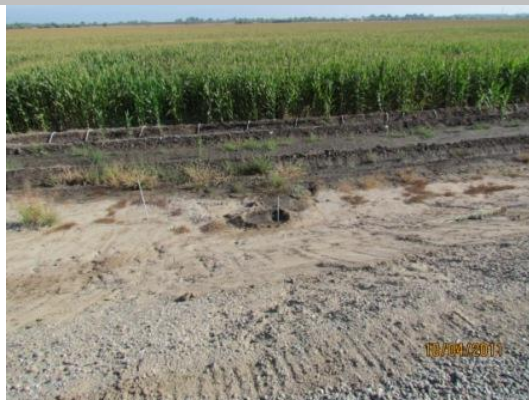
Photo 2 of 2 : FA_2017_RD2092_116_10_20170921_00003.jpg

A sand boil was found on the landside of the levee. It was caused by a pipe leak couple of feet below the boil location. LMA was notified to repair it as soon as possible. The picture was taken from the crown looking upstream.

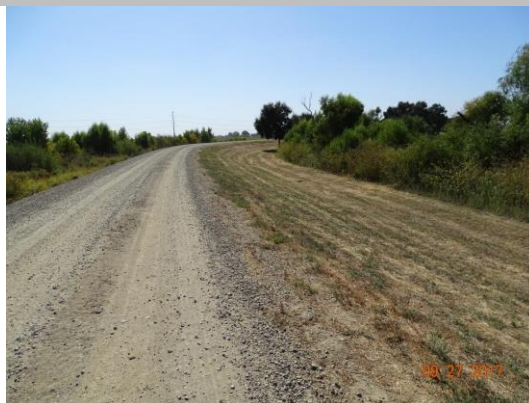
Photo 1 of 1 : FA_2017_RD2092_116_19_20170928_00059.jpg

| Acceptable vegetation. | | | | | | |

View of the vegetation on the waterside slope of the levee looking upstream. Fall 2017

| V1 : Control annual grass and weeds on the levee slopes and easements. | | | | | | |

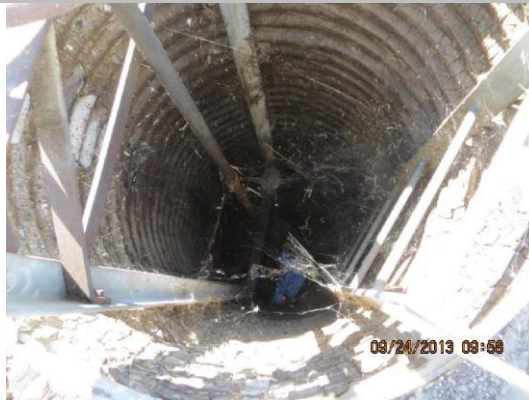
Photo 2 of 3 : UCIP_FA_2017_20891_35215.jpg

Slide gate in 36-inch CMP riser on WS slope.

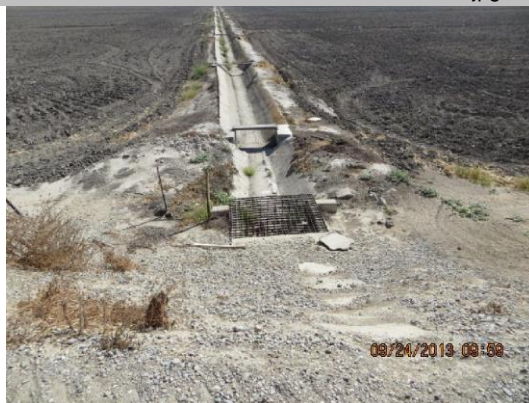
Photo 3 of 3 : UCIP_FA_2017_20891_35214.jpg

Concrete headwall at base of LS toe.

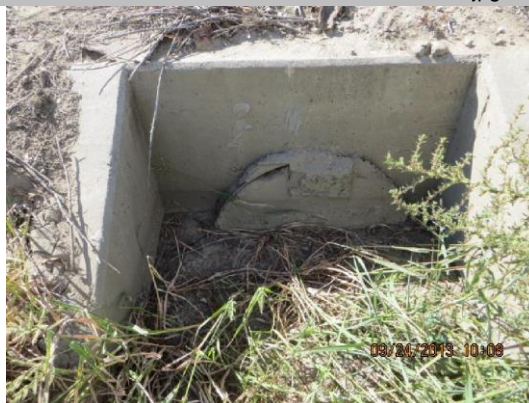
Photo 2 of 2 : UCIP_FA_2017_20904_35220.jpg

Pipe and concrete headwall visible on LS toe.

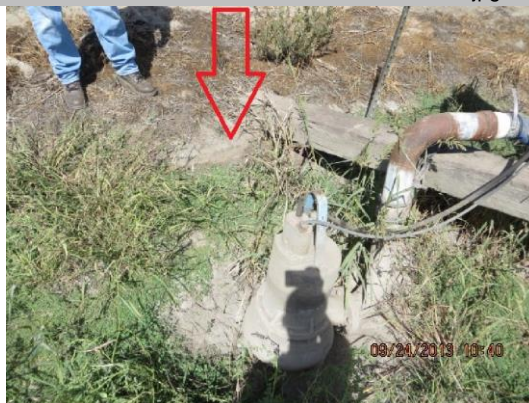
Photo 3 of 3 : UCIP_FA_2017_20943_35252.jpg

| FS_ID:20943 DS_ID:20567 EP_NO: N/A Repair Type: Non-Urgent Crossing Status: Found UCIP Comments: Appears abandoned and if so should be done so properly. FIELD_STRUCT_DESC: *ABANDONED* 24-inch corrugated metal drainage pipe through the levee, 15 feet below the crown. Flap gate on the waterside (WS) end. Concrete U-shaped headwall on the WS end. Concrete headwall on the landside (LS) toe next to pump. [Additional Reference(s): DWR Levee Log, 2005. USACE San Joaquin O&M Manual 5, August 1961, (HLM 2.44)]. FS Date: 9/24/2013 | | | | | |

Concrete headwall next to pump on WS toe.

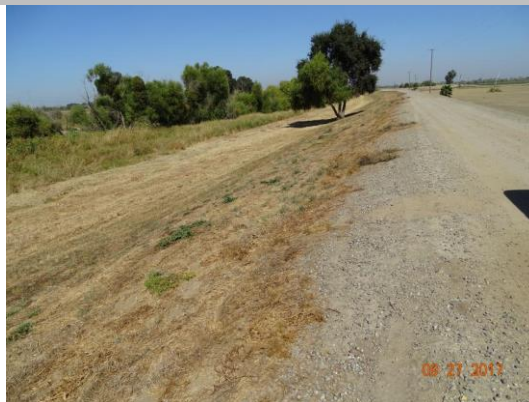
Photo 1 of 2 : FA_2017_RD2092_116_36_20170928_00062.jpg

| LMA repaired the rodent hole at this location. | | | | | |

LMA repaired a few rodent holes on the waterside slope of the levee looking downstream. Fall 2017

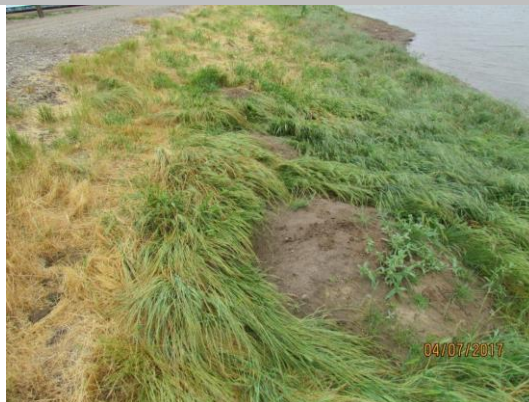
Photo 2 of 2 : FA_2017_RD2092_116_36_20170921_00010.jpg

View of a rodent hole on the waterside slope of the levee.

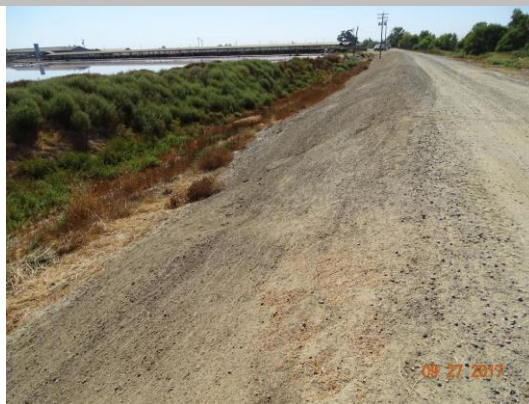
Photo 1 of 2 : FA_2017_RD2092_116_34_20170928_00061.jpg

| LMA repaired the rodent holes at this location. | | | | | |

View of the landside slope of the levee where the LMA repaired a few rodent holes. Fall 2017

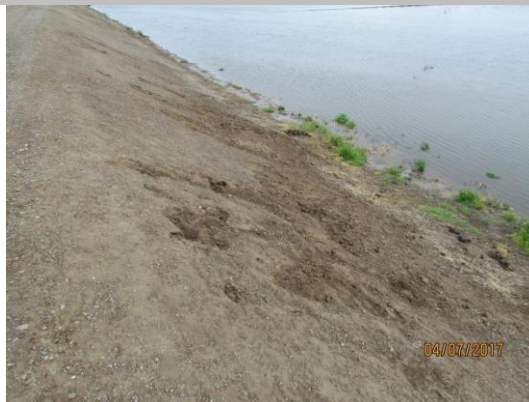
Photo 2 of 2 : FA_2017_RD2092_116_34_20170921_00008.jpg

View of rodent holes on the landside slope of the levee looking downstream. Spring 2017

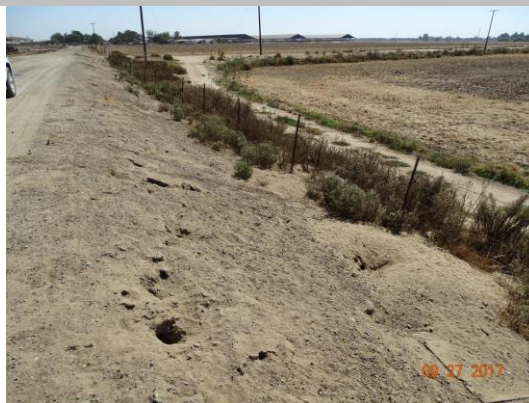
Photo 1 of 2 : FA_2017_RD2092_116_35_20170928_00064.jpg

Updated picture of the rodent holes on the waterside of the levee looking upstream. Fall 2017

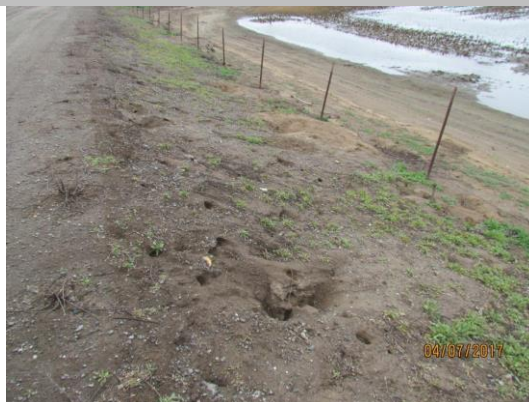
Photo 2 of 2 : FA_2017_RD2092_116_35_20170921_00009.jpg

View of multiple rodent holes on the waterside slope of the levee. Spring 2017

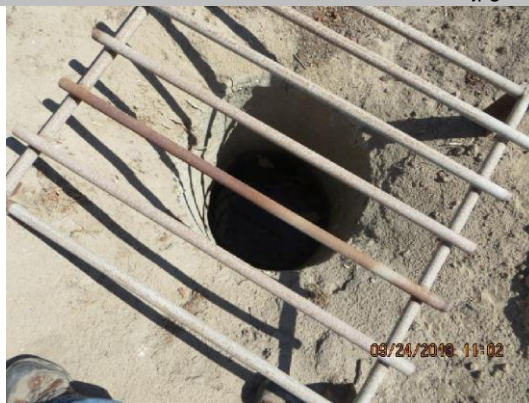
Photo 3 of 3 : UCIP_FA_2017_20945_35262.jpg

Grate over sump on LS toe.
