**Flood Control Project Maintenance
Levee Inspections**

Maintenance Issue Types Only, Levee Inspection Report By Mile - Fall 2018

Reclamation District No. 2092 Dos Rios

Waterway	Bank	Unit Miles	Inspection Start/End	Inspector
Unit No. 01 San Joaquin River	Right	3.71	10/04/2018 10/04/2018	Corey Fujitani

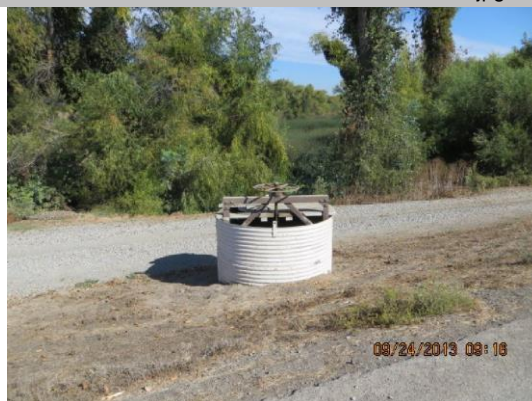
Photo 1 of 3 : UCIP_FA_2018_27123_50242.jpg

LM Start	0.18	Rating **	M	Issue No.	973
LM End	0.18	Issue Type +	Ma	Location *	
Category	Supplemental			GPS Latitude/Longitude	
				Start	End
Item	DWR UCIP LMA Responsibility			37.602031 °	37.602031 °
				-121.161249 °	-121.161249 °
DWR ID	20561				
Comment Code					
Inspector Comment					
FS_ID:27123 DS_ID:20561 EP_NO: N/A Repair Type: Non-Urgent Crossing Status: Found UCIP Comments: 09/24/2013 Pipe rusted through at headwall on LS toe. Good candidate for video inspection. (W. Wylie - DWR UCIP) FIELD_STRUCT_DESC: 60-inch corrugated metal drainage pipe through the levee, 19 feet below the crown. Flap gate on the waterside (WS) end. Slide gate in an 80-inch corrugated metal pipe (CMP) riser on the WS slope. Concrete U-shaped headwalls on both ends. [Additional Reference(s): DWR Levee Log, 2005. USACE San Joaquin O&M Manual 5, August 1961, (HLM 0.18)]. FS Date: 1/16/2014 12:03:14 PM

Slide gate in 80-inch CMP riser on WS slope.

Comment Code						
Inspector Comment						
FS_ID:27123						
DS_ID:20561						
EP_NO: N/A						
Repair Type: Non-Urgent						
Crossing Status: Found						
UCIP Comments: 09/24/2013 Pipe rusted through at headwall on LS toe. Good candidate for video inspection. (W. Wylie - DWR UCIP)						
FIELD_STRUCT_DESC: 60-inch corrugated metal drainage pipe through the levee, 19 feet below the crown. Flap gate on the waterside (WS) end. Slide gate in an 80-inch corrugated metal pipe (CMP) riser on the WS slope. Concrete U-shaped headwalls on both ends.						
[Additional Reference(s): DWR Levee Log, 2005. USACE San Joaquin O&M Manual 5, August 1961, (HLM 0.18)].						
FS Date: 1/16/2014 12:03:14 PM

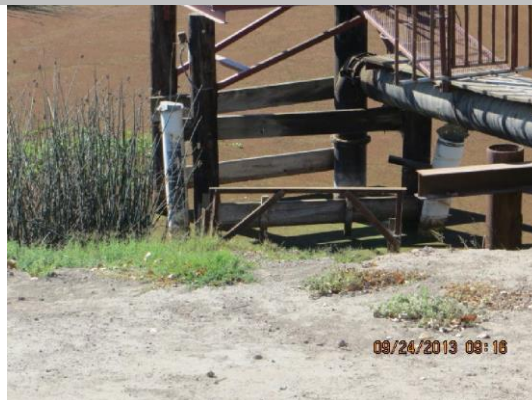
Photo 2 of 3 : UCIP_FA_2018_27123_50241.jpg

Concrete headwall on LS toe in front of pump on pier.

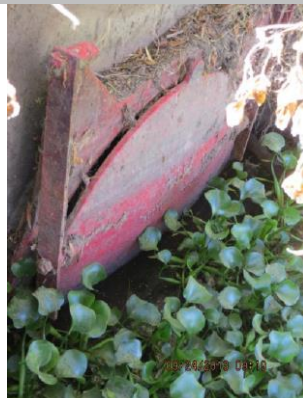
Photo 3 of 3 : UCIP_FA_2018_27123_50240.jpg

Flapgate and headwall on WS toe.

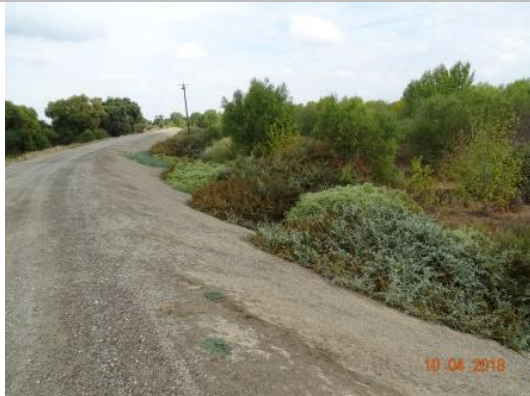
Photo 1 of 1 : FA_2018_RD2092_116_36_20181005_00048.jpg

LM Start	0.36	Rating **	M	Issue No.	36
LM End	0.75	Issue Type +	Ma	Location *	LS
Category	Earthen Levee			GPS Latitude/Longitude	
				Start	End
Item	Vegetation			37.601353 °	37.597473 °
				-121.164330 °	-121.168471 °
DWR ID	DWR_RD2092_01_f_2018_36				
Comment Code					
V1 : Control annual grass and weeds on the levee slopes and easements.					
Inspector Comment					
vegetation along landside toe and slope.

Vegetation along landside slope and toe obstructing view. (Fall 2018)

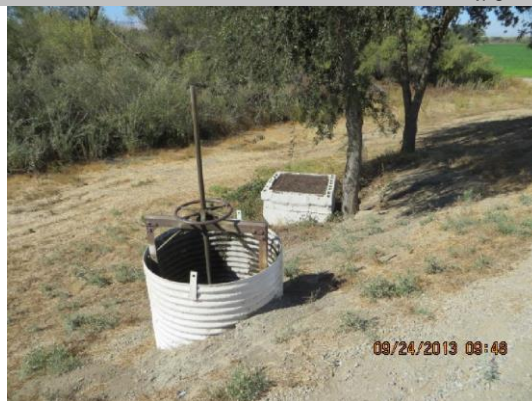
Photo 1 of 2 : UCIP_FA_2018_20889_35213.jpg

LM Start	1.30	Rating **	A/W	Issue No.	976	
LM End	1.30	Issue Type +	Ma	Location *		
Category	Supplemental			GPS Latitude/Longitude		
				Start		End
Item	DWR UCIP LMA Responsibility			37.590603 °		37.590603 °
				-121.164111 °		-121.164111 °
DWR ID	20562					
Comment Code						
Inspector Comment						
FS_ID:20889 DS_ID:20562 EP_NO: N/A Repair Type: No Action Needed Crossing Status: Found UCIP Comments: FIELD_STRUCT_DESC: 36-inch corrugated metal drainage pipe through the levee, 15 feet below the crown. Slide gate in a 48-inch corrugated metal pipe (CMP) riser on the waterside (WS) slope. 4-foot by 6-foot concrete distribution box on the landside (LS) toe. 5-foot by 5-foot concrete riser on the WS toe. [Additional Reference(s): DWR Levee Log, 2005. USACE San Joaquin O&M Manual 5, August 1961, (HLM 1.31)]. FS Date: 9/24/2013

Slide gate in 48-inch CMP riser on WS slope.

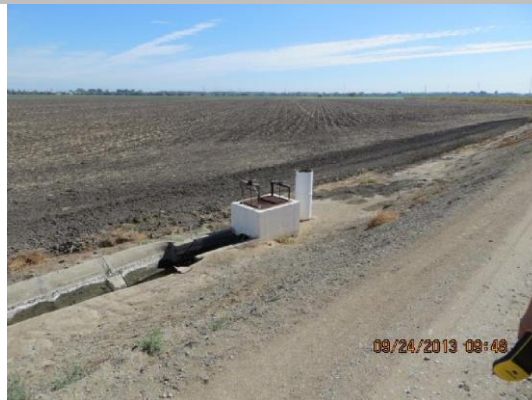
Photo 2 of 2 : UCIP_FA_2018_20889_35212.jpg

Concrete distribution box at concrete canal on LS toe.

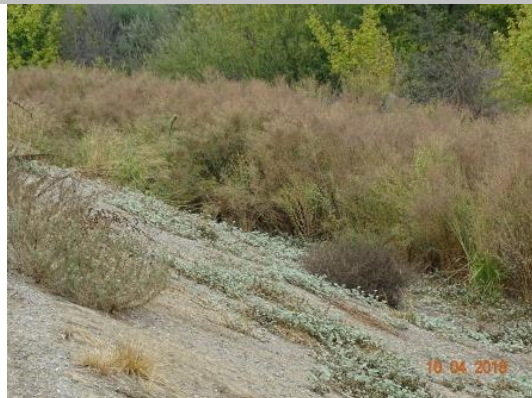
Photo 1 of 1 : FA_2018_RD2092_116_34_20181005_00051.jpg

LM Start	1.30	Rating **	M	Issue No.	34
LM End	1.53	Issue Type +	Ma	Location *	LS
Category	Earthen Levee			GPS Latitude/Longitude	
				Start	End
Item	Vegetation			37.590588 °	37.588044 °
				-121.164098 °	-121.162216 °
DWR ID	DWR_RD2092_01_f_2018_34				
Comment Code					
V1 : Control annual grass and weeds on the levee slopes and easements.					
Inspector Comment					
vegetation along landside toe

Vegetation along landside toe preventing access and view. (Fall 2018)

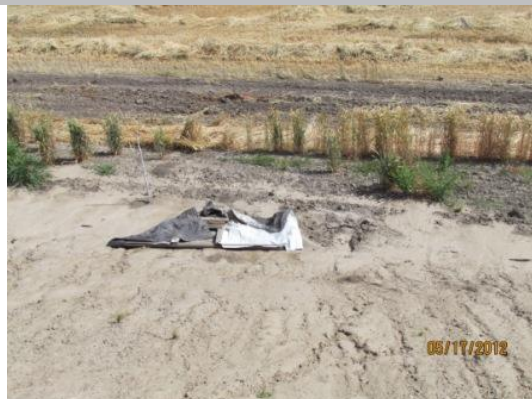
Photo 1 of 2 : FA_2018_RD2092_116_10_20180905_00002.jpg

LM Start	1.32	Rating **	A/W	Issue No.	10
LM End	1.32	Issue Type +	Ma	Location *	LS
Category	Earthen Levee			GPS Latitude/Longitude	
				Start	End
Item	Encroachments			37.590467 °	37.590467 °
				-121.163822 °	-121.163822 °
DWR ID	DWR_RD2092_01_s_2012_10				
Comment Code					
PI : Pipe					
Inspector Comment					
A sand boil appeared on the landside toe of the levee because of an underground pipe leakage. The pipe and boil have been repaired but should be monitored.

During spring inspection 2012, the sand boil was not active but materials were present on the landside toe of the levee. The sand boil occurred due to an underground irrigation pipe leakage. The picture was taken from the crown looking toward the toe of the levee. The area was repaired but should be monitored.

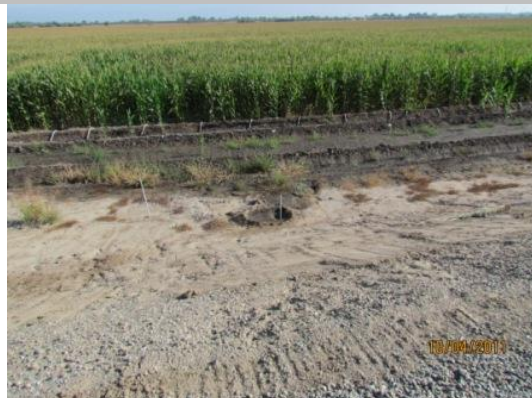
Photo 2 of 2 : FA_2018_RD2092_116_10_20180905_00003.jpg

LM Start	1.32	Rating **	A/W	Issue No.	10 (cont)	
LM End	1.32	Issue Type +	Ma	Location *	LS	
Category	Earthen Levee			GPS Latitude/Longitude		
				Start	End	
Item	Encroachments			37.590467 °	37.590467 °	
				-121.163822 °	-121.163822 °	
DWR ID	DWR_RD2092_01_s_2012_10					
Comment Code						
PI : Pipe						
Inspector Comment						
A sand boil appeared on the landside toe of the levee because of an underground pipe leakage. The pipe and boil have been repaired but should be monitored.

A sand boil was found on the landside of the levee. It was caused by a pipe leak couple of feet below the boil location. LMA was notified to repair it as soon as possible. The picture was taken from the crown looking upstream.

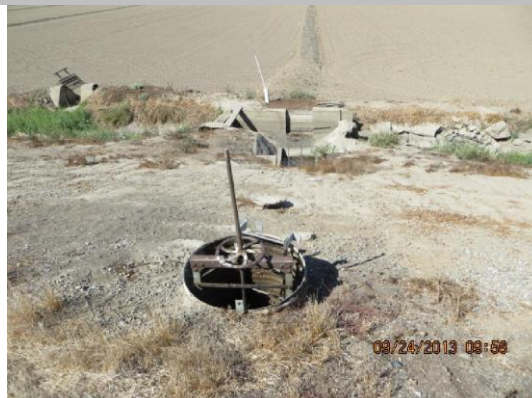
Photo 1 of 3 : UCIP_FA_2018_20891_35216.jpg

LM Start	1.69	Rating **	A/W	Issue No.	977
LM End	1.69	Issue Type +	Ma	Location *	
Category	Supplemental			GPS Latitude/Longitude	
				Start	End
Item	DWR UCIP LMA Responsibility			37.585938 °	37.585938 °
				-121.163348 °	-121.163348 °
DWR ID	20563				
Comment Code					
Inspector Comment					
FS_ID:20891 DS_ID:20563 EP_NO: N/A Repair Type: No Action Needed Crossing Status: Found UCIP Comments: FIELD_STRUCT_DESC: 24-inch corrugated metal drainage pipe through the levee, 14 feet below the crown. Slide gate in a corrugated metal pipe (CMP) riser on the waterside (WS) slope. Concrete U-shaped headwall at the landside (LS) toe. [Additional Reference(s): DWR Levee Log, 2005. USACE San Joaquin O&M Manual 5, August 1961, (HLM 1.71)]. FS Date: 9/24/2013

Slide gate in 36-inch CMP riser on WS slope.

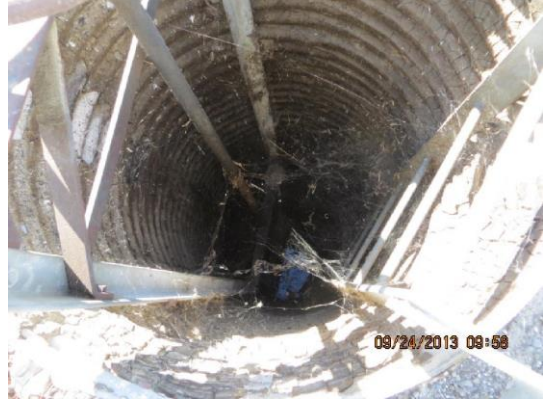
Photo 2 of 3 : UCIP_FA_2018_20891_35215.jpg

LM Start	1.69	Rating **	A/W	Issue No.	977 (cont)	
LM End	1.69	Issue Type +	Ma	Location *		
Category	Supplemental			GPS Latitude/Longitude		
				Start	End	
Item	DWR UCIP LMA Responsibility			37.585938 °	37.585938 °	
				-121.163348 °	-121.163348 °	
DWR ID	20563					
Comment Code						
Inspector Comment						
FS_ID:20891						
DS_ID:20563						
EP_NO: N/A						
Repair Type: No Action Needed						
Crossing Status: Found						
UCIP Comments:						
FIELD_STRUCT_DESC: 24-inch corrugated metal drainage pipe through the levee, 14 feet below the crown. Slide gate in a corrugated metal pipe (CMP) riser on the waterside (WS) slope. Concrete U-shaped headwall at the landside (LS) toe. [Additional Reference(s): DWR Levee Log, 2005. USACE San Joaquin O&M Manual 5, August 1961, (HLM 1.71)].						
FS Date: 9/24/2013

Slide gate in 36-inch CMP riser on WS slope.

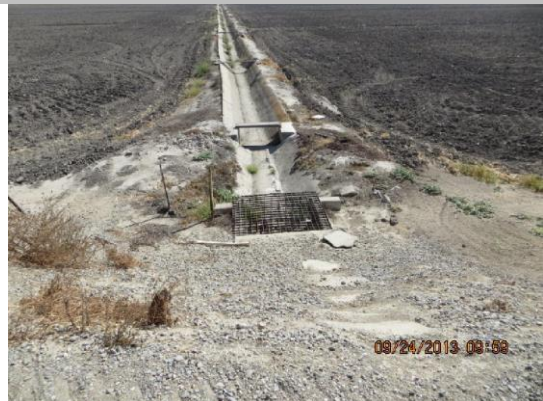
Photo 3 of 3 : UCIP_FA_2018_20891_35214.jpg

Concrete headwall at base of LS toe.

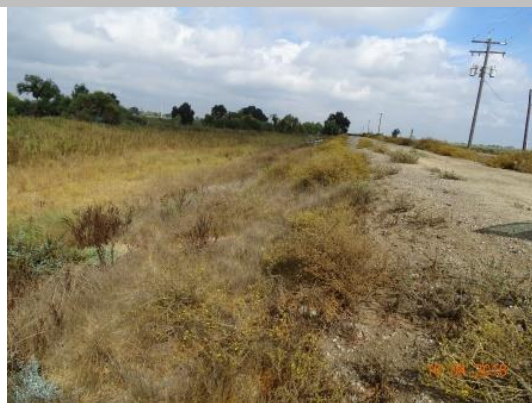
Photo 1 of 1 : FA_2018_RD2092_116_32_20181005_00052.jpg

LM Start	1.82	Rating **	U	Issue No.	32
LM End	2.71	Issue Type +	Ma	Location *	WS
Category	Earthen Levee			GPS Latitude/Longitude	
				Start	End
Item	Vegetation			37.584168°	37.576007°
				-121.162668°	-121.157221°
DWR ID	DWR_RD2092_01_f_2018_32				
Comment Code					
V1 : Control annual grass and weeds on the levee slopes and easements.					
Inspector Comment

Vegetation on waterside slope should be maintained. (Fall 2018)

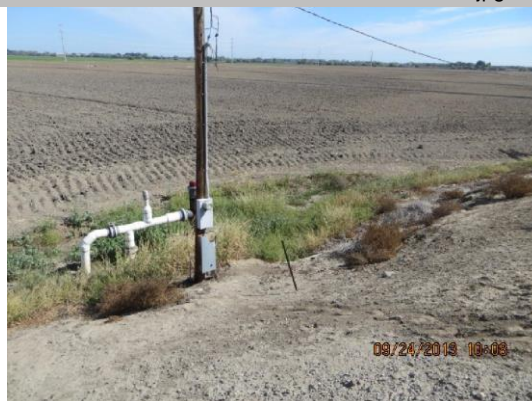
Photo 1 of 2 : UCIP_FA_2018_20904_35221.jpg

LM Start	2.07	Rating **	A/W	Issue No.	978
LM End	2.07	Issue Type +	Ma	Location *	
Category	Supplemental			GPS Latitude/Longitude	
				Start	End
Item	DWR UCIP LMA Responsibility			37.584212 °	37.584212 °
				-121.158347 °	-121.158347 °
DWR ID	20564				
Comment Code					
Inspector Comment					
FS_ID:20904 DS_ID:20564 EP_NO: N/A Repair Type: No Action Needed Crossing Status: Found UCIP Comments: FIELD_STRUCT_DESC: *ABANDONED* 30-inch corrugated metal drainage pipe through the levee, 15 feet below the crown. Flap gate on the waterside (WS) end. Concrete U-shaped headwalls on both ends. Filled with concrete on the landside (LS) toe. [Additional Reference(s): DWR Levee Log, 2005. USACE San Joaquin O&M Manual 5, August 1961, (HLM 2.10), 36-inch pipe listed]. FS Date: 9/24/2013

Pipe and concrete headwall visible on LS toe to right of powerpole.

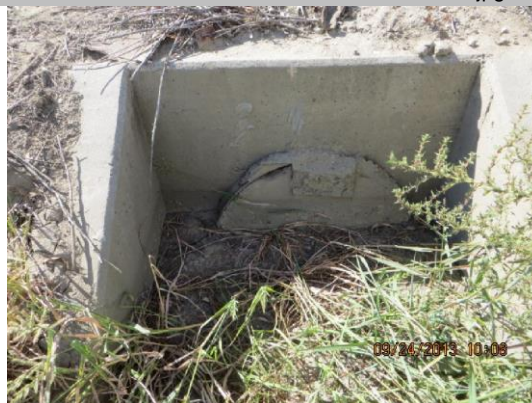
Photo 2 of 2 : UCIP_FA_2018_20904_35220.jpg

Pipe and concrete headwall visible on LS toe.

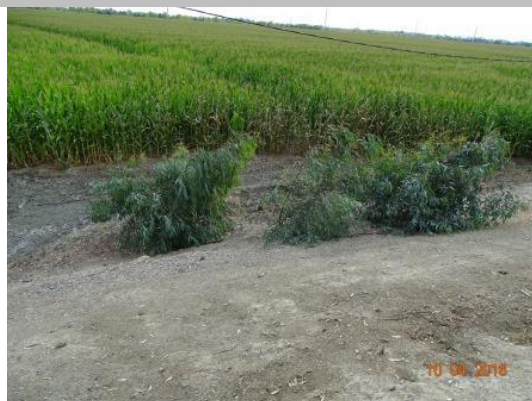
Photo 1 of 1 : FA_2018_RD2092_116_43_20181005_00053.jpg

LM Start	2.07	Rating **	M	Issue No.	43
LM End	2.07	Issue Type +	Ma	Location *	LS
Category	Earthen Levee			GPS Latitude/Longitude	
				Start	End
Item	Trim / Thin Trees			37.584215 °	37.584215 °
				-121.158290 °	-121.158290 °
DWR ID	DWR_RD2092_01_f_2018_43				
Comment Code					
T2 : Thin trees to allow visibility of the ground and room to flood fight.					
Inspector Comment					
remove trees before they are established

View of saplings along landside levee toe. (Fall 2018)

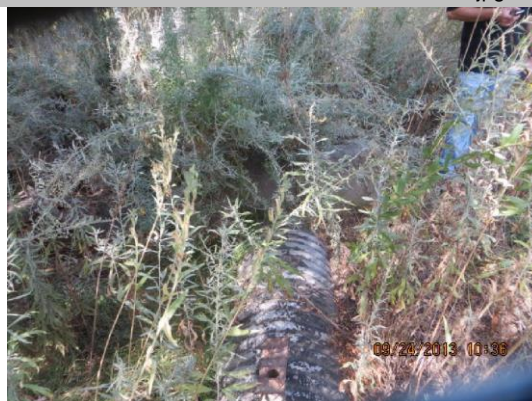
Photo 1 of 3 : UCIP_FA_2018_20943_35251.jpg

LM Start	2.40	Rating **	M	Issue No.	981
LM End	2.40	Issue Type +	Ma	Location *	
Category	Supplemental			GPS Latitude/Longitude	
				Start	End
Item	DWR UCIP LMA Responsibility			37.580426 °	37.580426 °
				-121.156798 °	-121.156798 °
DWR ID	20567				
Comment Code					
Inspector Comment					
FS_ID:20943 DS_ID:20567 EP_NO: N/A Repair Type: Non-Urgent Crossing Status: Found UCIP Comments: 09/24/2013 Appears abandoned and if so should be done so properly. (W. Wylie - DWR UCIP) FIELD_STRUCT_DESC: *ABANDONED* 24-inch corrugated metal drainage pipe through the levee, 15 feet below the crown. Flap gate on the waterside (WS) end. Concrete U-shaped headwall on the WS end. Concrete headwall on the landside (LS) toe next to pump. [Additional Reference(s): DWR Levee Log, 2005. USACE San Joaquin O&M Manual 5, August 1961, (HLM 2.44)]. FS Date: 9/24/2013

24-inch pipe visible on WS berm.

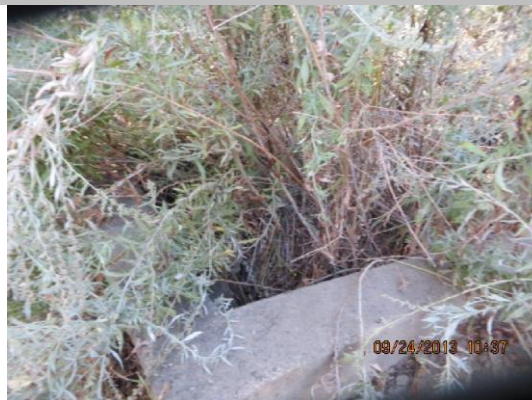
Photo 2 of 3 : UCIP_FA_2018_20943_35250.jpg

Concrete U-shaped headwall and flapgate on WS berm.

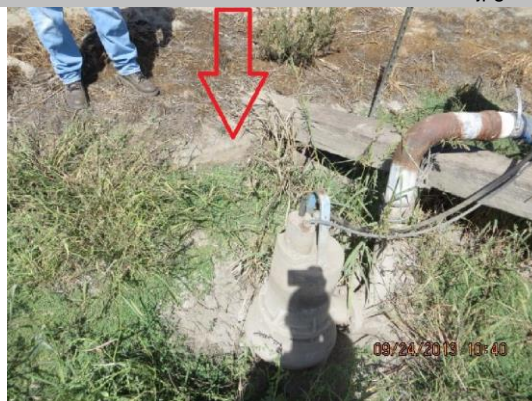
Photo 3 of 3 : UCIP_FA_2018_20943_35252.jpg

Comment Code						
Inspector Comment						
FS_ID:20943						
DS_ID:20567						
EP_NO: N/A						
Repair Type: Non-Urgent						
Crossing Status: Found						
UCIP Comments: 09/24/2013 Appears abandoned and if so should be done so properly. (W. Wylie - DWR UCIP)						
FIELD_STRUCT_DESC: *ABANDONED* 24-inch corrugated metal drainage pipe through the levee, 15 feet below the crown. Flap gate on the waterside (WS) end. Concrete U-shaped headwall on the WS end. Concrete headwall on the landside (LS) toe next to pump. [Additional Reference(s): DWR Levee Log, 2005. USACE San Joaquin O&M Manual 5, August 1961, (HLM 2.44)].						
FS Date: 9/24/2013

Concrete headwall next to pump on WS toe.

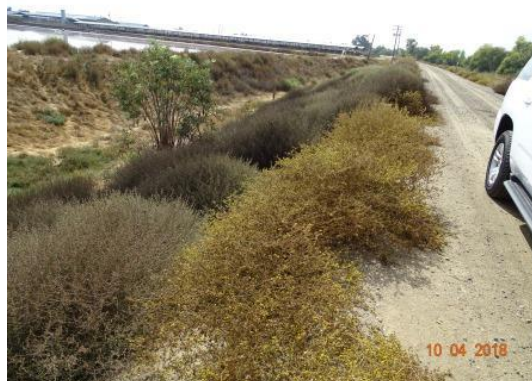
Photo 1 of 1 : FA_2018_RD2092_116_25_20181005_00054.jpg

LM Start	2.42	Rating **	U	Issue No.	25
LM End	2.71	Issue Type +	Ma	Location *	LS
Category	Earthen Levee			GPS Latitude/Longitude	
				Start	End
Item	Vegetation			37.580202°	37.576059°
				-121.156904°	-121.157241°
DWR ID	DWR_RD2092_01_f_2018_25				
Comment Code					
V1 : Control annual grass and weeds on the levee slopes and easements.					
Inspector Comment					
View of landside slope completely obstructed up vegetation.

View of vegetation along landside slope looking upstream. (Fall 2018)

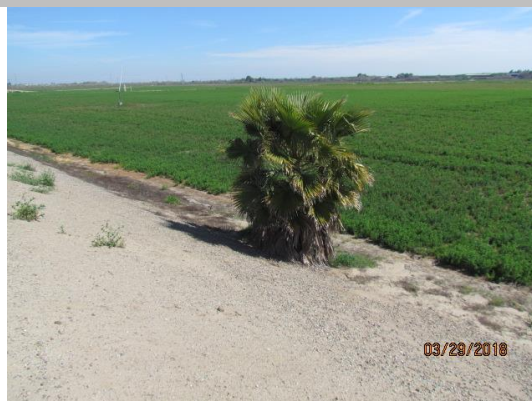
Photo 1 of 1 : FA_2018_RD2092_116_19_20180905_00008.jpg

LM Start	2.55	Rating **	U	Issue No.	19
LM End	2.55	Issue Type +	Ma	Location *	LS
Category	Earthen Levee			GPS Latitude/Longitude	
				Start	End
Item	Vegetation			37.578333 °	37.578333 °
				-121.157011 °	-121.157011 °
DWR ID	DWR_RD2092_01_s_2018_19				
Comment Code					
V7 : Trees / Woody Vegetation					
Inspector Comment					
Palm tree at landward toe should be removed.

Looking at Palm tree at landward toe. (Spring 2018)

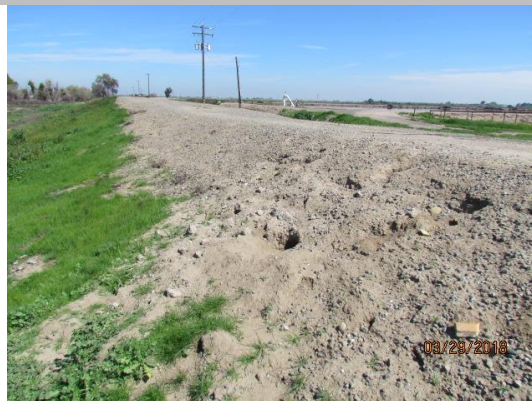
Photo 1 of 4 : FA_2018_RD2092_116_17_20180905_00004.jpg

LM Start	2.63	Rating **	U	Issue No.	17
LM End	2.76	Issue Type +	Ma	Location *	WS
Category	Earthen Levee			GPS Latitude/Longitude	
				Start	End
Item	Animal Control			37.577186°	37.575364°
				-121.157159°	-121.157093°
DWR ID	DWR_RD2092_01_s_2018_17				
Comment Code					
A1 : Exterminate rodents and backfill and compact or grout burrows.					
Inspector Comment					
Several large rodent holes within this reach.

Looking upstream on waterward slope at several large rodent holes. (Spring 2018)

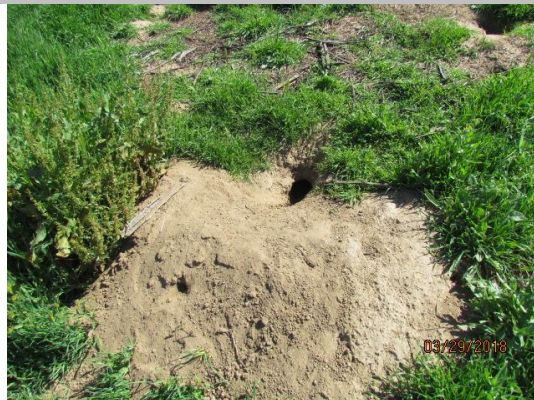
Photo 2 of 4 : FA_2018_RD2092_116_17_20180905_00005.jpg

LM Start	2.63	Rating **	U	Issue No.	17 (cont)	
LM End	2.76	Issue Type +	Ma	Location *	WS	
Category	Earthen Levee			GPS Latitude/Longitude		
				Start		End
Item	Animal Control			37.577186°		37.575364°
				-121.157159°		-121.157093°
DWR ID	DWR_RD2092_01_s_2018_17					
Comment Code						
A1 : Exterminate rodents and backfill and compact or grout burrows.						
Inspector Comment						
Several large rodent holes within this reach.

Looking at typical large rodent holes on waterward slope. (Spring 2018)

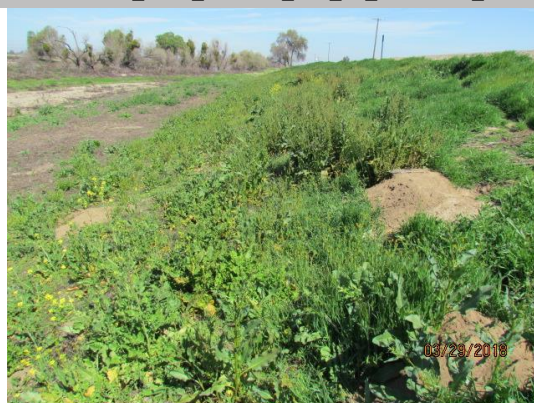
Photo 3 of 4 : FA_2018_RD2092_116_17_20180905_00006.jpg

Looking upstream at large rodent holes on waterward slope. (Spring 2018)

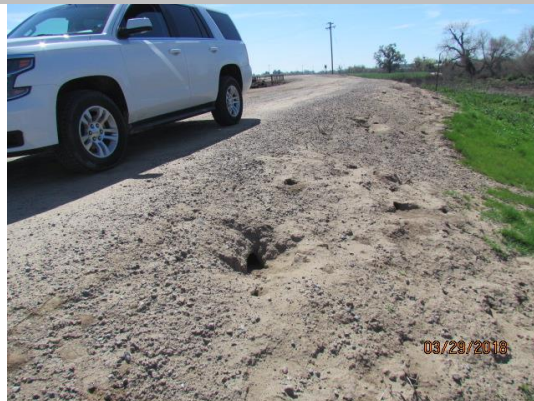
Photo 4 of 4 : FA_2018_RD2092_116_17_20180905_00007.jpg

Looking downstream at several rodent holes on waterward slope. (Spring 2018)

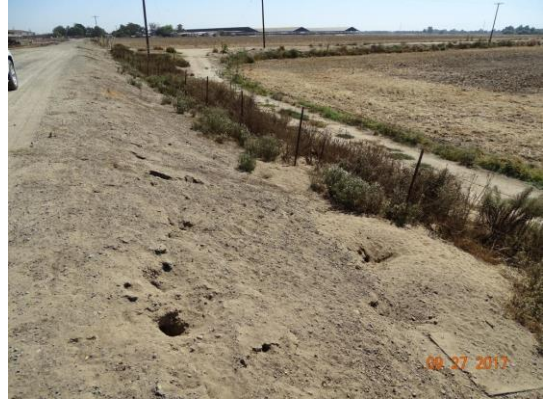
Photo 1 of 4 : FA_2018_RD2092_116_35_20180905_00013.jpg

LM Start	2.82	Rating **	U	Issue No.	35
LM End	3.01	Issue Type +	Ma	Location *	WS
Category	Earthen Levee			GPS Latitude/Longitude	
				Start	End
Item	Animal Control			37.574869 °	37.574141 °
				-121.156247 °	-121.152762 °
DWR ID	DWR_RD2092_01_s_2017_35				
Comment Code					
A3 : No rodents visible, but rodent burrows visible; need to backfill and compact or grout burrows.					
Inspector Comment

Updated picture of the rodent holes on the waterside of the levee looking upstream. Fall 2017

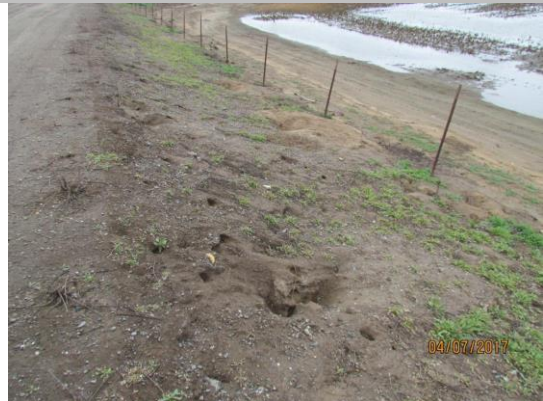
Photo 2 of 4 : FA_2018_RD2092_116_35_20180905_00014.jpg

View of multiple rodent holes on the waterside slope of the levee. Spring 2017

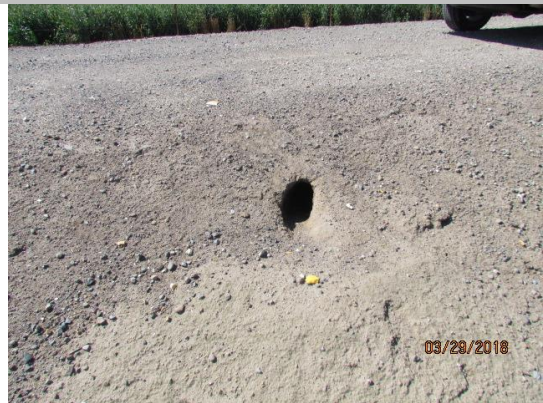
Photo 3 of 4 : FA_2018_RD2092_116_35_20180905_00015.jpg

Looking at Typical view of rodent holes on landward slope within this reach. (Spring 2018)

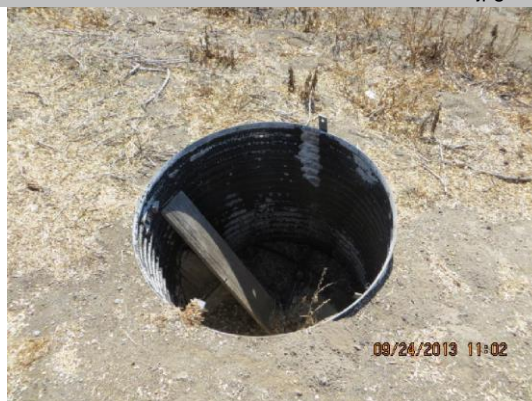
Photo 1 of 3 : UCIP_FA_2018_20945_35261.jpg

LM Start	3.47	Rating **	M	Issue No.	984	
LM End	3.47	Issue Type +	Ma	Location *		
Category	Supplemental			GPS Latitude/Longitude		
				Start		End
Item	DWR UCIP LMA Responsibility			37.573304 °		37.573304 °
				-121.144747 °		-121.144747 °
DWR ID	20572					
Comment Code						
Inspector Comment						
FS_ID:20945						
DS_ID:20572						
EP_NO: N/A						
Repair Type: Non-Urgent						
Crossing Status: Found						
UCIP Comments: 09/24/2013 This pipe appears abandoned and if so, should be done so properly. (W. Wylie - DWR UCIP)						
FIELD_STRUCT_DESC: *ABANDONED* 36-inch corrugated metal drainage pipe through the levee, 11 feet below the crown. Slide gate in a corrugated metal pipe (CMP) riser on the waterside (WS) slope. Concrete headwalls on both ends. [Additional Reference(s): DWR Levee Log, 2005. USACE San Joaquin O&M Manual 5, August 1961, (HLM 3.52)].						
FS Date: 9/24/2013

48-inch CMP riser on WS slope.

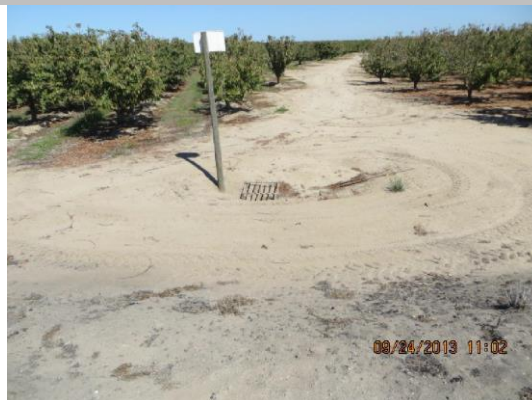
Photo 2 of 3 : UCIP_FA_2018_20945_35260.jpg

Grate over sump on LS toe.

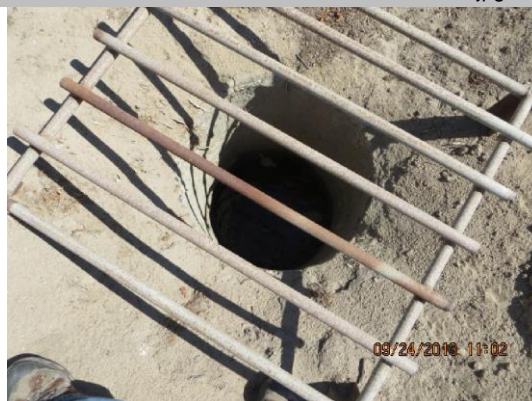
Photo 3 of 3 : UCIP_FA_2018_20945_35262.jpg

Comment Code						
Inspector Comment						
FS_ID:20945						
DS_ID:20572						
EP_NO: N/A						
Repair Type: Non-Urgent						
Crossing Status: Found						
UCIP Comments: 09/24/2013 This pipe appears abandoned and if so, should be done so properly. (W. Wylie - DWR UCIP)						
FIELD_STRUCT_DESC: *ABANDONED* 36-inch corrugated metal drainage pipe through the levee, 11 feet below the crown. Slide gate in a corrugated metal pipe (CMP) riser on the waterside (WS) slope. Concrete headwalls on both ends. [Additional Reference(s): DWR Levee Log, 2005. USACE San Joaquin O&M Manual 5, August 1961, (HLM 3.52)].						
FS Date: 9/24/2013

Grate over sump on LS toe.
