**Flood Control Project Maintenance
Levee Inspections**

Maintenance Issue Types Only, Levee Inspection Report By Mile - Fall 2019

Reclamation District No. 2092 Dos Rios

Waterway	Bank	Unit Miles	Inspection Start/End	Inspector
Unit No. 01 San Joaquin River	Right	3.71	09/19/2019 09/19/2019	Corey Fujitani

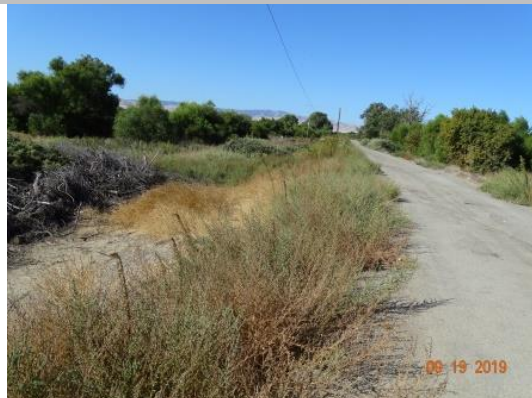
Photo 1 of 1 : FA_2019_RD2092_116_32_20190924_00063.jpg

LM Start	0.08	Rating **	U	Issue No.	32
LM End	0.20	Issue Type +	Ma	Location *	LS
Category	Earthen Levee			GPS Latitude/Longitude	
				Start	End
Item	Vegetation			37.602510 °	37.601898 °
				-121.159538 °	-121.161582 °
DWR ID	DWR_RD2092_01_f_2019_32				
Comment Code					
V1 : Control annual grass and weeds on the levee slopes and easements.					
Inspector Comment

View of vegetation on landside slope looking upstream. (Fall 2019)

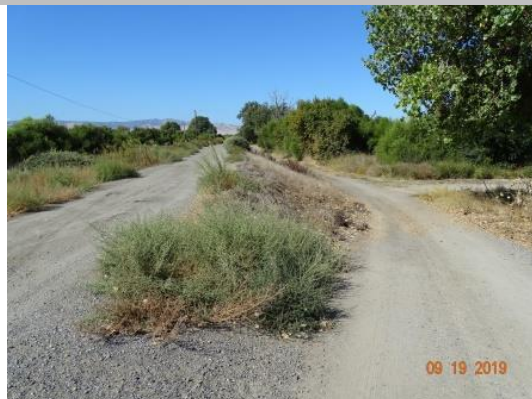
Photo 1 of 1 : FA_2019_RD2092_116_34_20190924_00064.jpg

LM Start	0.08	Rating **	U	Issue No.	34
LM End	2.89	Issue Type +	Ma	Location *	WS
Category	Earthen Levee			GPS Latitude/Longitude	
				Start	End
Item	Vegetation			37.602501 °	37.574610 °
				-121.159588 °	-121.154898 °
DWR ID	DWR_RD2092_01_f_2019_34				
Comment Code					
V1 : Control annual grass and weeds on the levee slopes and easements.					
Inspector Comment

View of vegetation along waterside slope. (Fall 2019)

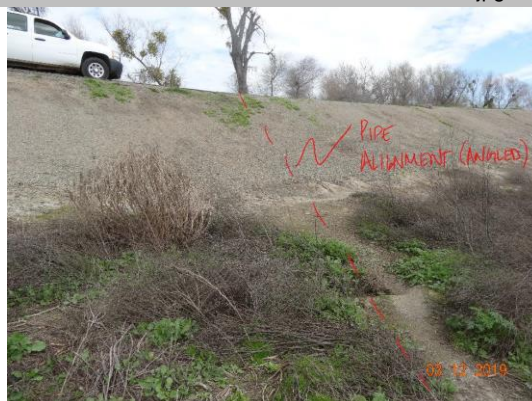
Photo 3 of 3 : UCIP_FA_2019_53799_79058.jpg

Comment Code						
Inspector Comment						
DS_ID:20561 FS_ID:53799 EP_NO: N/A Repair Type: Urgent Crossing Status: Found UCIP Comments: 03/12/2019 A thorough internal evaluation of this crossing is necessary. Pipe shows evidence of pipe integrity (LS) issues (pipe wall sections missing on LS inlet) and levee integrity issues (sink hole visible along LS pipe alignment). Internal inspection is recommended for this crossing to determine the extent of pipe damage through the levee. Pipe crosses the levee at an angle at a depth of about 19 feet. Recommend caution be taken at this crossing when driving over levee until additional information becomes available to determine condition of pipe through levee. Recommend cover be placed on riser to address safety concern (riser is 80 inches in diameter and about 19 feet deep). Slide gate appears to be blocked by sediment/debris preventing slide gate to work properly. Unable to confirm if the flap gate located on the WS is still broken (see photo from 2017). (O. Magana - DWR UCIP)09/24/2013 Pipe rusted through at headwall on LS toe. Good candidate for video inspection. (W. Wylie - DWR UCIP) FIELD_STRUCT_DESC: 60-inch corrugated metal drainage pipe through the levee, 19 feet below the crown. Flap gate on the waterside (WS) end. Slide gate in an 80-inch corrugated metal pipe (CMP) riser on the WS slope. Concrete U-shaped headwalls on both ends. [Additional Reference(s): DWR Levee Log, 2005. USACE San Joaquin O&M Manual 5, August 1961, (HLM 0.18)]. FS Date: 3/12/2019 12:05:00 PM

LS view: pipe crosses levee at angle, approximate alignment on LS.

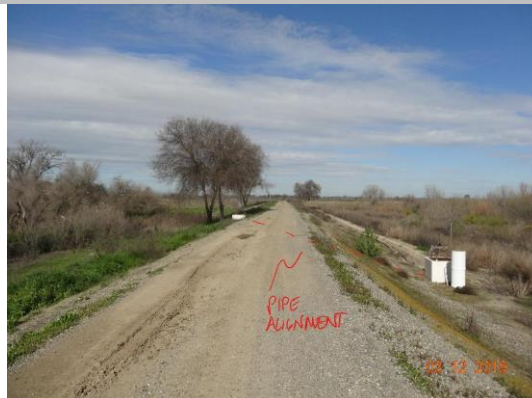
Photo 1 of 3 : UCIP_FA_2019_53820_79073.jpg

Comment Code						
Inspector Comment						
DS_ID:20562 FS_ID:53820 EP_NO: N/A Repair Type: Non-Urgent Crossing Status: Found UCIP Comments: 03/12/2019 During UCIP visual inspection, no pipe or levee integrity issues were observed. Distribution box located on the WS is falling apart (bricks missing). This crossing is an active crossing however, no permit has been found authorizing crossing. Need to determine who maintains and operates this crossing. (O. Magana - DWR UCIP) FIELD_STRUCT_DESC: 36-inch corrugated metal drainage pipe through the levee, 15 feet below the crown. Slide gate in a 48-inch corrugated metal pipe (CMP) riser on the waterside (WS) slope. 4-foot by 6-foot concrete distribution box on the landside (LS) toe. 5-foot by 5-foot concrete riser on the WS toe. [Additional Reference(s): DWR Levee Log, 2005. USACE San Joaquin O&M Manual 5, August 1961, (HLM 1.31)]. FS Date: 3/12/2019 12:06:00 PM

Overview of pipe alignment through levee, photo taking looking d/s toward crossing.

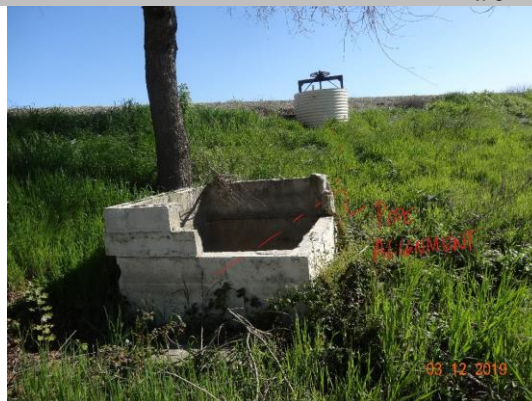
Photo 2 of 3 : UCIP_FA_2019_53820_79078.jpg

WS view: approximate alignment on WS.

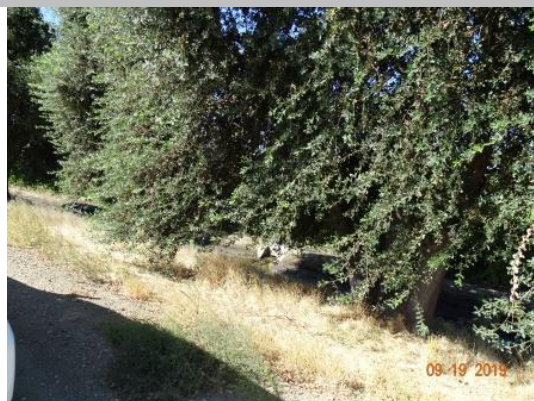
Photo 1 of 1 : FA_2019_RD2092_116_48_20190924_00070.jpg

LM Start	1.60	Rating **	M	Issue No.	48
LM End	1.60	Issue Type +	Ma	Location *	WS
Category	Earthen Levee			GPS Latitude/Longitude	
				Start	End
Item	Trim / Thin Trees			37.587068 °	37.587068 °
				-121.162773 °	-121.162773 °
DWR ID	DWR_RD2092_01_f_2019_48				
Comment Code					
T1 : Trim trees to at least five feet above ground level.					
Inspector Comment

View of branches hanging over waterside slope. (Fall 2019)

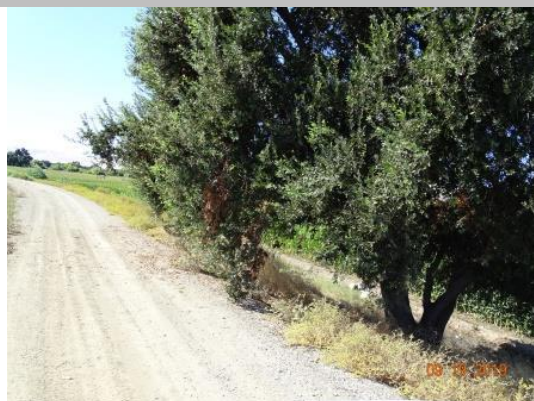
Photo 1 of 2 : FA_2019_RD2092_116_49_20190924_00074.jpg

LM Start	1.65	Rating **	M	Issue No.	49
LM End	1.65	Issue Type +	Ma	Location *	WS
Category	Earthen Levee			GPS Latitude/Longitude	
				Start	End
Item	Trim / Thin Trees			37.586430 °	37.586430 °
				-121.163108 °	-121.163108 °
DWR ID	DWR_RD2092_01_f _ 2019_49				
Comment Code					
T4 : Trim trees over roadway to at least 12 feet above ground level.					
Inspector Comment

View of branches hanging over levee crown. (Fall 2019)

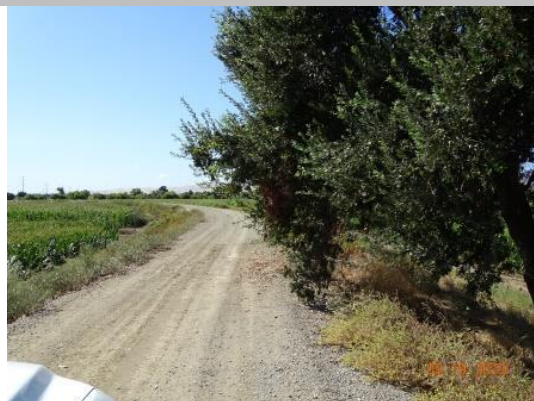
Photo 2 of 2 : FA_2019_RD2092_116_49_20190924_00075.jpg

Looking upstream along the levee crown. (Fall 2019)

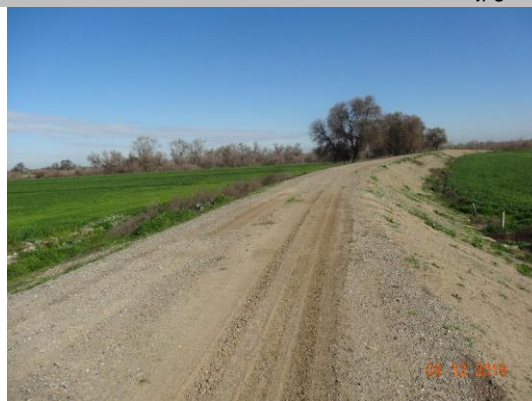
Photo 1 of 3 : UCIP_FA_2019_53817_79086.jpg

Comment Code					
Inspector Comment					
DS_ID:20563 FS_ID:53817 EP_NO: N/A Repair Type: Urgent Crossing Status: Found UCIP Comments: 03/12/2019 A thorough internal evaluation of this crossing is required, pipe shows evidence of pipe integrity (LS) issues (pipe wall sections missing on WS outlet). Internal inspection is recommended for this crossing to determine the extent of pipe damage through the levee. Maintenance issues identified at this crossing include: flap gate missing on WS, debris found inside concrete distribution box, and missing cover on riser. No permit has been identified for this crossing. Need to determine who maintains crossing; crossing appears functional. (O. Magana - DWR UCIP) FIELD_STRUCT_DESC: 24-inch corrugated metal drainage pipe through the levee, 14 feet below the crown. Slide gate in a corrugated metal pipe (CMP) riser on the waterside (WS) slope. Concrete U-shaped headwall at the landside (LS) toe. [Additional Reference(s): DWR Levee Log, 2005. USACE San Joaquin O&M Manual 5, August 1961, (HLM 1.71)]. FS Date: 3/12/2019 12:07:00 PM

Overview of levee crown looking d/s towards pipe crossing.

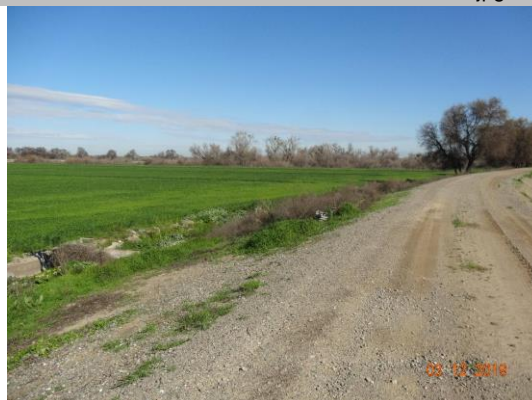
Photo 2 of 3 : UCIP_FA_2019_53817_79087.jpg

WS view: overview of WS.

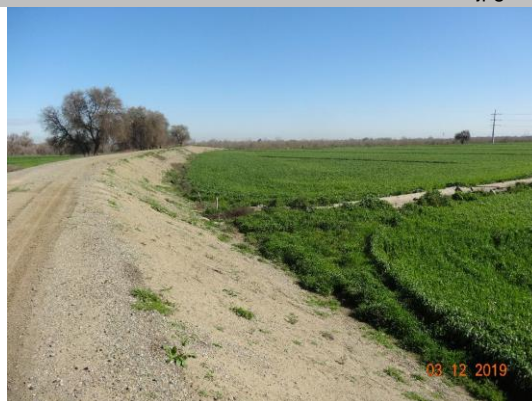
Photo 3 of 3 : UCIP_FA_2019_53817_79085.jpg

Comment Code						
Inspector Comment						
DS_ID:20563 FS_ID:53817 EP_NO: N/A Repair Type: Urgent Crossing Status: Found UCIP Comments: 03/12/2019 A thorough internal evaluation of this crossing is required, pipe shows evidence of pipe integrity (LS) issues (pipe wall sections missing on WS outlet). Internal inspection is recommended for this crossing to determine the extent of pipe damage through the levee. Maintenance issues identified at this crossing include: flap gate missing on WS, debris found inside concrete distribution box, and missing cover on riser. No permit has been identified for this crossing. Need to determine who maintains crossing; crossing appears functional. (O. Magana - DWR UCIP) FIELD_STRUCT_DESC: 24-inch corrugated metal drainage pipe through the levee, 14 feet below the crown. Slide gate in a corrugated metal pipe (CMP) riser on the waterside (WS) slope. Concrete U-shaped headwall at the landside (LS) toe. [Additional Reference(s): DWR Levee Log, 2005. USACE San Joaquin O&M Manual 5, August 1961, (HLM 1.71)]. FS Date: 3/12/2019 12:07:00 PM

LS view: overview of LS.

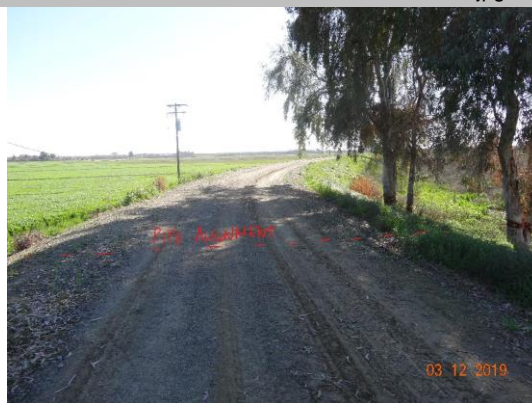
Photo 1 of 3 : UCIP_FA_2019_53814_79091.jpg

Comment Code					
Inspector Comment					
DS_ID:20564 FS_ID:53814 EP_NO: N/A Repair Type: Non-Urgent Crossing Status: Found UCIP Comments: 03/12/2019 Concrete headwall found on LS toe. Pipe appears to have been grouted through. No other appurtenances were found during inspection. WS outlet was not found. Need to coordinate with the CVFPB to determine if additional steps are needed to comply with Title 23. (O. Magana - DWR UCIP) FIELD_STRUCT_DESC: *ABANDONED* 30-inch corrugated metal drainage pipe through the levee, 15 feet below the crown. Flap gate on the waterside (WS) end. Concrete U-shaped headwalls on both ends. Filled with concrete on the landside (LS) toe. [Additional Reference(s): DWR Levee Log, 2005. USACE San Joaquin O&M Manual 5, August 1961, (HLM 2.10), 36-inch pipe listed]. FS Date: 3/12/2019 12:08:00 PM

Overview of levee crown, looking u/s from d/s, and approximate pipe alignment.

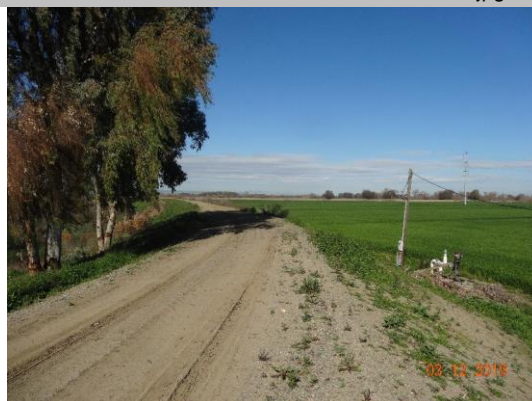
Photo 2 of 3 : UCIP_FA_2019_53814_79092.jpg

Comment Code						
Inspector Comment						
DS_ID:20564 FS_ID:53814 EP_NO: N/A Repair Type: Non-Urgent Crossing Status: Found UCIP Comments: 03/12/2019 Concrete headwall found on LS toe. Pipe appears to have been grouted through. No other appurtenances were found during inspection. WS outlet was not found. Need to coordinate with the CVFPB to determine if additional steps are needed to comply with Title 23. (O. Magana - DWR UCIP) FIELD_STRUCT_DESC: *ABANDONED* 30-inch corrugated metal drainage pipe through the levee, 15 feet below the crown. Flap gate on the waterside (WS) end. Concrete U-shaped headwalls on both ends. Filled with concrete on the landside (LS) toe. [Additional Reference(s): DWR Levee Log, 2005. USACE San Joaquin O&M Manual 5, August 1961, (HLM 2.10), 36-inch pipe listed]. FS Date: 3/12/2019 12:08:00 PM

Overview of levee at crossing, photo taken u/s looking d/s towards pipe crossing.

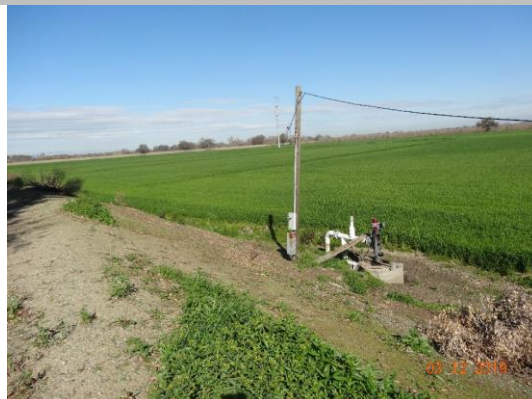
Photo 3 of 3 : UCIP_FA_2019_53814_79093.jpg

LS view: concrete riser, power pole, and groundwater pump station.

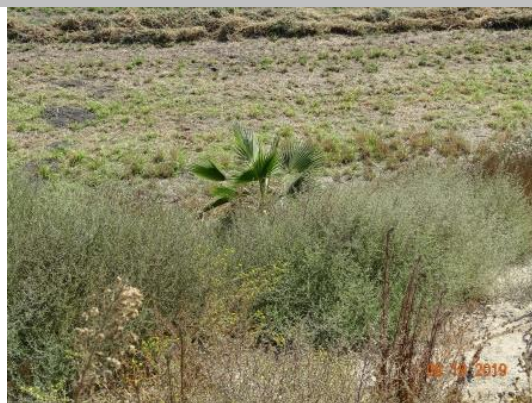
Photo 1 of 1 : FA_2019_RD2092_116_50_20190924_00071.jpg

LM Start	2.44	Rating **	M	Issue No.	50
LM End	2.44	Issue Type +	Ma	Location *	LS
Category	Earthen Levee			GPS Latitude/Longitude	
				Start	End
Item	Trim / Thin Trees			37.579945 °	37.579945 °
				-121.156995 °	-121.156995 °
DWR ID	DWR_RD2092_01_f_2019_50				
Comment Code					
T2 : Thin trees to allow visibility of the ground and room to flood fight.					
Inspector Comment					
Palm tree should be removed from landside slope before it can establish.

View of palm tree in landside slope. (Fall 2019)

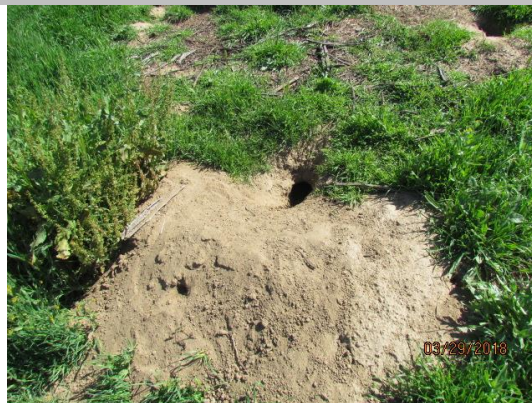
Photo 2 of 4 : FA_2019_RD2092_116_17_20190912_00004.jpg

Looking at typical large rodent holes on waterward slope. (Spring 2018)

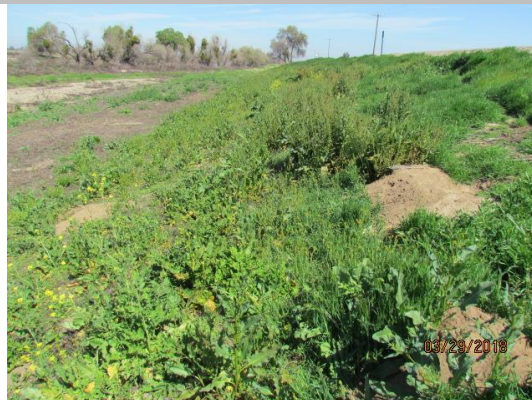
Photo 3 of 4 : FA_2019_RD2092_116_17_20190912_00005.jpg

Looking upstream at large rodent holes on waterward slope. (Spring 2018)

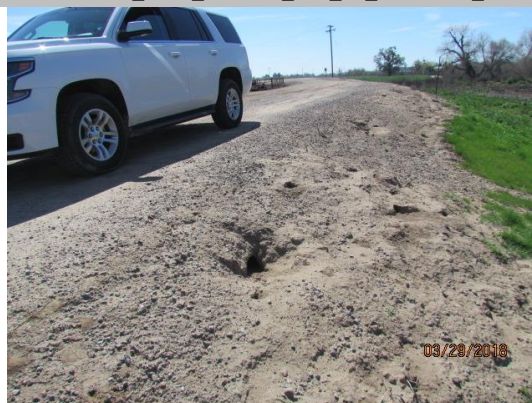
Photo 4 of 4 : FA_2019_RD2092_116_17_20190912_00006.jpg

Looking downstream at several rodent holes on waterward slope. (Spring 2018)

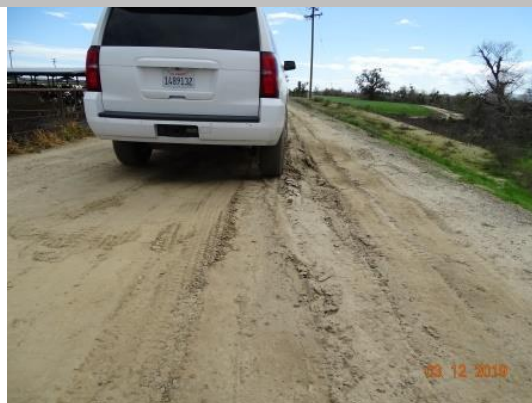
Photo 1 of 2 : FA_2019_RD2092_116_45_20190912_00021.jpg

LM Start	2.74	Rating **	M	Issue No.	45
LM End	2.74	Issue Type +	Ma	Location *	CR
Category	Earthen Levee			GPS Latitude/Longitude	
				Start	End
Item	Crown Surface / Depressions / Rutting			37.575514 °	37.575514 °
				-121.157140 °	-121.157140 °
DWR ID	DWR_RD2092_01_s_2019_45				
Comment Code					
C2 : Repair depressions or ruts in the crown or slope.					
Inspector Comment					
Depression and rutting in levee crown should be repaired.

View of rutting along levee crown. (Spring 2019)

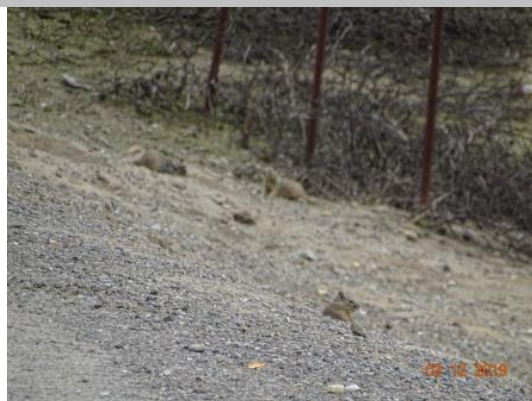
Photo 1 of 3 : FA_2019_RD2092_116_35_20190912_00012.jpg

LM Start	2.82	Rating **	M	Issue No.	35
LM End	3.01	Issue Type +	Ma	Location *	WS
Category	Earthen Levee			GPS Latitude/Longitude	
				Start	End
Item	Animal Control			37.574869 °	37.574141 °
				-121.156247 °	-121.152762 °
DWR ID	DWR_RD2092_01_s_2017_35				
Comment Code					
A1 : Exterminate rodents and backfill and compact or grout burrows.					
Inspector Comment

Squirrels observed along waterside slope. (Spring 2019)

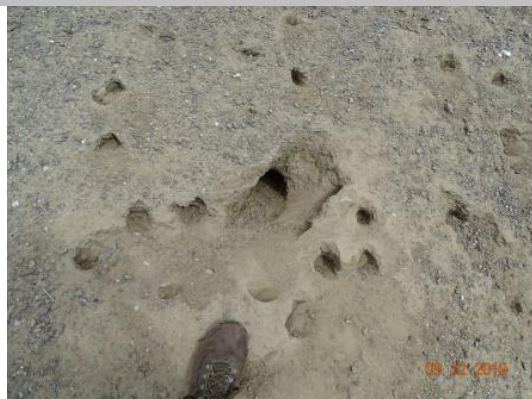
Photo 2 of 3 : FA_2019_RD2092_116_35_20190912_00013.jpg

View of typical rodent holes. (Spring 2019)

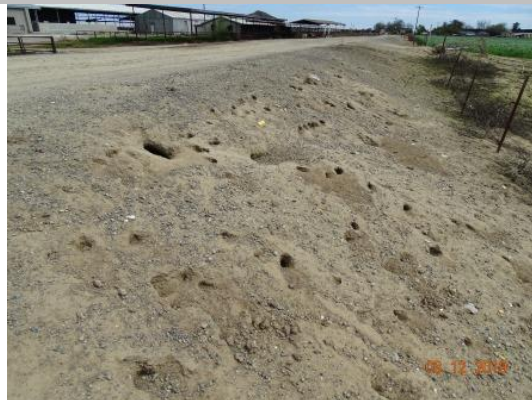
Photo 3 of 3 : FA_2019_RD2092_116_35_20190912_00014.jpg

View of several rodent burrows along waterside slope. (Spring 2019)

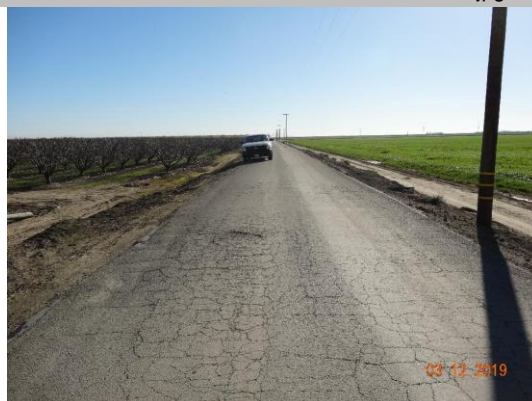
Photo 2 of 3 : UCIP_FA_2019_53786_79150.jpg

Comment Code						
Inspector Comment						
DS_ID:20572 FS_ID:53786 EP_NO: N/A Repair Type: Non-Urgent Crossing Status: Found UCIP Comments: 03/12/2019 No permit was found authorizing crossing. Unable to confirm if crossing is in use. Recommend adding cover to riser to address safety concern. No slide gate was found in CMP riser. If crossing is no longer in use, recommend proper abandonment or removal from levee. Owner will need to coordinate with CVFPB to be compliant with Title 23. (O. Magana - DWR UCIP) 09/24/2013 This pipe appears abandoned and if so, should be done so properly. (W. Wylie - DWR UCIP) FIELD_STRUCT_DESC: *ABANDONED* 36-inch corrugated metal drainage pipe through the levee, 11 feet below the crown. Slide gate in a corrugated metal pipe (CMP) riser on the waterside (WS) slope. Concrete headwalls on both ends. [Additional Reference(s): DWR Levee Log, 2005. USACE San Joaquin O&M Manual 5, August 1961, (HLM 3.52)]. FS Date: 3/12/2019 12:11:53 PM

Overview of levee crown looking u/S towards crossing.

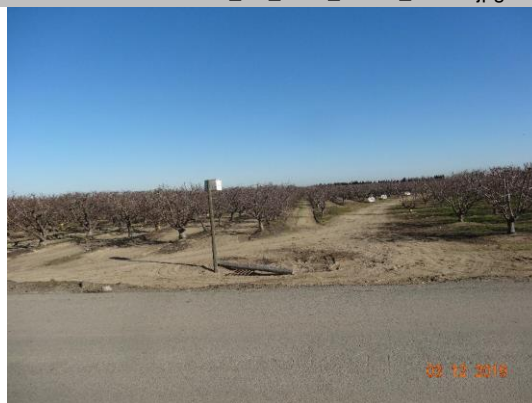
Photo 3 of 3 : UCIP_FA_2019_53786_79144.jpg

LS view: overview of land use on LS.
