**Flood Control Project Maintenance
Levee Inspections**

Maintenance Issue Types Only, Levee Inspection Report By Mile - Fall 2020

Reclamation District No. 2092 Dos Rios

Waterway	Bank	Unit Miles	Inspection Start/End	Inspector
Unit No. 01 San Joaquin River	Right	3.71	09/16/2020 09/16/2020	Corey Fujitani

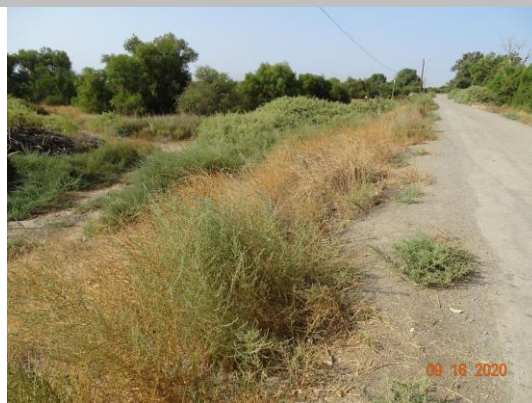
Photo 1 of 1 : FA_2020_RD2092_116_30_20200918_00073.jpg

LM Start	0.09	Rating **	U	Issue No.	30
LM End	2.18	Issue Type +	Ma	Location *	LS
Category	Earthen Levee			GPS Latitude/Longitude	
				Start	End
Item	Vegetation			37.602477 °	37.583295 °
				-121.159706 °	-121.156664 °
DWR ID	DWR_RD2092_01_f_2020_30				
Comment Code					
V1 : Control annual grass and weeds on the levee slopes and easements.					
Inspector Comment

Looking upstream along the landside slope. (Fall 2020)

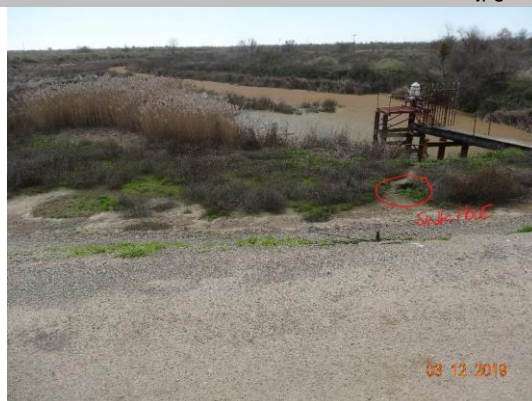
Photo 2 of 3 : UCIP_FA_2020_53799_79054.jpg

LS view: overview of LS with sink hole visible along pipe alignment.

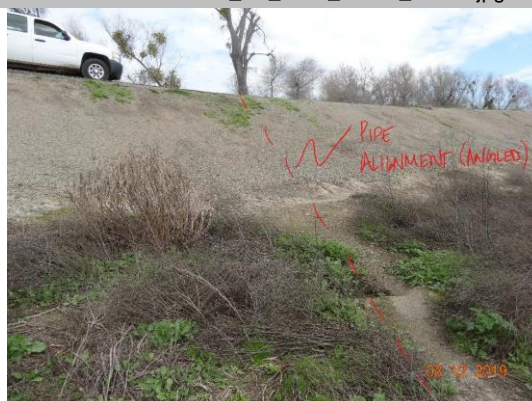
Photo 3 of 3 : UCIP_FA_2020_53799_79058.jpg

LS view: pipe crosses levee at angle, approximate alignment on LS.

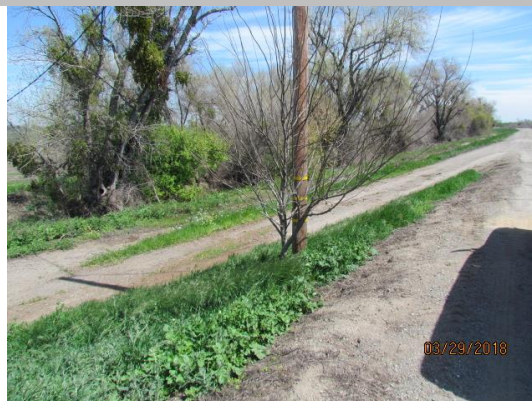
Photo 1 of 1 : FA_2020_RD2092_116_31_20200901_00014.jpg

LM Start	0.44	Rating **	M	Issue No.	31
LM End	0.44	Issue Type +	Ma	Location *	WS
Category	Earthen Levee			GPS Latitude/Longitude	
				Start	End
Item	Trim / Thin Trees			37.601149 °	37.601149 °
				-121.165772 °	-121.165772 °
DWR ID	DWR_RD2092_01_s_2018_31				
Comment Code					
T2 : Thin trees to allow visibility of the ground and room to flood fight.					
Inspector Comment					
Remove small tree on waterward shoulder before tree is establish.

Looking upstream at small tree on waterward should next to pole.
(Spring 2018)

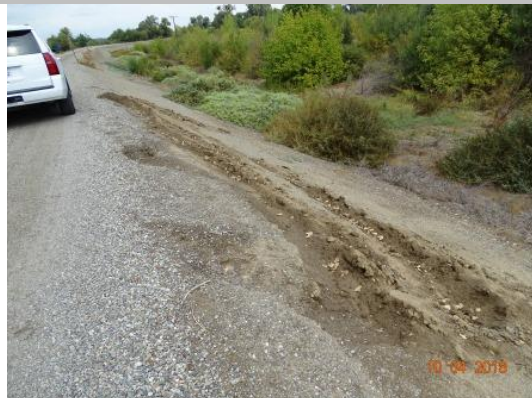
Photo 1 of 1 : FA_2020_RD2092_116_40_20200901_00017.jpg

LM Start	0.59	Rating **	M	Issue No.	40
LM End	0.59	Issue Type +	Ma	Location *	LS
Category	Earthen Levee			GPS Latitude/Longitude	
				Start	End
Item	Slope Stability			37.599406 °	37.599406 °
				-121.167083 °	-121.167083 °
DWR ID	DWR_RD2092_01_f_2018_40				
Comment Code					
S3 : Repair the levee slope damaged by vehicle traffic and prevent access where possible.					
Inspector Comment					
Vehicle tracks on the landside slope should be repaired.

Vehicle tracks on landside slope approximately 6" deep perpendicular to the slope. (Fall 2018)

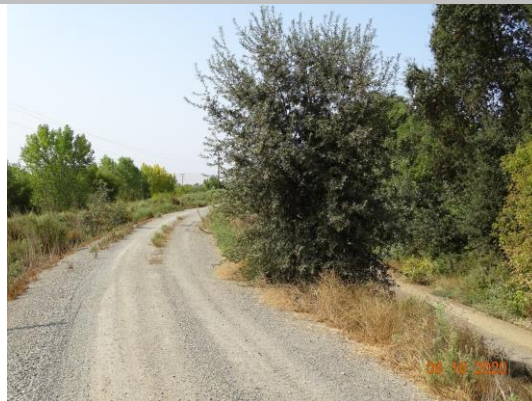
Photo 1 of 1 : FA_2020_RD2092_116_21_20200918_00074.jpg

LM Start	0.61	Rating **	M	Issue No.	21
LM End	0.61	Issue Type +	Ma	Location *	WS
Category	Earthen Levee			GPS Latitude/Longitude	
				Start	End
Item	Trim / Thin Trees			37.599208 °	37.599208 °
				-121.167150 °	-121.167150 °
DWR ID	DWR_RD2092_01_s_2018_21				
Comment Code					
T2 : Thin trees to allow visibility of the ground and room to flood fight.					
Inspector Comment					
Remove small tree on waterward shoulder before tree is established.

Looking upstream at a tree growing in the waterside shoulder. (Fall 2020)

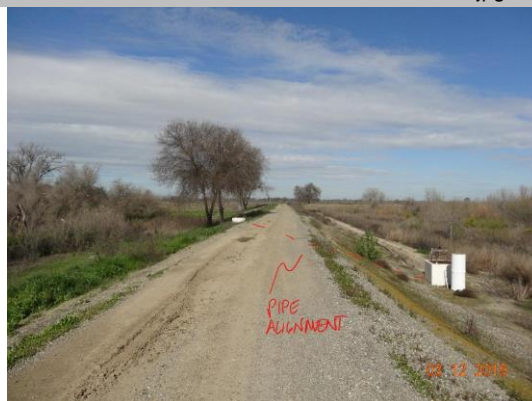
Photo 1 of 3 : UCIP_FA_2020_53820_79073.jpg

LM Start	1.30	Rating **	M	Issue No.	977	
LM End	1.30	Issue Type +	Ma	Location *		
Category	Supplemental			GPS Latitude/Longitude		
				Start	End	
Item	DWR UCIP LMA Responsibility			37.590603 °	37.590603 °	
				-121.164111 °	-121.164111 °	
DWR ID	20562

Comment Code						
Inspector Comment						
DS_ID:20562 FS_ID:53820 EP_NO: N/A Repair Type: Non-Urgent EVAL Issue: Maintenance Compliance Issue Crossing Status: Found UCIP Comments: 03/12/2019 During UCIP visual inspection, no pipe or levee integrity issues were observed. Distribution box located on the WS is falling apart (bricks missing). This crossing is an active crossing however, no permit has been found authorizing crossing. Need to determine who maintains and operates this crossing. (O. Magana - DWR UCIP) FIELD_STRUCT_DESC: 36-inch corrugated metal drainage pipe through the levee, 15 feet below the crown. Slide gate in a 48-inch corrugated metal pipe (CMP) riser on the waterside (WS) slope. 4-foot by 6-foot concrete distribution box on the landside (LS) toe. 5-foot by 5-foot concrete riser on the WS toe. [Additional Reference(s): DWR Levee Log, 2005. USACE San Joaquin O&M Manual 5, August 1961, (HLM 1.31)]. FS Date: 3/12/2019 12:06:00 PM

Overview of pipe alignment through levee, photo taking looking d/s toward crossing.

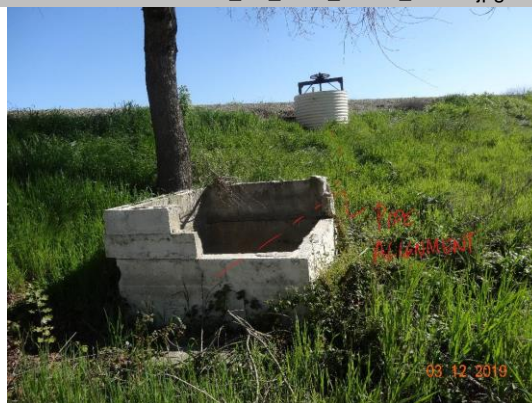
Photo 2 of 3 : UCIP_FA_2020_53820_79078.jpg

WS view: approximate alignment on WS.

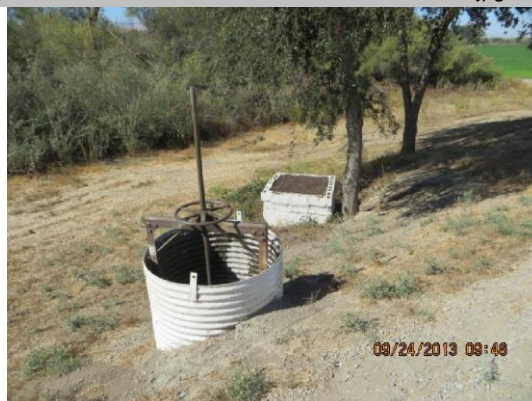
Photo 3 of 3 : UCIP_FA_2020_53820_35213.jpg

Slide gate in 48-inch CMP riser on WS slope.

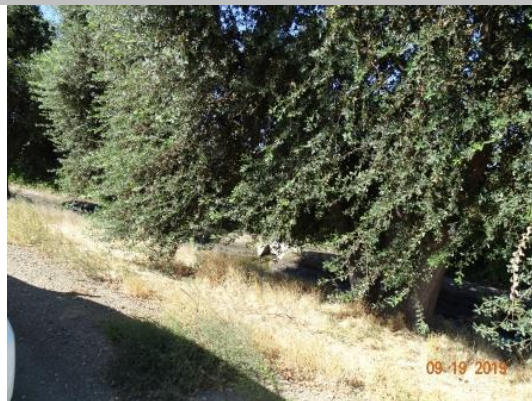
Photo 1 of 1 : FA_2020_RD2092_116_48_20200901_00024.jpg

LM Start	1.60	Rating **	M	Issue No.	48
LM End	1.60	Issue Type +	Ma	Location *	WS
Category	Earthen Levee			GPS Latitude/Longitude	
				Start	End
Item	Trim / Thin Trees			37.587068 °	37.587068 °
				-121.162773 °	-121.162773 °
DWR ID	DWR_RD2092_01_f_2019_48				
Comment Code					
T1 : Trim trees to at least five feet above ground level.					
Inspector Comment

View of branches hanging over waterside slope. (Fall 2019)

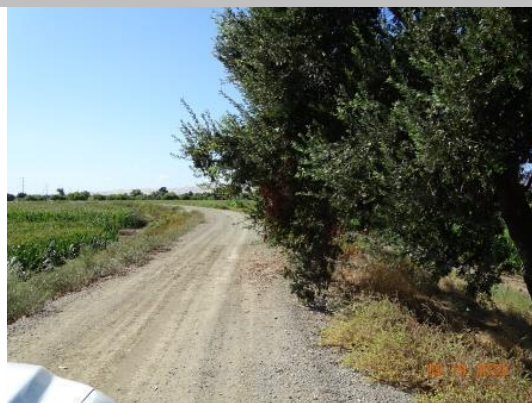
Photo 1 of 1 : FA_2020_RD2092_116_49_20200901_00026.jpg

LM Start	1.65	Rating **	M	Issue No.	49
LM End	1.65	Issue Type +	Ma	Location *	WS
Category	Earthen Levee			GPS Latitude/Longitude	
				Start	End
Item	Trim / Thin Trees			37.586430 °	37.586430 °
				-121.163108 °	-121.163108 °
DWR ID	DWR_RD2092_01_f_2019_49				
Comment Code					
T4 : Trim trees over roadway to at least 12 feet above ground level.					
Inspector Comment

View of branches hanging over levee crown. (Fall 2019)

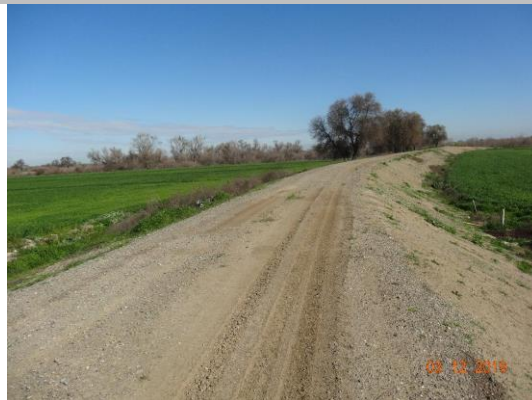
Photo 1 of 3 : UCIP_FA_2020_53817_79086.jpg

LM Start	1.69	Rating **	U	Issue No.	978
LM End	1.69	Issue Type +	Ma	Location *	
Category	Supplemental			GPS Latitude/Longitude	
				Start	End
Item	DWR UCIP LMA Responsibility			37.585938 °	37.585938 °
				-121.163348 °	-121.163348 °
DWR ID	20563

DS_ID:20563
FS_ID:53817
EP_NO: N/A
Repair Type: Urgent
EVAL Issue: Pipe Integrity
Crossing Status: Found
UCIP Comments: 03/12/2019 A thorough internal evaluation of this crossing is required, pipe shows evidence of pipe integrity (LS) issues (pipe wall sections missing on WS outlet). Internal inspection is recommended for this crossing to determine the extent of pipe damage through the levee. Maintenance issues identified at this crossing include: flap gate missing on WS, debris found inside concrete distribution box, and missing cover on riser. No permit has been identified for this crossing. Need to determine who maintains crossing; crossing appears functional. (O. Magana - DWR UCIP)
FIELD_STRUCT_DESC: 24-inch corrugated metal drainage pipe through the levee, 14 feet below the crown. Slide gate in a corrugated metal pipe (CMP) riser on the waterside (WS) slope. Concrete U-shaped headwall at the landside (LS) toe. [Additional Reference(s): DWR Levee Log, 2005. USACE San Joaquin O&M Manual 5, August 1961, (HLM 1.71)].

Overview of levee crown looking d/s towards pipe crossing.

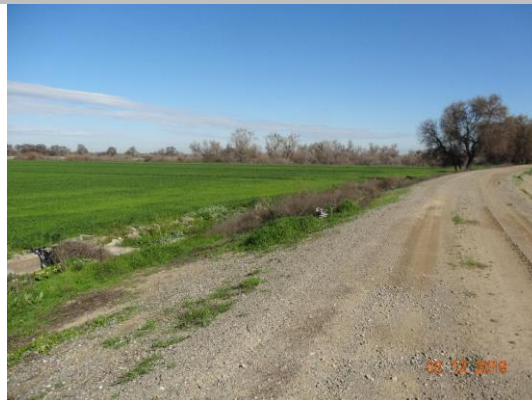
Photo 2 of 3 : UCIP_FA_2020_53817_79087.jpg

WS view: overview of WS.

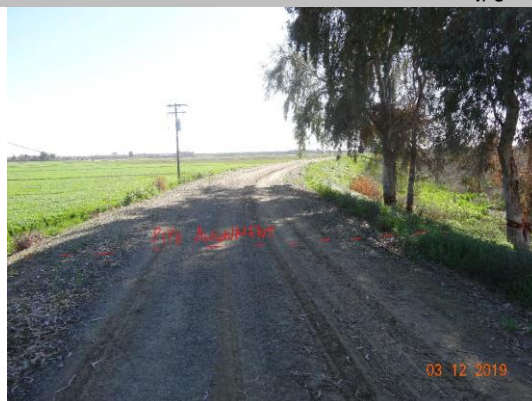
Photo 1 of 3 : UCIP_FA_2020_53814_79091.jpg

LM Start	2.07	Rating **	M	Issue No.	979
LM End	2.07	Issue Type +	Ma	Location *	
Category	Supplemental			GPS Latitude/Longitude	
				Start	End
Item	DWR UCIP LMA Responsibility			37.584212 °	37.584212 °
				-121.158347 °	-121.158347 °
DWR ID	20564

Comment Code					
Inspector Comment					
DS_ID:20564 FS_ID:53814 EP_NO: N/A Repair Type: Non-Urgent EVAL Issue: Unauthorized Encroachment, installed decades prior Crossing Status: Found UCIP Comments: 03/12/2019 Concrete headwall found on LS toe. Pipe appears to have been grouted through. No other appurtenances were found during inspection. WS outlet was not found. Need to coordinate with the CVFPB to determine if additional steps are needed to comply with Title 23. (O. Magana - DWR UCIP) FIELD_STRUCT_DESC: *ABANDONED* 30-inch corrugated metal drainage pipe through the levee, 15 feet below the crown. Flap gate on the waterside (WS) end. Concrete U-shaped headwalls on both ends. Filled with concrete on the landside (LS) toe. [Additional Reference(s): DWR Levee Log, 2005. USACE San Joaquin O&M Manual 5, August 1961, (HLM 2.10), 36-inch pipe listed]. FS Date: 3/12/2019 12:08:00 PM

Overview of levee crown, looking u/s from d/s, and approximate pipe alignment.

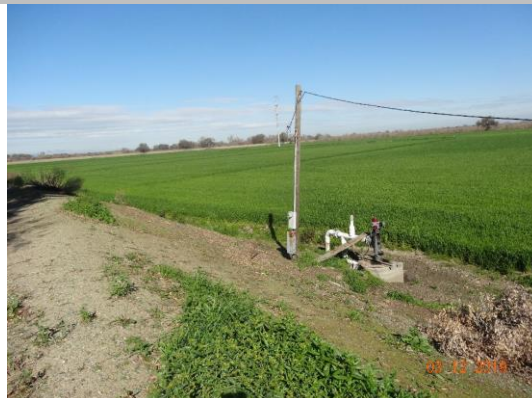
Photo 3 of 3 : UCIP_FA_2020_53814_79093.jpg

LS view: concrete riser, power pole, and groundwater pump station.

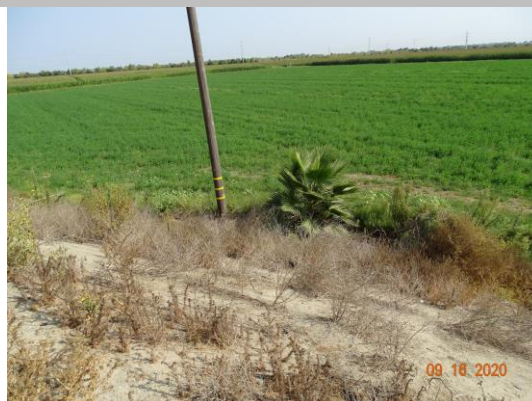
Photo 1 of 1 : FA_2020_RD2092_116_43_20200918_00077.jpg

LM Start	2.23	Rating **	M	Issue No.	43
LM End	2.23	Issue Type +	Ma	Location *	LS
Category	Earthen Levee			GPS Latitude/Longitude	
				Start	End
Item	Trim / Thin Trees			37.582717 °	37.582717 °
				-121.155980 °	-121.155980 °
DWR ID	DWR_RD2092_01_f_2020_43				
Comment Code					
T2 : Thin trees to allow visibility of the ground and room to flood fight.					
Inspector Comment					
Palm tree in landside toe should be removed before it can establish.

View of small palm tree growing on the landside toe. (Fall 2020)

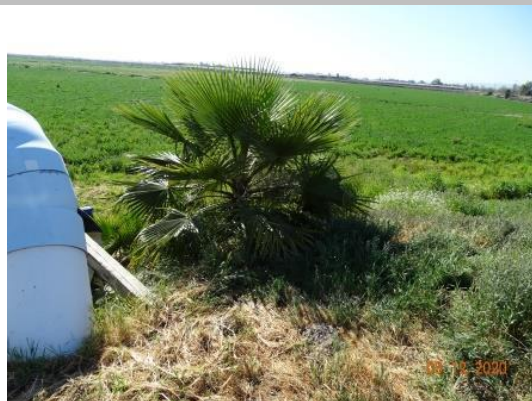
Photo 1 of 1 : FA_2020_RD2092_116_58_20200901_00029.jpg

LM Start	2.34	Rating **	M	Issue No.	58
LM End	2.34	Issue Type +	Ma	Location *	LS
Category	Earthen Levee			GPS Latitude/Longitude	
				Start	End
Item	Trim / Thin Trees			37.581166 °	37.581166 °
				-121.156156 °	-121.156156 °
DWR ID	DWR_RD2092_01_s_2020_58				
Comment Code					
T2 : Thin trees to allow visibility of the ground and room to flood fight.					
Inspector Comment					
Palm tree should be removed from the landside slope.

View of palm tree growing on the landside slope. (Spring 2020)

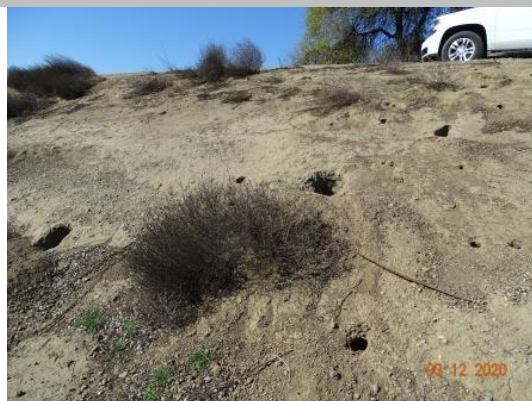
Photo 1 of 2 : FA_2020_RD2092_116_44_20200901_00018.jpg

LM Start	2.59	Rating **	U	Issue No.	44
LM End	2.63	Issue Type +	Ma	Location *	LS
Category	Earthen Levee			GPS Latitude/Longitude	
				Start	End
Item	Animal Control			37.577789 °	37.577159 °
				-121.157090 °	-121.157150 °
DWR ID	DWR_RD2092_01_f_2018_44				
Comment Code					
A1 : Exterminate rodents and backfill and compact or grout burrows.					
Inspector Comment					
There are several burrows along the landside slope that need to be backfilled.

View of rodent burrows in landside slope. (Spring 2020)

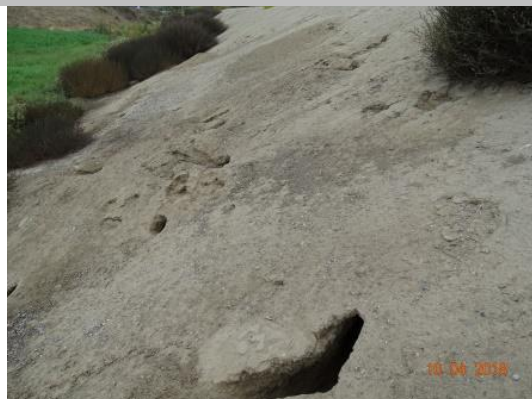
Photo 2 of 2 : FA_2020_RD2092_116_44_20200901_00019.jpg

View of animal burrows looking upstream. (Fall 2018)

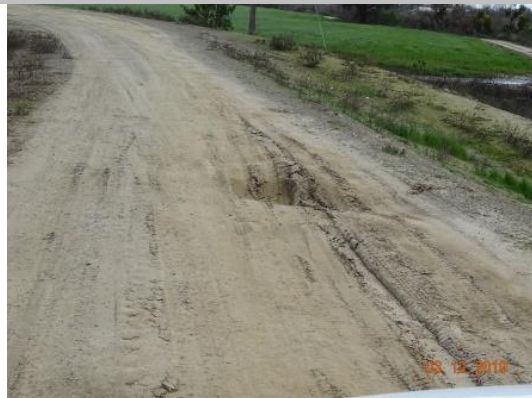
Photo 1 of 1 : FA_2020_RD2092_116_45_20200901_00021.jpg

LM Start	2.74	Rating **	M	Issue No.	45
LM End	2.74	Issue Type +	Ma	Location *	CR
Category	Earthen Levee			GPS Latitude/Longitude	
				Start	End
Item	Crown Surface / Depressions / Rutting			37.575514 °	37.575514 °
				-121.157140 °	-121.157140 °
DWR ID	DWR_RD2092_01_s_2019_45				
Comment Code					
C2 : Repair depressions or ruts in the crown or slope.					
Inspector Comment					
Depression and rutting in levee crown should be repaired.

View of depression in levee crown. (Spring 2019)

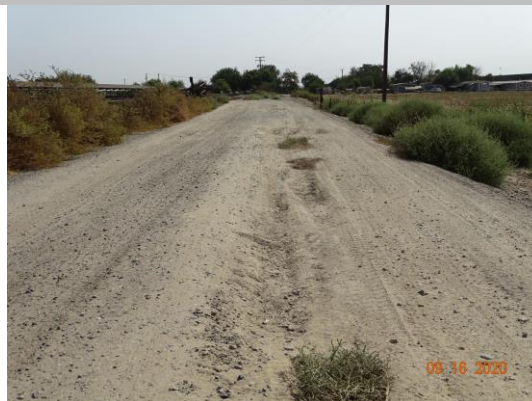
Photo 1 of 1 : FA_2020_RD2092_116_60_20200918_00079.jpg

LM Start	2.83	Rating **	M	Issue No.	60
LM End	2.94	Issue Type +	Ma	Location *	CR
Category	Earthen Levee			GPS Latitude/Longitude	
				Start	End
Item	Crown Surface / Depressions / Rutting			37.574810 °	37.574425 °
				-121.155947 °	-121.154046 °
DWR ID	DWR_RD2092_01_s_2020_60				
Comment Code					
C2 : Repair depressions or ruts in the crown or slope.					
Inspector Comment					
Potholes and rutting in the levee crown should be repaired.

View of rutting on the levee crown looking downstream. (Fall 2020)
