**Flood Control Project Maintenance  
Levee Inspections**

**Maintenance Issue Types Only, Levee Inspection Report By Mile - Fall 2021**

**Reclamation District No. 2092 Dos Rios**

Waterway	Bank	Unit Miles	Inspection Start/End	Inspector
Unit No. 01 San Joaquin River	Right	3.71	09/08/2021 09/08/2021	Corey Fujitani

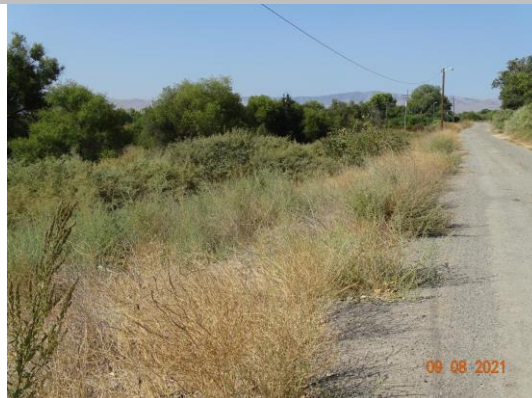
Photo 1 of 1 : FA\_2021\_RD2092\_116\_29\_20210909\_00061.jpg

LM Start	0.09	Rating **	M	Issue No.	29
LM End	0.15	Issue Type +	Ma	Location *	LS
Category	Earthen Levee			GPS Latitude/Longitude	
				Start	End
Item	Vegetation			37.602450 °	37.602184 °
				-121.159760 °	-121.160792 °
DWR ID	DWR_RD2092_01_f_2021_29				
Comment Code					
V1 : Control annual grass and weeds on the levee slopes and easements.					
Inspector Comment

Looking upstream along the landside slope and shoulder. (Fall 2021)

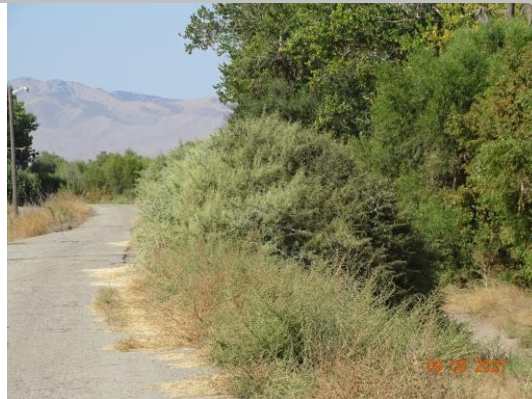
Photo 1 of 1 : FA\_2021\_RD2092\_116\_32\_20210909\_00062.jpg

LM Start	0.13	Rating **	U	Issue No.	32
LM End	0.13	Issue Type +	Ma	Location *	WS
Category	Earthen Levee			GPS Latitude/Longitude	
				Start	End
Item	Vegetation			37.602322 °	37.602322 °
				-121.160378 °	-121.160378 °
DWR ID	DWR_RD2092_01_f_2021_32				
Comment Code					
V2 : Remove the wild growth other than native grasses from the levee slopes.					
Inspector Comment

View of a large shrub growing on the waterside slope and shoulder. (Fall 2021)

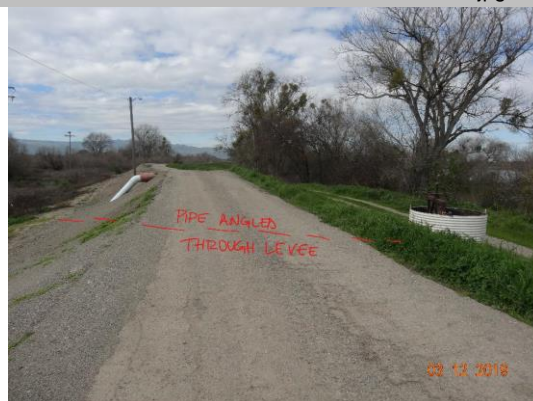
Photo 1 of 3 : UCIP\_FA\_2021\_53799\_79055.jpg

LM Start	0.18	Rating **	U	Issue No.	973	
LM End	0.18	Issue Type +	Ma	Location *		
Category	Supplemental			GPS Latitude/Longitude		
				Start	End	
Item	DWR UCIP LMA Responsibility			37.602031 °	37.602031 °	
				-121.161249 °	-121.161249 °	
DWR ID	20561

Comment Code						
Inspector Comment						
DS_ID:20561 FS_ID:53799 EP_NO: N/A Repair Type: Urgent EVAL Issue: Pipe Integrity Crossing Status: Found UCIP Comments: 03/12/2019 A thorough internal evaluation of this crossing is necessary. Pipe shows evidence of pipe integrity (LS) issues (pipe wall sections missing on LS inlet) and levee integrity issues (sink hole visible along LS pipe alignment). Internal inspection is recommended for this crossing to determine the extent of pipe damage through the levee. Pipe crosses the levee at an angle at a depth of about 19 feet. Recommend caution be taken at this crossing when driving over levee until additional information becomes available to determine condition of pipe through levee. Recommend cover be placed on riser to address safety concern (riser is 80 inches in diameter and about 19 feet deep). Slide gate appears to be blocked by sediment/debris preventing slide gate to work properly. Unable to confirm if the flap gate located on the WS is still broken (see photo from 2017). (O. Magana - DWR UCIP)09/24/2013 Pipe rusted through at headwall on LS toe. Good candidate for video inspection. (W. Wylie - DWR UCIP) FIELD_STRUCT_DESC: 60-inch corrugated metal drainage pipe through the levee, 19 feet below the crown. Flap gate on the waterside (WS) end. Slide gate in an 80-inch corrugated metal pipe (CMP) riser on the WS slope. Concrete U-shaped headwalls on both ends. [Additional Reference(s): DWR Levee Log, 2005. USACE San Joaquin O&M Manual 5, August 1961, (HLM 0.18)]. FS Date: 3/12/2019 12:05:00 PM

Overview of levee with approximate pipe alignment (pipe angled through levee).

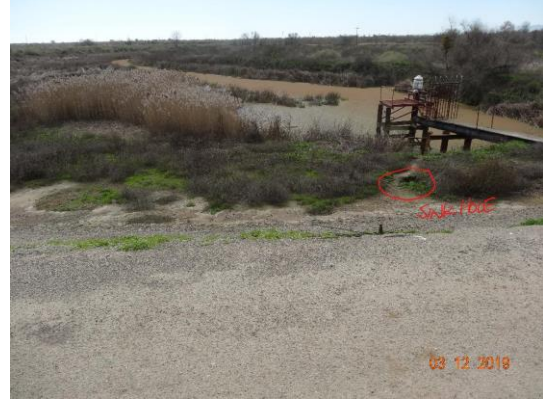
Photo 2 of 3 : UCIP\_FA\_2021\_53799\_79054.jpg

LS view: overview of LS with sink hole visible along pipe alignment.

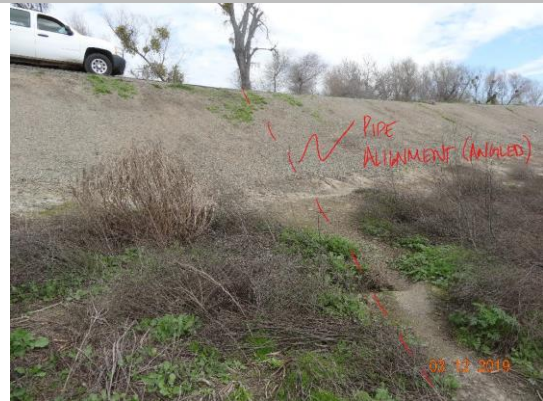
Photo 3 of 3 : UCIP\_FA\_2021\_53799\_79058.jpg

LS view: pipe crosses levee at angle, approximate alignment on LS.

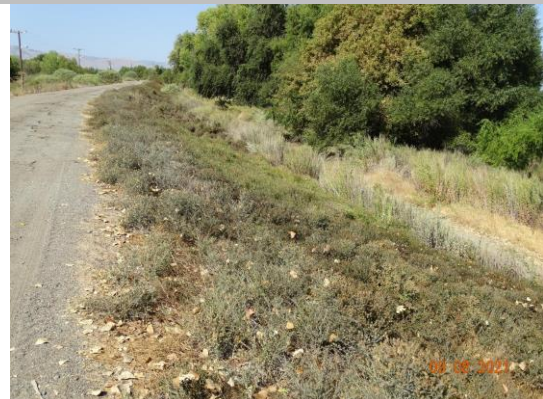
Photo 1 of 1 : FA\_2021\_RD2092\_116\_33\_20210909\_00063.jpg

LM Start	0.28	Rating **	M	Issue No.	33
LM End	2.75	Issue Type +	Ma	Location *	WS
Category	Earthen Levee			GPS Latitude/Longitude	
				Start	End
Item	Vegetation			37.601589 °	37.575440 °
				-121.163037 °	-121.157137 °
DWR ID	DWR_RD2092_01_f_2021_33				
Comment Code					
V1 : Control annual grass and weeds on the levee slopes and easements.					
Inspector Comment

View of the waterside slope looking upstream. (Fall 2021)

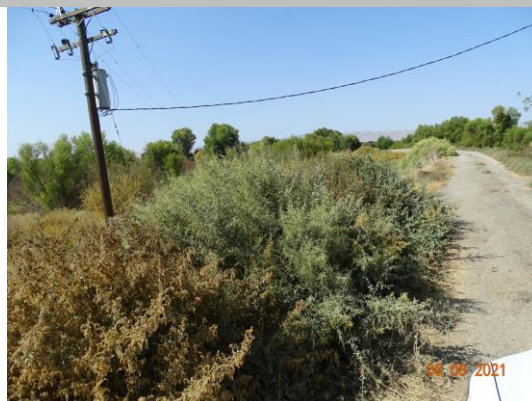
Photo 1 of 1 : FA\_2021\_RD2092\_116\_35\_20210909\_00064.jpg

LM Start	0.42	Rating **	U	Issue No.	35
LM End	0.85	Issue Type +	Ma	Location *	LS
Category	Earthen Levee			GPS Latitude/Longitude	
				Start	End
Item	Vegetation			37.601191 °	37.595959 °
				-121.165544 °	-121.168261 °
DWR ID	DWR_RD2092_01_f_2021_35				
Comment Code					
V1 : Control annual grass and weeds on the levee slopes and easements.					
Inspector Comment

Looking upstream along the landside slope. (Fall 2021)

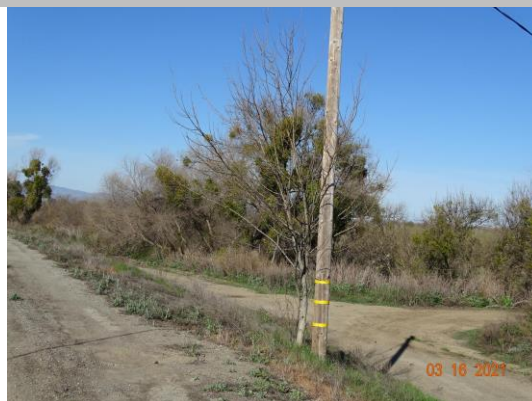
Photo 1 of 1 : FA\_2021\_RD2092\_116\_31\_20210830\_00007.jpg

LM Start	0.44	Rating **	M	Issue No.	31
LM End	0.44	Issue Type +	Ma	Location *	WS
Category	Earthen Levee			GPS Latitude/Longitude	
				Start	End
Item	Trim / Thin Trees			37.601149 °	37.601149 °
				-121.165772 °	-121.165772 °
DWR ID	DWR_RD2092_01_s_2018_31				
Comment Code					
T2 : Thin trees to allow visibility of the ground and room to flood fight.					
Inspector Comment					
Remove small tree on waterward shoulder before tree is established.

View of small tree growing on waterside shoulder. (Spring 2021)

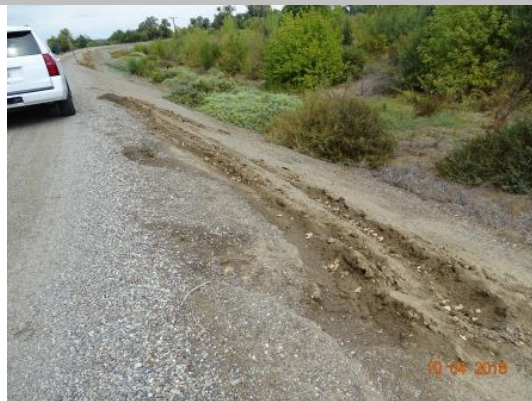
Photo 1 of 1 : FA\_2021\_RD2092\_116\_40\_20210830\_00009.jpg

LM Start	0.59	Rating **	M	Issue No.	40
LM End	0.59	Issue Type +	Ma	Location *	LS
Category	Earthen Levee			GPS Latitude/Longitude	
				Start	End
Item	Slope Stability			37.599406 °	37.599406 °
				-121.167083 °	-121.167083 °
DWR ID	DWR_RD2092_01_f_2018_40				
Comment Code					
S3 : Repair the levee slope damaged by vehicle traffic and prevent access where possible.					
Inspector Comment					
Vehicle tracks on the landside slope should be repaired.

Vehicle tracks on landside slope approximately 6" deep perpendicular to the slope. (Fall 2018)

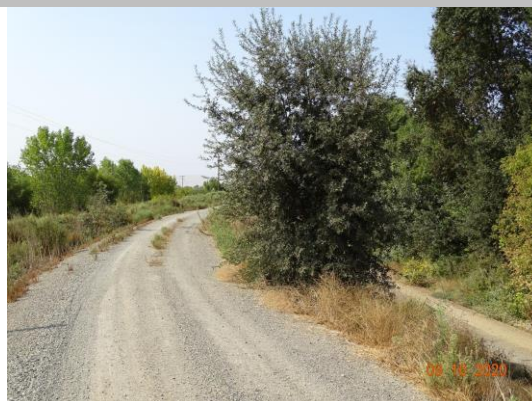
Photo 1 of 1 : FA\_2021\_RD2092\_116\_21\_20210830\_00005.jpg

LM Start	0.61	Rating **	M	Issue No.	21
LM End	0.61	Issue Type +	Ma	Location *	WS
Category	Earthen Levee			GPS Latitude/Longitude	
				Start	End
Item	Trim / Thin Trees			37.599208 °	37.599208 °
				-121.167150 °	-121.167150 °
DWR ID	DWR_RD2092_01_s_2021_21				
Comment Code					
T2 : Thin trees to allow visibility of the ground and room to flood fight.					
Inspector Comment					
Remove small tree on waterward shoulder before tree is established.

Looking upstream at a tree growing in the waterside shoulder. (Fall 2020)

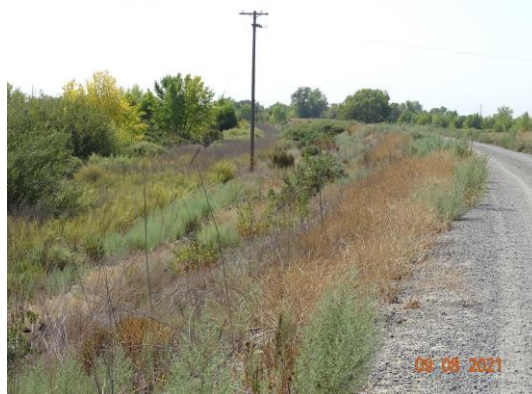
Photo 1 of 1 : FA\_2021\_RD2092\_116\_36\_20210909\_00065.jpg

LM Start	0.85	Rating **	M	Issue No.	36
LM End	2.73	Issue Type +	Ma	Location *	LS
Category	Earthen Levee			GPS Latitude/Longitude	
				Start	End
Item	Vegetation			37.595956 °	37.575708 °
				-121.168260 °	-121.157241 °
DWR ID	DWR_RD2092_01_f_2021_36				
Comment Code					
V1 : Control annual grass and weeds on the levee slopes and easements.					
Inspector Comment

View of vegetation growing on the landside slope. (Fall 2021)

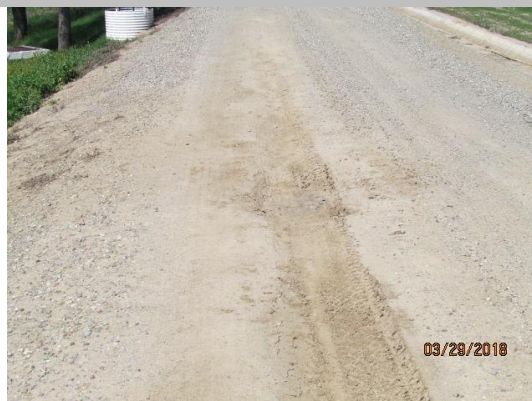
Photo 1 of 1 : FA\_2021\_RD2092\_116\_39\_20210830\_00008.jpg

Looking upstream at rutting and depression on levee crown. (Spring 2018)

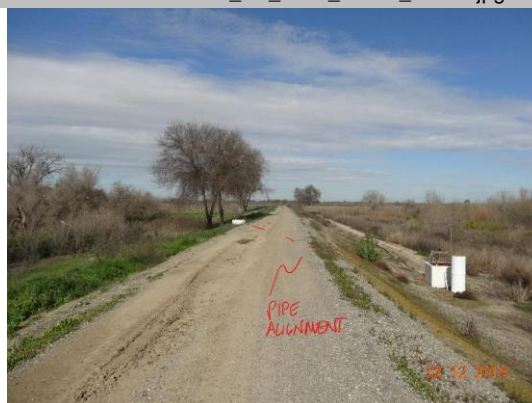
Photo 1 of 3 : UCIP\_FA\_2021\_53820\_79073.jpg

LM Start	1.30	Rating **	M	Issue No.	977	
LM End	1.30	Issue Type +	Ma	Location *		
Category	Supplemental			GPS Latitude/Longitude		
				Start		End
Item	DWR UCIP LMA Responsibility			37.590603 °	37.590603 °	
				-121.164111 °	-121.164111 °	
DWR ID	20562

Comment Code						
Inspector Comment						
DS_ID:20562 FS_ID:53820 EP_NO: N/A Repair Type: Non-Urgent EVAL Issue: Maintenance Compliance Issue Crossing Status: Found UCIP Comments: 03/12/2019 During UCIP visual inspection, no pipe or levee integrity issues were observed. Distribution box located on the WS is falling apart (bricks missing). This crossing is an active crossing however, no permit has been found authorizing crossing. Need to determine who maintains and operates this crossing. (O. Magana - DWR UCIP) FIELD_STRUCT_DESC: 36-inch corrugated metal drainage pipe through the levee, 15 feet below the crown. Slide gate in a 48-inch corrugated metal pipe (CMP) riser on the waterside (WS) slope. 4-foot by 6-foot concrete distribution box on the landside (LS) toe. 5-foot by 5-foot concrete riser on the WS toe. [Additional Reference(s): DWR Levee Log, 2005. USACE San Joaquin O&M Manual 5, August 1961, (HLM 1.31)]. FS Date: 3/12/2019 12:06:00 PM

Overview of pipe alignment through levee, photo taking looking d/s toward crossing.

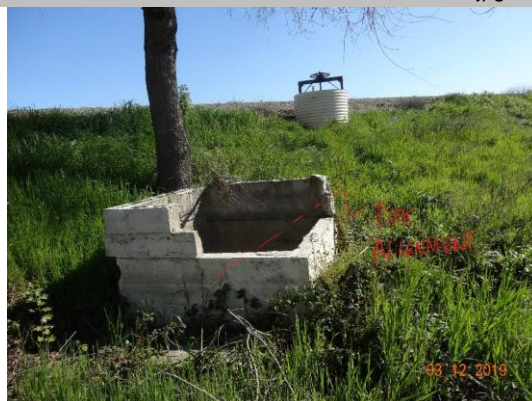
Photo 2 of 3 : UCIP\_FA\_2021\_53820\_79078.jpg

WS view: approximate alignment on WS.

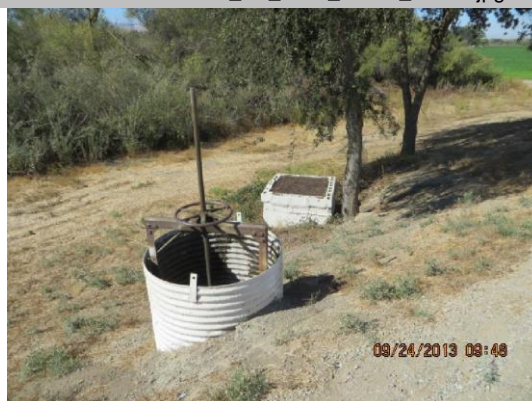
Photo 3 of 3 : UCIP\_FA\_2021\_53820\_35213.jpg

Slide gate in 48-inch CMP riser on WS slope.

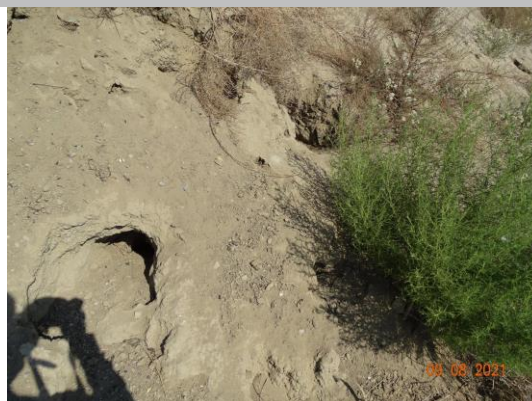
Photo 1 of 1 : FA\_2021\_RD2092\_116\_57\_20210909\_00066.jpg

View of multiple large rodent burrows in the landside slope. (Fall 2021)

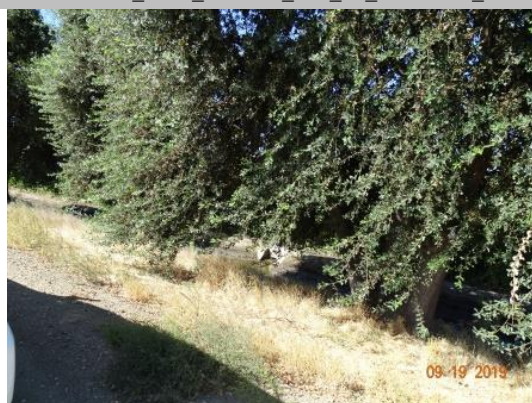
Photo 1 of 1 : FA\_2021\_RD2092\_116\_48\_20210830\_00013.jpg

LM Start	1.60	Rating **	M	Issue No.	48
LM End	1.62	Issue Type +	Ma	Location *	WS
Category	Earthen Levee			GPS Latitude/Longitude	
				Start	End
Item	Trim / Thin Trees			37.587068 °	37.586794 °
				-121.162773 °	-121.162950 °
DWR ID	DWR_RD2092_01_f_2019_48				
Comment Code					
T1 : Trim trees to at least five feet above ground level.					
Inspector Comment

View of branches hanging over waterside slope. (Fall 2019)

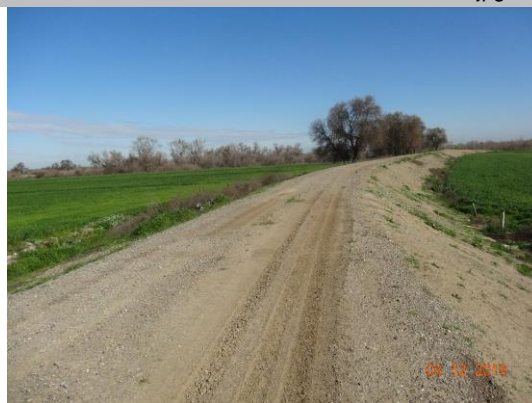
Photo 1 of 3 : UCIP\_FA\_2021\_53817\_79086.jpg

Comment Code						
Inspector Comment						
DS_ID:20563 FS_ID:53817 EP_NO: N/A Repair Type: Urgent EVAL Issue: Pipe Integrity Crossing Status: Found UCIP Comments: 03/12/2019 A thorough internal evaluation of this crossing is required, pipe shows evidence of pipe integrity (LS) issues (pipe wall sections missing on WS outlet). Internal inspection is recommended for this crossing to determine the extent of pipe damage through the levee. Maintenance issues identified at this crossing include: flap gate missing on WS, debris found inside concrete distribution box, and missing cover on riser. No permit has been identified for this crossing. Need to determine who maintains crossing; crossing appears functional. (O. Magana - DWR UCIP) FIELD_STRUCT_DESC: 24-inch corrugated metal drainage pipe through the levee, 14 feet below the crown. Slide gate in a corrugated metal pipe (CMP) riser on the waterside (WS) slope. Concrete U-shaped headwall at the landside (LS) toe. [Additional Reference(s): DWR Levee Log, 2005. USACE San Joaquin O&M Manual 5, August 1961, (HLM 1.71)]. FS Date: 3/12/2019 12:07:00 PM

Overview of levee crown looking d/s towards pipe crossing.

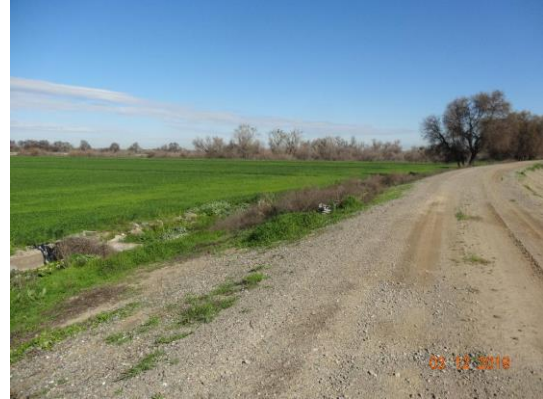
Photo 2 of 3 : UCIP\_FA\_2021\_53817\_79087.jpg

WS view: overview of WS.

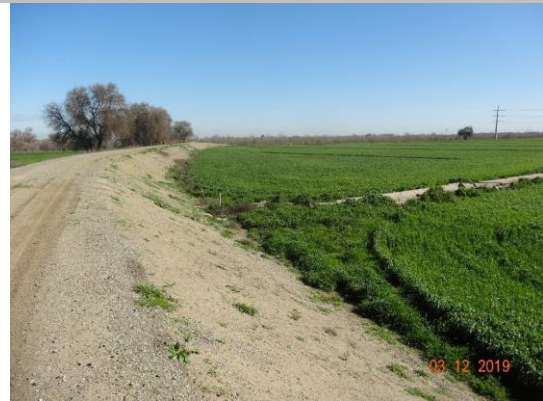
Photo 3 of 3 : UCIP\_FA\_2021\_53817\_79085.jpg

LS view: overview of LS.

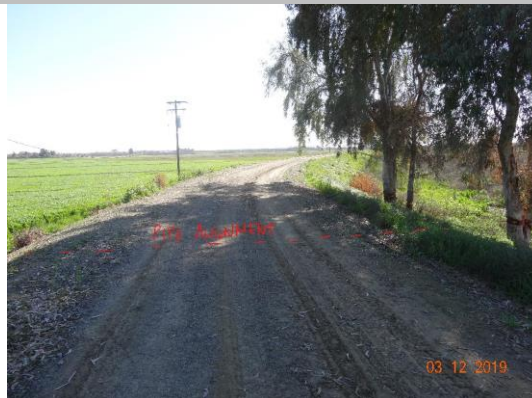
Photo 1 of 3 : UCIP\_FA\_2021\_53814\_79091.jpg

Comment Code					
Inspector Comment					
DS_ID:20564 FS_ID:53814 EP_NO: N/A Repair Type: Non-Urgent EVAL Issue: Unauthorized Encroachment, installed decades prior Crossing Status: Found UCIP Comments: 03/12/2019 Concrete headwall found on LS toe. Pipe appears to have been grouted through. No other appurtenances were found during inspection. WS outlet was not found. Need to coordinate with the CVFPB to determine if additional steps are needed to comply with Title 23. (O. Magana - DWR UCIP) FIELD_STRUCT_DESC: *ABANDONED* 30-inch corrugated metal drainage pipe through the levee, 15 feet below the crown. Flap gate on the waterside (WS) end. Concrete U-shaped headwalls on both ends. Filled with concrete on the landside (LS) toe. [Additional Reference(s): DWR Levee Log, 2005. USACE San Joaquin O&M Manual 5, August 1961, (HLM 2.10), 36-inch pipe listed]. FS Date: 3/12/2019 12:08:00 PM

Overview of levee crown, looking u/s from d/s, and approximate pipe alignment.

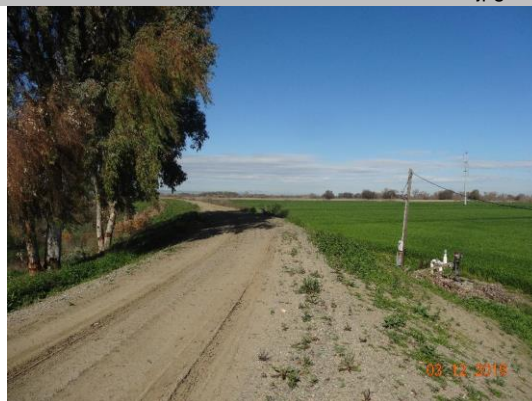
Photo 2 of 3 : UCIP\_FA\_2021\_53814\_79092.jpg

Overview of levee at crossing, photo taken u/s looking d/s towards pipe crossing.

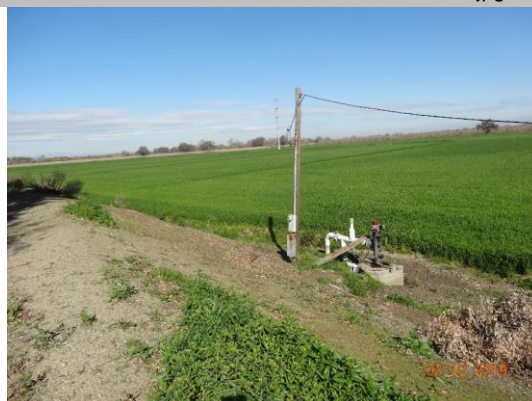
Photo 3 of 3 : UCIP\_FA\_2021\_53814\_79093.jpg

LS view: concrete riser, power pole, and groundwater pump station.

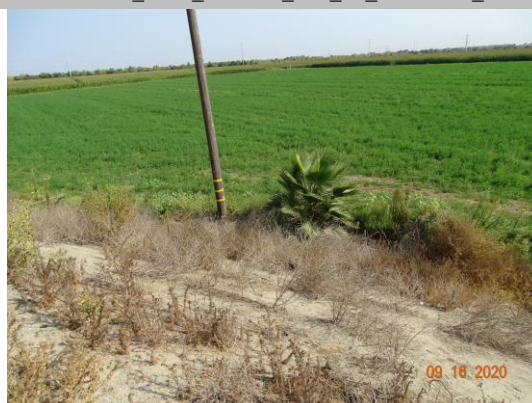
Photo 1 of 1 : FA\_2021\_RD2092\_116\_43\_20210830\_00010.jpg

LM Start	2.23	Rating **	M	Issue No.	43
LM End	2.23	Issue Type +	Ma	Location *	LS
Category	Earthen Levee			GPS Latitude/Longitude	
				Start	End
Item	Trim / Thin Trees			37.582717 °	37.582717 °
				-121.155980 °	-121.155980 °
DWR ID	DWR_RD2092_01_f_2020_43				
Comment Code					
T2 : Thin trees to allow visibility of the ground and room to flood fight.					
Inspector Comment					
Palm tree in landside toe should be removed before it can establish.

View of small palm tree growing on the landside toe. (Fall 2020)

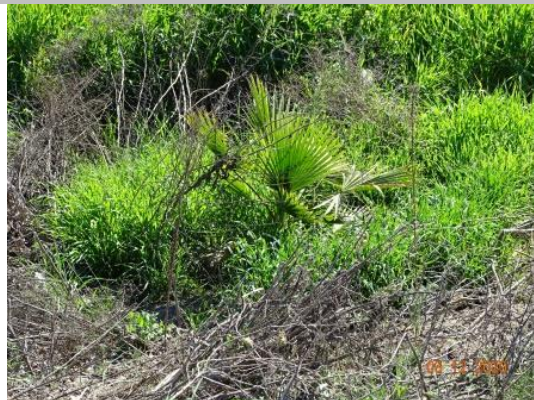
Photo 1 of 1 : FA\_2021\_RD2092\_116\_59\_20210830\_00019.jpg

Upclose view of palm tree growing at the levee toe. (Spring 2020)

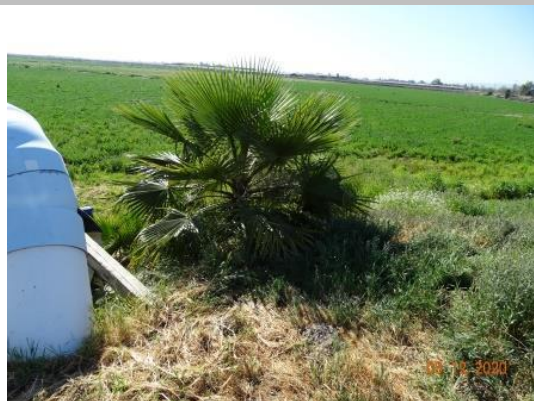
Photo 1 of 1 : FA\_2021\_RD2092\_116\_58\_20210830\_00018.jpg

LM Start	2.34	Rating **	M	Issue No.	58
LM End	2.34	Issue Type +	Ma	Location *	LS
Category	Earthen Levee			GPS Latitude/Longitude	
				Start	End
Item	Trim / Thin Trees			37.581166 °	37.581166 °
				-121.156156 °	-121.156156 °
DWR ID	DWR_RD2092_01_s_2020_58				
Comment Code					
T2 : Thin trees to allow visibility of the ground and room to flood fight.					
Inspector Comment					
Palm tree should be removed from the landside slope.

View of palm tree growing on the landside slope. (Spring 2020)

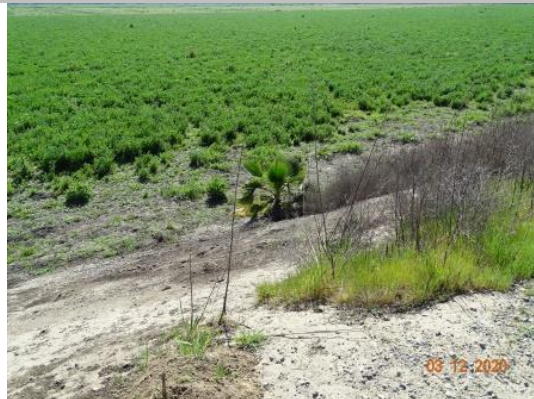
Photo 1 of 1 : FA\_2021\_RD2092\_116\_50\_20210830\_00015.jpg

LM Start	2.44	Rating **	M	Issue No.	50
LM End	2.44	Issue Type +	Ma	Location *	LS
Category	Earthen Levee			GPS Latitude/Longitude	
				Start	End
Item	Trim / Thin Trees			37.579945 °	37.579945 °
				-121.156995 °	-121.156995 °
DWR ID	DWR_RD2092_01_f_2019_50				
Comment Code					
T2 : Thin trees to allow visibility of the ground and room to flood fight.					
Inspector Comment					
Palm tree should be removed from landside slope before it can establish.

View of palm tree in the landside slope. (Spring 2020)

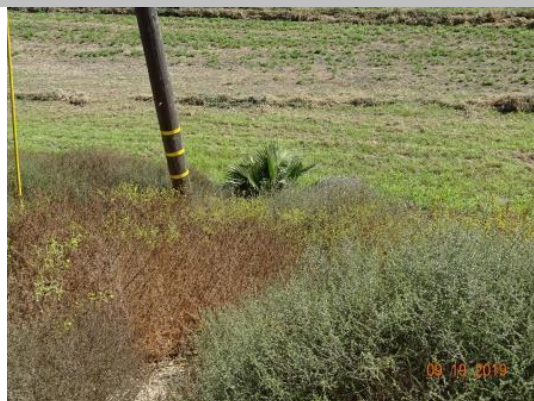
Photo 1 of 1 : FA\_2021\_RD2092\_116\_51\_20210830\_00016.jpg

View of palm tree growing in landside toe. (Fall 2019)

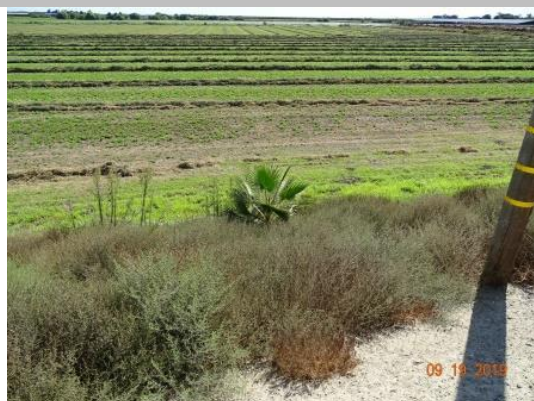
Photo 1 of 1 : FA\_2021\_RD2092\_116\_19\_20210830\_00003.jpg

LM Start	2.55	Rating **	M	Issue No.	19
LM End	2.55	Issue Type +	Ma	Location *	LS
Category	Earthen Levee			GPS Latitude/Longitude	
				Start	End
Item	Trim / Thin Trees			37.578333 °	37.578333 °
				-121.157011 °	-121.157011 °
DWR ID	DWR_RD2092_01_s_2018_19				
Comment Code					
T2 : Thin trees to allow visibility of the ground and room to flood fight.					
Inspector Comment					
Palm trees at landward slope and toe should be removed.

View of palm tree growing on landside slope. (Fall 2019)

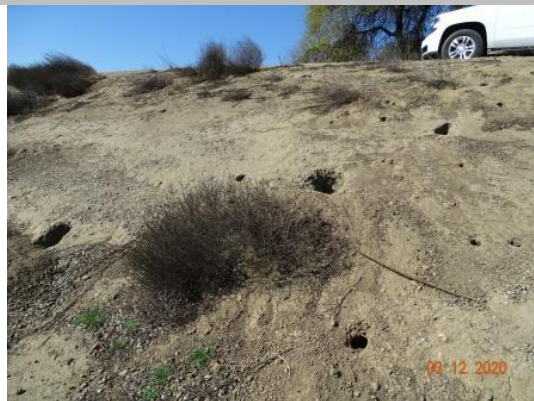
Photo 1 of 1 : FA\_2021\_RD2092\_116\_44\_20210830\_00011.jpg

LM Start	2.59	Rating **	U	Issue No.	44
LM End	2.63	Issue Type +	Ma	Location *	LS
Category	Earthen Levee			GPS Latitude/Longitude	
				Start	End
Item	Animal Control			37.577789 °	37.577159 °
				-121.157090 °	-121.157150 °
DWR ID	DWR_RD2092_01_f_2018_44				
Comment Code					
A1 : Exterminate rodents and backfill and compact or grout burrows.					
Inspector Comment					
There are several burrows along the landside slope that need to be backfilled.

View of rodent burrows in landside slope. (Spring 2020)

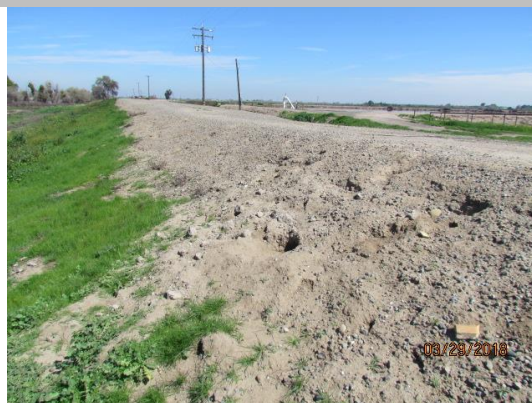
Photo 1 of 1 : FA\_2021\_RD2092\_116\_17\_20210830\_00002.jpg

Looking upstream on waterward slope at several large rodent holes.  
(Spring 2018)

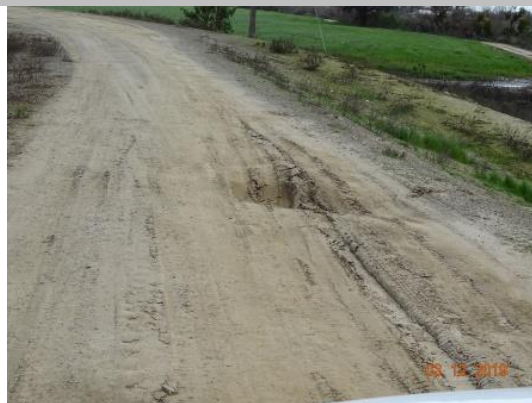
Photo 1 of 1 : FA\_2021\_RD2092\_116\_45\_20210830\_00012.jpg

LM Start	2.74	Rating **	M	Issue No.	45
LM End	2.74	Issue Type +	Ma	Location *	CR
Category	Earthen Levee			GPS Latitude/Longitude	
				Start	End
Item	Crown Surface / Depressions / Rutting			37.575514 °	37.575514 °
				-121.157140 °	-121.157140 °
DWR ID	DWR_RD2092_01_s_2019_45				
Comment Code					
C2 : Repair depressions or ruts in the crown or slope.					
Inspector Comment					
Depression and rutting in levee crown should be repaired.

View of depression in levee crown. (Spring 2019)

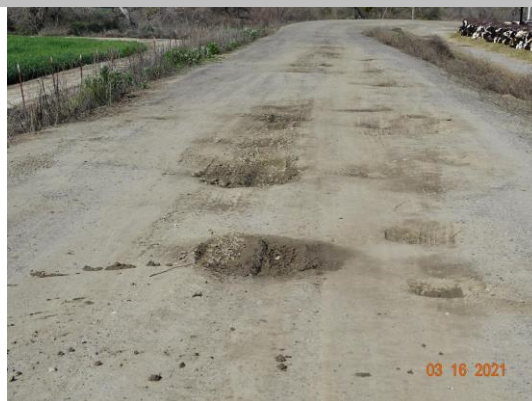
Photo 1 of 1 : FA\_2021\_RD2092\_116\_60\_20210830\_00020.jpg

LM Start	2.83	Rating **	U	Issue No.	60
LM End	2.94	Issue Type +	Ma	Location *	CR
Category	Earthen Levee			GPS Latitude/Longitude	
				Start	End
Item	Crown Surface / Depressions / Rutting			37.574810 °	37.574425 °
				-121.155947 °	-121.154046 °
DWR ID	DWR_RD2092_01_s_2020_60				
Comment Code					
C2 : Repair depressions or ruts in the crown or slope.					
Inspector Comment					
Potholes and rutting in the levee crown should be repaired.

View of rutting and potholes on levee crown looking downstream. (Spring 2021)

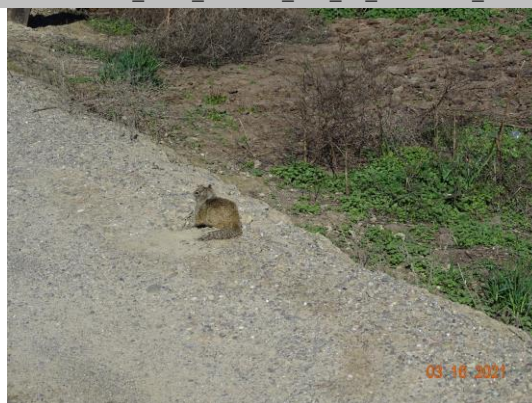
Photo 1 of 1 : FA\_2021\_RD2092\_116\_52\_20210830\_00017.jpg

LM Start	2.94	Rating **	A/W	Issue No.	52
LM End	2.94	Issue Type +	Ma	Location *	LS
Category	Earthen Levee			GPS Latitude/Longitude	
				Start	End
Item	Animal Control			37.574455 °	37.574455 °
				-121.154069 °	-121.154069 °
DWR ID	DWR_RD2092_01_s_2021_52				
Comment Code					
A1 : Exterminate rodents and backfill and compact or grout burrows.					
Inspector Comment					
Single rodent and burrow observed on landside shoulder.

View of single burrow and rodent observed on landside shoulder. (Spring 2021)

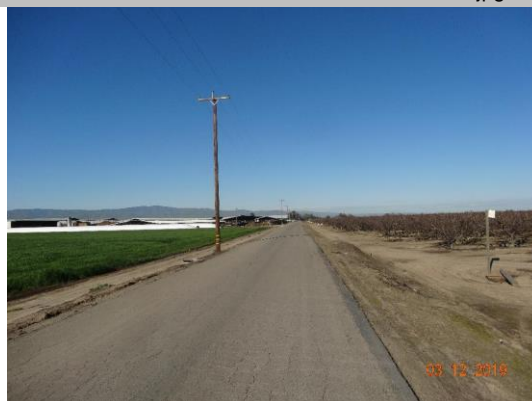
Photo 1 of 3 : UCIP\_FA\_2021\_53786\_79145.jpg

Comment Code						
Inspector Comment						
DS_ID:20572 FS_ID:53786 EP_NO: N/A Repair Type: Non-Urgent EVAL Issue: Safety Issue Crossing Status: Found UCIP Comments: 03/12/2019 No permit was found authorizing crossing. Unable to confirm if crossing is in use. Recommend adding cover to riser to address safety concern. No slide gate was found in CMP riser. If crossing is no longer in use, recommend proper abandonment or removal from levee. Owner will need to coordinate with CVFPB to be compliant with Title 23. (O. Magana - DWR UCIP) 09/24/2013 This pipe appears abandoned and if so, should be done so properly. (W. Wylie - DWR UCIP) FIELD_STRUCT_DESC: *ABANDONED* 36-inch corrugated metal drainage pipe through the levee, 11 feet below the crown. Slide gate in a corrugated metal pipe (CMP) riser on the waterside (WS) slope. Concrete headwalls on both ends. [Additional Reference(s): DWR Levee Log, 2005. USACE San Joaquin O&M Manual 5, August 1961, (HLM 3.52)]. FS Date: 3/12/2019 12:11:53 PM

Overview of levee crown looking d/s towards crossing.

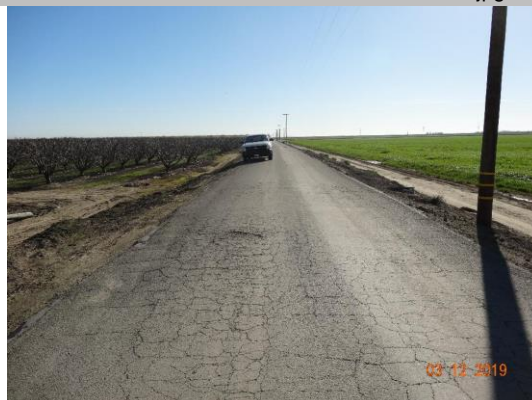
Photo 2 of 3 : UCIP\_FA\_2021\_53786\_79150.jpg

Overview of levee crown looking u/S towards crossing.

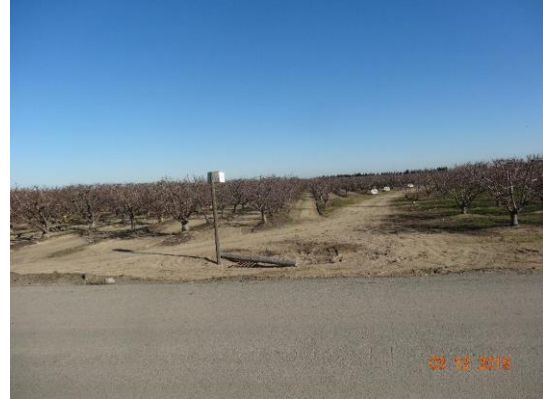
Photo 3 of 3 : UCIP\_FA\_2021\_53786\_79144.jpg

LS view: overview of land use on LS.
