**Flood Control Project Maintenance  
Levee Inspections**

**Maintenance Issue Types Only, Levee Inspection Report By Mile - Fall 2022**

**Reclamation District No. 2092 Dos Rios**

Waterway	Bank	Unit Miles	Inspection Start/End	Inspector
Unit No. 01 San Joaquin River	Right	3.71	09/07/2022 09/07/2022	Corey Fujitani

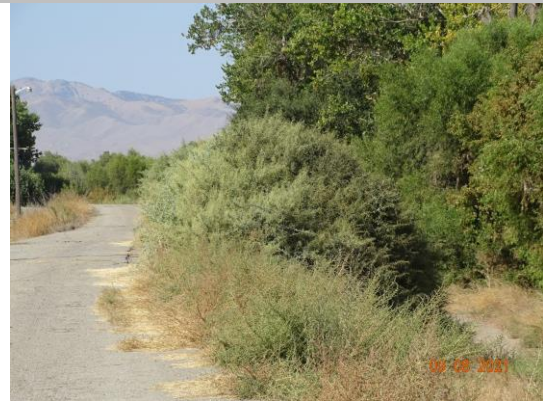
Photo 1 of 1 : FA\_2022\_RD2092\_116\_32\_20220822\_00008.jpg

LM Start	0.13	Rating **	U	Issue No.	32
LM End	0.13	Issue Type +	Ma	Location *	WS
Category	Earthen Levee			GPS Latitude/Longitude	
				Start	End
Item	Vegetation			37.602322 °	37.602322 °
				-121.160378 °	-121.160378 °
DWR ID	DWR_RD2092_01_f _ 2021_32				
Comment Code					
V2 : Remove the wild growth and woody vegetation other than native grasses from the levee slopes.					
Inspector Comment

View of a large shrub growing on the waterside slope and shoulder. (Fall 2021)

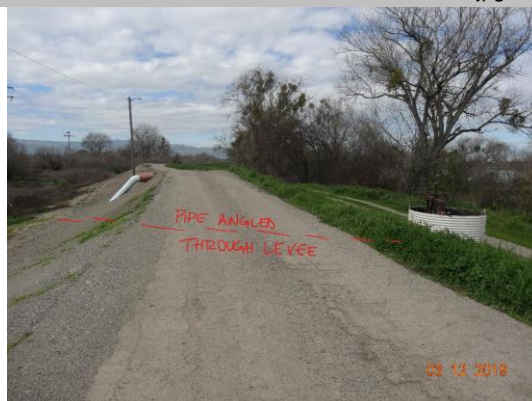
Photo 1 of 3 : UCIP\_FA\_2022\_53799\_79055.jpg

LM Start	0.18	Rating **	U	Issue No.	973	
LM End	0.18	Issue Type +	Ma	Location *		
Category	Supplemental			GPS Latitude/Longitude		
				Start	End	
Item	DWR UCIP LMA Responsibility			37.602031 °	37.602031 °	
				-121.161249 °	-121.161249 °	
DWR ID	20561

Comment Code						
Inspector Comment						
DS_ID:20561 FS_ID:53799 EP_NO: N/A Repair Type: Urgent EVAL Issue: 1, Pipe Integrity Crossing Status: Found UCIP Comments: 03/12/2019 A thorough internal evaluation of this crossing is necessary. Pipe shows evidence of pipe integrity (LS) issues (pipe wall sections missing on LS inlet) and levee integrity issues (sink hole visible along LS pipe alignment). Internal inspection is recommended for this crossing to determine the extent of pipe damage through the levee. Pipe crosses the levee at an angle at a depth of about 19 feet. Recommend caution be taken at this crossing when driving over levee until additional information becomes available to determine condition of pipe through levee. Recommend cover be placed on riser to address safety concern (riser is 80 inches in diameter and about 19 feet deep). Slide gate appears to be blocked by sediment/debris preventing slide gate to work properly. Unable to confirm if the flap gate located on the WS is still broken (see photo from 2017). (O. Magana - DWR UCIP)09/24/2013 Pipe rusted through at headwall on LS toe. Good candidate for video inspection. (W. Wylie - DWR UCIP) FIELD_STRUCT_DESC: 60-inch corrugated metal drainage pipe through the levee, 19 feet below the crown. Flap gate on the waterside (WS) end. Slide gate in an 80-inch corrugated metal pipe (CMP) riser on the WS slope. Concrete U-shaped headwalls on both ends. [Additional Reference(s): DWR Levee Log, 2005. USACE San Joaquin O&M Manual 5, August 1961, (HLM 0.18)]. FS Date: 3/12/2019 12:05:00 PM

Overview of levee with approximate pipe alignment (pipe angled through levee).

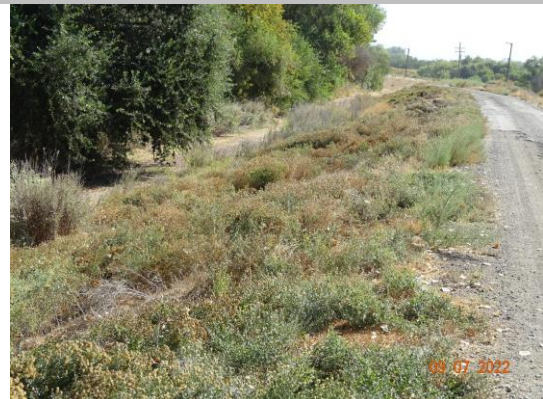
Photo 1 of 1 : FA\_2022\_RD2092\_116\_35\_20220915\_00069.jpg

LM Start	0.30	Rating **	M	Issue No.	35
LM End	2.87	Issue Type +	Ma	Location *	WS
Category	Earthen Levee			GPS Latitude/Longitude	
				Start	End
Item	Vegetation			37.601499 °	37.574698 °
				-121.163339 °	-121.155367 °
DWR ID	DWR_RD2092_01_f_2022_35				
Comment Code					
V1 : Control annual grass and weeds on the levee slopes and easements.					
Inspector Comment

Looking east along the waterside slope. (Fall 2022)

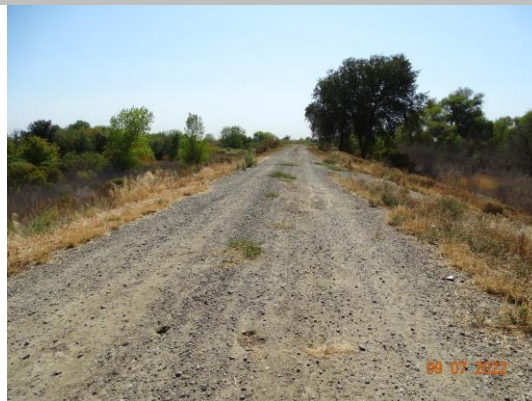
Photo 1 of 1 : FA\_2022\_RD2092\_116\_39\_20220915\_00071.jpg

Looking upstream at rutting and depression on levee crown. (Fall 2022)

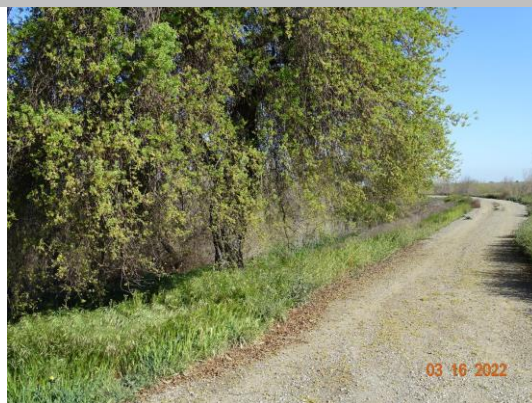
Photo 1 of 1 : FA\_2022\_RD2092\_116\_37\_20220822\_00010.jpg

View of tree branches hanging over the waterside slope and shoulder.  
(Spring 2022)

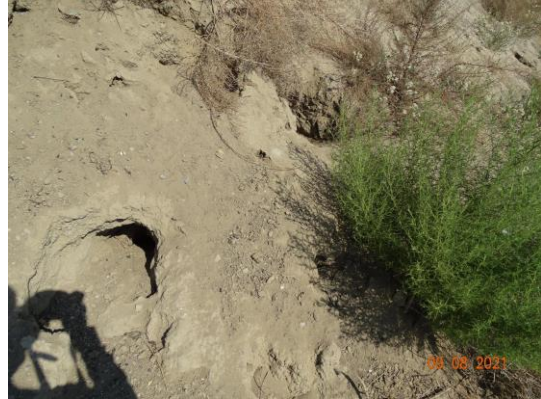
Photo 1 of 1 : FA\_2022\_RD2092\_116\_57\_20220822\_00021.jpg

View of multiple large rodent burrows in the landside slope. (Fall 2021)

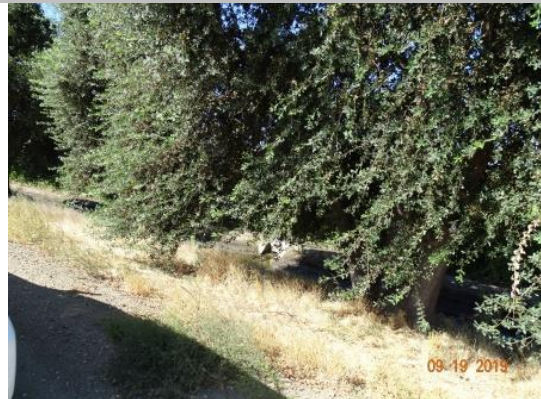
Photo 1 of 1 : FA\_2022\_RD2092\_116\_48\_20220822\_00016.jpg

LM Start	1.60	Rating **	M	Issue No.	48
LM End	1.62	Issue Type +	Ma	Location *	WS
Category	Earthen Levee			GPS Latitude/Longitude	
				Start	End
Item	Trim / Thin Trees			37.587068 °	37.586794 °
				-121.162773 °	-121.162950 °
DWR ID	DWR_RD2092_01_f _ 2019_48				
Comment Code					
T1 : Trim and thin trees to at least five feet above ground level to allow visibility of the ground and room to flood fight.					
Inspector Comment

View of branches hanging over waterside slope. (Fall 2019)

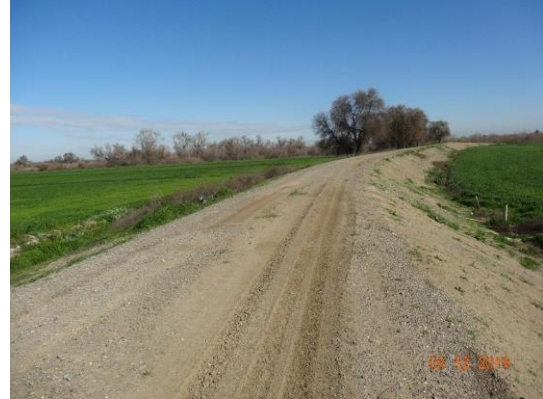
Photo 1 of 3 : UCIP\_FA\_2022\_53817\_79086.jpg

Comment Code					
Inspector Comment					
DS_ID:20563 FS_ID:53817 EP_NO: N/A Repair Type: Urgent EVAL Issue: 1, Pipe Integrity Crossing Status: Found UCIP Comments: 03/12/2019 A thorough internal evaluation of this crossing is required, pipe shows evidence of pipe integrity (LS) issues (pipe wall sections missing on WS outlet). Internal inspection is recommended for this crossing to determine the extent of pipe damage through the levee. Maintenance issues identified at this crossing include: flap gate missing on WS, debris found inside concrete distribution box, and missing cover on riser. No permit has been identified for this crossing. Need to determine who maintains crossing; crossing appears functional. (O. Magana - DWR UCIP) FIELD_STRUCT_DESC: 24-inch corrugated metal drainage pipe through the levee, 14 feet below the crown. Slide gate in a corrugated metal pipe (CMP) riser on the waterside (WS) slope. Concrete U-shaped headwall at the landside (LS) toe. [Additional Reference(s): DWR Levee Log, 2005. USACE San Joaquin O&M Manual 5, August 1961, (HLM 1.71)]. FS Date: 3/12/2019 12:07:00 PM

Overview of levee crown looking d/s towards pipe crossing.

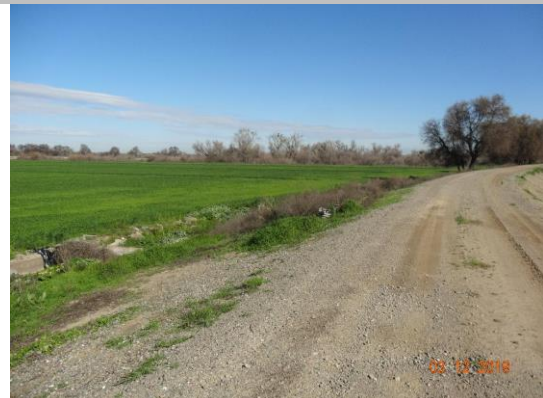
Photo 2 of 3 : UCIP\_FA\_2022\_53817\_79087.jpg

WS view: overview of WS.

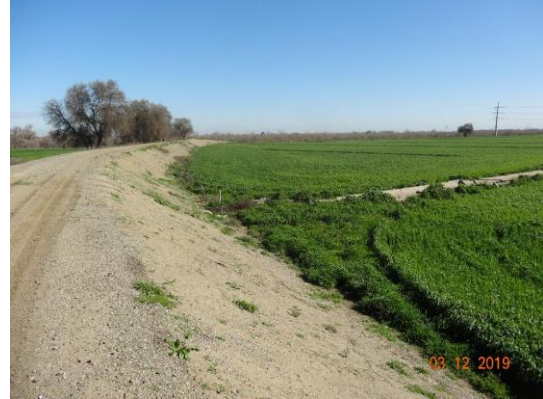
Photo 3 of 3 : UCIP\_FA\_2022\_53817\_79085.jpg

LS view: overview of LS.

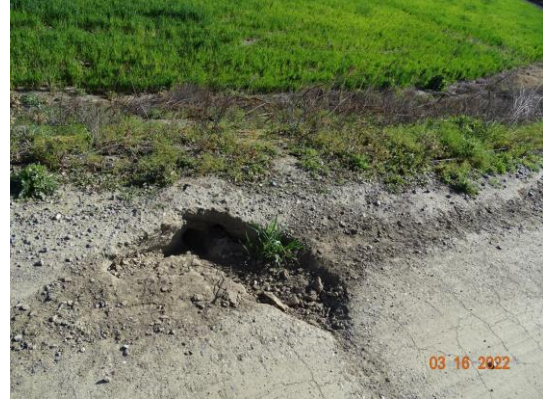
Photo 1 of 1 : FA\_2022\_RD2092\_116\_49\_20220822\_00017.jpg

Levee crown collapsing into a rodent burrow. (Spring 2022)

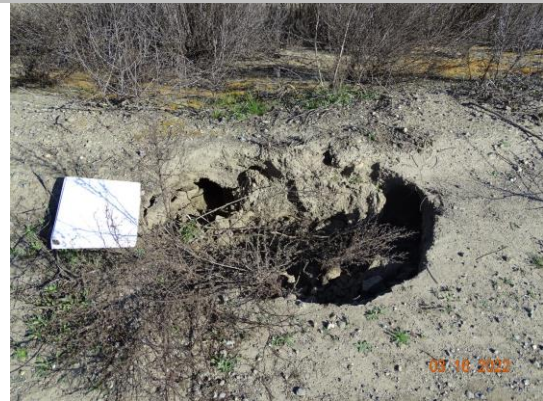
Photo 1 of 1 : FA\_2022\_RD2092\_116\_62\_20220822\_00026.jpg

LM Start	1.88	Rating **	U	Issue No.	62
LM End	1.88	Issue Type +	Ma	Location *	CR
Category	Earthen Levee			GPS Latitude/Longitude	
				Start	End
Item	Animal Control			37.584091 °	37.584091 °
				-121.161624 °	-121.161624 °
DWR ID	DWR_RD2092_01_s_2022_62				
Comment Code					
A3 : No rodents visible, but rodent burrows visible; need to backfill and compact or grout burrows.					
Inspector Comment					
Rodent burrow has collapsed in landside shoulder causing a hole on the crown.

Large hole in the levee crown from rodent burrows collapsing. (Spring 2022)

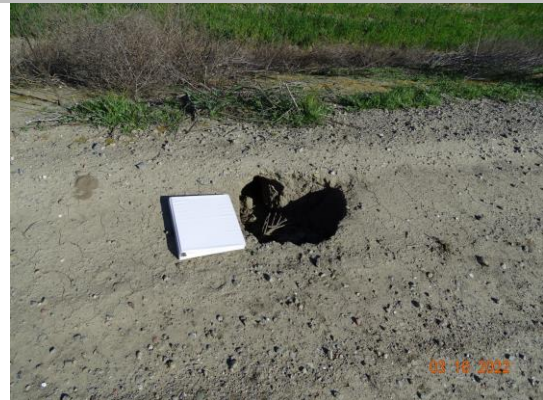
Photo 1 of 1 : FA\_2022\_RD2092\_116\_63\_20220822\_00027.jpg

LM Start	1.90	Rating **	M	Issue No.	63
LM End	1.90	Issue Type +	Ma	Location *	CR
Category	Earthen Levee			GPS Latitude/Longitude	
				Start	End
Item	Animal Control			37.584185 °	37.584185 °
				-121.161336 °	-121.161336 °
DWR ID	DWR_RD2092_01_s_2022_63				
Comment Code					
A3 : No rodents visible, but rodent burrows visible; need to backfill and compact or grout burrows.					
Inspector Comment

Hole in the levee crown from rodent burrows collapsing. (Spring 2022)

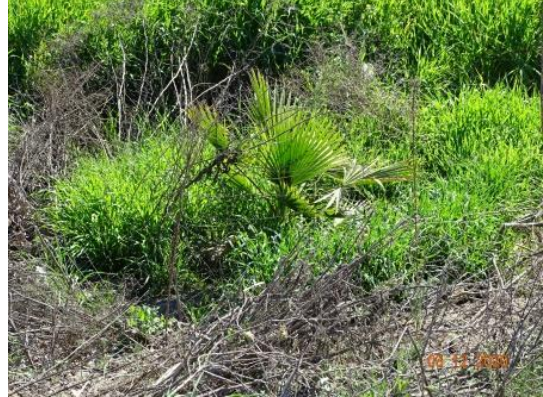
Photo 1 of 1 : FA\_2022\_RD2092\_116\_59\_20220822\_00023.jpg

Upclose view of palm tree growing at the levee toe. (Spring 2020)

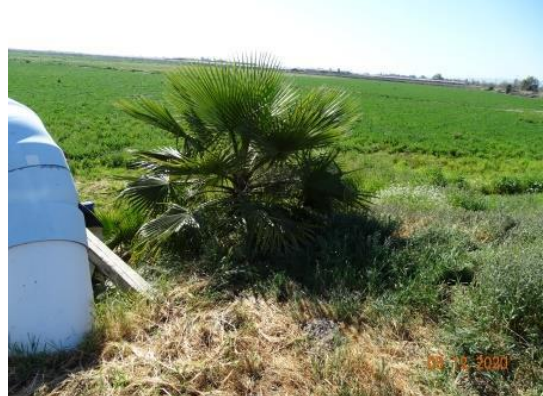
Photo 1 of 1 : FA\_2022\_RD2092\_116\_58\_20220822\_00022.jpg

LM Start	2.34	Rating **	M	Issue No.	58
LM End	2.34	Issue Type +	Ma	Location *	LS
Category	Earthen Levee			GPS Latitude/Longitude	
				Start	End
Item	Trim / Thin Trees			37.581166 °	37.581166 °
				-121.156156 °	-121.156156 °
DWR ID	DWR_RD2092_01_s_2022_58				
Comment Code					
T1 : Trim and thin trees to at least five feet above ground level to allow visibility of the ground and room to flood fight.					
Inspector Comment					
Palm tree should be removed from the landside slope.

View of palm tree growing on the landside slope. (Spring 2020)

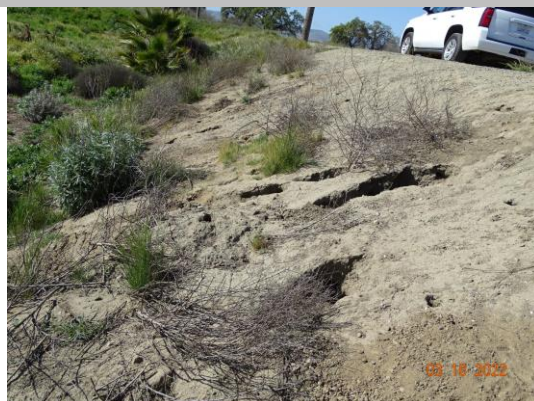
Photo 1 of 1 : FA\_2022\_RD2092\_116\_66\_20220822\_00028.jpg

View of several large rodent holes in the landside slope. (Spring 2022)

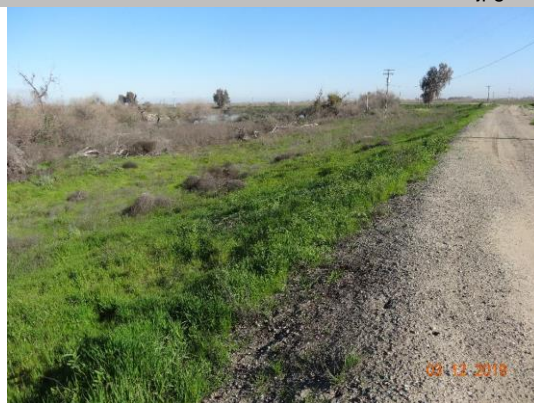
Photo 1 of 3 : UCIP\_FA\_2022\_54052\_79119.jpg

LM Start	2.40	Rating **	M	Issue No.	983	
LM End	2.40	Issue Type +	Ma	Location *		
Category	Supplemental			GPS Latitude/Longitude		
				Start	End	
Item	DWR UCIP LMA Responsibility			37.580426 °	37.580426 °	
				-121.156798 °	-121.156798 °	
DWR ID	20567

Comment Code						
Inspector Comment						
DS_ID:20567 FS_ID:54052 EP_NO: N/A Repair Type: Non-Urgent EVAL Issue: Crossing Status: Indicator Found UCIP Comments: 03/12/2019 Unable to locate concrete headwall on the WS due to high water. Unable to locate concrete headwall on LS due to dense vegetation. No permit was found authorizing crossing. If crossing is no longer in use recommend removing crossing and appurtenances from levee. Need to coordinate with CVFPB to determine pipe owner. (O. Magana - DWR UCIP) 09/24/2013 Appears abandoned and if so should be done so properly. (W. Wylie - DWR UCIP) FIELD_STRUCT_DESC: *ABANDONED* 24-inch corrugated metal drainage pipe through the levee, 15 feet below the crown. Flap gate on the waterside (WS) end. Concrete U-shaped headwall on the WS end. Concrete headwall on the landside (LS) toe next to pump. [Additional Reference(s): DWR Levee Log, 2005. USACE San Joaquin O&M Manual 5, August 1961, (HLM 2.44)]. FS Date: 3/12/2019 12:09:00 PM

WS view: overview of WS.

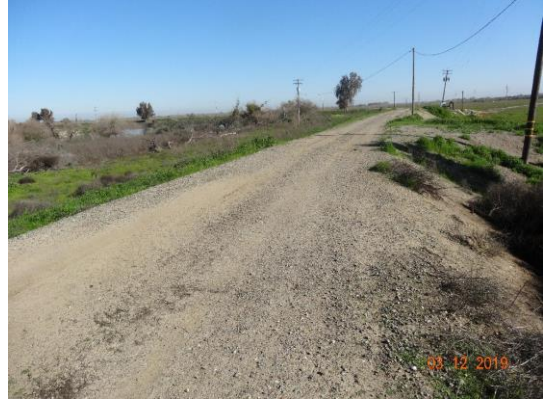
Photo 2 of 3 : UCIP\_FA\_2022\_54052\_79118.jpg

Overview of levee crown looking d/s towards crossing.

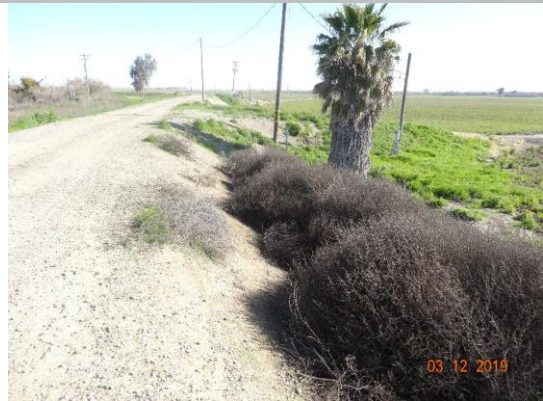
Photo 3 of 3 : UCIP\_FA\_2022\_54052\_79117.jpg

LS view: overview of LS.

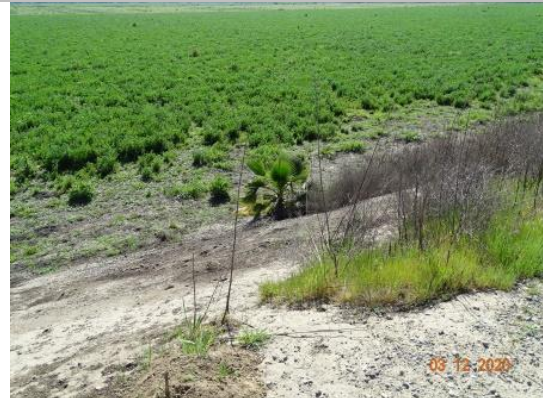
Photo 1 of 1 : FA\_2022\_RD2092\_116\_50\_20220822\_00018.jpg

View of palm tree in the landside slope. (Spring 2020)

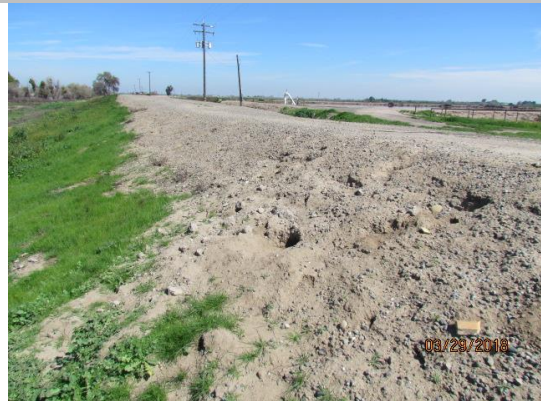
Photo 1 of 1 : FA\_2022\_RD2092\_116\_17\_20220822\_00002.jpg

Looking upstream on waterward slope at several large rodent holes.  
(Spring 2018)

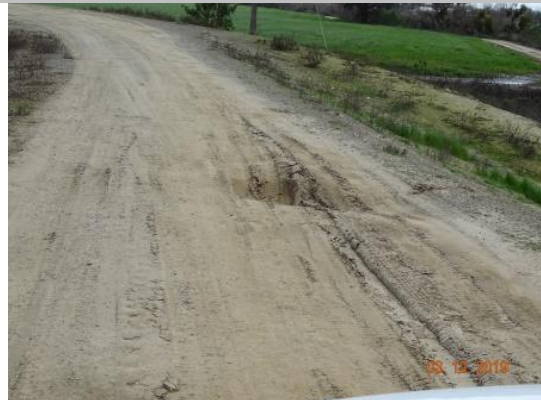
Photo 1 of 1 : FA\_2022\_RD2092\_116\_45\_20220822\_00015.jpg

LM Start	2.74	Rating **	U	Issue No.	45
LM End	2.74	Issue Type +	Ma	Location *	CR
Category	Earthen Levee			GPS Latitude/Longitude	
				Start	End
Item	Crown Surface / Depressions / Rutting			37.575514 °	37.575514 °
				-121.157140 °	-121.157140 °
DWR ID	DWR_RD2092_01_s_2019_45				
Comment Code					
C2 : Repair depressions or ruts in the crown or slope.					
Inspector Comment					
Depression and rutting in levee crown should be repaired.

View of depression in levee crown. (Spring 2019)

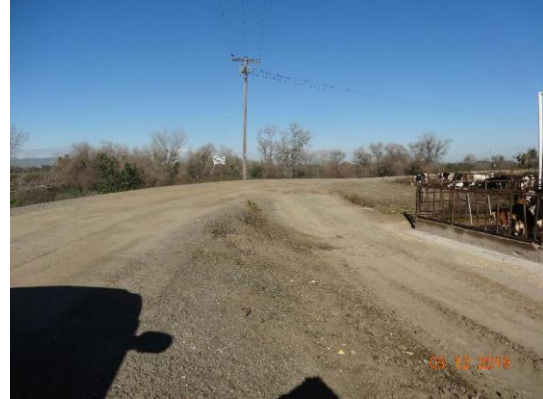
Photo 1 of 3 : UCIP\_FA\_2022\_53813\_79128.jpg

LM Start	2.79	Rating **	M	Issue No.	985
LM End	2.79	Issue Type +	Ma	Location *	
Category	Supplemental			GPS Latitude/Longitude	
				Start	End
Item	DWR UCIP LMA Responsibility			37.575002 °	37.575002 °
				-121.156753 °	-121.156753 °
DWR ID	20569				
Comment Code					
Inspector Comment					
DS_ID:20569 FS_ID:53813 EP_NO: N/A Repair Type: Non-Urgent EVAL Issue: Crossing Status: Not Found UCIP Comments: 03/12/2019 Need to confirm status of crossing through levee section. (O. Magana - DWR UCIP) FIELD_STRUCT_DESC: 24-inch corrugated metal drainage pipe through the levee, 6 feet below the crown. Concrete U-shaped headwall and flap gate on the waterside (WS) end. [Additional Reference(s): DWR Levee Log, 2005. USACE San Joaquin O&M Manual 5, August 1961, (HLM 2.83)]. FS Date: 3/12/2019 12:10:00 PM

LS view: overview of LS.

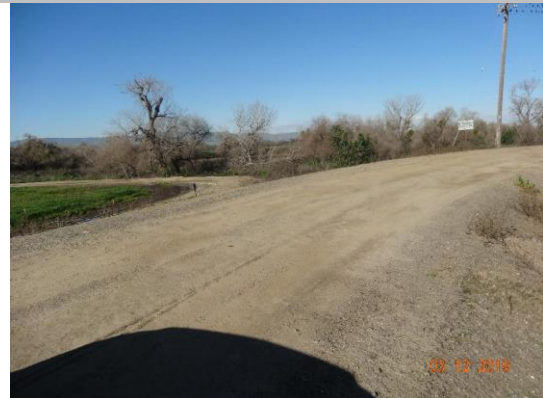
Photo 2 of 3 : UCIP\_FA\_2022\_53813\_79129.jpg

Overview of levee crown where crossing should be.

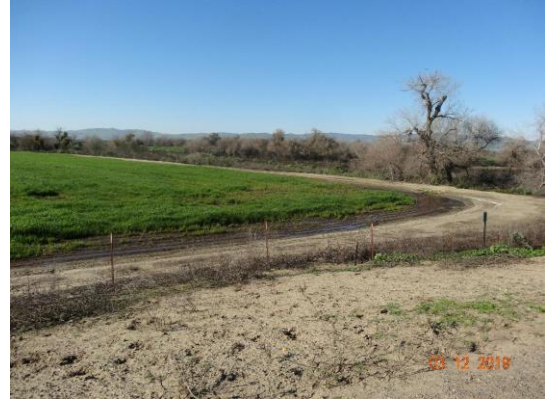
Photo 3 of 3 : UCIP\_FA\_2022\_53813\_79130.jpg

WS view: overview of WS.

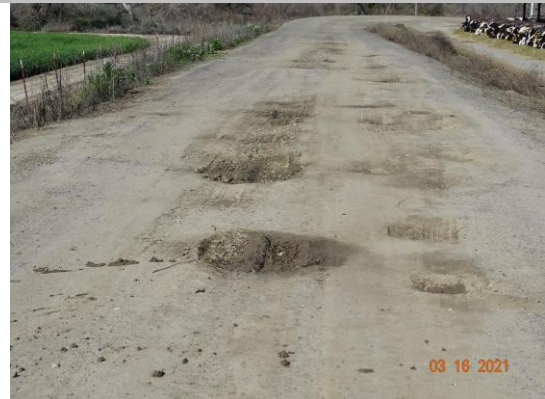
Photo 1 of 1 : FA\_2022\_RD2092\_116\_60\_20220822\_00024.jpg

LM Start	2.82	Rating **	U	Issue No.	60
LM End	2.94	Issue Type +	Ma	Location *	CR
Category	Earthen Levee			GPS Latitude/Longitude	
				Start	End
Item	Crown Surface / Depressions / Rutting			37.574868 °	37.574425 °
				-121.156163 °	-121.154046 °
DWR ID	DWR_RD2092_01_s_2020_60				
Comment Code					
C2 : Repair depressions or ruts in the crown or slope.					
Inspector Comment					
Potholes and rutting in the levee crown should be repaired.

View of rutting and potholes on levee crown looking downstream.  
(Spring 2021)

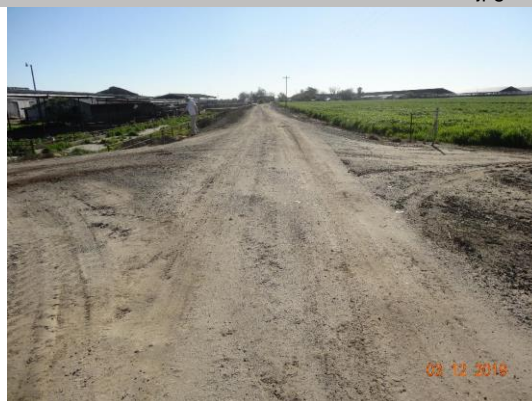
Photo 1 of 3 : UCIP\_FA\_2022\_53810\_79135.jpg

Comment Code						
Inspector Comment						
DS_ID:20570 FS_ID:53810 EP_NO: N/A Repair Type: Non-Urgent EVAL Issue: Crossing Status: Indicator Found UCIP Comments: 03/12/2019 Unable to locate concrete headwall on the WS. Concrete headwall is still visible on the LS however, this crossing appears to be abandoned. No permit was found authorizing crossing. If crossing is no longer in use recommend removing crossing and appurtenances from levee. (O. Magana - DWR UCIP) 09/24/2013 Appears abandoned and if so, should be done so properly. (W. Wylie - DWR UCIP) FIELD_STRUCT_DESC: *ABANDONED* 24-inch corrugated metal drainage pipe through the levee, 6.5 feet below the crown. Concrete U-shaped headwall and flap gate on the waterside (WS) end. Concrete headwall on the landside (LS) slope. [Additional Reference(s): DWR Levee Log, 2005. USACE San Joaquin O&M Manual 5, August 1961]. FS Date: 3/12/2019 12:11:00 PM

Overview of levee at crossing, photo taken d/s looking u/s towards crossing.

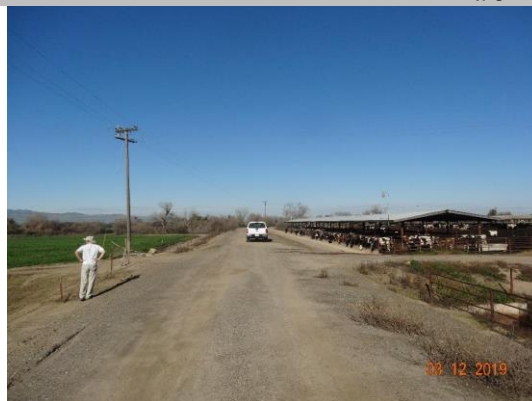
Photo 2 of 3 : UCIP\_FA\_2022\_53810\_79136.jpg

Overview of levee at crossing, photo taken u/s looking d/s towards crossing.

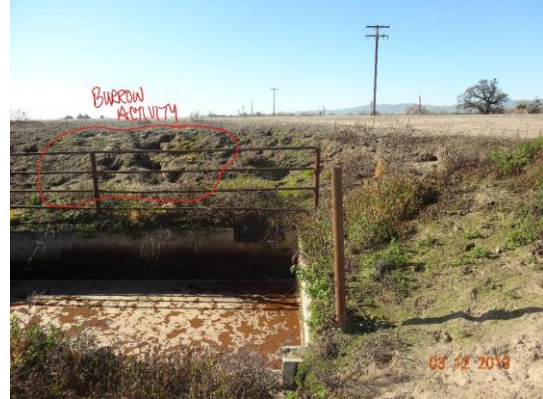
Photo 3 of 3 : UCIP\_FA\_2022\_53810\_79140.jpg

LS view: heavy burrow activity observed on LS slope.

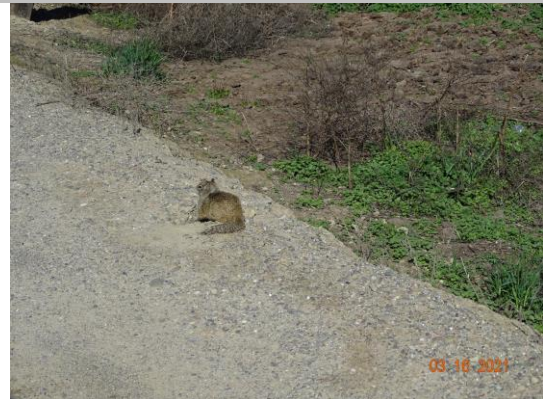
Photo 1 of 1 : FA\_2022\_RD2092\_116\_52\_20220822\_00020.jpg

LM Start	2.94	Rating **	A/W	Issue No.	52
LM End	2.94	Issue Type +	Ma	Location *	LS
Category	Earthen Levee			GPS Latitude/Longitude	
				Start	End
Item	Animal Control			37.574455 °	37.574455 °
				-121.154069 °	-121.154069 °
DWR ID	DWR_RD2092_01_s_2021_52				
Comment Code					
A1 : Exterminate rodents and backfill and compact or grout burrows.					
Inspector Comment					
Single rodent and burrow observed on landside shoulder.

View of single burrow and rodent observed on landside shoulder. (Spring 2021)

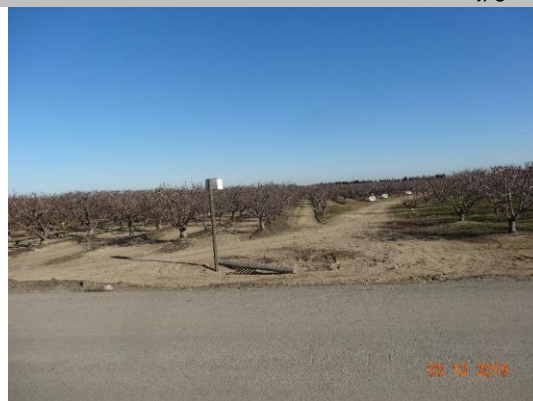
Photo 3 of 3 : UCIP\_FA\_2022\_53786\_79144.jpg

LS view: overview of land use on LS.
