**Flood Control Project Maintenance
Levee Inspections**

Maintenance Issue Types Only, Levee Inspection Report By Mile - Fall 2023

Reclamation District No. 2092 Dos Rios

Waterway	Bank	Unit Miles	Inspection Start/End	Inspector
Unit No. 01 San Joaquin River	Right	3.71	09/06/2023 09/06/2023	Nate Hicks

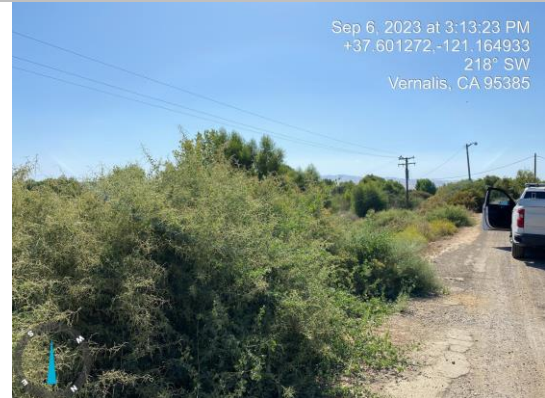
Photo 1 of 1 : FA_2023_RD2092_116_13_20230922_00070.jpg

LM Start	0.00	Rating **	U	Issue No.	13
LM End	3.10	Issue Type +	Ma	Location *	LS
Category	Earthen Levee			GPS Latitude/Longitude	
				Start	End
Item	Vegetation			37.602600°	37.573675°
				-121.158100°	-121.151367°
DWR ID	DWR_RD2092_01_f_2023_13				
Comment Code					
V1 : Control annual grass and weeds on the levee slopes and easements.					
Inspector Comment

View of vegetation on the landside slope (Fall 2023).

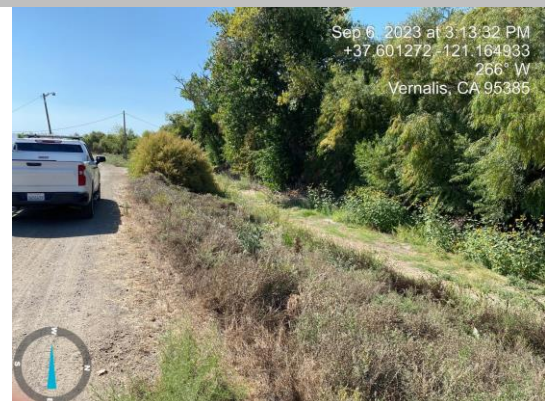
Photo 1 of 1 : FA_2023_RD2092_116_14_20230922_00071.jpg

LM Start	0.00	Rating **	U	Issue No.	14
LM End	3.10	Issue Type +	Ma	Location *	WS
Category	Earthen Levee			GPS Latitude/Longitude	
				Start	End
Item	Vegetation			37.602600°	37.573673°
				-121.158100°	-121.151360°
DWR ID	DWR_RD2092_01_f_2023_14				
Comment Code					
V1 : Control annual grass and weeds on the levee slopes and easements.					
Inspector Comment

View of vegetation on the waterside slope (Fall 2023).

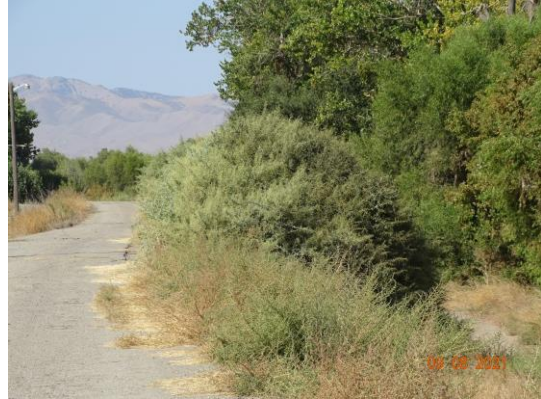
Photo 1 of 1 : FA_2023_RD2092_116_32_20230905_00009.jpg

View of a large shrub growing on the waterside slope and shoulder. (Fall 2021)

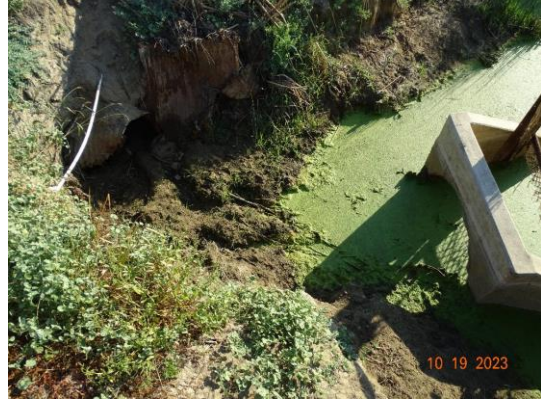
Photo 1 of 3 : UCIP_FA_2023_81387_117478.jpg

DS_ID:20561
FS_ID:81387
EP_NO: N/A
Repair Type: Urgent
EVAL Issue: 1, Pipe Integrity
Crossing Status: Found
UCIP Comments: 10/19/2023 Record remains Urgent. DMP internal video inspection has found severe pipe defects. Crossing will be monitored until funding becomes available to address the issues. Unable to confirm if flap gate is still broken (from the 2017 inspection) due to it being covered with a tarp. The flap gate hinges are bent causing the flap gate to not close properly; needs to be fixed. LS concrete headwall is completely separated from the pipe. No sink hole along LS pipe alignment (as noted in the 2019 inspection) during this inspection. No cover was present on CMP riser causing a safety hazard. Debris appears to be present at the slide gate which could potentially cause the slide gate to not close properly. (M. Thao - DWR UCIP) 03/12/2019 A thorough internal evaluation of this crossing is necessary. Pipe shows evidence of pipe integrity (LS) issues (pipe wall sections missing on LS inlet) and levee integrity issues (sink hole visible along LS pipe alignment). Internal inspection is recommended for this crossing to determine the extent of pipe damage through the levee. Pipe crosses the levee at an angle at a depth of about 19 feet. Recommend caution be taken at this crossing when driving over levee until additional information becomes available to determine condition of pipe through levee. Recommend cover be placed on riser to address safety concern (riser is 80 inches in diameter and about 19 feet deep). Slide gate appears to be blocked by sediment/debris preventing slide gate to work properly. Unable to confirm if the flap gate located on the WS is still broken (see photo from 2017). (O. Magana - DWR UCIP)09/24/2013 Pipe rusted through at headwall on LS toe. Good candidate for video inspection. (W. Wylie - DWR UCIP)

LS view: Headwall (right) completely separated from pipe inlet (left).

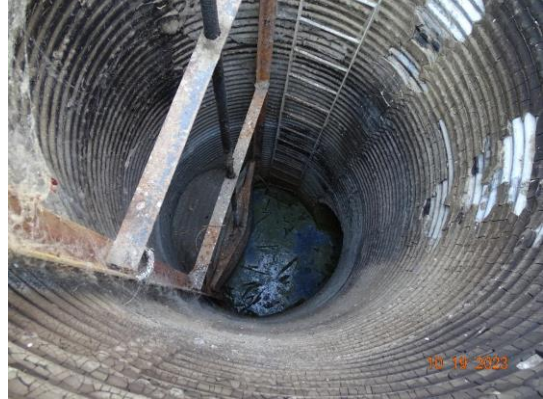
Photo 2 of 3 : UCIP_FA_2023_81387_117481.jpg

WS view: Slide gate located in CMP riser with debris.

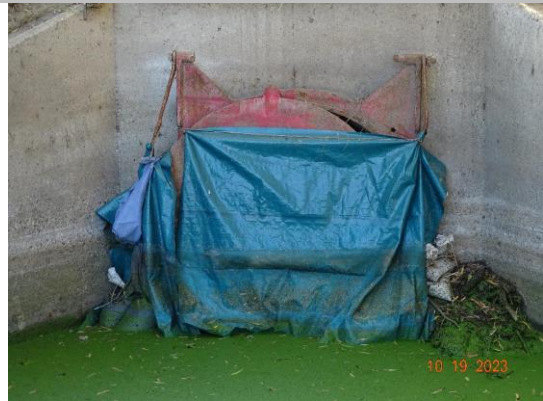
Photo 3 of 3 : UCIP_FA_2023_81387_117483.jpg

WS view: Close-up view of flap gate covered with tarp; hinge bent so flap gate is not closing properly.

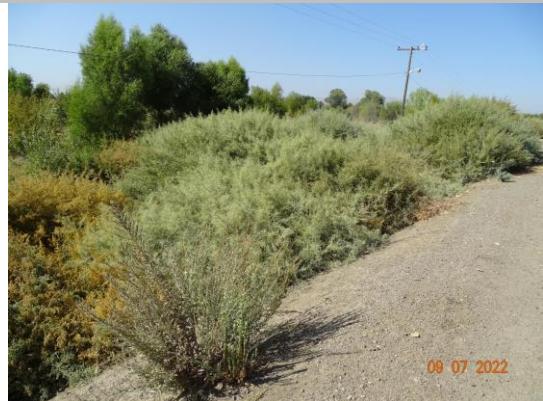
Photo 1 of 1 : FA_2023_RD2092_116_33_20230905_00010.jpg

LM Start	0.35	Rating **	U	Issue No.	33
LM End	0.75	Issue Type +	Ma	Location *	LS
Category	Earthen Levee			GPS Latitude/Longitude	
				Start	End
Item	Vegetation			37.601360°	37.597490°
				-121.164292°	-121.168434°
DWR ID	DWR_RD2092_01_s_2022_33				
Comment Code					
V2 : Remove the wild growth and woody vegetation other than native grasses from the levee slopes.					
Inspector Comment

Several large bushes obstructing view of the landside slope. (Fall 2022)

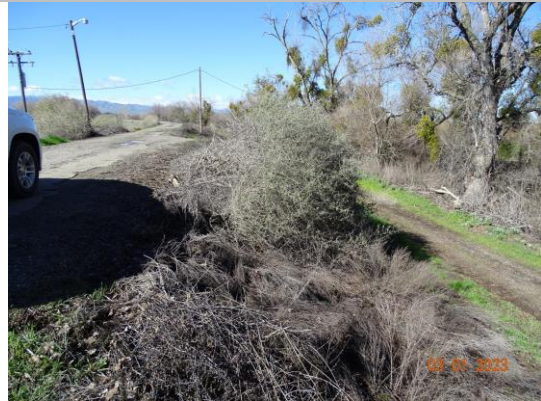
Photo 1 of 1 : FA_2023_RD2092_116_29_20230905_00007.jpg

Woody vegetation on waterside slope (Spring 2023).

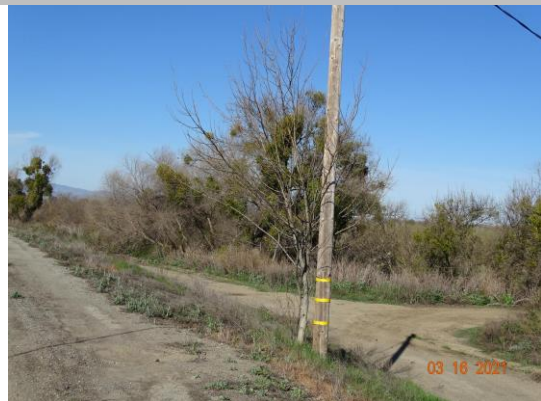
Photo 1 of 1 : FA_2023_RD2092_116_31_20230905_00008.jpg

LM Start	0.44	Rating **	M	Issue No.	31
LM End	0.44	Issue Type +	Ma	Location *	WS
Category	Earthen Levee			GPS Latitude/Longitude	
				Start	End
Item	Trim / Thin Trees			37.601149°	37.601149°
				-121.165772°	-121.165772°
DWR ID	DWR_RD2092_01_s_2018_31				
Comment Code					
T1 : Trim and thin trees to at least five feet above ground level to allow visibility of the ground and room to flood fight.					
Inspector Comment					
Remove small tree on waterward shoulder before tree is established.

View of small tree growing on waterside shoulder. (Spring 2021)

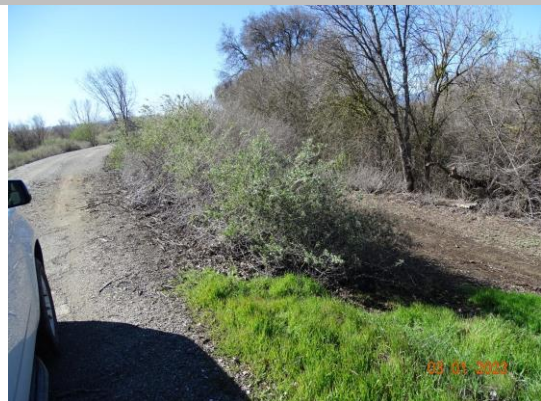
Photo 1 of 1 : FA_2023_RD2092_116_35_20230905_00011.jpg

LM Start	0.58	Rating **	U	Issue No.	35
LM End	0.58	Issue Type +	Ma	Location *	WS
Category	Earthen Levee			GPS Latitude/Longitude	
				Start	End
Item	Vegetation			37.599526°	37.599526°
				-121.167076°	-121.167076°
DWR ID	DWR_RD2092_01_s_2023_35				
Comment Code					
V2 : Remove the wild growth and woody vegetation other than native grasses from the levee slopes.					
Inspector Comment

View of woody vegetation on waterside slope (Spring 2023).

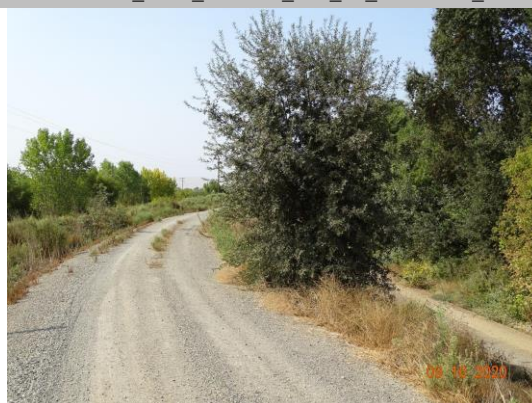
Photo 1 of 1 : FA_2023_RD2092_116_21_20230905_00005.jpg

LM Start	0.61	Rating **	M	Issue No.	21
LM End	0.61	Issue Type +	Ma	Location *	WS
Category	Earthen Levee			GPS Latitude/Longitude	
				Start	End
Item	Trim / Thin Trees			37.599208°	37.599208°
				-121.167150°	-121.167150°
DWR ID	DWR_RD2092_01_s_2021_21				
Comment Code					
T1 : Trim and thin trees to at least five feet above ground level to allow visibility of the ground and room to flood fight.					
Inspector Comment					
Remove small tree on waterward shoulder before tree is established.

Looking upstream at a tree growing in the waterside shoulder. (Fall 2020)

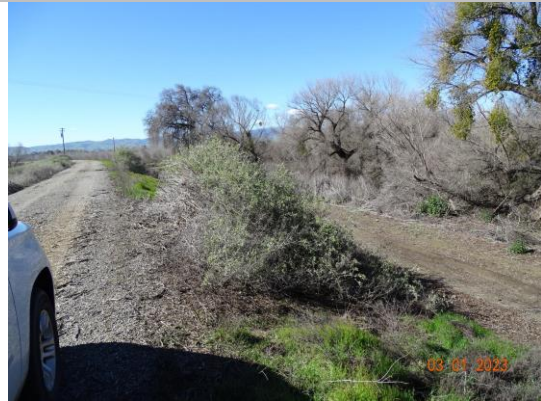
Photo 1 of 1 : FA_2023_RD2092_116_64_20230905_00030.jpg

View of woody vegation on the waterside slope (Spring 2023).

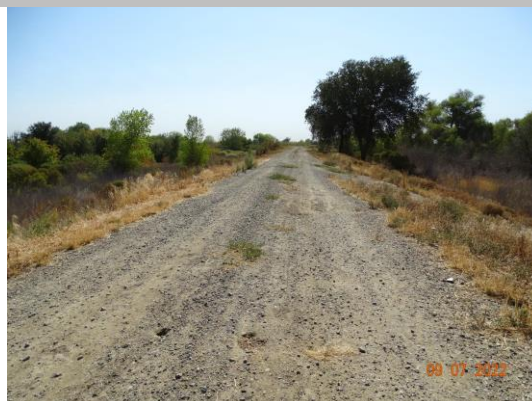
Photo 1 of 1 : FA_2023_RD2092_116_39_20230905_00013.jpg

Looking upstream at rutting and depression on levee crown. (Fall 2022)

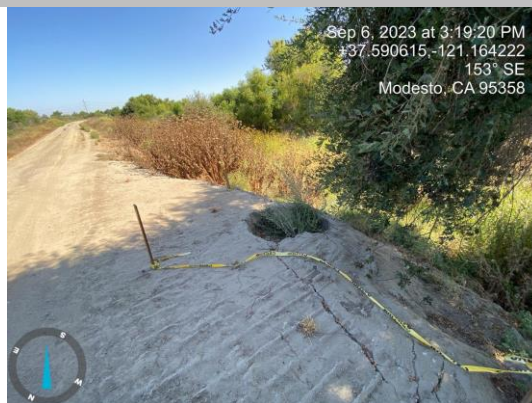
Photo 1 of 1 : FA_2023_RD2092_116_15_20230922_00069.jpg

LM Start	1.29	Rating **	U	Issue No.	15
LM End	1.29	Issue Type +	Ma	Location *	CR
Category	Earthen Levee			GPS Latitude/Longitude	
				Start	End
Item	Erosion / Bank Caving			37.590674°	37.590674°
				-121.164195°	-121.164195°
DWR ID	DWR_RD2092_01_f_2023_15				
Comment Code					
E2 : Schedule repair of erosion site prior to the next inspection.					
Inspector Comment					
A sinkhole has formed on the waterside shoulder and needs to be backfilled and compacted.

View of sinkhole near waterside shoulder (Fall 2023).

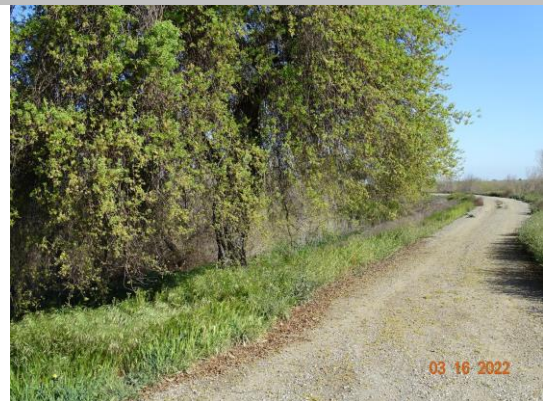
Photo 1 of 1 : FA_2023_RD2092_116_37_20230905_00012.jpg

View of tree branches hanging over the waterside slope and shoulder. (Spring 2022)

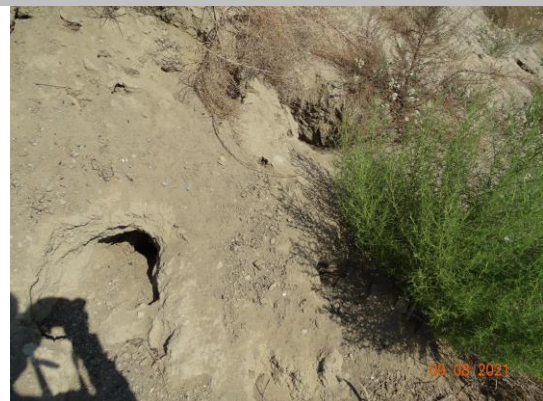
Photo 1 of 1 : FA_2023_RD2092_116_57_20230905_00024.jpg

LM Start	1.58	Rating **	U	Issue No.	57
LM End	1.58	Issue Type +	Ma	Location *	LS
Category	Earthen Levee			GPS Latitude/Longitude	
				Start	End
Item	Animal Control			37.587344°	37.587344°
				-121.162631°	-121.162631°
DWR ID	DWR_RD2092_01_f_2021_57				
Comment Code					
A3 : No rodents visible, but rodent burrows visible; need to backfill and compact or grout burrows.					
Inspector Comment

View of multiple large rodent burrows in the landside slope. (Fall 2021)

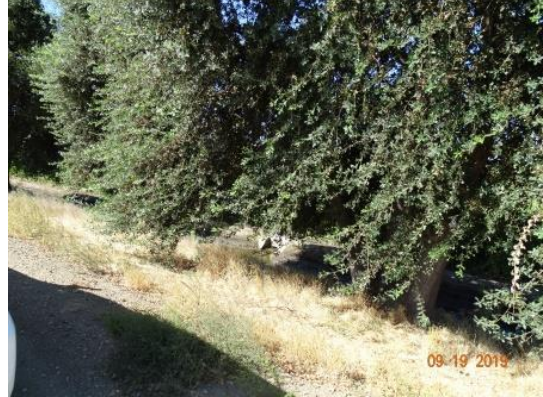
Photo 1 of 1 : FA_2023_RD2092_116_48_20230905_00019.jpg

View of branches hanging over waterside slope. (Fall 2019)

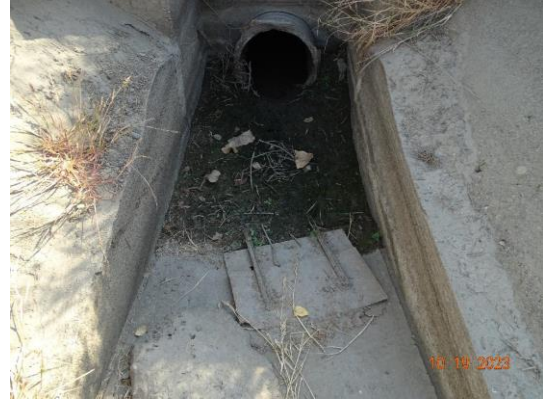
Photo 1 of 2 : UCIP_FA_2023_81556_117531.jpg

Comment Code					
Inspector Comment					
DS_ID:20563 FS_ID:81556 EP_NO: N/A Repair Type: Urgent EVAL Issue: 3a, Flood Risk Crossing Status: Found UCIP Comments: 10/19/2023 Record remains Urgent. Slide gate on waterside missing potentially allowing uncontrolled flood water from WS to LS. Unable to locate CMP riser on WS slope due to overgrown vegetation. No issues observed on the LS headwall. DMP internal video inspection has found none or minor pipe defects. Recommend next video inspection in 5 years. (M. Thao - DWR UCIP) 03/12/2019 A thorough internal evaluation of this crossing is required, pipe shows evidence of pipe integrity (LS) issues (pipe wall sections missing on WS outlet). Internal inspection is recommended for this crossing to determine the extent of pipe damage through the levee. Maintenance issues identified at this crossing include: flap gate missing on WS, debris found inside concrete distribution box, and missing cover on riser. No permit has been identified for this crossing. Need to determine who maintains crossing; crossing appears functional. (O. Magana - DWR UCIP) FIELD_STRUCT_DESC: 24-inch corrugated metal drainage pipe through the levee, 14 feet below the crown. Slide gate in a corrugated metal pipe (CMP) riser on the waterside (WS) slope. Concrete U-shaped headwall at the landside (LS) toe. [Additional Reference(s): DWR Levee Log, 2005. USACE San Joaquin O&M Manual 5, August 1961, (HLM 1.71)]. FS Date: 10/19/2023 10:15:17 AM

WS view: Pipe outlet at toe with missing flap gate.

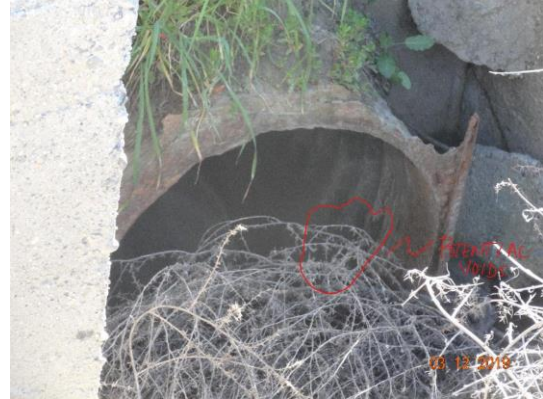
Photo 2 of 2 : UCIP_FA_2023_81556_79081.jpg

WS view: potential voids visible at pipe outlet.

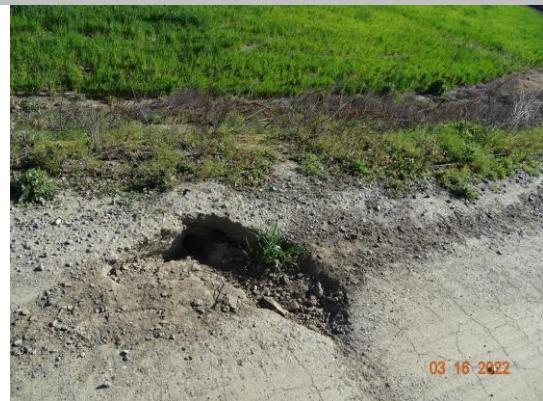
Photo 1 of 1 : FA_2023_RD2092_116_49_20230905_00020.jpg

LM Start	1.81	Rating **	M	Issue No.	49
LM End	1.81	Issue Type +	Ma	Location *	CR
Category	Earthen Levee			GPS Latitude/Longitude	
				Start	End
Item	Animal Control			37.584288°	37.584288°
				-121.162864°	-121.162864°
DWR ID	DWR_RD2092_01_s_2022_49				
Comment Code					
A3 : No rodents visible, but rodent burrows visible; need to backfill and compact or grout burrows.					
Inspector Comment					
Rodent burrow in landside shoulder has collapsed into the crown.

Levee crown collapsing into a rodent burrow. (Spring 2022)

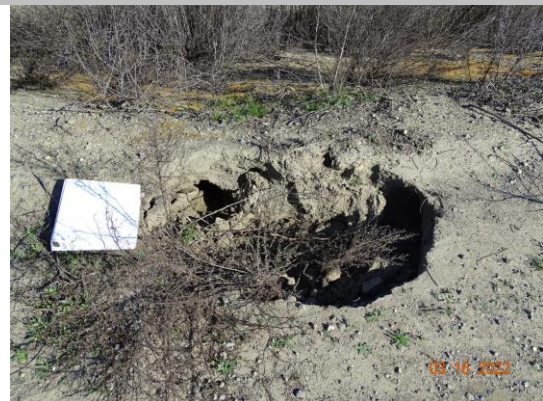
Photo 1 of 1 : FA_2023_RD2092_116_62_20230905_00028.jpg

LM Start	1.88	Rating **	U	Issue No.	62
LM End	1.88	Issue Type +	Ma	Location *	CR
Category	Earthen Levee			GPS Latitude/Longitude	
				Start	End
Item	Animal Control			37.584091°	37.584091°
				-121.161624°	-121.161624°
DWR ID	DWR_RD2092_01_s_2022_62				
Comment Code					
A3 : No rodents visible, but rodent burrows visible; need to backfill and compact or grout burrows.					
Inspector Comment					
Rodent burrow has collapsed in landside shoulder causing a hole on the crown.

Large hole in the levee crown from rodent burrows collapsing. (Spring 2022)

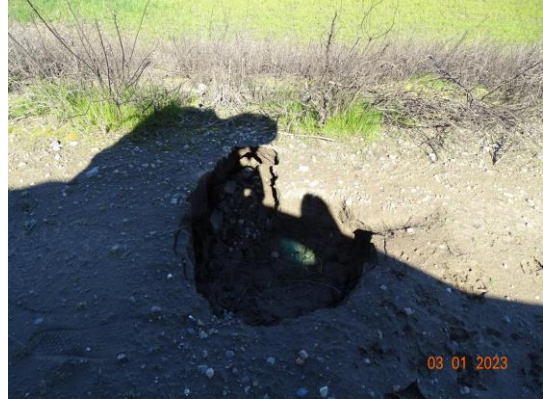
Photo 1 of 1 : FA_2023_RD2092_116_63_20230905_00029.jpg

View of collapsed rodent hole on the crown of the levee (Spring 2023).

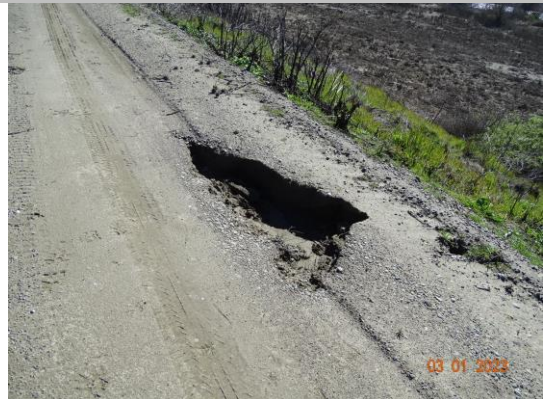
Photo 1 of 1 : FA_2023_RD2092_116_70_20230905_00032.jpg

View of collapsed rodent hole on the crown of the levee (Spring 2023).

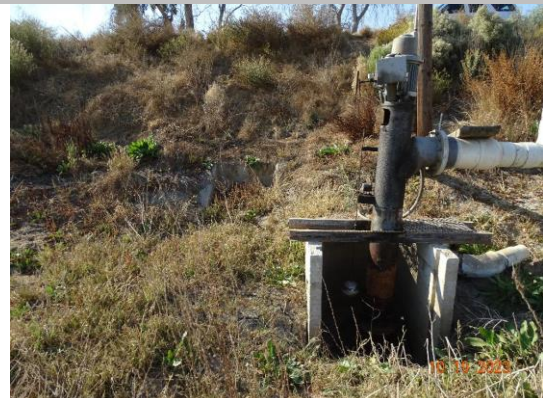
Photo 2 of 3 : UCIP_FA_2023_81477_117866.jpg

Comment Code					
Inspector Comment					
DS_ID:20564 FS_ID:81477 EP_NO: N/A Repair Type: Non-Urgent EVAL Issue: Crossing Status: Found UCIP Comments: 10/19/2023 Record remains Non-Urgent. Crossing appears abandoned; unable to locate a permit and confirm proper pipe abandonment. Overgrown vegetation limits inspection of levee on WS. (M. Thao - DWR UCIP) 03/12/2019 Concrete headwall found on LS toe. Pipe appears to have been grouted through. No other appurtenances were found during inspection. WS outlet was not found. Need to coordinate with the CVFPB to determine if additional steps are needed to comply with Title 23. (O. Magana - DWR UCIP) FIELD_STRUCT_DESC: *ABANDONED* 30-inch corrugated metal drainage pipe through the levee, 15 feet below the crown. Flap gate on the waterside (WS) end. Concrete U-shaped headwalls on both ends. Filled with concrete on the landside (LS) toe. [Additional Reference(s): DWR Levee Log, 2005. USACE San Joaquin O&M Manual 5, August 1961, (HLM 2.10), 36-inch pipe listed]. FS Date: 10/19/2023 2:50:09 PM

LS view: Concrete headwall and pipe inlet at toe (left); groundwater pump and concrete drop structure approximately 10 feet off toe (right).

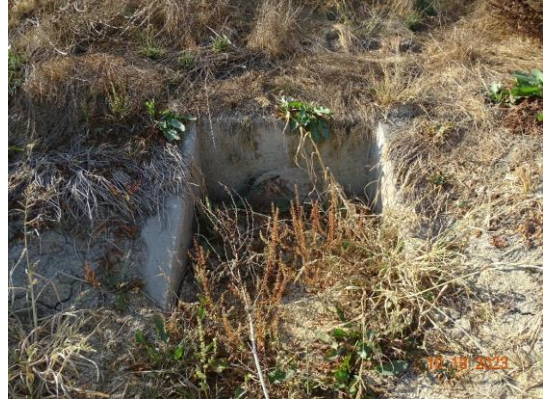
Photo 3 of 3 : UCIP_FA_2023_81477_117867.jpg

LS view: Close-up view of concrete headwall and pipe inlet on toe.

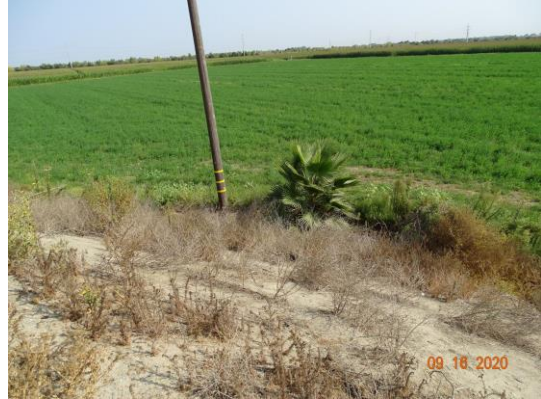
Photo 1 of 1 : FA_2023_RD2092_116_43_20230905_00016.jpg

View of small palm tree growing on the landside toe. (Fall 2020)

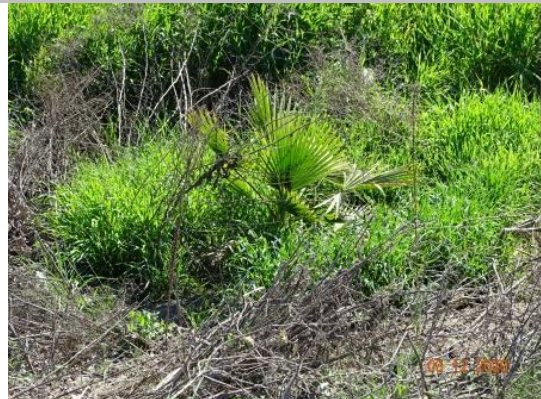
Photo 1 of 1 : FA_2023_RD2092_116_59_20230905_00026.jpg

Up close view of palm tree growing at the levee toe. (Spring 2020)

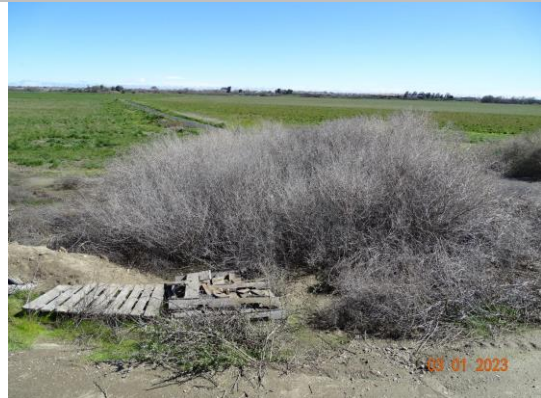
Photo 1 of 1 : FA_2023_RD2092_116_74_20230905_00033.jpg

View of woody vegetation on landside slope (Spring 2023).

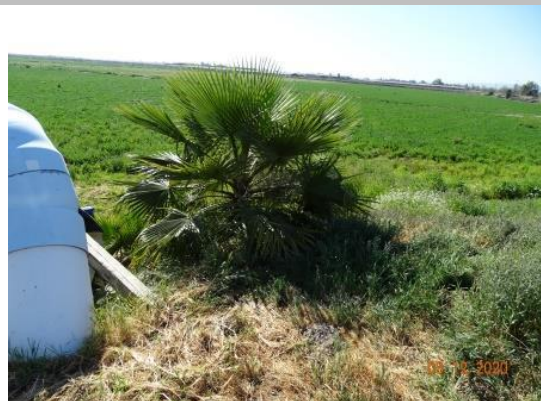
Photo 1 of 1 : FA_2023_RD2092_116_58_20230905_00025.jpg

View of palm tree growing on the landside slope. (Spring 2020)

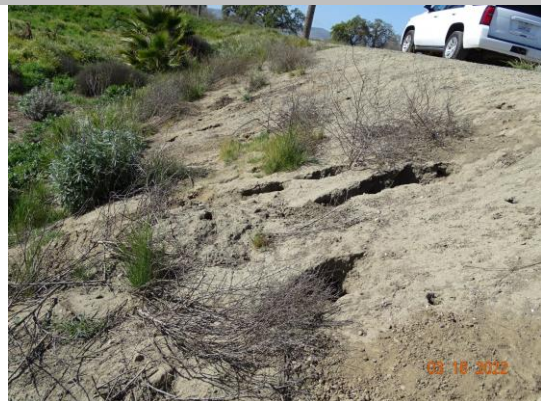
Photo 1 of 1 : FA_2023_RD2092_116_66_20230905_00031.jpg

View of several large rodent holes in the landside slope. (Spring 2022)

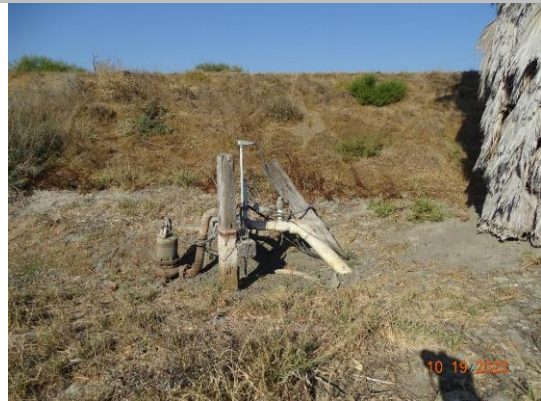
Photo 3 of 3 : UCIP_FA_2023_81503_117959.jpg

LS view: Looking toward levee; no concrete headwall found. Pipe appurtenances associated with a different record (DSID 20568).

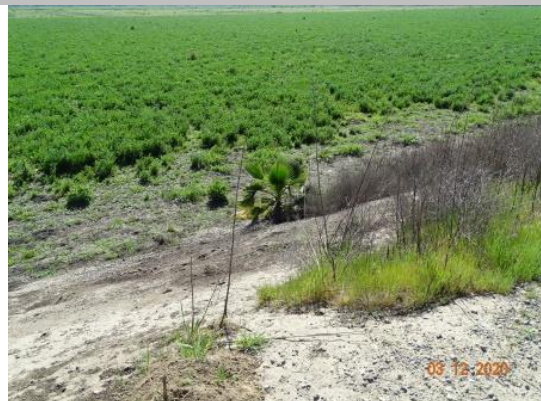
Photo 1 of 1 : FA_2023_RD2092_116_50_20230905_00021.jpg

View of palm tree in the landside slope. (Spring 2020)

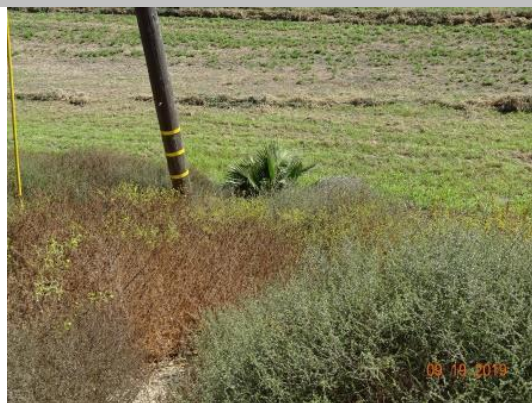
Photo 1 of 1 : FA_2023_RD2092_116_51_20230905_00022.jpg

View of palm tree growing in landside toe. (Fall 2019)

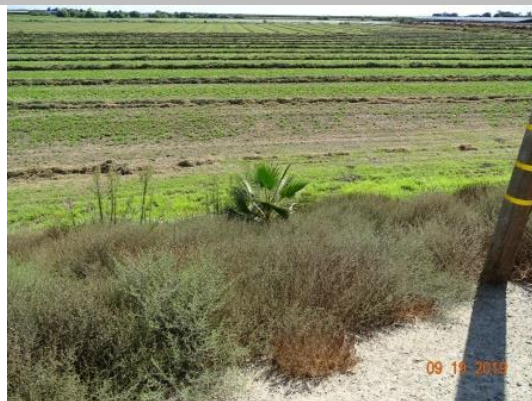
Photo 1 of 1 : FA_2023_RD2092_116_19_20230905_00003.jpg

View of palm tree growing on landside slope. (Fall 2019)

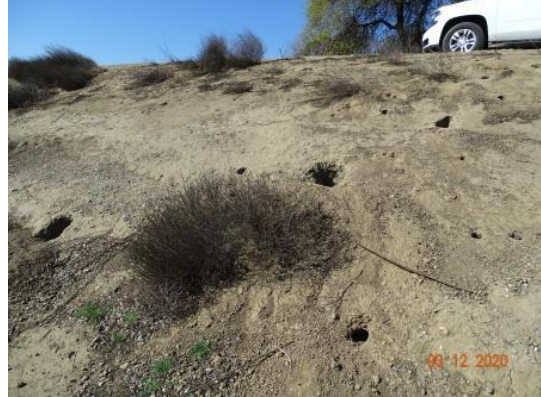
Photo 1 of 1 : FA_2023_RD2092_116_44_20230905_00017.jpg

View of rodent burrows in landside slope. (Spring 2020)

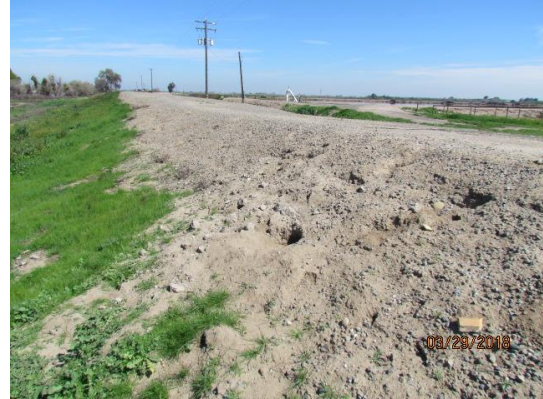
Photo 1 of 1 : FA_2023_RD2092_116_17_20230905_00002.jpg

Looking upstream on waterward slope at several large rodent holes.
(Spring 2018)

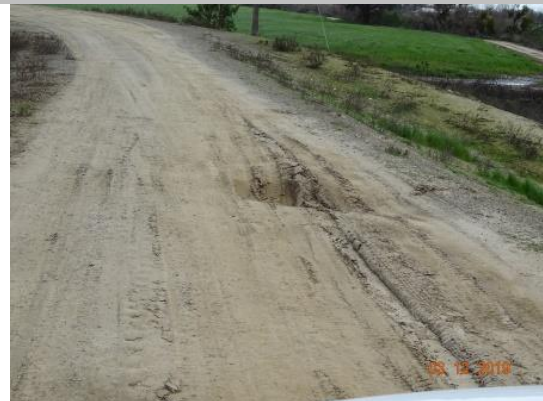
Photo 1 of 1 : FA_2023_RD2092_116_45_20230905_00018.jpg

LM Start	2.74	Rating **	U	Issue No.	45
LM End	2.74	Issue Type +	Ma	Location *	CR
Category	Earthen Levee			GPS Latitude/Longitude	
				Start	End
Item	Crown Surface / Depressions / Rutting			37.575514°	37.575514°
				-121.157140°	-121.157140°
DWR ID	DWR_RD2092_01_s_2019_45				
Comment Code					
C2 : Repair depressions or ruts in the crown or slope.					
Inspector Comment					
Depression and rutting in levee crown should be repaired.

View of depression in levee crown. (Spring 2019)

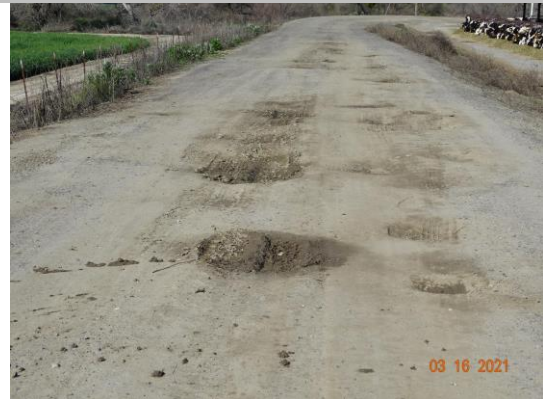
Photo 1 of 1 : FA_2023_RD2092_116_60_20230905_00027.jpg

LM Start	2.82	Rating **	U	Issue No.	60
LM End	2.94	Issue Type +	Ma	Location *	CR
Category	Earthen Levee			GPS Latitude/Longitude	
				Start	End
Item	Crown Surface / Depressions / Rutting			37.574868°	37.574425°
				-121.156163°	-121.154046°
DWR ID	DWR_RD2092_01_s_2020_60				
Comment Code					
C2 : Repair depressions or ruts in the crown or slope.					
Inspector Comment					
Potholes and rutting in the levee crown should be repaired.

View of rutting and potholes on levee crown looking downstream. (Spring 2021)

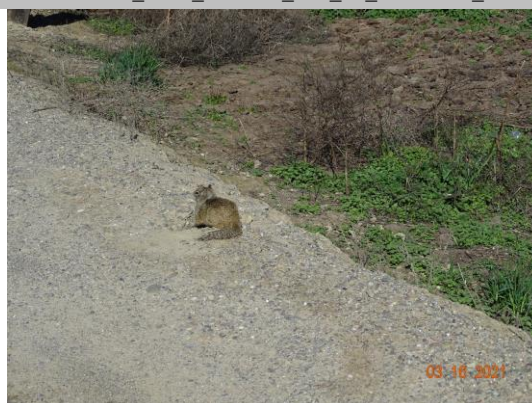
Photo 1 of 1 : FA_2023_RD2092_116_52_20230905_00023.jpg

View of single burrow and rodent observed on landside shoulder. (Spring 2021)

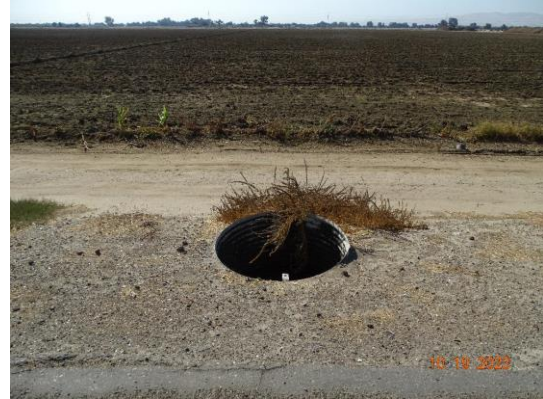
Photo 1 of 2 : UCIP_FA_2023_81482_117882.jpg

WS view: 48-inch CMP riser with no cover on slope; looking from crown.

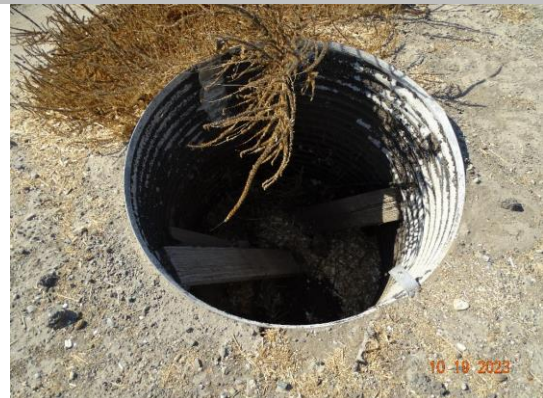
Photo 2 of 2 : UCIP_FA_2023_81482_117883.jpg

WS view: Debris within 48-inch CMP riser.
