**Flood Control Project Maintenance  
Levee Inspections**

## Maintenance Issue Types Only, Levee Inspection Report By Mile - Fall 2024

### Reclamation District No. 2092 Dos Rios

Waterway	Bank	Unit Miles	Inspection Start/End	Inspector
Unit No. 01 San Joaquin River	Right	3.71	10/15/2024 10/15/2024	Nate Hicks

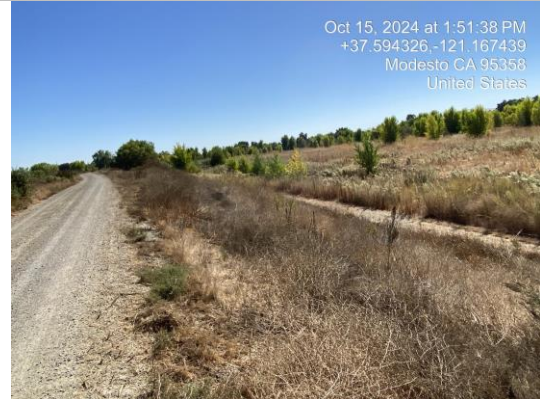
Photo 1 of 1 : FA\_2024\_RD2092\_116\_14\_20241021\_00055.jpg

LM Start	0.00	Rating **	U	Issue No.	14
LM End	2.94	Issue Type +	Ma	Location *	WS
Category	Earthen Levee			GPS Latitude/Longitude	
				Start	End
Item	Vegetation			37.602535°	37.574428°
				-121.158097°	-121.154023°
DWR ID	DWR_RD2092_01_f_2024_14				
Comment Code					
V1 : Control annual grass and weeds on the levee slopes and easements.					
Inspector Comment

View of vegetation on the waterside slope (Fall 2024).

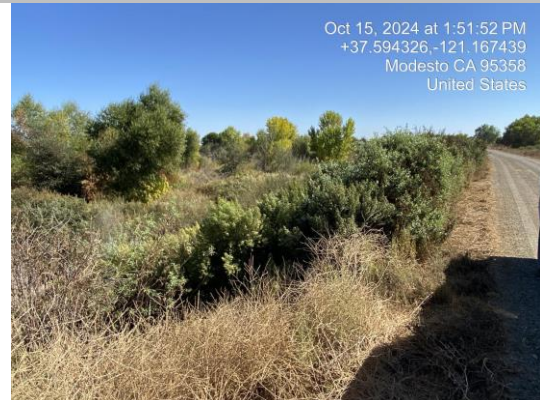
Photo 1 of 1 : FA\_2024\_RD2092\_116\_13\_20241021\_00056.jpg

LM Start	0.05	Rating **	U	Issue No.	13
LM End	2.94	Issue Type +	Ma	Location *	LS
Category	Earthen Levee			GPS Latitude/Longitude	
				Start	End
Item	Vegetation			37.602519°	37.574428°
				-121.159001°	-121.154024°
DWR ID	DWR_RD2092_01_f_2024_13				
Comment Code					
V1 : Control annual grass and weeds on the levee slopes and easements.					
Inspector Comment

View of vegetation on the landside slope (Fall 2024).

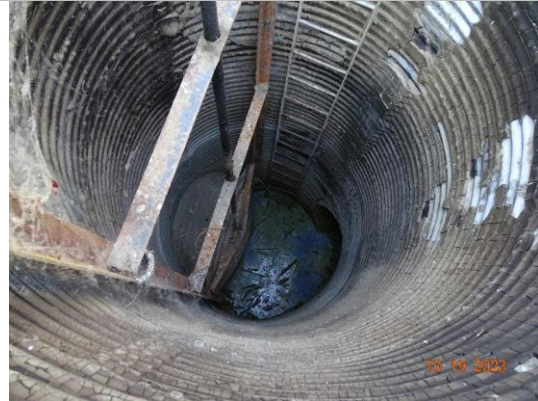
Photo 2 of 3 : UCIP\_FA\_2024\_81387\_117481.jpg

WS view: Slide gate located in CMP riser with debris.

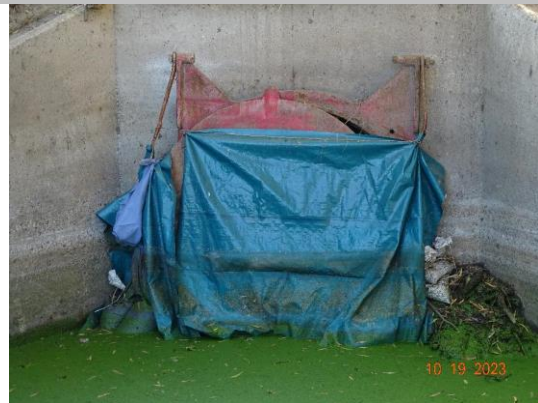
Photo 3 of 3 : UCIP\_FA\_2024\_81387\_117483.jpg

WS view: Close-up view of flap gate covered with tarp; hinge bent so flap gate is not closing properly.

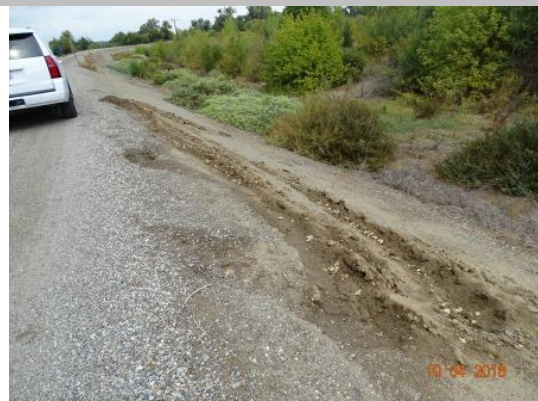
Photo 1 of 1 : FA\_2024\_RD2092\_116\_40\_20241015\_00010.jpg

LM Start	0.59	Rating **	M	Issue No.	40
LM End	0.59	Issue Type +	Ma	Location *	LS
Category	Earthen Levee			GPS Latitude/Longitude	
				Start	End
Item	Erosion / Vehicle Traffic			37.599406°	37.599406°
				-121.167083°	-121.167083°
DWR ID	DWR_RD2092_01_f_2018_40				
Comment Code					
E6 : Repair the levee slope damaged by vehicle traffic and prevent access where possible.					
Inspector Comment					
Vehicle tracks on the landside slope should be repaired.

Vehicle tracks on landside slope approximately 6" deep perpendicular to the slope. (Fall 2018)

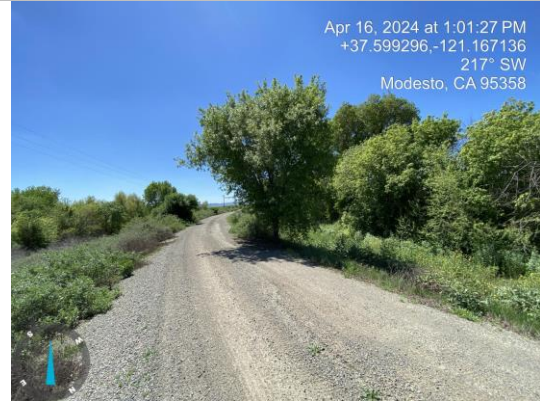
Photo 1 of 1 : FA\_2024\_RD2092\_116\_21\_20241015\_00006.jpg

LM Start	0.61	Rating **	M	Issue No.	21
LM End	0.61	Issue Type +	Ma	Location *	WS
Category	Earthen Levee			GPS Latitude/Longitude	
				Start	End
Item	Trim / Thin Trees			37.599208°	37.599208°
				-121.167150°	-121.167150°
DWR ID	DWR_RD2092_01_s_2024_21				
Comment Code					
T1 : Trim and thin trees to at least five feet above ground level to allow visibility of the ground and room to flood fight.					
Inspector Comment					
Trim tree 5 feet above the ground level.

Looking upstream at a tree growing in the waterside shoulder (Spring 2024).

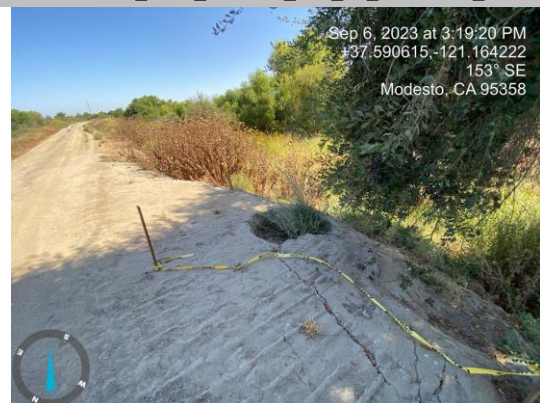
Photo 1 of 1 : FA\_2024\_RD2092\_116\_15\_20241015\_00002.jpg

LM Start	1.29	Rating **	U	Issue No.	15
LM End	1.29	Issue Type +	Ma	Location *	CR
Category	Earthen Levee			GPS Latitude/Longitude	
				Start	End
Item	Erosion / Bank Caving			37.590674°	37.590674°
				-121.164195°	-121.164195°
DWR ID	DWR_RD2092_01_f_2023_15				
Comment Code					
E2 : Schedule repair of erosion site prior to the next inspection.					
Inspector Comment					
A sinkhole has formed on the waterside shoulder and needs to be backfilled and compacted.

View of sinkhole near waterside shoulder (Fall 2023).

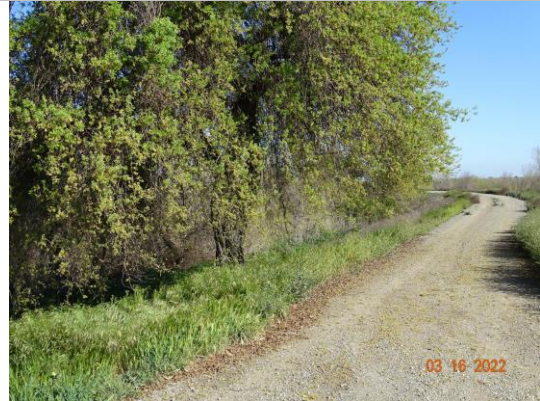
Photo 1 of 1 : FA\_2024\_RD2092\_116\_37\_20241015\_00008.jpg

LM Start	1.53	Rating **	M	Issue No.	37
LM End	1.53	Issue Type +	Ma	Location *	WS
Category	Earthen Levee			GPS Latitude/Longitude	
				Start	End
Item	Trim / Thin Trees			37.587961°	37.587961°
				-121.162259°	-121.162259°
DWR ID	DWR_RD2092_01_s_2021_37				
Comment Code					
T4 : Trim trees over roadway to at least 12 feet above ground level.					
Inspector Comment

View of tree branches hanging over the waterside slope and shoulder.  
(Spring 2022)

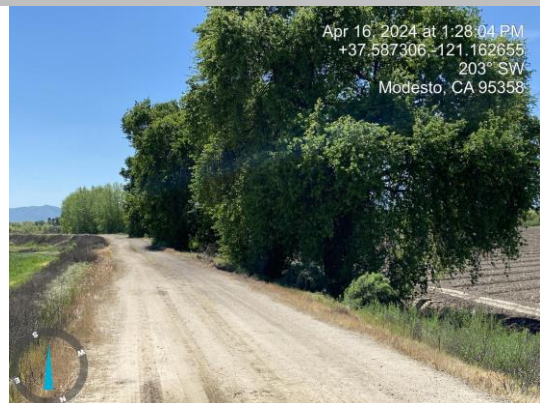
Photo 1 of 1 : FA\_2024\_RD2092\_116\_48\_20241015\_00013.jpg

LM Start	1.60	Rating **	M	Issue No.	48
LM End	1.71	Issue Type +	Ma	Location *	WS
Category	Earthen Levee			GPS Latitude/Longitude	
				Start	End
Item	Trim / Thin Trees			37.587068°	37.585551°
				-121.162773°	-121.163388°
DWR ID	DWR_RD2092_01_f_2019_48				
Comment Code					
T1 : Trim and thin trees to at least five feet above ground level to allow visibility of the ground and room to flood fight.					
Inspector Comment

View of low hanging tree limbs on the waterside slope (Spring 2024).

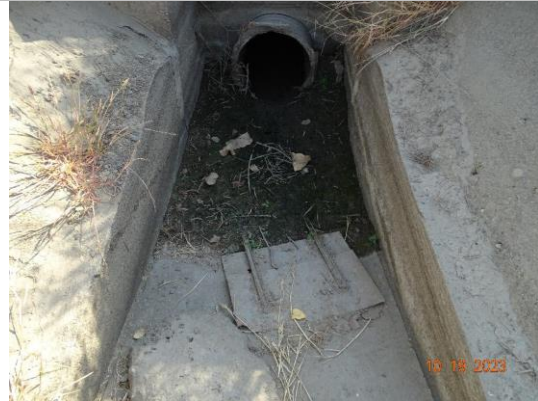
Photo 1 of 2 : UCIP\_FA\_2024\_81556\_117531.jpg

Comment Code						
Inspector Comment						
DS_ID:20563 FS_ID:81556 EP_NO: N/A Repair Type: Urgent EVAL Issue: 3a, Flood Risk Crossing Status: Found UCIP Comments: 10/19/2023 Record remains Urgent. Closure device on waterside missing potentially allowing uncontrolled flood water from WS to LS. Unable to locate CMP riser on WS slope due to overgrown vegetation. No issues observed on the LS headwall. DMP internal video inspection has found none or minor pipe defects. Recommend next video inspection in 5 years. (M. Thao - DWR UCIP) 03/12/2019 A thorough internal evaluation of this crossing is required, pipe shows evidence of pipe integrity (LS) issues (pipe wall sections missing on WS outlet). Internal inspection is recommended for this crossing to determine the extent of pipe damage through the levee. Maintenance issues identified at this crossing include: flap gate missing on WS, debris found inside concrete distribution box, and missing cover on riser. No permit has been identified for this crossing. Need to determine who maintains crossing; crossing appears functional. (O. Magana - DWR UCIP) FIELD_STRUCT_DESC: 24-inch corrugated metal drainage pipe through the levee, 14 feet below the crown. Slide gate in a corrugated metal pipe (CMP) riser on the waterside (WS) slope. Concrete U-shaped headwall at the landside (LS) toe. [Additional Reference(s): DWR Levee Log, 2005. USACE San Joaquin O&M Manual 5, August 1961, (HLM 1.71)]. FS Date: 10/19/2023 10:15:17 AM

WS view: Pipe outlet at toe with missing closure device.

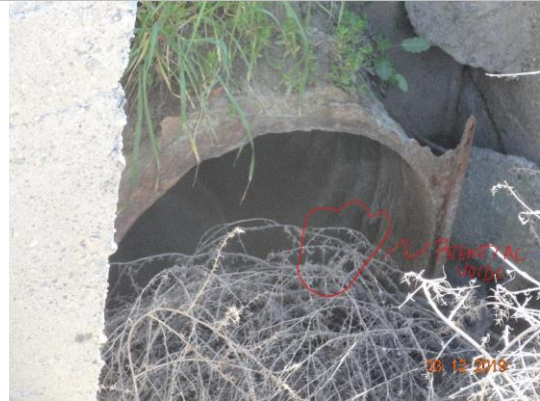
Photo 2 of 2 : UCIP\_FA\_2024\_81556\_79081.jpg

WS view: potential voids visible at pipe outlet.

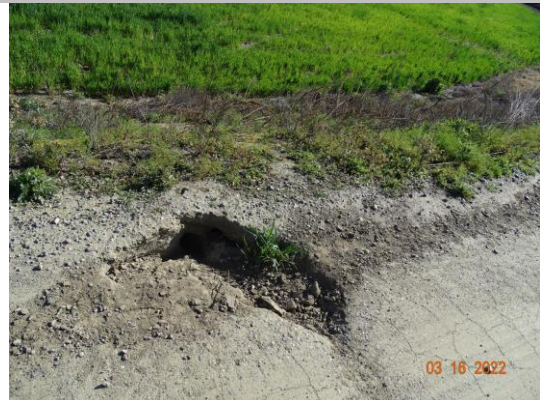
Photo 1 of 1 : FA\_2024\_RD2092\_116\_49\_20241015\_00014.jpg

LM Start	1.81	Rating **	A/W	Issue No.	49
LM End	1.81	Issue Type +	Ma	Location *	CR
Category	Earthen Levee			GPS Latitude/Longitude	
				Start	End
Item	Animal Control			37.584288°	37.584288°
				-121.162864°	-121.162864°
DWR ID	DWR_RD2092_01_s_2022_49				
Comment Code					
A3 : No rodents visible, but rodent burrows visible; need to backfill and compact or grout burrows.					
Inspector Comment

Levee crown collapsing into a rodent burrow. (Spring 2022)

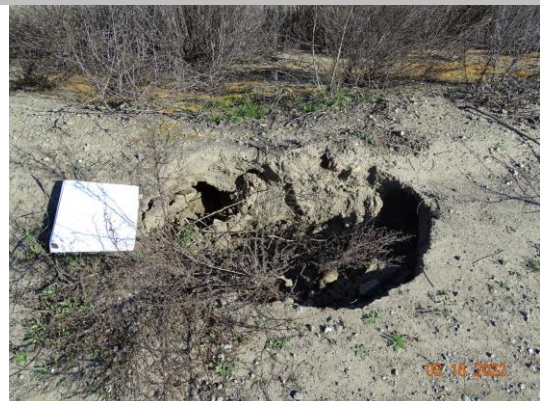
Photo 1 of 1 : FA\_2024\_RD2092\_116\_62\_20241015\_00021.jpg

LM Start	1.88	Rating **	A/W	Issue No.	62
LM End	1.88	Issue Type +	Ma	Location *	CR
Category	Earthen Levee			GPS Latitude/Longitude	
				Start	End
Item	Animal Control			37.584091°	37.584091°
				-121.161624°	-121.161624°
DWR ID	DWR_RD2092_01_s_2022_62				
Comment Code					
A3 : No rodents visible, but rodent burrows visible; need to backfill and compact or grout burrows.					
Inspector Comment

Large hole in the levee crown from rodent burrows collapsing. (Spring 2022)

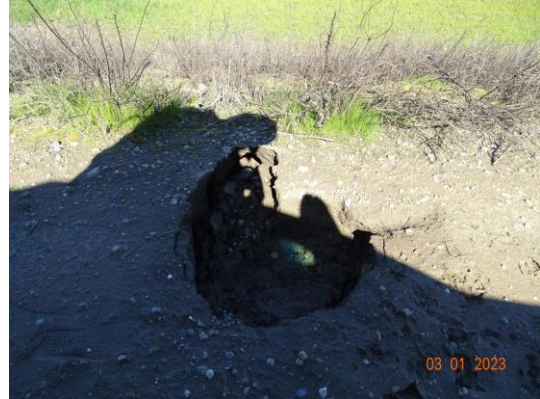
Photo 1 of 1 : FA\_2024\_RD2092\_116\_63\_20241015\_00022.jpg

View of collapsed rodent hole on the crown of the levee (Spring 2023).

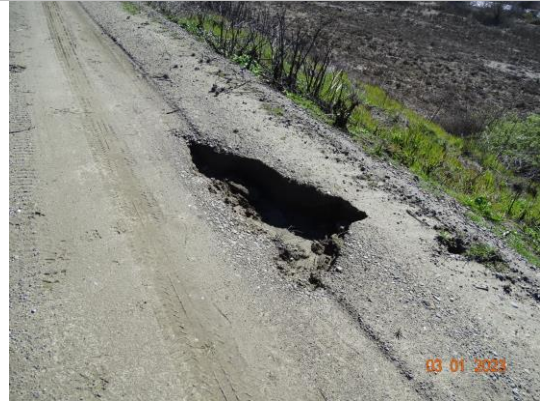
Photo 1 of 1 : FA\_2024\_RD2092\_116\_70\_20241015\_00025.jpg

LM Start	1.95	Rating **	A/W	Issue No.	70
LM End	1.95	Issue Type +	Ma	Location *	CR
Category	Earthen Levee			GPS Latitude/Longitude	
				Start	End
Item	Animal Control			37.584379°	37.584379°
				-121.160335°	-121.160335°
DWR ID	DWR_RD2092_01_s_2023_70				
Comment Code					
A3 : No rodents visible, but rodent burrows visible; need to backfill and compact or grout burrows.					
Inspector Comment

View of collapsed rodent hole on the crown of the levee (Spring 2023).

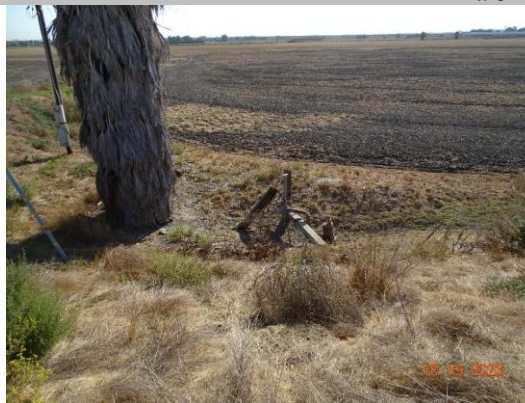
Photo 2 of 3 : UCIP\_FA\_2024\_81503\_117958.jpg

Comment Code						
Inspector Comment						
DS_ID:20567 FS_ID:81503 EP_NO: N/A Repair Type: Non-Urgent EVAL Issue: Crossing Status: Found UCIP Comments: 10/19/2023 Record remains Non-Urgent. Concrete headwall on LS may be buried; therefore, unable to locate concrete headwall. Concrete headwall on WS approximately 100 feet off toe was found; however, dense vegetation prevented inspection of the flap gate. Top of pipe leading to headwall is visible within the floodway. If crossing is no longer in use, recommend owner contact CVFPB to abandon pipe properly. (M. Thao - DWR UCIP) 03/12/2019 Unable to locate concrete headwall on the WS due to high water. Unable to locate concrete headwall on LS due to dense vegetation. No permit was found authorizing crossing. If crossing is no longer in use recommend removing crossing and appurtenances from levee. Need to coordinate with CVFPB to determine pipe owner. (O. Magana - DWR UCIP) 09/24/2013 Appears abandoned and if so should be done so properly. (W. Wylie - DWR UCIP) FIELD_STRUCT_DESC: *ABANDONED* 24-inch corrugated metal drainage pipe through the levee, 15 feet below the crown. Flap gate on the waterside (WS) end. Concrete U-shaped headwall on the WS end. Concrete headwall on the landside (LS) toe next to pump. [Additional Reference(s): DWR Levee Log, 2005. USACE San Joaquin O&M Manual 5, August 1961, (HLM 2.44)]. FS Date: 10/19/2023 8:57:18 AM

LS view: Looking from crown; no concrete headwall found. Pipe appurtenances associated with a different record (DSID 20568).

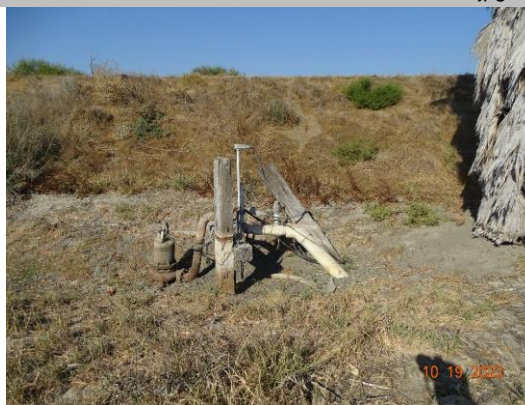
Photo 3 of 3 : UCIP\_FA\_2024\_81503\_117959.jpg

LS view: Looking toward levee; no concrete headwall found. Pipe appurtenances associated with a different record (DSID 20568).

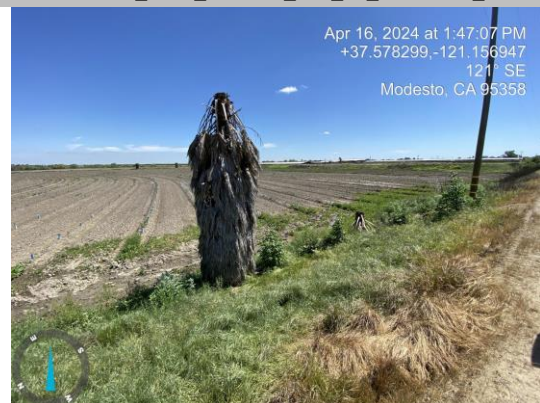
Photo 1 of 1 : FA\_2024\_RD2092\_116\_19\_20241015\_00004.jpg

View of palm tree on the landside slope and toe (Spring 2024).

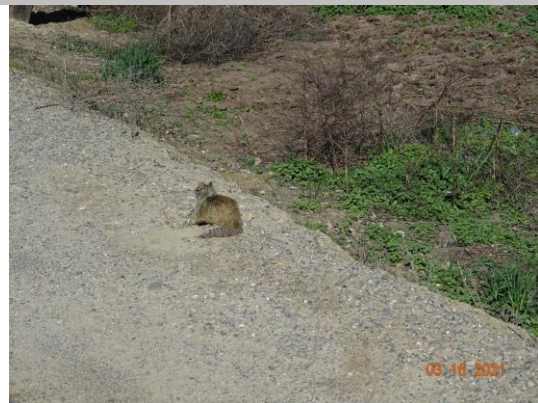
Photo 1 of 1 : FA\_2024\_RD2092\_116\_52\_20241015\_00017.jpg

LM Start	2.94	Rating **	A/W	Issue No.	52
LM End	2.94	Issue Type +	Ma	Location *	LS
Category	Earthen Levee			GPS Latitude/Longitude	
				Start	End
Item	Animal Control			37.574455°	37.574455°
				-121.154069°	-121.154069°
DWR ID	DWR_RD2092_01_s_2021_52				
Comment Code					
A1 : Exterminate rodents and backfill and compact or grout burrows.					
Inspector Comment					
Single rodent and burrow observed on landside shoulder. Backfill and monitor area for increase in rodent activity.

View of single burrow and rodent observed on landside shoulder. (Spring 2021)

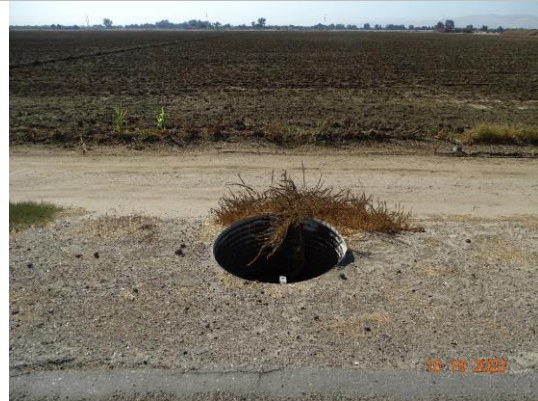
Photo 1 of 2 : UCIP\_FA\_2024\_81482\_117882.jpg

Comment Code						
Inspector Comment						
DS_ID:20572 FS_ID:81482 EP_NO:N/A Repair Type: Non-Urgent EVAL Issue: 4b, Safety Issue Crossing Status: Found UCIP Comments: 10/19/2023 Record remains Non-Urgent. No cover was present on WS CMP riser causing a safety hazard; recommend adding a cover. Debris found in CMP riser but no slide gate present. Concrete headwalls were not found on landside (LS) or WS. Geophysical study indicates possible presence of pipe through levee. If crossing is no longer in use, owner needs to coordinate with the CVFPB to remove or abandon crossing properly. (M. Thao - DWR UCIP) 03/12/2019 No permit was found authorizing crossing. Unable to confirm if crossing is in use. Recommend adding cover to riser to address safety concern. No slide gate was found in CMP riser. If crossing is no longer in use, recommend proper abandonment or removal from levee. Owner will need to coordinate with CVFPB to be compliant with Title 23. (O. Magana - DWR UCIP) 09/24/2013 This pipe appears abandoned and if so, should be done so properly. (W. Wylie - DWR UCIP) FIELD_STRUCT_DESC: 36-inch corrugated metal drainage pipe through the levee, 11 feet below the crown. Slide gate in a corrugated metal pipe (CMP) riser on the waterside (WS) slope. Concrete headwalls on both ends. [Additional Reference(s): DWR Levee Log, 2005. USACE San Joaquin O&M Manual 5, August 1961, (HLM 3.52)]. FS Date: 10/19/2023 12:01:36 PM

WS view: 48-inch CMP riser with no cover on slope; looking from crown.

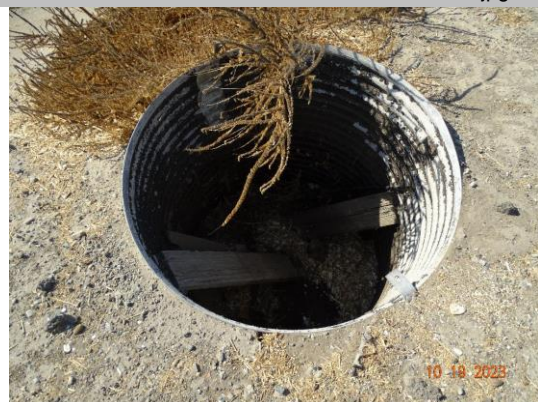
Photo 2 of 2 : UCIP\_FA\_2024\_81482\_117883.jpg

WS view: Debris within 48-inch CMP riser.
