**Flood Control Project Maintenance
Levee Inspections**

Maintenance Issue Types Only, Levee Inspection Report By Mile - Spring 2015

Reclamation District No. 2092 Dos Rios

Waterway	Bank	Unit Miles	Inspection Start/End	Inspector
Unit No. 01 San Joaquin River	Right	3.71	04/02/2015 04/02/2015	Pavel Kazi

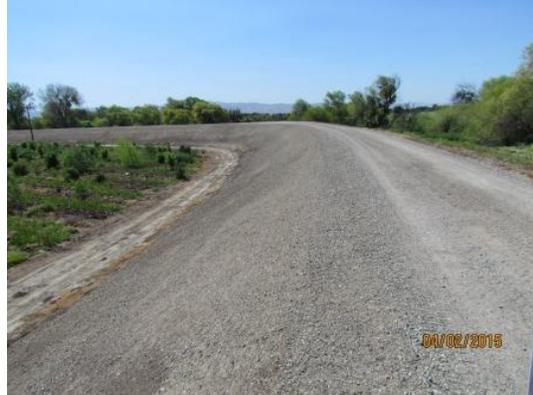
Photo 1 of 1 : SP_2015_RD2092_116_14_20150406_00015.jpg

LM Start	0.44	Rating **	A	Issue No.	14
LM End	0.44	Issue Type +	Ma	Location *	LS
Category	Earthen Levee		GPS Latitude/Longitude		
			Start	End	
Item	Vegetation		37.601192 °	37.601192 °	
			-121.165838 °	-121.165838 °	
DWR ID	DWR_RD2092_01_s_2015_14				
Action/Comments					
Control annual grass and weeds on the levee slopes and easements.

View of the landside slope of the levee looking upstream during spring 2015 inspection.

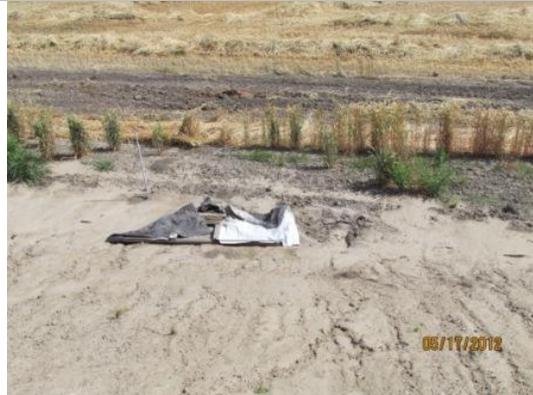
Photo 1 of 2 : SP_2015_RD2092_116_10_20150313_00003.jpg

LM Start	1.32	Rating **	A/W	Issue No.	10
LM End	1.32	Issue Type +	Ma	Location *	LS
Category	Earthen Levee		GPS Latitude/Longitude		
			Start	End	
Item	Encroachments		37.590467 °	37.590467 °	
			-121.163822 °	-121.163822 °	
DWR ID	DWR_RD2092_01_s_2012_10				
Action/Comments					
Pipe Inspector Comments: A sand boil appeared on the landside toe of the levee because of an underground pipe leakage. The pipe and boil have been repaired but should be monitored.

During spring inspection 2012, the sand boil was not active but materials were present on the landside toe of the levee. The sand boil occurred due to an underground irrigation pipe leakage. The picture was taken from the crown looking toward the toe of the levee. The area was repaired but should be monitored.

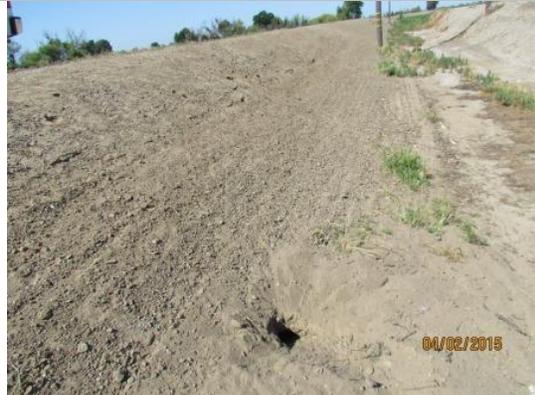
Photo 1 of 1 : SP_2015_RD2092_116_19_20150406_00016.jpg

LM Start	2.70	Rating **	M	Issue No.	19
LM End	2.70	Issue Type +	Ma	Location *	LS
Category	Earthen Levee		GPS Latitude/Longitude		
			Start	End	
Item	Animal Control		37.576165 °	37.576165 °	
			-121.157230 °	-121.157230 °	
DWR ID	DWR_RD2092_01_s_2015_19				
Action/Comments					
No rodents visible, but rodent burrows visible; need to backfill and compact or grout burrows.

A rodent hole was found on the landside toe of the levee looking downstream.
