**Flood Control Project Maintenance
Levee Inspections**

Maintenance Issue Types Only, Levee Inspection Report By Mile - Spring 2016

Reclamation District No. 2092 Dos Rios

Waterway	Bank	Unit Miles	Inspection Start/End	Inspector
Unit No. 01 San Joaquin River	Right	3.71	04/07/2016 04/07/2016	Pavel Kazi

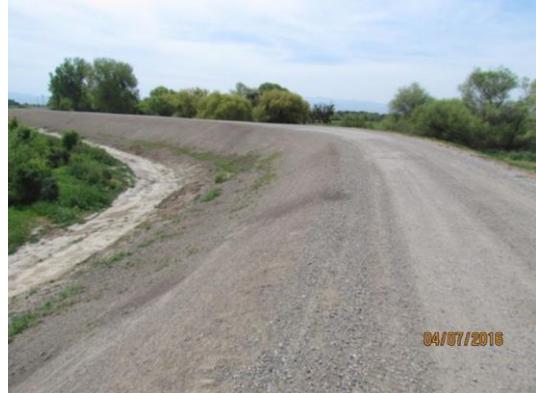
Photo 1 of 1 : SP_2016_RD2092_116_2_20160408_00032.jpg

LM Start	0.47	Rating **	A	Issue No.	2
LM End	0.47	Issue Type +	Ma	Location *	LS
Category	Earthen Levee		GPS Latitude/Longitude		
			Start	End	
Item	Vegetation		37.601056 °	37.601056 °	
			-121.166305 °	-121.166305 °	
DWR ID	DWR_RD2092_01_s_2016_2				
Comment Code					
V1 : Control annual grass and weeds on the levee slopes and easements.					
Inspector Comment

View of acceptable vegetation on the landside of the levee.

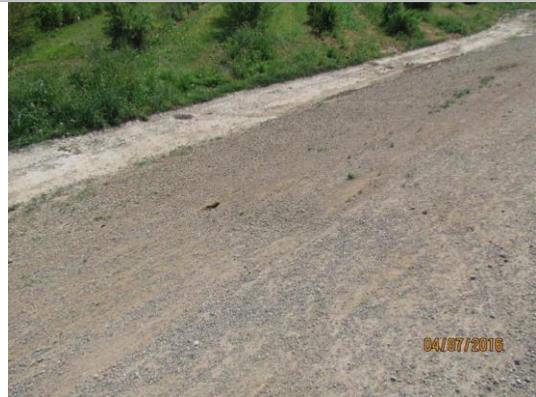
Photo 1 of 1 : SP_2016_RD2092_116_13_20160408_00033.jpg

LM Start	0.65	Rating **	M	Issue No.	13
LM End	0.65	Issue Type +	Ma	Location *	LS
Category	Earthen Levee		GPS Latitude/Longitude		
			Start	End	
Item	Animal Control		37.598640 °	37.598640 °	
			-121.167578 °	-121.167578 °	
DWR ID	DWR_RD2092_01_s_2016_13				
Comment Code					
A3 : No rodents visible, but rodent burrows visible; need to backfill and compact or grout burrows.					
Inspector Comment

View of rodent holes on the landside of the levee looking upstream.

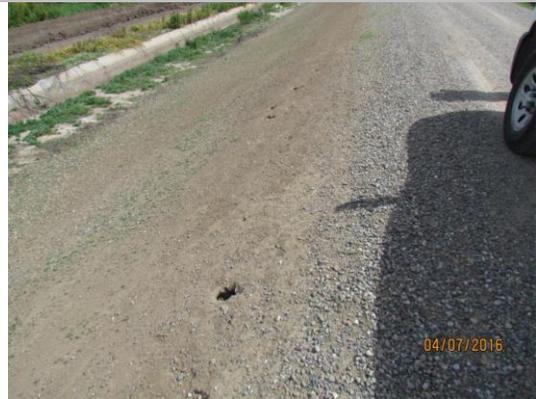
Photo 1 of 1 : SP_2016_RD2092_116_15_20160408_00034.jpg

LM Start	1.21	Rating **	M	Issue No.	15
LM End	1.21	Issue Type +	Ma	Location *	LS
Category	Earthen Levee		GPS Latitude/Longitude		
			Start	End	
Item	Animal Control		37.591293 °	37.591293 °	
			-121.165434 °	-121.165434 °	
DWR ID	DWR_RD2092_01_s_2016_15				
Comment Code					
A3 : No rodents visible, but rodent burrows visible; need to backfill and compact or grout burrows.					
Inspector Comment

View of rodent holes on the landside of the levee.

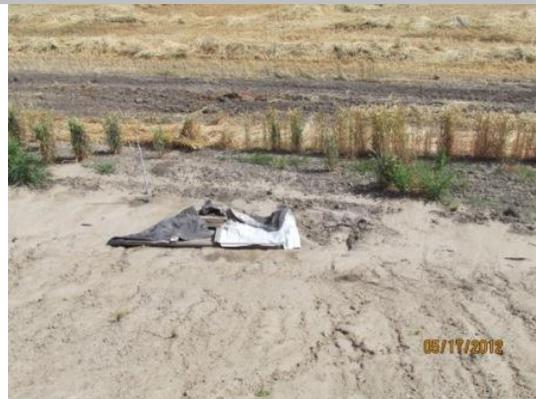
Photo 1 of 2 : SP_2016_RD2092_116_10_20160219_00003.jpg

LM Start	1.32	Rating **	A/W	Issue No.	10
LM End	1.32	Issue Type +	Ma	Location *	LS
Category	Earthen Levee		GPS Latitude/Longitude		
			Start	End	
Item	Encroachments		37.590467 °	37.590467 °	
			-121.163822 °	-121.163822 °	
DWR ID	DWR_RD2092_01_s_2012_10				
Comment Code					
PI : Pipe					
Inspector Comment					
A sand boil appeared on the landside toe of the levee because of an underground pipe leakage. The pipe and boil have been repaired but should be monitored.

During spring inspection 2012, the sand boil was not active but materials were present on the landside toe of the levee. The sand boil occurred due to an underground irrigation pipe leakage. The picture was taken from the crown looking toward the toe of the levee. The area was repaired but should be monitored.

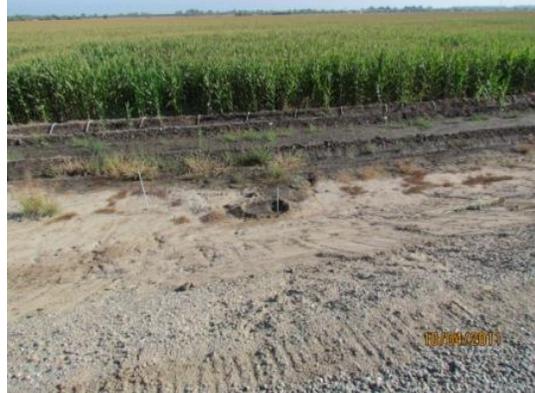
Photo 2 of 2 : SP_2016_RD2092_116_10_20160219_00004.jpg

LM Start	1.32	Rating **	A/W	Issue No.	10 (cont)
LM End	1.32	Issue Type +	Ma	Location *	LS
Category	Earthen Levee		GPS Latitude/Longitude		
			Start	End	
Item	Encroachments		37.590467 °	37.590467 °	
			-121.163822 °	-121.163822 °	
DWR ID	DWR_RD2092_01_s_2012_10				
Comment Code					
PI : Pipe					
Inspector Comment					
A sand boil appeared on the landside toe of the levee because of an underground pipe leakage. The pipe and boil have been repaired but should be monitored.

A sand boil was found on the landside of the levee. It was caused by a pipe leak couple of feet below the boil location. LMA was notified to repair it as soon as possible. The picture was taken from the crown looking upstream.

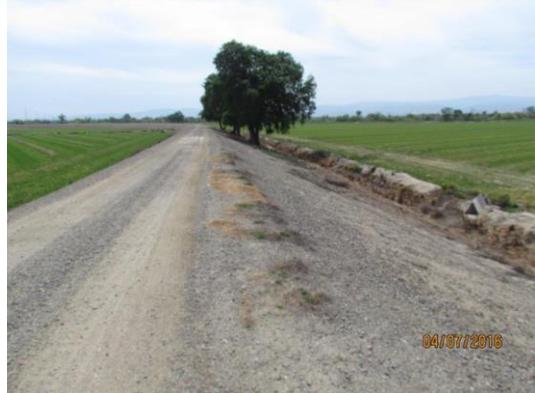
Photo 1 of 1 : SP_2016_RD2092_116_16_20160408_00035.jpg

LM Start	1.56	Rating **	A	Issue No.	16
LM End	1.56	Issue Type +	Ma	Location *	WS
Category	Earthen Levee		GPS Latitude/Longitude		
			Start	End	
Item	Vegetation		37.587590 °	37.587590 °	
			-121.162455 °	-121.162455 °	
DWR ID	DWR_RD2092_01_s_2016_16				
Comment Code					
V1 : Control annual grass and weeds on the levee slopes and easements.					
Inspector Comment

View of the acceptable vegetation on the waterside of the levee.

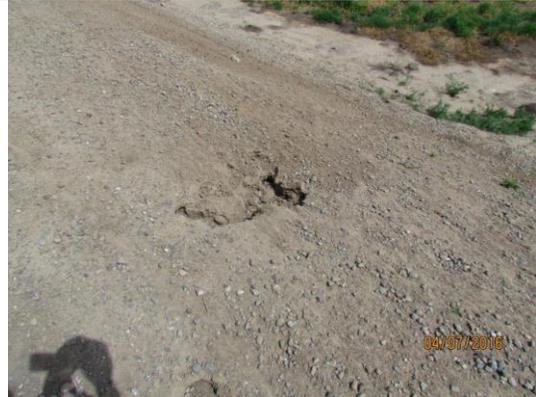
Photo 1 of 1 : SP_2016_RD2092_116_17_20160408_00036.jpg

LM Start	2.39	Rating **	M	Issue No.	17
LM End	2.39	Issue Type +	Ma	Location *	LS
Category	Earthen Levee		GPS Latitude/Longitude		
			Start	End	
Item	Erosion / Bank Caving		37.580628 °	37.580628 °	
			-121.156624 °	-121.156624 °	
DWR ID	DWR_RD2092_01_s_2016_17				
Comment Code					
E2 : Schedule repair of erosion site prior to the next inspection.					
Inspector Comment					
Erosion due to runoff

View of an erosion caused by runoff on the waterside slope of the levee.

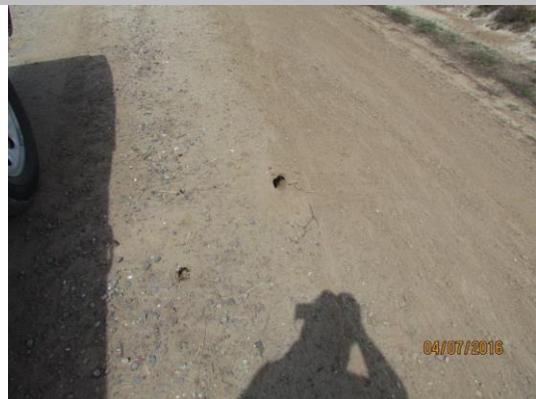
Photo 1 of 1 : SP_2016_RD2092_116_29_20160408_00037.jpg

LM Start	2.68	Rating **	M	Issue No.	29
LM End	2.68	Issue Type +	Ma	Location *	LS
Category	Earthen Levee		GPS Latitude/Longitude		
			Start	End	
Item	Animal Control		37.576451 °	37.576451 °	
			-121.157208 °	-121.157208 °	
DWR ID	DWR_RD2092_01_s_2016_29				
Comment Code					
A3 : No rodents visible, but rodent burrows visible; need to backfill and compact or grout burrows.					
Inspector Comment

View of rodent holes on the landside shoulder of the levee looking downstream.

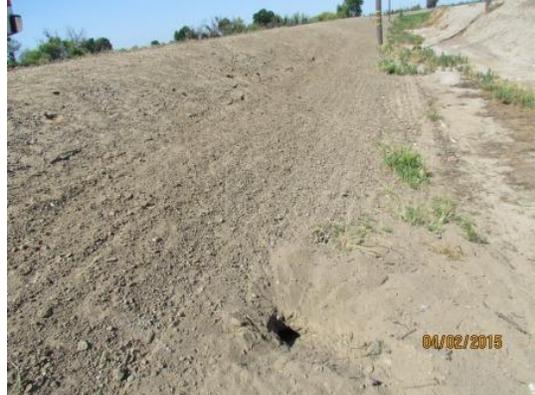
Photo 1 of 1 : SP_2016_RD2092_116_19_20160219_00006.jpg

LM Start	2.70	Rating **	M	Issue No.	19
LM End	2.70	Issue Type +	Ma	Location *	LS
Category	Earthen Levee		GPS Latitude/Longitude		
			Start	End	
Item	Animal Control		37.576165 °	37.576165 °	
			-121.157230 °	-121.157230 °	
DWR ID	DWR_RD2092_01_s_2015_19				
Comment Code					
A3 : No rodents visible, but rodent burrows visible; need to backfill and compact or grout burrows.					
Inspector Comment

A rodent hole was found on the landside toe of the levee looking downstream.

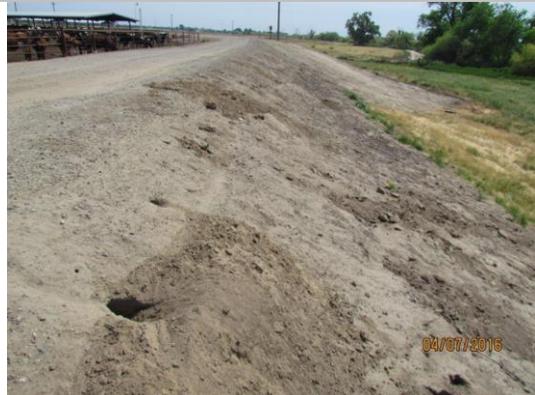
Photo 1 of 1 : SP_2016_RD2092_116_30_20160408_00038.jpg

LM Start	2.73	Rating **	U	Issue No.	30
LM End	2.73	Issue Type +	Ma	Location *	WS
Category	Earthen Levee		GPS Latitude/Longitude		
			Start	End	
Item	Animal Control		37.575743 °	37.575743 °	
			-121.157237 °	-121.157237 °	
DWR ID	DWR_RD2092_01_s_2016_30				
Comment Code					
A3 : No rodents visible, but rodent burrows visible; need to backfill and compact or grout burrows.					
Inspector Comment

View of multiple rodent holes on the waterside of the levee looking upstream.
