**Flood Control Project Maintenance
Levee Inspections**

Fall 2008 Levee Maintenance Deficiency Summary Report

San Joaquin River Basin

Reclamation District No. 2094

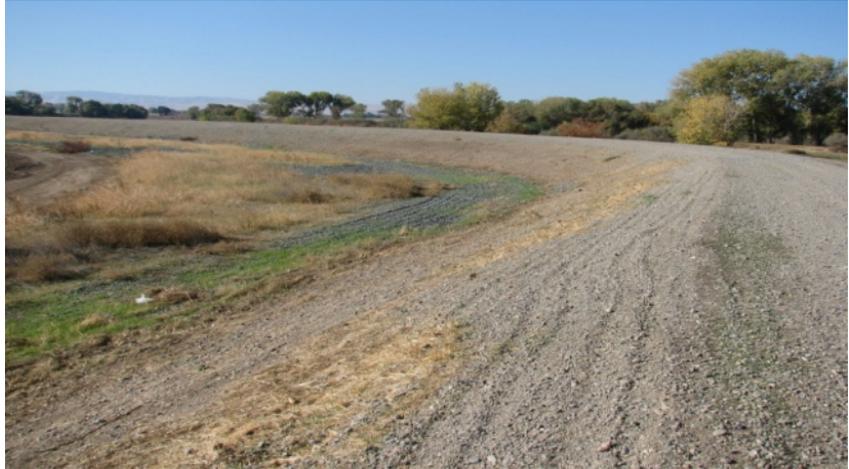
LMR Line	Levee Mile		Category	Item	* Location	** Rating	Action/Comment	GPS Latitude/Longitude		Photo	Issue
	Start	End						Start	End		
1	0.10	0.10	Earthen Levee	Vegetation	LS	A	Inspector Comments: This entire levee is free of vegetation. Very well maintained. Photos were taken at roughly LM 0.1 to show the good conditions on both LS and WS. Conditions are typical throughout levee.	37.771500 ° -121.300327 °	37.771501 ° -121.300327 °	Y	4
2	0.18	0.27	Earthen Levee	Animal Control	WS	M	No rodents visible, but rodent burrows visible; need to backfill and compact or grout borrows.	37.770437 ° -121.301015 °	37.769448 ° -121.300975 °	Y	2
3	0.40	0.45	Earthen Levee	Animal Control	WS	M	No rodents visible, but rodent burrows visible; need to backfill and compact or grout borrows.	37.768393 ° -121.299187 °	37.768500 ° -121.298360 °		5
4	0.40	0.45	Earthen Levee	Animal Control	LS	M	No rodents visible, but rodent burrows visible; need to backfill and compact or grout borrows.	37.768393 ° -121.299187 °	37.768467 ° -121.298355 °	Y	3

Levee Mile Report Line	1
Start Levee Mile	0.10
End Levee Mile	0.10
Location	
Category	Earthen Levee
Item	Vegetation
Photo documents general condition of this levee is well maintained.

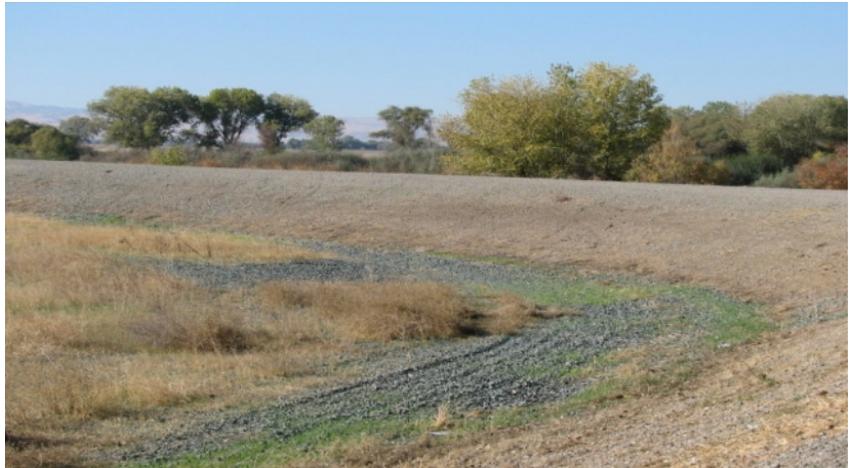
Levee Mile Report Line	1
Start Levee Mile	0.10
End Levee Mile	0.10
Location	
Category	Earthen Levee
Item	Vegetation
Another view.

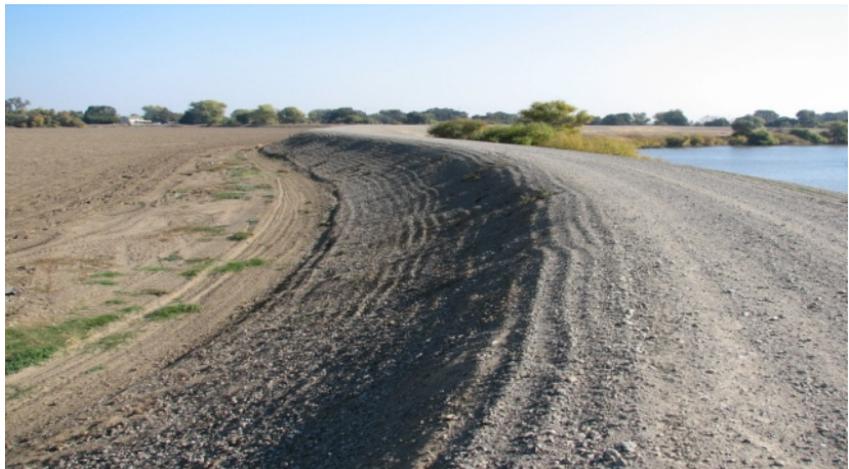
Levee Mile Report Line	1
Start Levee Mile	0.10
End Levee Mile	0.10
Location	
Category	Earthen Levee
Item	Vegetation
Another typical view. This shot was taken a bit farther along so the levee mile is not exactly 0.1 any longer.

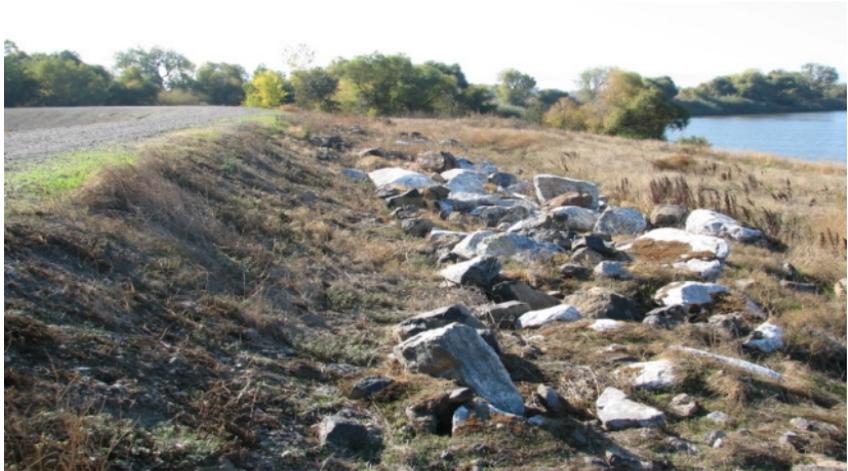
Levee Mile Report Line	2
Start Levee Mile	0.18
End Levee Mile	0.27
Location	
Category	Earthen Levee
Item	Animal Control
<p>Water side at approximate LM 0.24 unit 1 RD 2094. Inspector discovered evidence of many burrow holes in this area.</p>

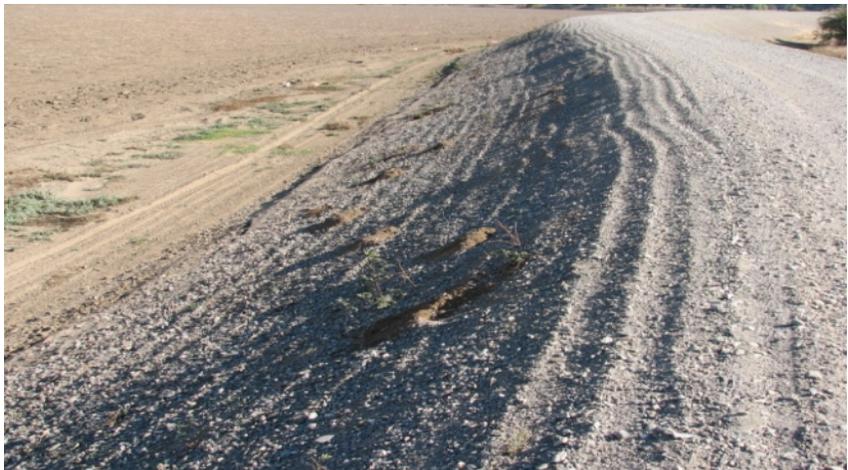
Levee Mile Report Line	4
Start Levee Mile	0.40
End Levee Mile	0.45
Location	
Category	Earthen Levee
Item	Animal Control
<p>Brown fluffy mounds were observed along the LS and WS at approximate LM vicinity 0.38. These mounds were unique to this area and may be caused by some type of burrowing animal.</p>

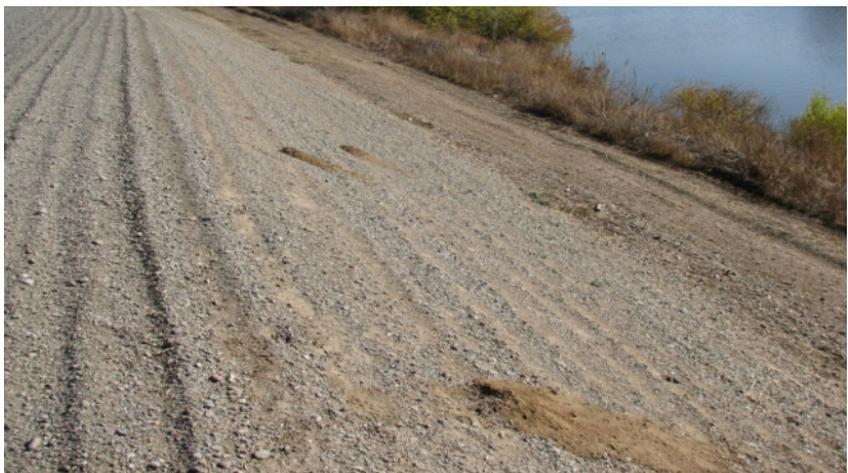
Levee Mile Report Line	4
Start Levee Mile	0.40
End Levee Mile	0.45
Location	
Category	Earthen Levee
Item	Animal Control
<p>WS view</p>
