**Flood Control Project Maintenance  
Levee Inspections**

**Fall 2010 Levee Maintenance Deficiency Summary Report**

**Reclamation District No. 2094 Wathal**

**Levee Inspection Report By Mile - Fall 2010**

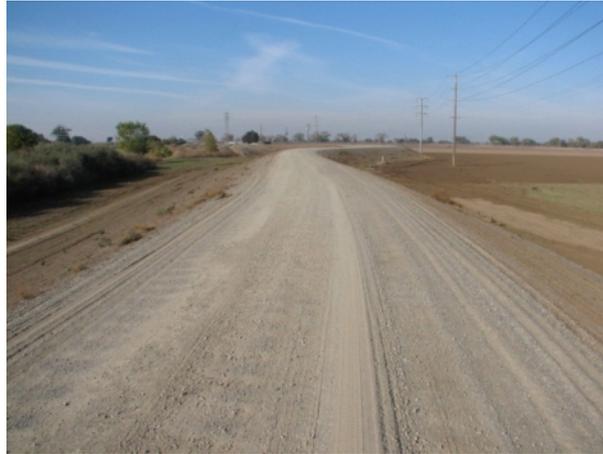
Levee Mile Report Line	1
Start Levee Mile	0.01
End Levee Mile	2.80
Location	Water Side
Category	Earthen Levee
Item	Vegetation
Levee slopes free of obstructive vegetation. Photo near LM 2.42 looking downstream.	
jpaasch_f_20101115_546.jpg

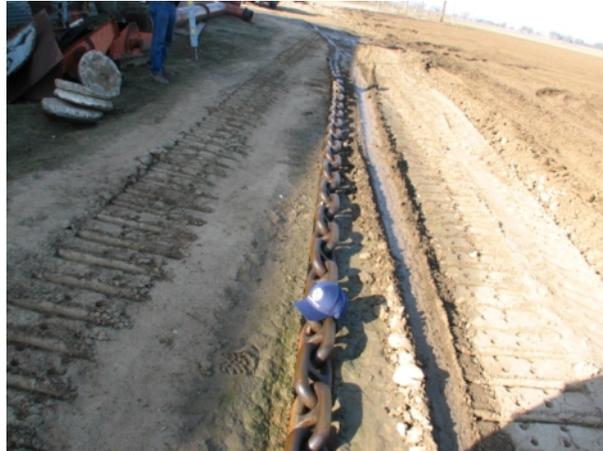
Levee Mile Report Line	1
Start Levee Mile	0.01
End Levee Mile	2.80
Location	Water Side
Category	Earthen Levee
Item	Vegetation
Photo of anchor chain used to manage vegetation on levee slopes.	
jpaasch_f_20101115_547.jpg

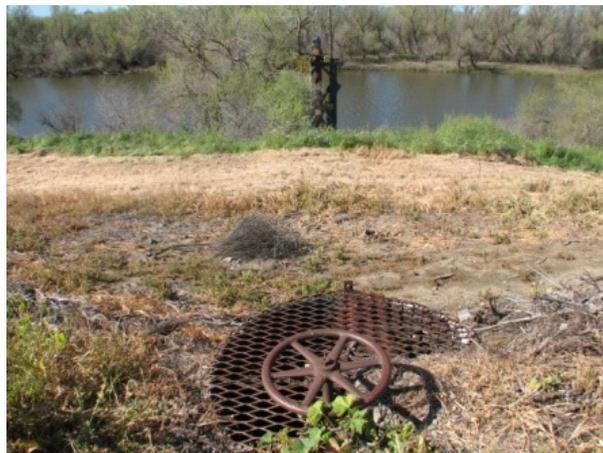
Levee Mile Report Line	3
Start Levee Mile	0.66
End Levee Mile	0.66
Location	Water Side
Category	Earthen Levee
Item	Encroachments
Irrigation intake on San Joaquin River. Positive closure device (sliuce gate) on water side hinge points. Pipe is through freeboard portion of levee. Concrete stand pipe beyond landside toe.	
jpaasch_f_20100923_366.jpg

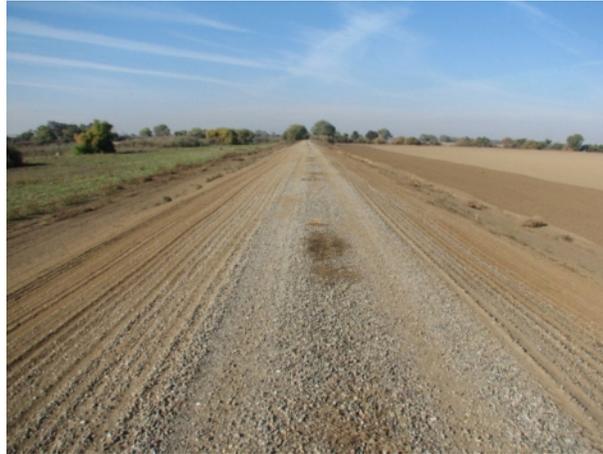
jpaasch\_f\_20101115\_001.jpg

Levee Mile Report Line	1
Start Levee Mile	0.01
End Levee Mile	0.46
Location	Water Side
Category	Earthen Levee
Item	Vegetation

Vegetation maintenance on Unit 2 is acceptable.
