**Flood Control Project Maintenance
Levee Inspections**

Fall 2013 Levee Maintenance Deficiency Summary Report

Reclamation District No. 2094 Wathal

Levee Inspection Report By Mile - Fall 2013

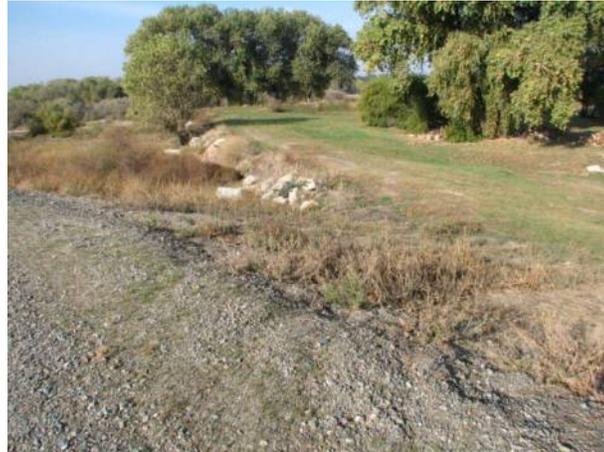
Levee Mile Report Line	4
Start Levee Mile	0.10
End Levee Mile	0.10
Location	Water Side
Category	Earthen Levee
Item	Encroachments
<p>11/09/2011 Tire marks shown onto the ramp from levee. Raised area extends to the trees in the background in the center of the photo.</p>	
<p>mkhashch_f_20130923_486.jpg</p>

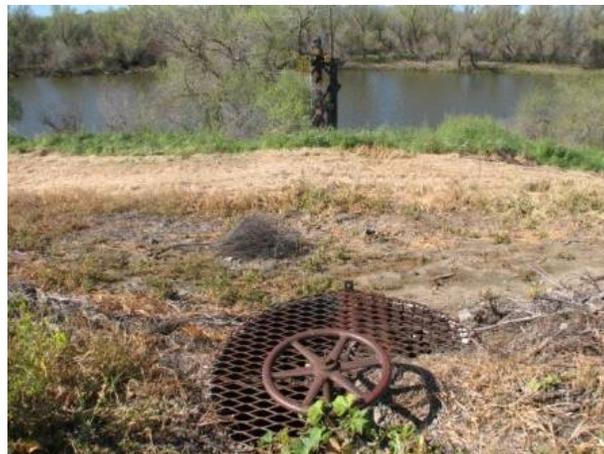
Levee Mile Report Line	7
Start Levee Mile	0.66
End Levee Mile	0.66
Location	Water Side
Category	Earthen Levee
Item	Encroachments
<p>Irrigation intake on the San Joaquin River. Positive closure device (sliuce gate) on water side hinge points. Pipe is through the freeboard portion of levee. Concrete stand pipe is shown beyond landside toe.</p>	
<p>mkhashch_f_20130923_484.jpg</p>

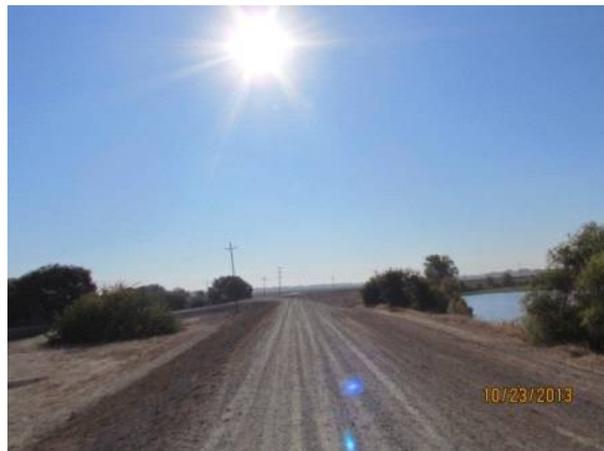
Levee Mile Report Line	8
Start Levee Mile	0.69
End Levee Mile	0.69
Location	Water Side
Category	Earthen Levee
Item	Vegetation
<p>View of acceptable vegetation control on levee slopes.</p>	
<p>mkhashch_f_20131028_700.JPG</p>

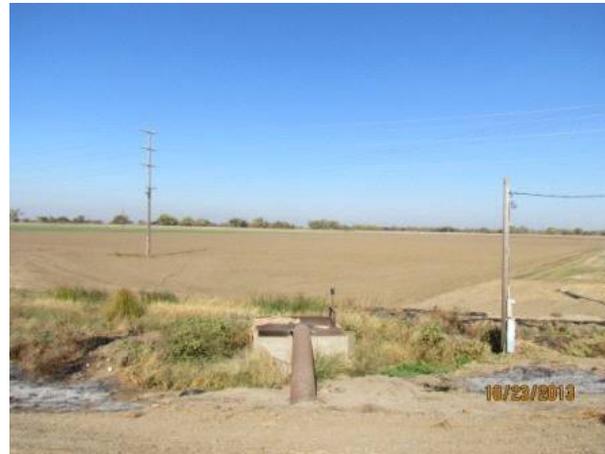
Levee Mile Report Line	10
Start Levee Mile	2.29
End Levee Mile	2.29
Location	Water Side
Category	Earthen Levee
Item	Encroachments

DWR ID: DWR_RD2094_01_s_2012_2		
10	2.29	2.29	Earthen Levee	Encroachments	WSA/W	En	PI : Pipe Inspector Comments: 20" steel rrigation intake.	37.752225 ° -121.296431 °	37.752225 ° -121.296431 °	3 Y
								DWR ID: DWR_RD2094_01_s_2012_3

View of the pipe daylighting on the landside levee slope.

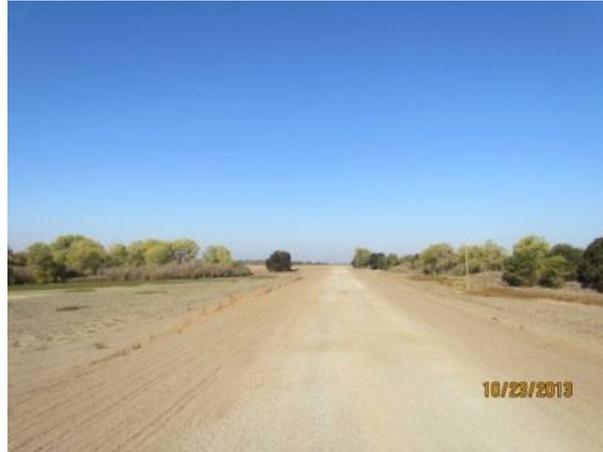
Levee Mile Report Line	1
Start Levee Mile	0.02
End Levee Mile	0.44
Location	Water Side
Category	Earthen Levee
Item	Vegetation
View of acceptable vegetation control on levee slopes.	
mkhashch_f_20131028_702.JPG

LMIR No.	Levee Mile		Category	Item	Location	Rating	Action/Comment	GPS Latitude/Longitude		Issue No. Photo
	Start	End						Start	End	
1	0.02	0.44	Earthen Levee	Vegetation	WS	A	V1 : Control annual grass and weeds on the levee slopes and easements.	37.759310 °	37.760589 °	1
						Ma		-121.299890 °	-121.306968 °	Y
