**Flood Control Project Maintenance  
Levee Inspections**  
**LMA District Cover Sheet**  
**Spring 2014 Levee Inspection Results**

**Reclamation District No. 2094 Wathal**

**Levee Inspection Report By Mile - Spring 2014**

Waterway		Bank	Unit Miles	Inspection Start/End	Inspector
Unit No. 01 San Joaquin River		Right	2.82	05/15/2014 05/15/2014	Maksim Khashchuk

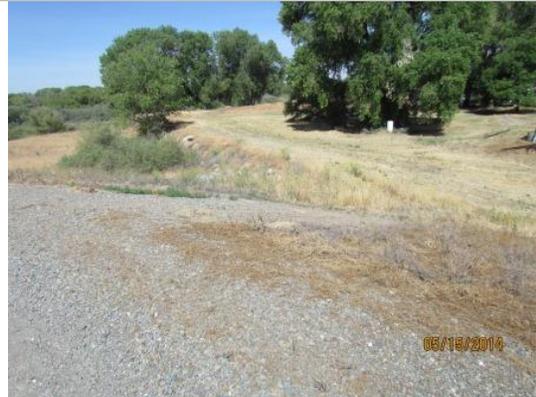
Photo 1 of 1 : mkhashch\_s\_20140519\_01038.jpg

LM Start	<b>0.10</b>	Rating **	M	Issue No.	<b>4</b>
LM End	<b>0.10</b>	Issue Type +	En	Location *	WS
Category	Earthen Levee		GPS Latitude/Longitude		
			Start	End	
Item	Encroachments		37.771685 °	37.771685 °	
			-121.300239 °	-121.300239 °	
DWR ID	DWR_RD2094_01_s_2012_4				
Action/Comments					
Ramp Inspector Comments: An access ramp has been built on the water side and extends into the channel. This could potentially alter the channel capacity. This item was also noted in the USACE comments.

Tire marks shown onto the ramp from levee. Raised area extends to the trees in the background in the center of the photo.

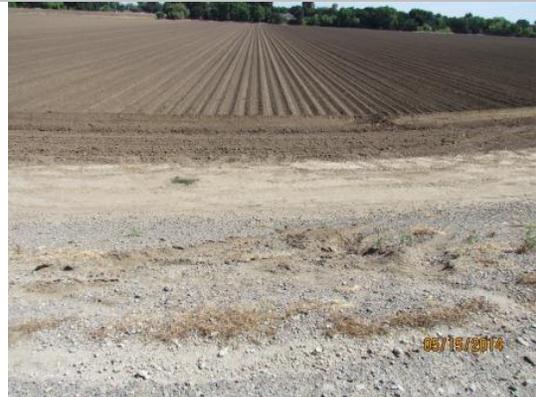
Photo 1 of 1 : mkhashch\_s\_20140519\_01039.jpg

View of the tire tracks on the landside levee slope.

LM Start	<b>0.39</b>	Rating **	M	Issue No.	<b>13</b>
LM End	<b>0.39</b>	Issue Type +	Ma	Location *	LS
Category	Earthen Levee		GPS Latitude/Longitude		
			Start	End	
Item	Slope Stability		37.768427 °	37.768427 °	
			-121.299267 °	-121.299267 °	
DWR ID	DWR_RD2094_01_s_2014_13				
Action/Comments					
Repair the levee slope damaged by vehicle traffic and prevent access where possible.

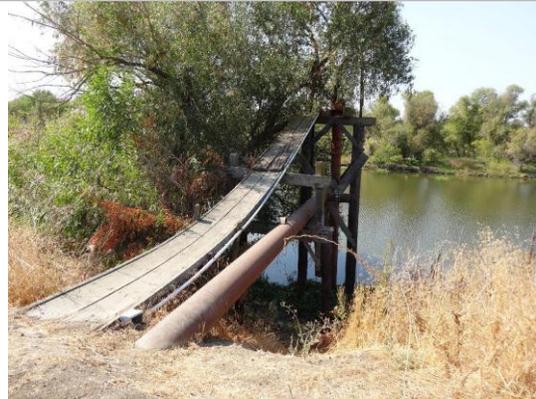
Photo 1 of 1 : UCIP\_2501.jpg

LM Start	<b>0.66</b>	Rating **	M	Issue No.	<b>6</b>
LM End	<b>0.66</b>	Issue Type +	En	Location *	LS
Category	Supplemental		GPS Latitude/Longitude		
			Start	End	
Item	DWR UCIP Field Study		37.767514 °	37.767514 °	
			-121.294926 °	-121.294926 °	
DWR ID	DWR_RD2094_01_s_2014_6				
Action/Comments					
Inspector Comments: FS_ID:21464 EP_NO: N/A Repair Type: Crossing Status: UCIP Comments: - walkway in poor condition and needs repair. electric conduit on waterside. FIELD_STRUCT_DESC: 14-inch concrete encased steel pipe and GI conduit through the levee, 10.0 feet below the crown, pump mounted on a pile structure in the stream, slide gate, 54-inch corrugated metal pipe riser on the waterward shoulder, concrete distribution box and service pole on the landward toe, installed by USCE, 1962 (O&M Unit No. 3, 1968) FS Date: 9/10/2013

WS view: pump on piling structure in the channel. Pipe (right- bottom) and conduit (bottom- left).

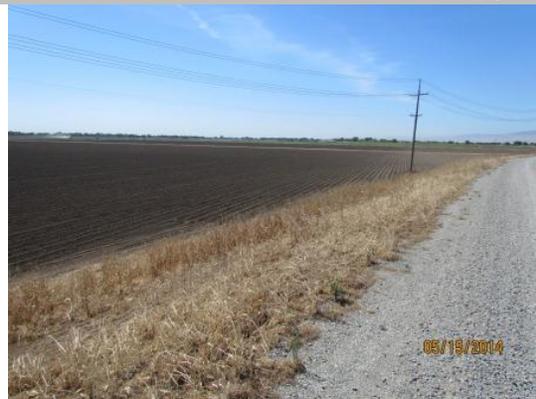
Photo 1 of 1 : mkhashch\_s\_20140519\_01040.jpg

View of the tall vegetation on the landside levee slope.

LM Start	<b>0.89</b>	Rating **	M	Issue No.	<b>1</b>
LM End	<b>1.07</b>	Issue Type +	Ma	Location *	LS
Category	Earthen Levee		GPS Latitude/Longitude		
			Start	End	
Item	Vegetation		37.764668 °	37.762428 °	
			-121.293413 °	-121.294769 °	
DWR ID	DWR_RD2094_01_s_2014_1				
Action/Comments					
Control annual grass and weeds on the levee slopes and easements.

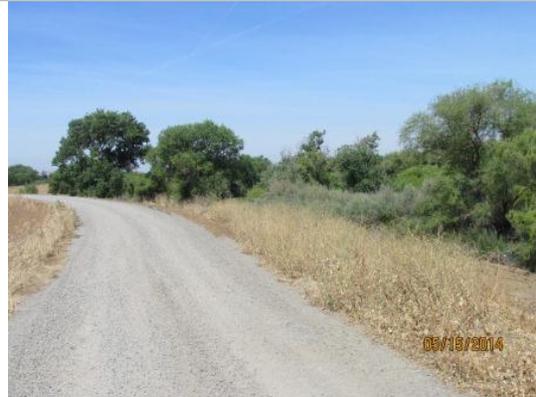
Photo 1 of 1 : mkhashch\_s\_20140519\_01041.jpg

View of the tall vegetation on the waterside levee slope.

LM Start	<b>1.26</b>	Rating **	M	Issue No.	<b>2</b>
LM End	<b>1.29</b>	Issue Type +	Ma	Location *	WS
Category	Earthen Levee		GPS Latitude/Longitude		
			Start	End	
Item	Vegetation		37.760613 °	37.760499 °	
			-121.297309 °	-121.297950 °	
DWR ID	DWR_RD2094_01_s_2014_2				
Action/Comments					
Control annual grass and weeds on the levee slopes and easements.

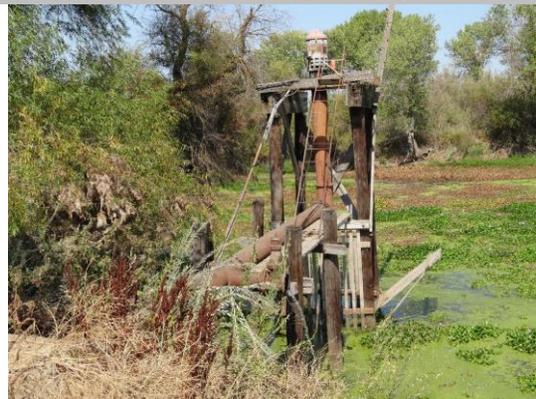
Photo 1 of 1 : UCIP\_2506.jpg

LM Start	<b>1.27</b>	Rating **	M	Issue No.	<b>7</b>
LM End	<b>1.27</b>	Issue Type +	En	Location *	WS
Category	Supplemental		GPS Latitude/Longitude		
			Start	End	
Item	DWR UCIP Field Study		37.760581 °	37.760581 °	
			-121.297373 °	-121.297373 °	
DWR ID	DWR_RD2094_01_s_2014_7				
Action/Comments					
Inspector Comments: FS_ID:21544 EP_NO: N/A Repair Type: Crossing Status: UCIP Comments: - working as drainage system during field visit. Pump was not running.electric conduit on WSopen pipe end in CMP riser. CMP needs cleaning. FIELD_STRUCT_DESC: 20-inch concrete encased steel pipe through the levee, 10.0 feet below the crown, pump mounted on a pile structure in the stream, gate valve, 54-inch corrugated metal pipe riser on the waterward shoulder, concrete distribution box and service pole on the landward toe (O&M Unit No. 3, 1968) FS Date: 9/10/2013

WS view: pipe and pump on piling structure in the channel. Walkway in poor condition.

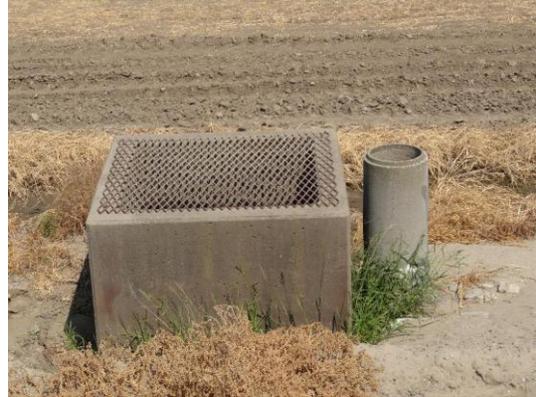
Photo 1 of 1 : UCIP\_2511.jpg

LM Start	<b>2.49</b>	Rating **	M	Issue No.	<b>8</b>
LM End	<b>2.49</b>	Issue Type +	En	Location *	WS
Category	Supplemental			GPS Latitude/Longitude	
				Start	End
Item	DWR UCIP Field Study			37.752308 °	37.752308 °
				-121.293191 °	-121.293191 °
DWR ID	DWR_RD2094_01_s_2014_8				
<b>Action/Comments</b>					
Inspector Comments: FS_ID:21545 EP_NO: N/A Repair Type: Crossing Status: UCIP Comments: - no pipes found on either side of the levee. concrete distribution box on LS. Soil erosion around distribution box. FIELD_STRUCT_DESC: Rectangular concrete distribution box on the landward toe FS Date: 9/10/2013

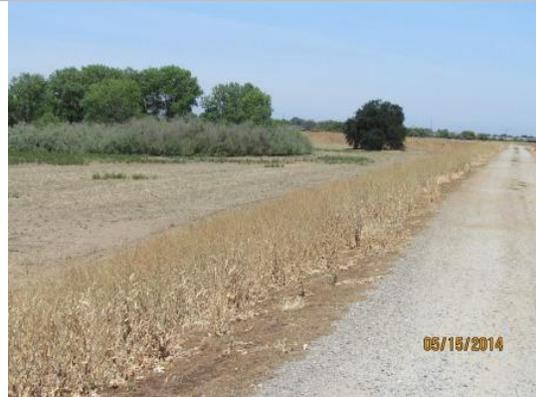
Photo 1 of 1 : mkhashch\_s\_20140519\_01042.jpg

View of the tall vegetation on the waterside levee slope.

LM Start	<b>0.01</b>	Rating **	M	Issue No.	<b>1</b>
LM End	<b>0.41</b>	Issue Type +	Ma	Location *	WS
Category	Earthen Levee			GPS Latitude/Longitude	
				Start	End
Item	Vegetation			37.759286 °	37.760643 °
				-121.299761 °	-121.306476 °
DWR ID	DWR_RD2094_02_s_2014_1				
Action/Comments					
Control annual grass and weeds on the levee slopes and easements.
