**Flood Control Project Maintenance  
Levee Inspections**

**Maintenance Issue Types Only, Levee Inspection Report By Mile - Spring 2016**

**Reclamation District No. 2094 Wathal**

Waterway	Bank	Unit Miles	Inspection Start/End	Inspector
Unit No. 01 San Joaquin River	Right	2.78	04/07/2016 04/07/2016	Maksim Khashchuk

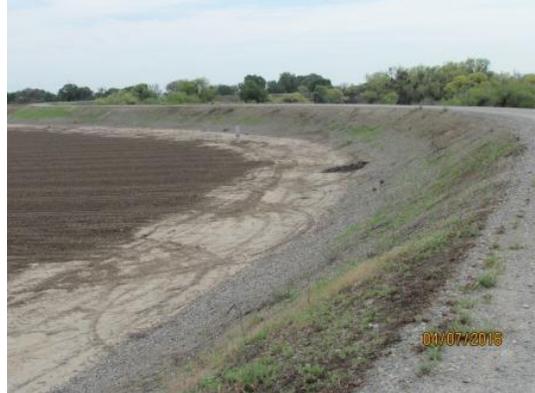
Photo 1 of 1 : SP\_2016\_RD2094\_320\_7\_20160412\_00014.jpg

LM Start	<b>0.34</b>	Rating **	A	Issue No.	<b>7</b>
LM End	<b>0.34</b>	Issue Type +	Ma	Location *	LS
Category	Earthen Levee		GPS Latitude/Longitude		
			Start	End	
Item	Vegetation		37.768761 °	37.768761 °	
			-121.299990 °	-121.299990 °	
DWR ID	DWR_RD2094_01_s_2016_7				
Comment Code					
V1 : Control annual grass and weeds on the levee slopes and easements.					
Inspector Comment

View of the acceptable vegetation on the landside levee slope.
