**Flood Control Project Maintenance
Levee Inspections
LMA District Cover Sheet
Spring 2013 Levee Inspection Results**

Reclamation District No. 2094 Wathal

Levee Inspection Report By Mile - Spring 2013

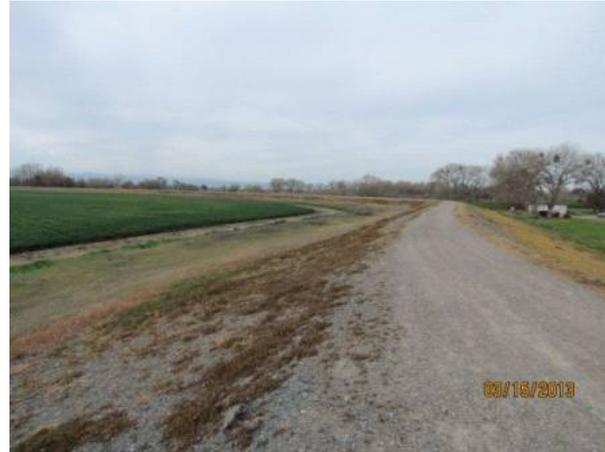
Levee Mile Report Line	4
Start Levee Mile	0.00
End Levee Mile	0.00
Location	Land Side
Category	
Item	Vegetation
View of acceptable vegetation on the landside slope.	
mkhashch_s_20130315_643.JPG

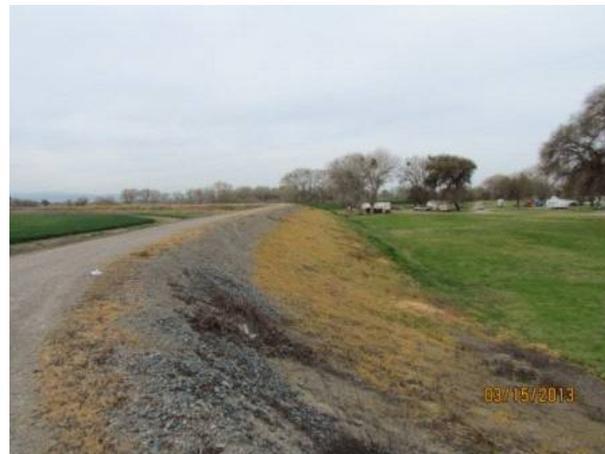
Levee Mile Report Line	5
Start Levee Mile	0.00
End Levee Mile	0.00
Location	Water Side
Category	
Item	Vegetation
View of acceptable vegetation on the waterside slope.	
mkhashch_s_20130315_642.JPG

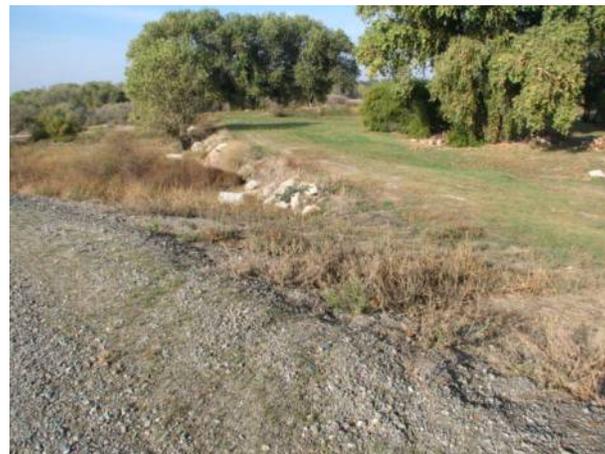
Levee Mile Report Line	6
Start Levee Mile	0.10
End Levee Mile	0.10
Location	Water Side
Category	
Item	Encroachments
11/09/2011 Tire marks shown onto the ramp from levee. Raised area extends to the trees in the background in the center of the photo.	
mkhashch_s_20130225_567.jpg

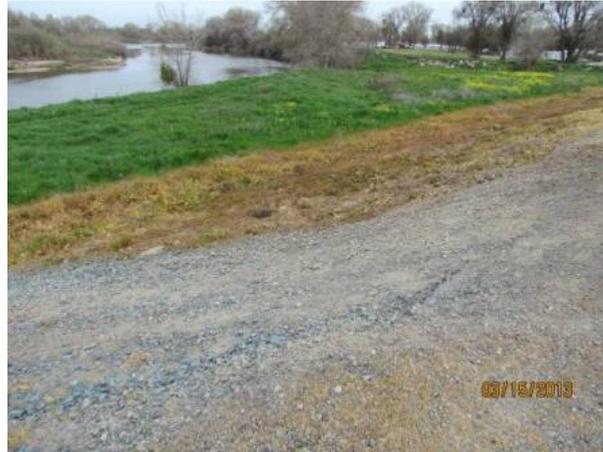
Levee Mile Report Line	7
Start Levee Mile	0.18
End Levee Mile	0.18
Location	Water Side
Category	
Item	Slope Stability
View of vehicle tire tracks on slope of levee.	
mkhashch_s_20130315_644.JPG

DWR ID: DWR_RD2094_01_s_2012_4		
7	0.18	0.18		Slope Stability	WS	M Ma	S3 : Repair the levee slope damaged by vehicle traffic and prevent access where possible.	37.770686 ° -121.300844 °	37.770686 ° -121.300844 °	13 Y
								DWR ID: DWR_RD2094_01_s_2013_13		
8	0.27	0.27		Slope Stability	LS	M Ma	S3 : Repair the levee slope damaged by vehicle traffic and prevent access where possible.	37.769353 ° -121.300893 °	37.769353 ° -121.300893 °	8 Y
								DWR ID: DWR_RD2094_01_s_2013_8		
9	0.66	0.66		Encroachments	WSA/W	Ma	PI : Pipe Inspector Comments: 14" steel irrigation intake with sluice gate.	37.767505 ° -121.294902 °	37.767505 ° -121.294902 °	1 Y
								DWR ID: DWR_RD2094_01_s_2012_1		
10	1.26	1.26		Encroachments	WSA/W	Ma	PI : Pipe Inspector Comments: 20" irrigation intake, sluice gate on water side hinge point.	37.760574 ° -121.297365 °	37.760574 ° -121.297365 °	2 Y
								DWR ID: DWR_RD2094_01_s_2012_2

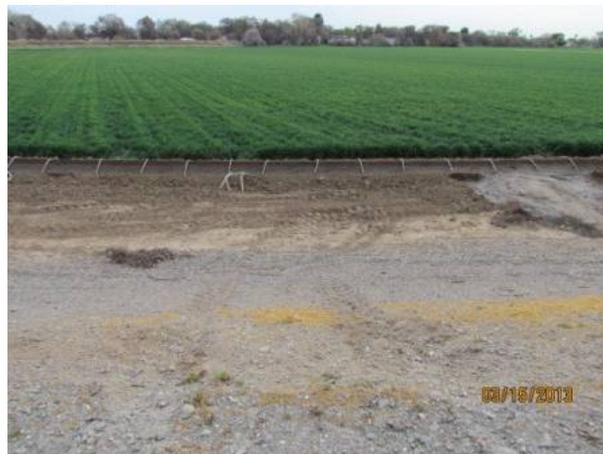
Levee Mile Report Line	8
Start Levee Mile	0.27
End Levee Mile	0.27
Location	Land Side
Category	
Item	Slope Stability
View of tractor tracks on slope of levee.	
mkhashch_s_20130315_645.JPG

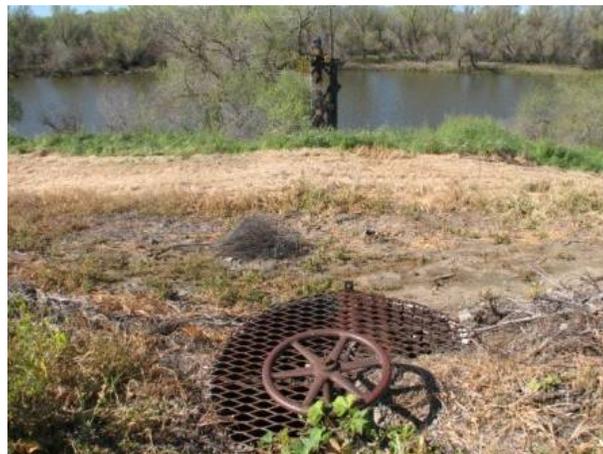
Levee Mile Report Line	9
Start Levee Mile	0.66
End Levee Mile	0.66
Location	Water Side
Category	
Item	Encroachments
Irrigation intake on the San Joaquin River. Positive closure device (sliuce gate) on water side hinge points. Pipe is through the freeboard portion of levee. Concrete stand pipe is shown beyond landside toe.	
mkhashch_s_20130225_565.jpg

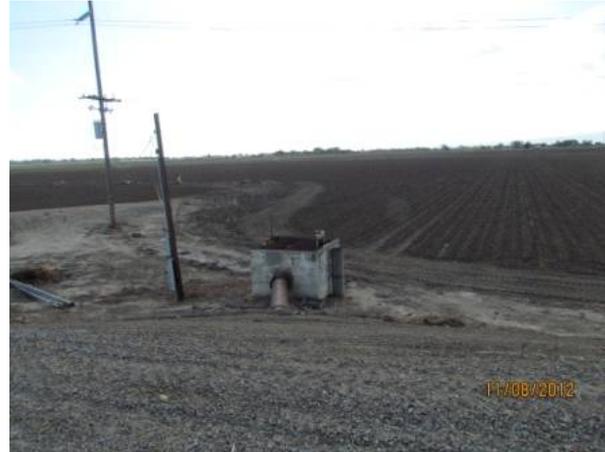
Levee Mile Report Line	10
Start Levee Mile	1.26
End Levee Mile	1.26
Location	Water Side
Category	
Item	Encroachments

View of the irrigation pipe at the landside toe.

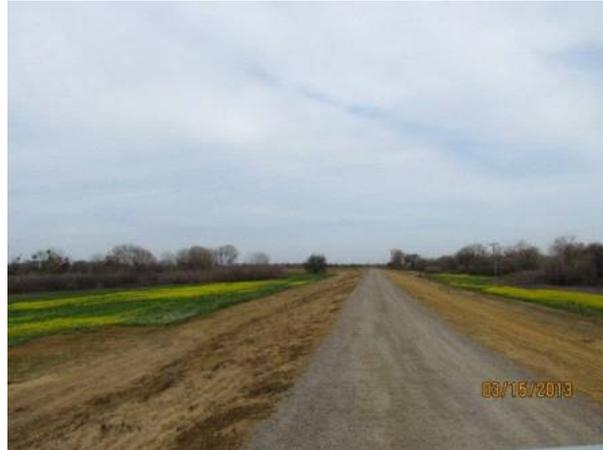
Levee Mile Report Line	1
Start Levee Mile	0.01
End Levee Mile	0.01
Location	Land Side
Category	
Item	Vegetation

View of acceptable vegetation on the levee slopes.

LMIR No.	Levee Mile		Category	Item	Location *	Rating ** +	Action/Comment	GPS Latitude/Longitude		Issue No. Photo
	Start	End						Start	End	
1	0.01	0.01		Vegetation	LS	A	V1 : Control annual grass and weeds on the levee slopes and easements.	37.759278 °	37.759278 °	1
					Ma			-121.299806 °	-121.299806 °	Y
