**Flood Control Project Maintenance
Levee Inspections**

Fall 2011 Levee Maintenance Deficiency Summary Report

Reclamation District No. 2095 Paradise Cut

Levee Inspection Report By Mile - Fall 2011

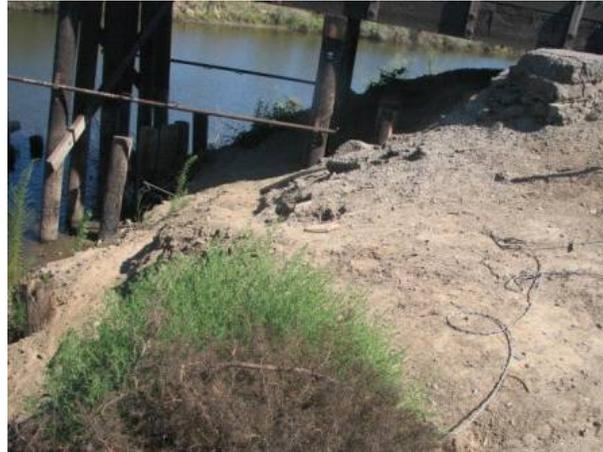
Levee Mile Report Line	5
Start Levee Mile	0.73
End Levee Mile	0.74
Location	Water Side
Category	Supplemental
Item	DWR Erosion Survey

Downstream view of the site.

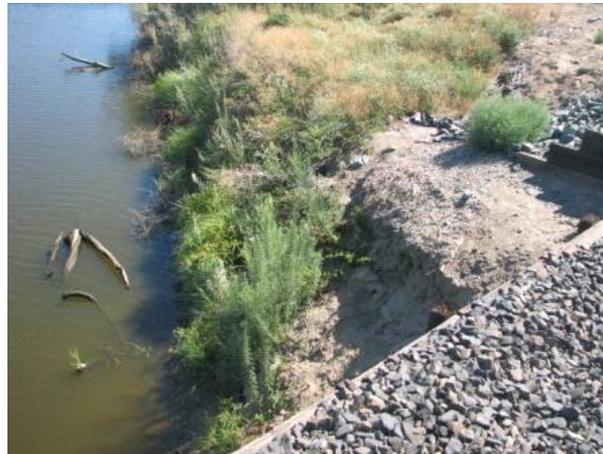
Levee Mile Report Line	5
Start Levee Mile	0.73
End Levee Mile	0.74
Location	Water Side
Category	Supplemental
Item	DWR Erosion Survey

Upstream view of the site looking from the RxR crossing.

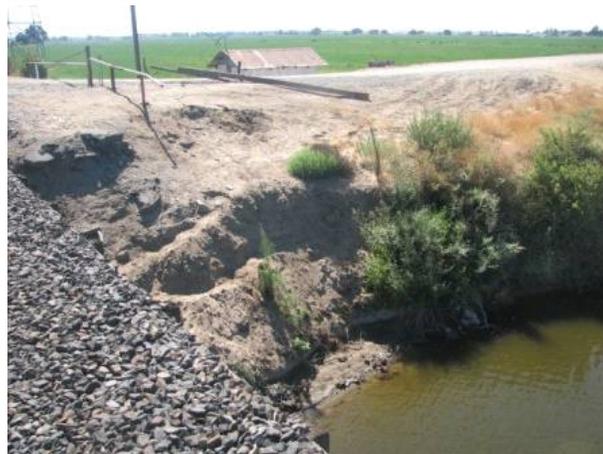
Levee Mile Report Line	5
Start Levee Mile	0.73
End Levee Mile	0.74
Location	Water Side
Category	Supplemental
Item	DWR Erosion Survey

Downstream view of the site from the RxR crossing

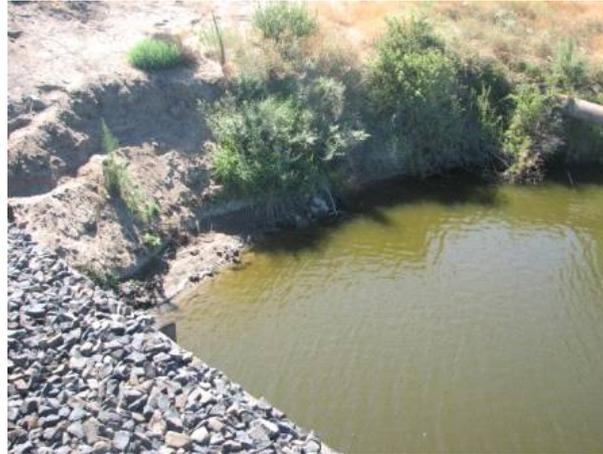
Levee Mile Report Line	5
Start Levee Mile	0.73
End Levee Mile	0.74
Location	Water Side
Category	Supplemental
Item	DWR Erosion Survey

Downstream view of the site.

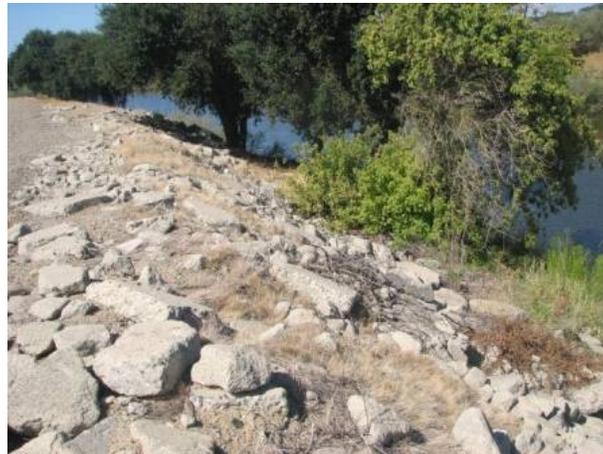
Levee Mile Report Line	6
Start Levee Mile	0.86
End Levee Mile	0.86
Location	Water Side
Category	Supplemental
Item	DWR Erosion Survey

6	0.86	0.86	Supplemental	DWR Erosion Survey	WS	U	Inspector Comments: 09/02/2011: No significant changes observed. 09/22/2010: No significant changes observed. Sloughing of the existing rip rap possibly due to a combination of steep slope and undesirable flood conditions. 08/06/2010: Recommended as local maintenance issue, per CLRO. 07/29/2009: No major change observed since last visit; near-vertical slope that has rip rap sloughing; site is recommended as a local maintenance issue, per CLRO CES Evaluation 2008 Report; Site # is the same as RM6.90, LM0.86; previously rated "U". 07/22/2008: Previous erosion site that is partially protected with concrete rubble; erosion scarp is adjacent to the sloughing rip rap. 03/13/2007: Site visited on 03/13/2007. [2011 Site ID:RD2095U01RM6.88]	37.761960 ° -121.318140 °	37.761960 ° -121.318140 °	2 Y

Direct view of the site.

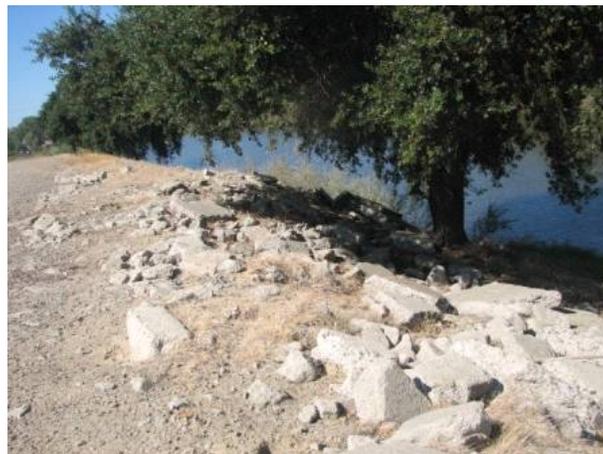
Levee Mile Report Line	6
Start Levee Mile	0.86
End Levee Mile	0.86
Location	Water Side
Category	Supplemental
Item	DWR Erosion Survey

Downstream view of the site.

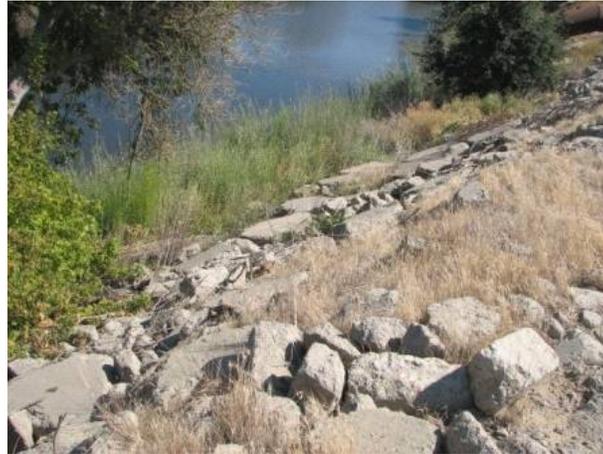
Levee Mile Report Line	6
Start Levee Mile	0.86
End Levee Mile	0.86
Location	Water Side
Category	Supplemental
Item	DWR Erosion Survey

Upwnstream view of the site.

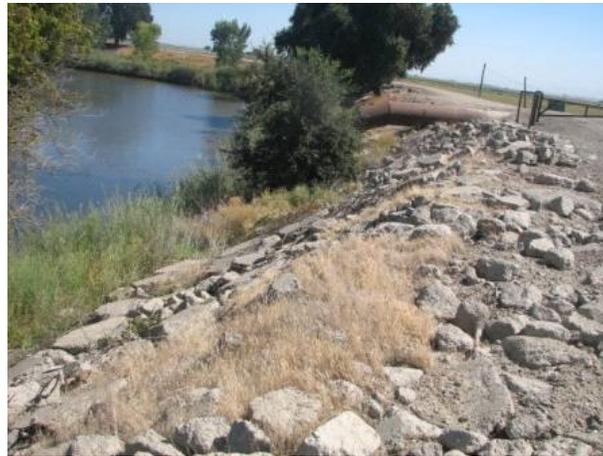
Levee Mile Report Line	6
Start Levee Mile	0.86
End Levee Mile	0.86
Location	Water Side
Category	Supplemental
Item	DWR Erosion Survey

Upstream view of the site from upper slope.

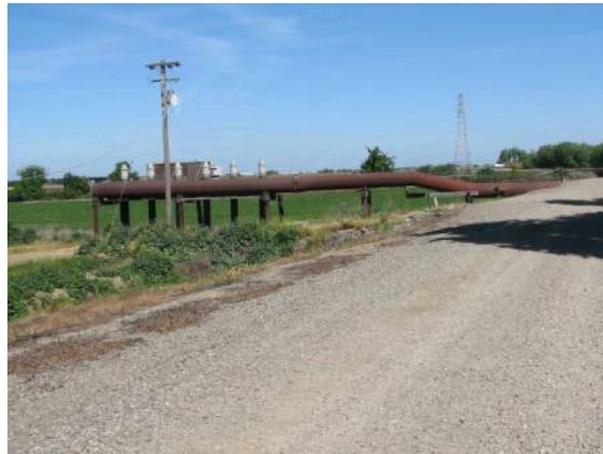
Levee Mile Report Line	7
Start Levee Mile	0.88
End Levee Mile	0.88
Location	Land Side
Category	Earthen Levee
Item	Encroachments

LMIR No.	Levee Mile		Category	Item	* Location	** Rating	Action/Comment	GPS Latitude/Longitude		Issue No. Photo
	Start	End						Start	End	
7	0.88	0.88	Earthen Levee	Encroachments	LS	W	Pipe Inspector Comments: Large pump platform for drainage into San Joaquin River. Three pumps. No positive closure devices. Pipe penetrates levee freeboard. No flap gate at outlet.	37.761362 ° -121.318062 °	37.761362 ° -121.318062 °	15 Y
8	0.88	0.88	Earthen Levee	Encroachments	WS	W	Pipe Inspector Comments: Gravity drain through base of levee. Positive closure on waterside hinge point. Flap gate obstructed by debris has been cleared.	37.761337 ° -121.318047 °	37.761337 ° -121.318047 °	16 Y
9	0.92	0.92	Earthen Levee	Encroachments	LS	A	Pipe Inspector Comments: Abandoned pipe has been capped.	37.760758 ° -121.317720 °	37.760758 ° -121.317720 °	6 Y
10	0.92	0.92	Earthen Levee	Encroachments	LS	C	Pipe Inspector Comments: North pipe is disconnected from pump with no closure devices or flap gate. Pipe runs through levee freeboard. Corrosion on waterside outlet. Hole cut on waterside hinge point where syphon breaker should be. 04/27/2011 situation unchanged. Picture attached	37.760758 ° -121.317720 °	37.760758 ° -121.317720 °	17

04/27/2011 Pumps at LM 0.88

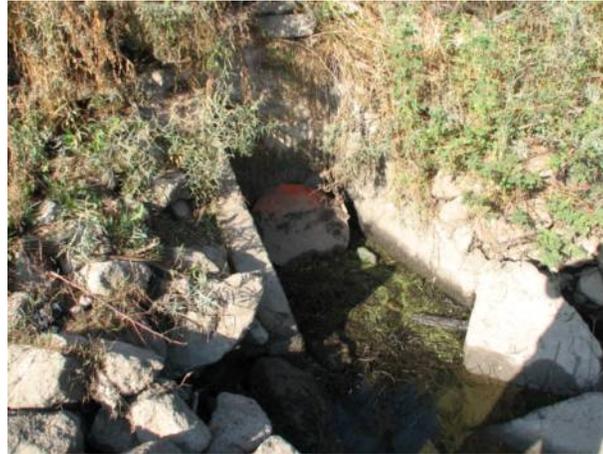
Levee Mile Report Line	8
Start Levee Mile	0.88
End Levee Mile	0.88
Location	Water Side
Category	Earthen Levee
Item	Encroachments

Gravity drainage outlet flaggate blocked by debris.

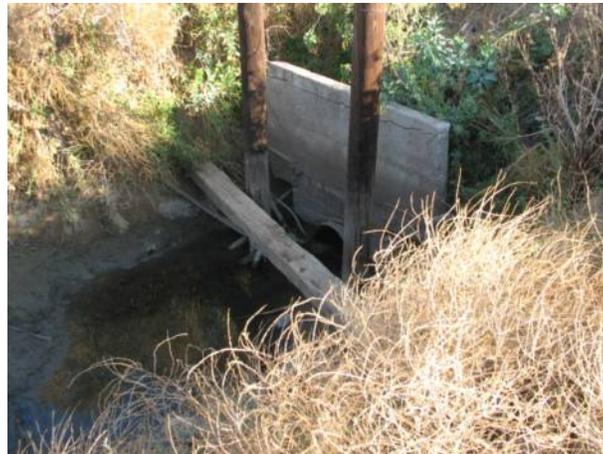
Levee Mile Report Line	8
Start Levee Mile	0.88
End Levee Mile	0.88
Location	Water Side
Category	Earthen Levee
Item	Encroachments

Gravity drain inlet.

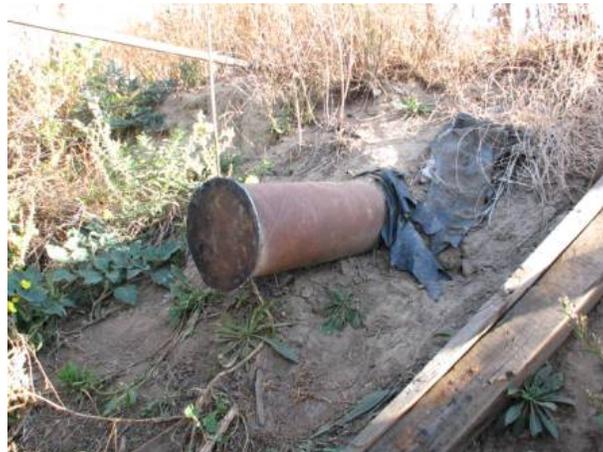
Levee Mile Report Line	9
Start Levee Mile	0.92
End Levee Mile	0.92
Location	Land Side
Category	Earthen Levee
Item	Encroachments

11/01/2011 Abandoned pipe has been capped.

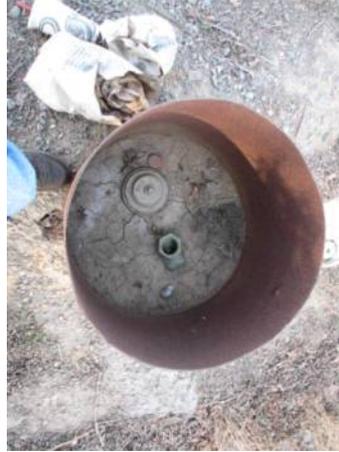
11	0.92	0.92	Earthen Levee	Encroachments	LS	W	Pipe Inspector Comments: Pipe on south is connected with siphon breaker at hinge point.	37.760792 ° -121.317705 °	37.760792 ° -121.317705 °	18 Y
12	1.18	1.18	Earthen Levee	Encroachments	WS	C	Equipment Inspector Comments: Fish and Game fish monitoring equipment.	37.759714 ° -121.313181 °	37.759714 ° -121.313181 °	3
13	1.34	1.34	Earthen Levee	Encroachments	WS	C	Equipment Inspector Comments: Department of Fish and Game fish monitoring station.	37.759370 ° -121.310324 °	37.759370 ° -121.310324 °	4

Levee Mile Report Line	11
Start Levee Mile	0.92
End Levee Mile	0.92
Location	Land Side
Category	Earthen Levee
Item	Encroachments
11/01/2011 Siphon breaker at hinge point on waterside.	
jeto_f_20111109_529.jpg

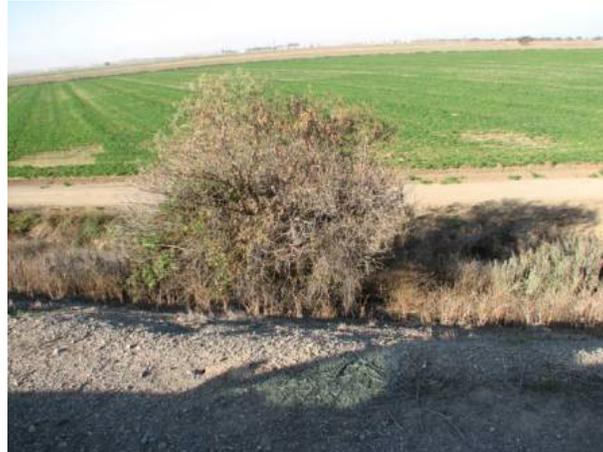
Levee Mile Report Line	1
Start Levee Mile	0.62
End Levee Mile	0.62
Location	Land Side
Category	Earthen Levee
Item	Vegetation
11/01/2011 Elderberry bush at landside toe.	
jeto_f_20111109_530.jpg

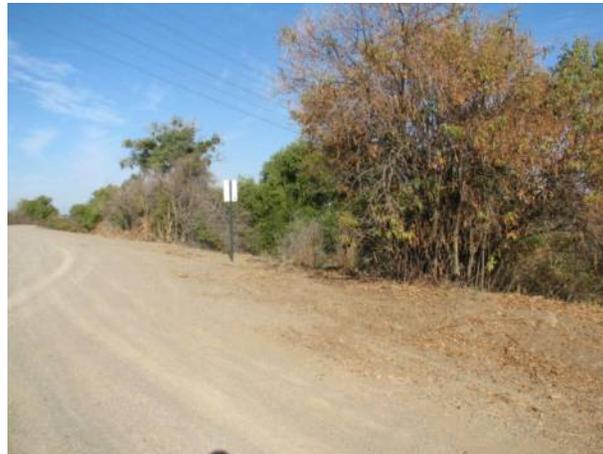
Levee Mile Report Line	5
Start Levee Mile	1.01
End Levee Mile	1.01
Location	Water Side
Category	Earthen Levee
Item	Vegetation
Elderberry blocks visibility of levee slope.	
jeto_f_20110923_376.jpg

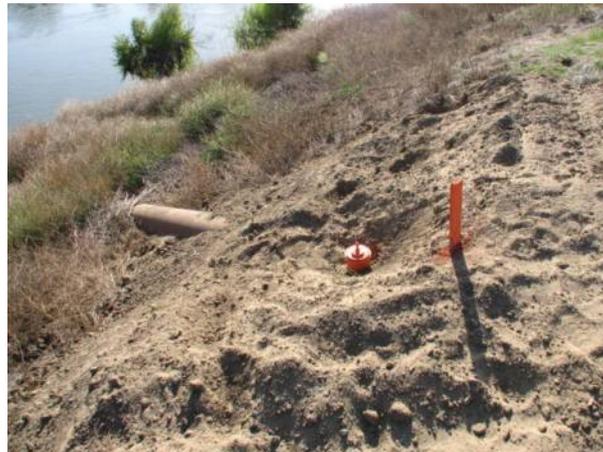
Levee Mile Report Line	9
Start Levee Mile	1.67
End Levee Mile	1.67
Location	Crown
Category	Earthen Levee
Item	Encroachments
11/01/2011 New siphon breaker at waterside hinge point.	
jeto_f_20111109_531.jpg

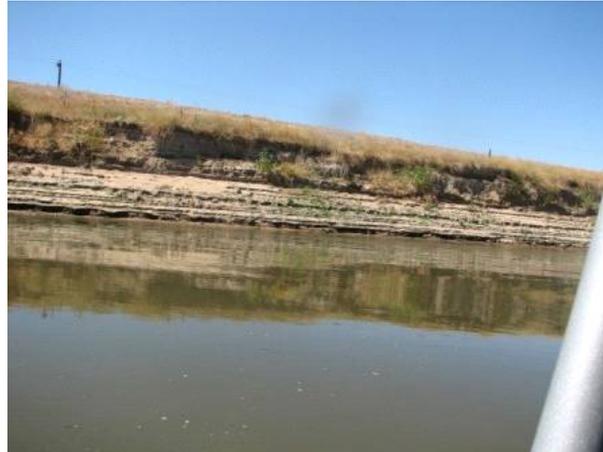
Levee Mile Report Line	10
Start Levee Mile	1.77
End Levee Mile	1.80
Location	Water Side
Category	Supplemental
Item	DWR Erosion Survey
Front view of the site. Note dense vegetation on the berm.	
SJR2011_RD2095U02RM60.62_1.jpg

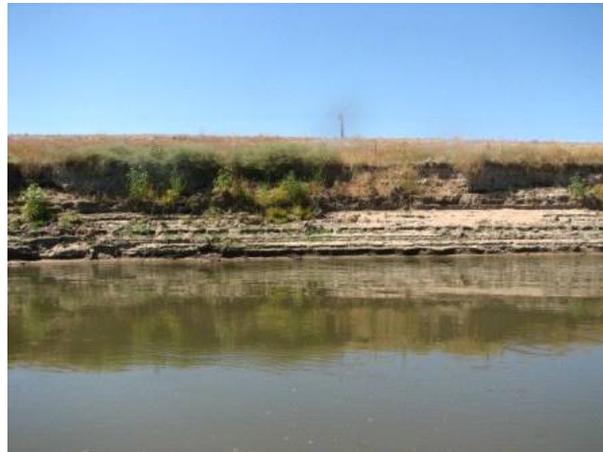
Levee Mile Report Line	10
Start Levee Mile	1.77
End Levee Mile	1.80
Location	Water Side
Category	Supplemental
Item	DWR Erosion Survey
Front view of the site.	
SJR2011_RD2095U02RM60.62_2.jpg

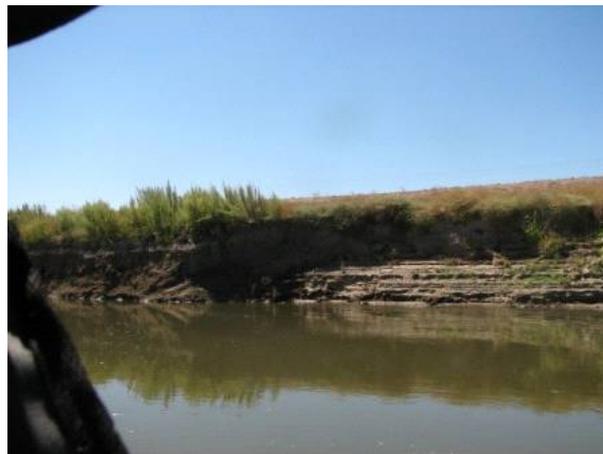
Levee Mile Report Line	10
Start Levee Mile	1.77
End Levee Mile	1.80
Location	Water Side
Category	Supplemental
Item	DWR Erosion Survey
Upstream view of the site.	
SJR2011_RD2095U02RM60.62_3.jpg

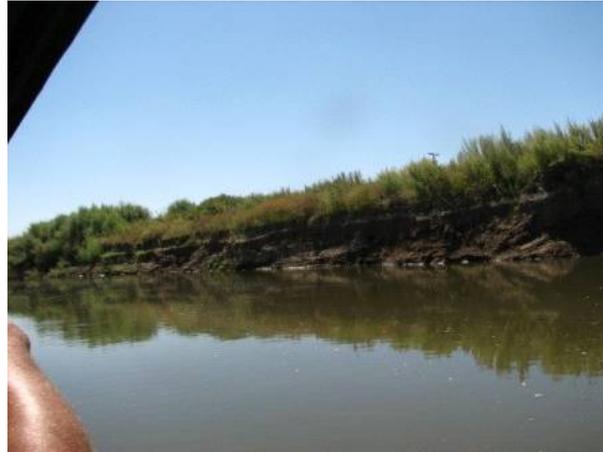
Levee Mile Report Line	10
Start Levee Mile	1.77
End Levee Mile	1.80
Location	Water Side
Category	Supplemental
Item	DWR Erosion Survey

Front view of the site.

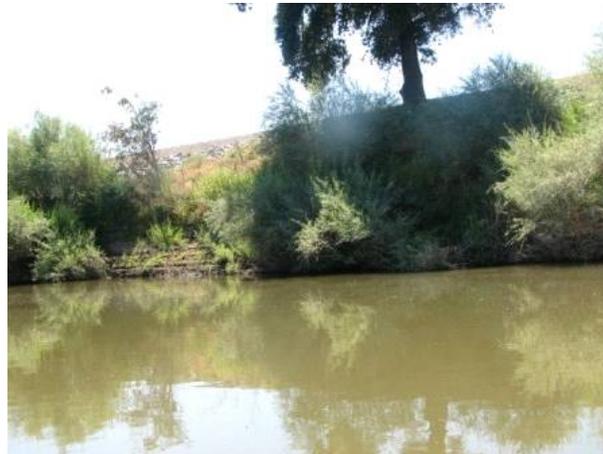
Levee Mile Report Line	11
Start Levee Mile	1.85
End Levee Mile	1.89
Location	Water Side
Category	Supplemental
Item	DWR Erosion Survey

LMIR No.	Levee Mile		Category	Item	Location *	Rating **	Action/Comment	GPS Latitude/Longitude		Issue No. Photo
	Start	End						Start	End	
11	1.85	1.89	Supplemental	DWR Erosion Survey	WS	M	Inspector Comments: 08/23/2011: Dense vegetation makes it difficult to view the possible erosion. No new development was observed on site. 09/23/2010: At the time of the inspection, the erosion site was difficult to view from the levee. Erosion is located on the bank toe, below the existing rip rap. There were no signs of repair on site, nor has the site been reported to be repaired by the district. Images taken from last year indicate that existing rip rap at the bank toe has sloughed exposing the underlying soils. Weakening of the toe could lead to future bank instability. 08/05/2010: Recommended for annual assessment and monitoring during flood events, per CLRO. 09/29/2009: No major change observed since last visit; sloughing of the rip rap above toe; erosion begins immediately downstream of existing rip rap revetment; roughly 15-foot berm remains; however, it will continue to erode and eventually intrude into the levee profile if left untreated. 10/20/2006: Just upstream of where berm starts to widen. [2011 Site ID:RD2095U02RM60.69]	37.738880 ° -121.298260 °	37.738880 ° -121.298260 °	2 Y

Direct view of the erosion. Note dense vegetation on site

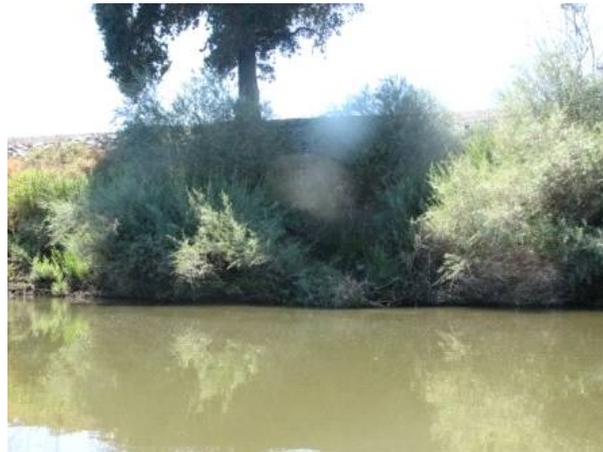
Levee Mile Report Line	11
Start Levee Mile	1.85
End Levee Mile	1.89
Location	Water Side
Category	Supplemental
Item	DWR Erosion Survey

Front view of the erosion.

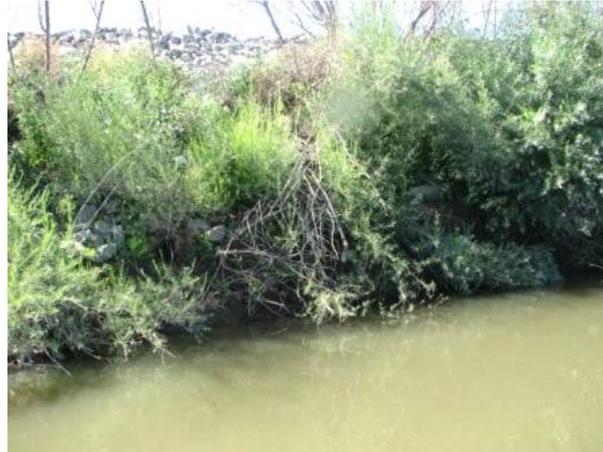
Levee Mile Report Line	11
Start Levee Mile	1.85
End Levee Mile	1.89
Location	Water Side
Category	Supplemental
Item	DWR Erosion Survey

Direct view of the erosion.

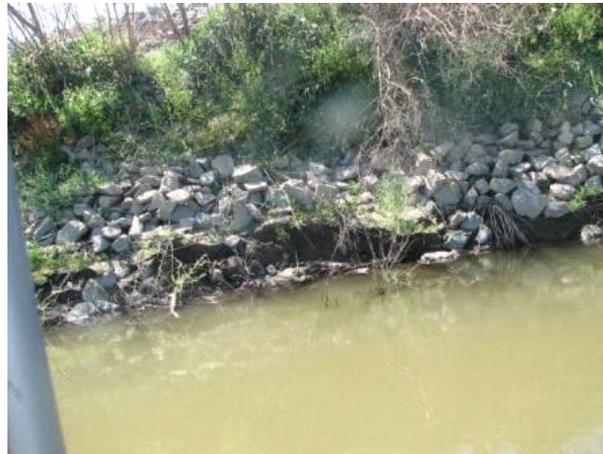
Levee Mile Report Line	11
Start Levee Mile	1.85
End Levee Mile	1.89
Location	Water Side
Category	Supplemental
Item	DWR Erosion Survey

A closer look at the site

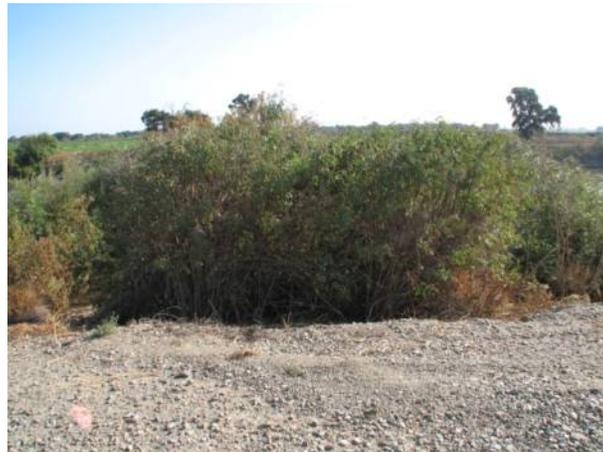
Levee Mile Report Line	13
Start Levee Mile	2.14
End Levee Mile	2.14
Location	Water Side
Category	Earthen Levee
Item	Vegetation

Vegetation on waterside slope obstructs access and visibility.
