**Flood Control Project Maintenance
Levee Inspections**

Fall 2009 Levee Maintenance Deficiency Summary Report

Reclamation District No. 2095 Paradise Cut

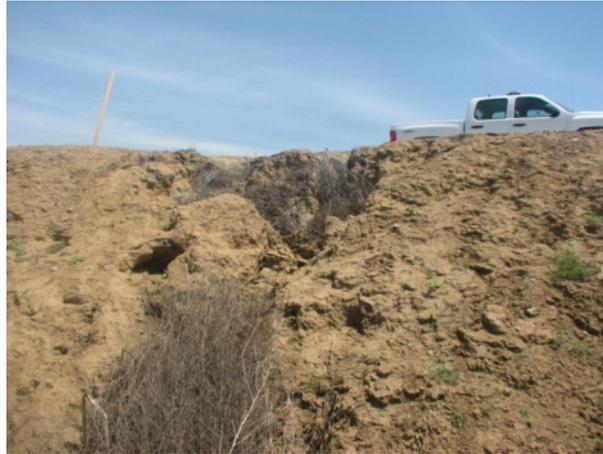
jpaasch_20091028_81.jpg

11	1.81	1.81	Earthen Levee	Erosion / Bank Caving	LS	M	Schedule repair of erosion site prior to the next inspection. Inspector Comments: Levee is approximately 40' wide at this location.	37.739710 ° -121.297943 °	37.739710 ° -121.297943 °	18 Y
12	1.85	1.89	Supplemental	DWR Erosion Survey	WS	U	Inspector Comments: 2009: No change observed; pocket erosion; erosion begins immediately downstream of existing riprap; recommend annual monitoring and assessment of erosion site, per CLRO CES Evaluation 2008 Report; site # same as RM62.6,LM1.87; previously rated "U" [2009 SiteID:RD2095U2RM60.69]	37.738880 ° -121.298260 °	37.738880 ° -121.298260 °	1
13	2.04	2.04	Earthen Levee	Erosion / Bank Caving	LS	C	Note and monitor erosion site.	37.736543 ° -121.298192 °	37.736543 ° -121.298192 °	16

Levee Mile Report Line	11
Start Levee Mile	1.81
End Levee Mile	1.81
Location	Land Side
Category	Earthen Levee
Item	Erosion / Bank Caving

Looking at erosion from landside toe.

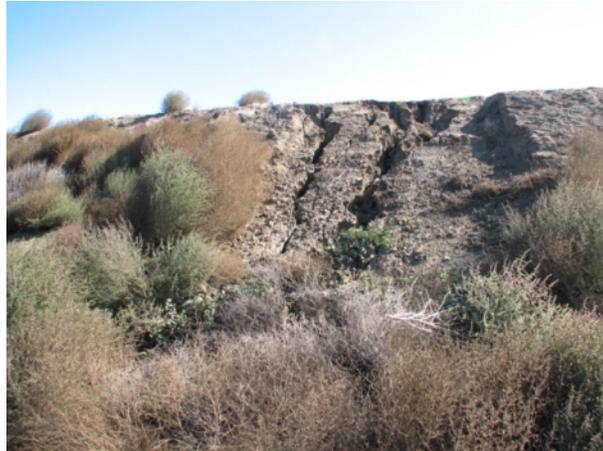
jpaasch_20091102_126.jpg

Levee Mile Report Line	11
Start Levee Mile	1.81
End Levee Mile	1.81
Location	Land Side
Category	Earthen Levee
Item	Erosion / Bank Caving

Photo of back-filled erosion site that has since deteriorated due to October storm. Sites since repaired and covered with straw for protection.
