**Flood Control Project Maintenance
Levee Inspections**

Fall 2012 Levee Maintenance Deficiency Summary Report

Reclamation District No. 2095 Paradise Cut

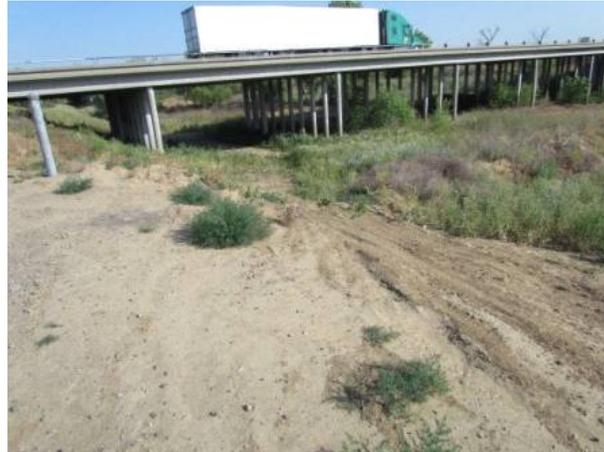
Levee Mile Report Line	4
Start Levee Mile	0.15
End Levee Mile	0.15
Location	Water Side
Category	Earthen Levee
Item	Encroachments
View of vehicle tracks eroding waterside slope. 05/18/2012	
mkhashch_f_20120927_329.jpg

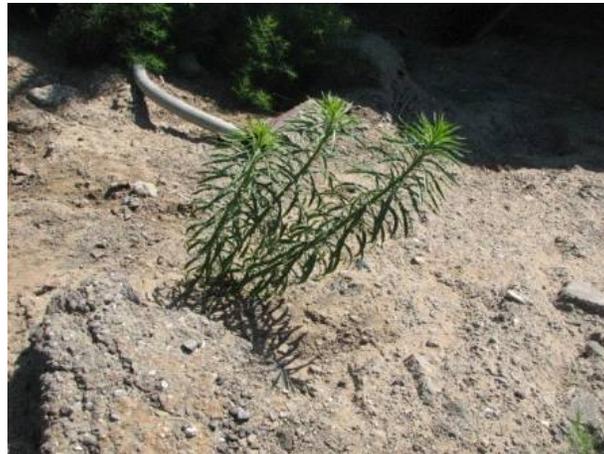
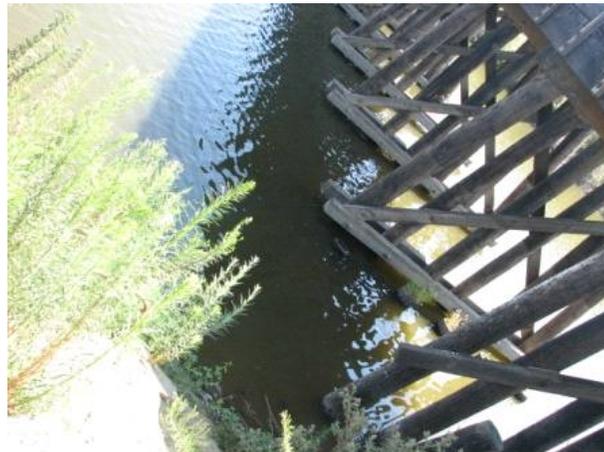
10	0.73	0.74	Supplemental	DWR Erosion Survey	WS	M Ma	Inspector Comments: 07/18/2012: No significant changes observed on site. 09/02/2011: No significant changes observed on site. 09/22/2010: No significant changes observed on site. There is now considerable vegetation at the water line and along the lower berm slope. However, the erosion on the lower berm slope is still present and has not been corrected. 08/06/2010: Recommended for local maintenance issue, per CLRO. 07/29/2009: No major change since last visit; noticeable vegetation growth; erosion is on berm, but if left untreated, it will eventually erode into levee prism; site is recommended for annual assessment and monitoring of site, per CLRO CES 2008 Report; Site # is the same as RM6.80,LM0.73; previously rated "U". 07/22/2008: Downstream of WPRR near siphon pipe & pump; sandy levee; visited by Jeff Van Gilder and LRO in 2008 for repair assessment; scouring downstream of RxR crossing, possibly caused by eddy effects. 03/13/2007: Site visited on 03/13/2007. [2012 Site ID:RD2095U01RM6.74]	37.763630 ° -121.319000 °	37.763630 ° -121.319000 °	1 Y

Levee Mile Report Line	10
Start Levee Mile	0.73
End Levee Mile	0.74
Location	Water Side
Category	Supplemental
Item	DWR Erosion Survey
Direct view of the erosion at the downstream of RR bridge.	
SJR2012_RD2095U01RM6.74_1.jpg

Levee Mile Report Line	10
Start Levee Mile	0.73
End Levee Mile	0.74
Location	Water Side
Category	Supplemental
Item	DWR Erosion Survey
looking up at the erosion from the lower levee slope	
SJR2012_RD2095U01RM6.74_2.jpg

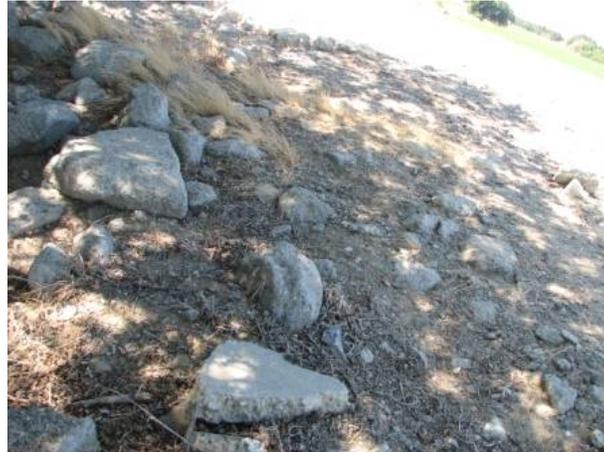
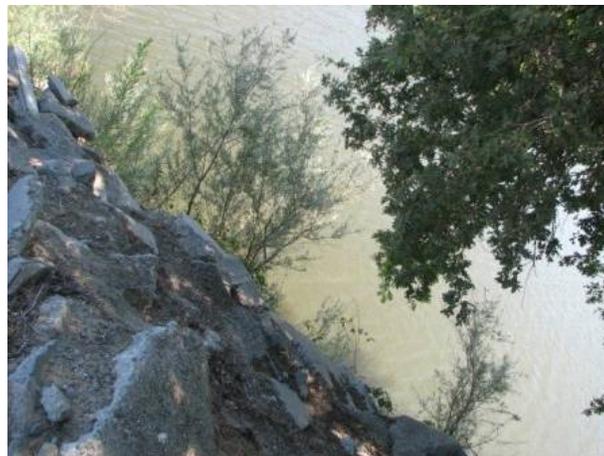
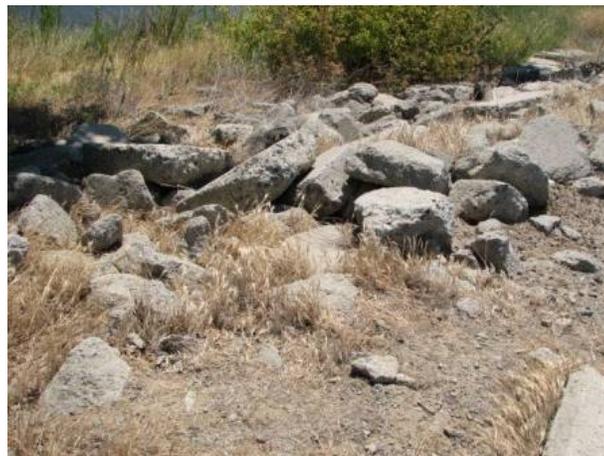
Levee Mile Report Line	11
Start Levee Mile	0.86
End Levee Mile	0.86
Location	Water Side
Category	Supplemental
Item	DWR Erosion Survey

11	0.86	0.86	Supplemental	DWR Erosion Survey	WS	U Ma	Inspector Comments: 07/18/2012: No significant changes observed. 09/02/2011: No significant changes observed. 09/22/2010: No significant changes observed. Sloughing of the existing rip rap possibly due to a combination of steep slope and undesirable flood conditions. 08/06/2010: Recommended as local maintenance issue, per CLRO. 07/29/2009: No major change observed since last visit; near-vertical slope that has rip rap sloughing; site is recommended as a local maintenance issue, per CLRO CES Evaluation 2008 Report; Site # is the same as RM6.90,LM0.86; previously rated "U". 07/22/2008: Previous erosion site that is partially protected with concrete rubble; erosion scarp is adjacent to the sloughing rip rap. 03/13/2007: Site visited on 03/13/2007. [2012 Site ID:RD2095U01RM6.88]	37.761960 ° -121.318140 °	37.761960 ° -121.318140 °	2 Y
----	------	------	--------------	--------------------	----	---------	---	------------------------------	------------------------------	--------

Direct view of the site

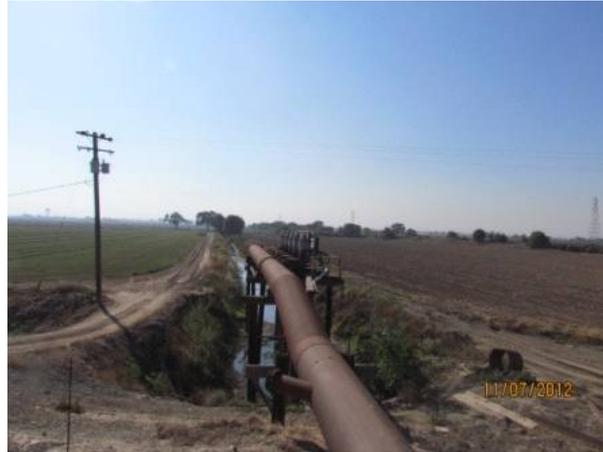
Levee Mile Report Line	12
Start Levee Mile	0.87
End Levee Mile	0.87
Location	Land Side
Category	Earthen Levee
Item	Encroachments

12	0.87	0.87	Earthen Levee	Encroachments	LS	A/W Ma	PI : Pipe Inspector Comments: Large pump platform for drainage into San Joaquin River. Three pumps. No positive closure devices. Pipe penetrates levee freeboard. No flap gate at outlet.	37.761472 ° -121.317840 °	37.761472 ° -121.317840 °	15 Y
----	------	------	---------------	---------------	----	-----------	--	------------------------------	------------------------------	---------

View of the pumps on landside.

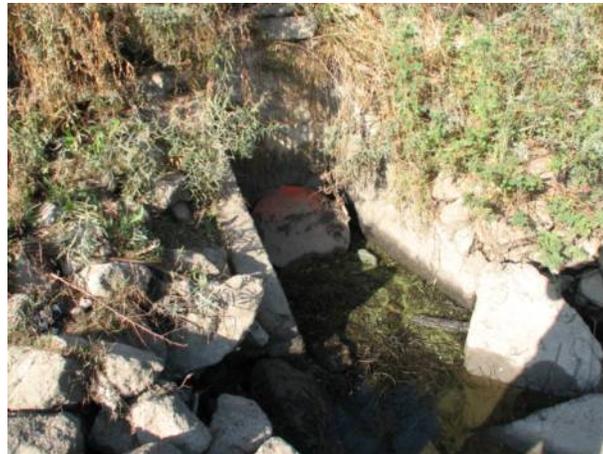
Levee Mile Report Line	13
Start Levee Mile	0.88
End Levee Mile	0.88
Location	Water Side
Category	Earthen Levee
Item	Encroachments

13	0.88	0.88	Earthen Levee	Encroachments	WSA/W	PI : Pipe Ma	Inspector Comments: Gravity drain through base of levee. Positive closure on waterside hinge point. Flap gate obstructed by debris has been cleared.	37.761337 ° -121.318047 °	37.761337 ° -121.318047 °	16 Y
----	------	------	---------------	---------------	-------	-----------------	--	------------------------------	------------------------------	---------

Gravity drainage outlet flaggate blocked by debris.

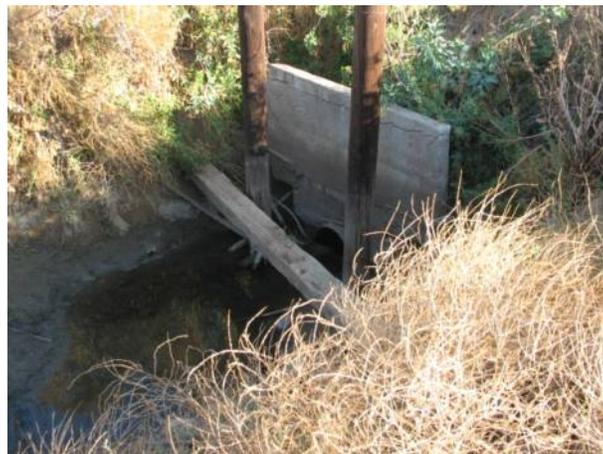
Levee Mile Report Line	13
Start Levee Mile	0.88
End Levee Mile	0.88
Location	Water Side
Category	Earthen Levee
Item	Encroachments

Gravity drain inlet.

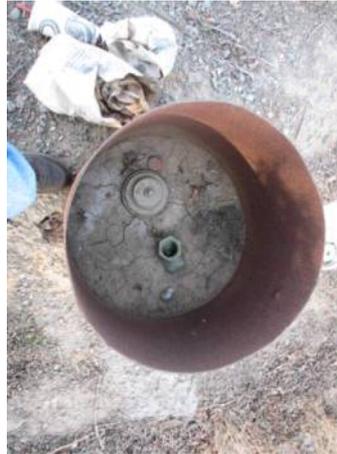
Levee Mile Report Line	14
Start Levee Mile	0.92
End Levee Mile	0.92
Location	Land Side
Category	Earthen Levee
Item	Encroachments
11/01/2011 Siphon breaker at hinge point on waterside.	
mkhashch_f_20120927_328.jpg

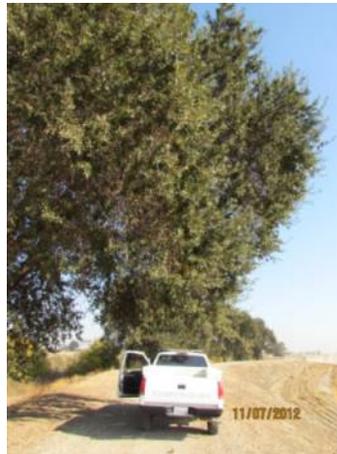
Levee Mile Report Line	15
Start Levee Mile	1.00
End Levee Mile	1.00
Location	Crown
Category	Earthen Levee
Item	Trim / Thin Trees
View of tree branches below 12 feet over crown.	
mkhashch_f_20121119_796.JPG

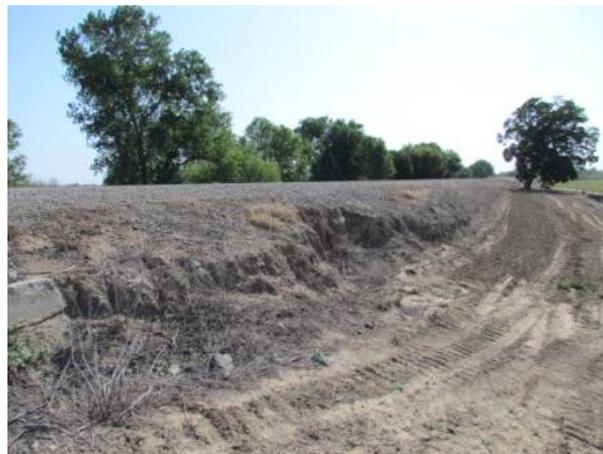
Levee Mile Report Line	16
Start Levee Mile	1.18
End Levee Mile	1.18
Location	Land Side
Category	Earthen Levee
Item	Slope Stability
View of erosion site on landside slope. 05/18/2012	
mkhashch_f_20120927_330.jpg

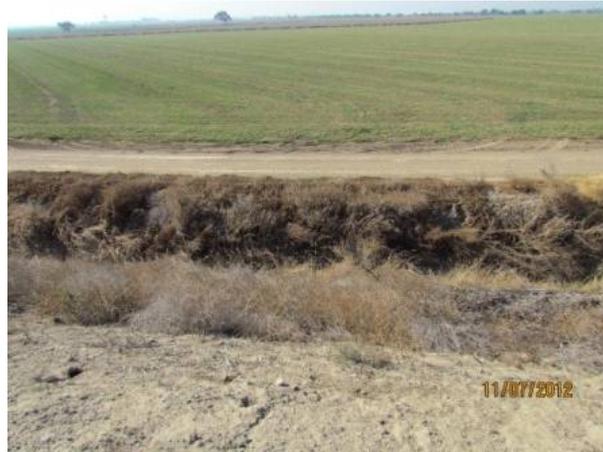
Levee Mile Report Line	1
Start Levee Mile	0.36
End Levee Mile	0.85
Location	Land Side
Category	Earthen Levee
Item	Encroachments
View of ditch along landside toe.	
mkhashch_f_20121119_797.JPG

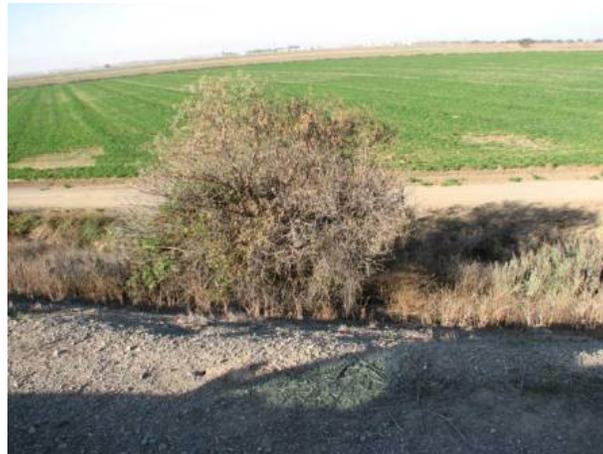
Levee Mile Report Line	3
Start Levee Mile	0.62
End Levee Mile	0.62
Location	Land Side
Category	Earthen Levee
Item	Vegetation
11/01/2011 Elderberry bush at landside toe.	
mkhashch_f_20120927_339.jpg

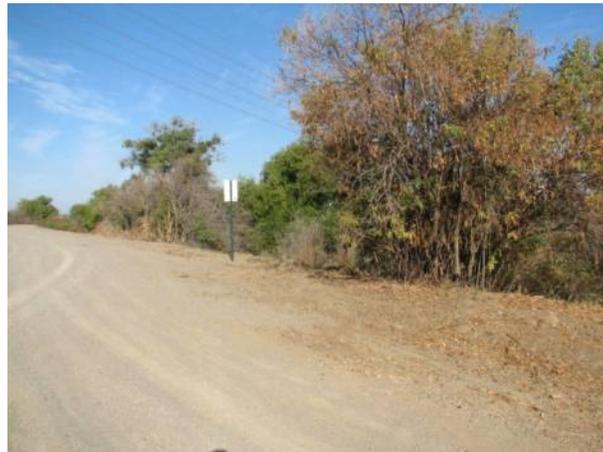
Levee Mile Report Line	7
Start Levee Mile	1.01
End Levee Mile	1.01
Location	Water Side
Category	Earthen Levee
Item	Vegetation
Elderberry blocks visibility of levee slope.	
mkhashch_f_20120927_344.jpg

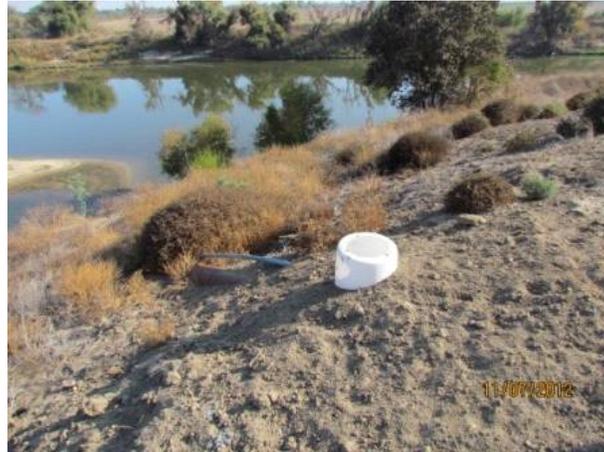
Levee Mile Report Line	12
Start Levee Mile	1.67
End Levee Mile	1.67
Location	Crown
Category	Earthen Levee
Item	Encroachments
View of corrected slope erosion. Siphon breaker valve is covered by bucket with drain pipe diverting water away from slope.	
mkhashch_f_20121119_798.JPG

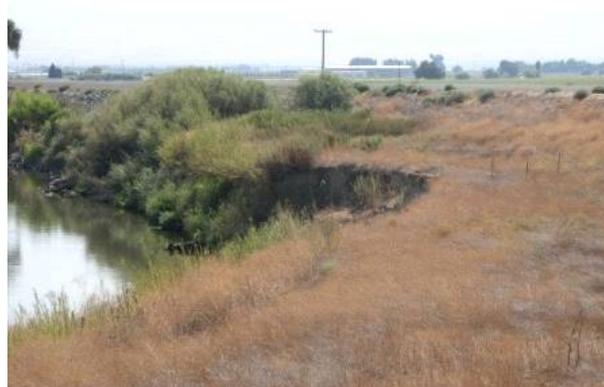
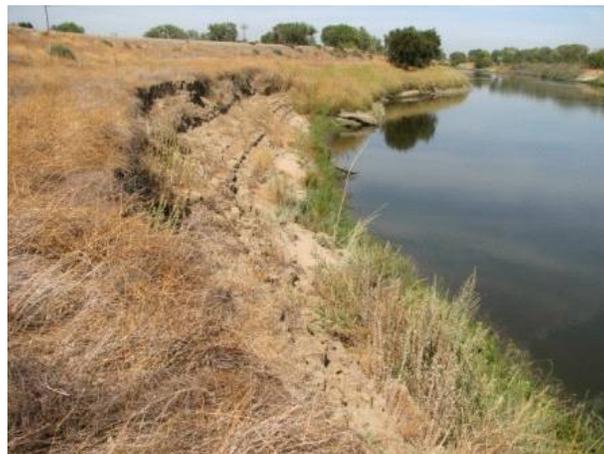
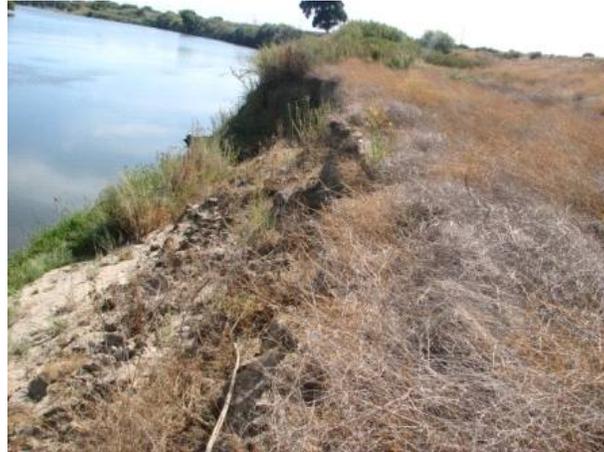
13	1.77	1.80	Supplemental	DWR Erosion Survey	WS	M Ma	<p>Inspector Comments: 09/13/2012: The site has been visited by land survey. The vegetation on the site shows the erosion has not developed significantly from the last survey.</p> <p>The site was not visited by boat survey due to the limitation of navigatable waterway.</p> <p>08/23/2011: No significant changes observed on the site.</p> <p>9/22/2010: No significant changes observed on site. There is moderate vegetation growth on the berm. Despite the erosion occurring on the berm, corrective action should be taken before the issue becomes severe.</p> <p>9/29/2009: Site is immediately downstream of a section of existing rip rap; there is a 20-foot berm remaining; berm will continue to erode unless erosion is mitigated; Site# is the same as RM62.6, LM1.87; recommended for annual assessment, per CES Evaluation 2008 Report</p> <p>2006: Visited 10/20/06 [2012 Site ID:RD2095U02RM60.62]</p>	37.740196 ° -121.297662 °	37.740196 ° -121.297662 °	1 Y

Levee Mile Report Line	13
Start Levee Mile	1.77
End Levee Mile	1.80
Location	Water Side
Category	Supplemental
Item	DWR Erosion Survey
Looking upstream of the site. Note dense vegetation on the berm.	
SJR2012_RD2095U02RM60.62_1.jpg

Levee Mile Report Line	13
Start Levee Mile	1.77
End Levee Mile	1.80
Location	Water Side
Category	Supplemental
Item	DWR Erosion Survey
Looking downstream of the site.	
SJR2012_RD2095U02RM60.62_2.jpg

Close view of the site.

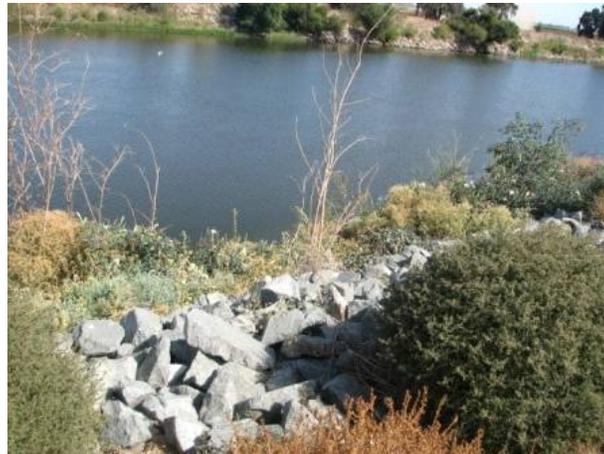
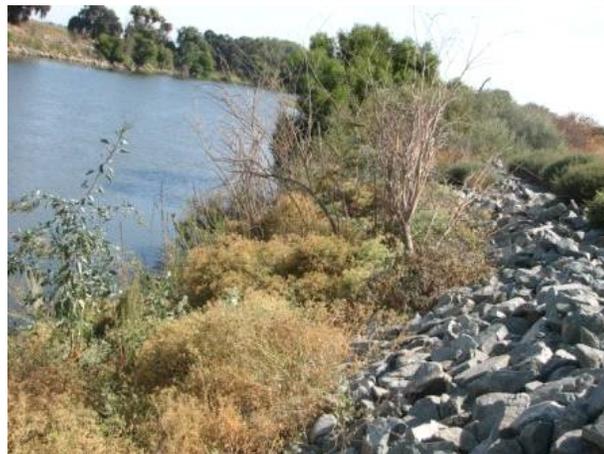
Levee Mile Report Line	14
Start Levee Mile	1.85
End Levee Mile	1.89
Location	Water Side
Category	Supplemental
Item	DWR Erosion Survey

14	1.85	1.89	Supplemental	DWR Erosion Survey	WS	M Ma	<p>Inspector Comments: 09/13/2012: The site has been visited by land survey. The erosion is not visible from the levee slope because of dense vegetation at the site. Levee slope is protected by placed rocks. The site was not visited by boat survey due to the limitation of navigatable waterway.</p> <p>08/23/2011: Dense vegetation makes it difficult to view the possible erosion. No new development was observed on site.</p> <p>09/23/2010: At the time of the inspection, the erosion site was difficult to view from the levee. Erosion is located on the bank toe, below the existing rip rap. There were no signs of repair on site, nor has the site been reported to be repaired by the district. Images taken from last year indicate that existing rip rap at the bank toe has sloughed exposing the underlying soils. Weakening of the toe could lead to future bank instability.</p> <p>08/05/2010: Recommended for annual assessment and monitoring during flood events, per CLRO.</p> <p>09/29/2009: No major change observed since last visit; sloughing of the rip rap above toe; erosion begins immediately downstream of existing rip rap revetment; roughly 15-foot berm remains; however, it will continue to erode and eventually intrude into the levee profile if left untreated.</p> <p>10/20/2006: Just upstream of where berm starts to widen. [2012 Site ID:RD2095U02RM60.69]</p>	37.738880 ° -121.298260 °	37.738880 ° -121.298260 °	2 Y

View form levee slope. The dense vegetation on the site block the view of the erosion

Front view of the erosion.

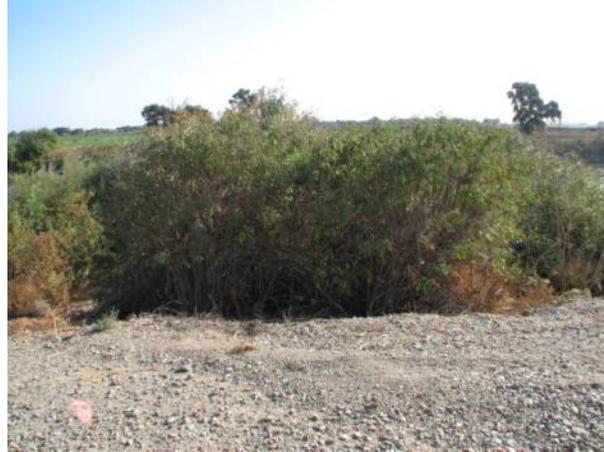
16	2.14	2.14	Earthen Levee	Vegetation	WS	M Ma	V4 : Elderberries are blocking visibility and flood fight capability.	37.734858 ° -121.297758 °	37.734858 ° -121.297758 °	20 Y
----	------	------	---------------	------------	----	---------	---	------------------------------	------------------------------	---------

Levee Mile Report Line	16
Start Levee Mile	2.14
End Levee Mile	2.14
Location	Water Side
Category	Earthen Levee
Item	Vegetation
Vegetation on waterside slope obstructs access and visibility.	
mkhashch_f_20120927_342.jpg
