**Flood Control Project Maintenance
Levee Inspections**

Fall 2014 Levee Maintenance Deficiency Summary Report

San Joaquin River Basin

Reclamation District No. 2095 Paradise Cut

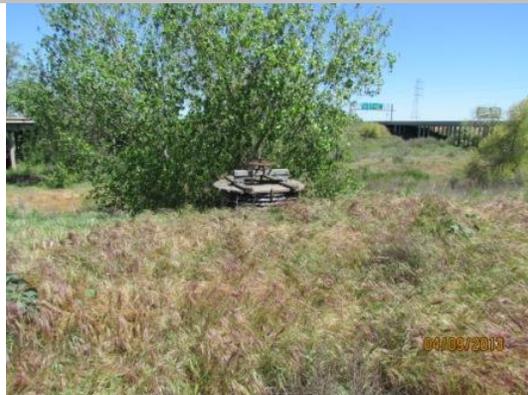
Photo 1 of 1 : FA_2014_RD2095_322_3_20141001_00004.jpg

LM Start	0.07	Rating **	A/W	Issue No.	3
LM End	0.07	Issue Type +	En	Location *	WS
Category	Earthen Levee		GPS Latitude/Longitude		
			Start	End	
Item	Encroachments		37.770572 °	37.770572 °	
			-121.326283 °	-121.326283 °	
DWR ID	DWR_RD2095_01_s_2013_3				
Action/Comments					
Pipe

View of the pipe at waterside levee hinge.

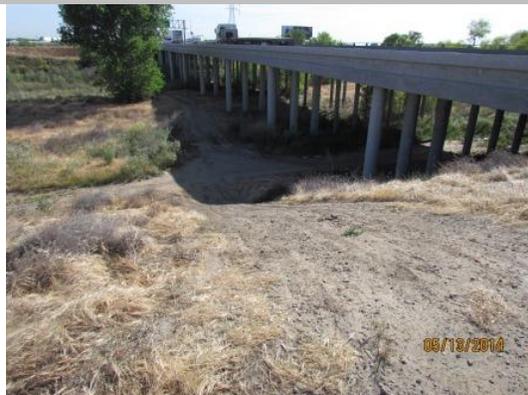
Photo 1 of 1 : FA_2014_RD2095_322_134_20141001_00012.jpg

LM Start	0.11	Rating **	A/W	Issue No.	134
LM End	0.11	Issue Type +	Ma	Location *	WS
Category	Earthen Levee		GPS Latitude/Longitude		
			Start	End	
Item	Slope Stability		37.770212 °	37.770212 °	
			-121.325675 °	-121.325675 °	
DWR ID	DWR_RD2095_01_s_2014_134				
Action/Comments					
Repair the levee slope damaged by vehicle traffic and prevent access where possible.

View of the vehicle access on the waterside levee slope.

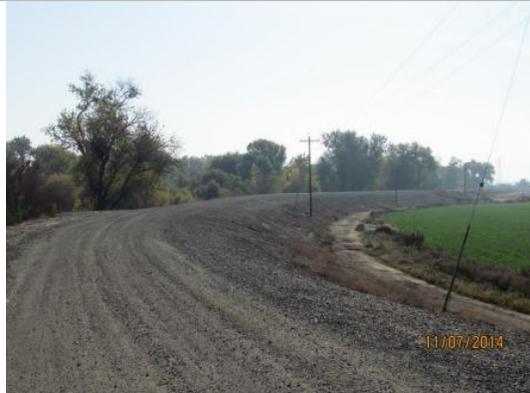
Photo 1 of 1 : FA_2014_RD2095_322_12_20141110_00017.jpg

LM Start	0.16	Rating **	A	Issue No.	12
LM End	0.16	Issue Type +	Ma	Location *	LS
Category	Earthen Levee		GPS Latitude/Longitude		
			Start	End	
Item	Vegetation		37.769889 °	37.769889 °	
			-121.324793 °	-121.324793 °	
DWR ID	DWR_RD2095_01_f_2014_12				
Action/Comments					
Control annual grass and weeds on the levee slopes and easements.

View of acceptable vegetation maintenance.

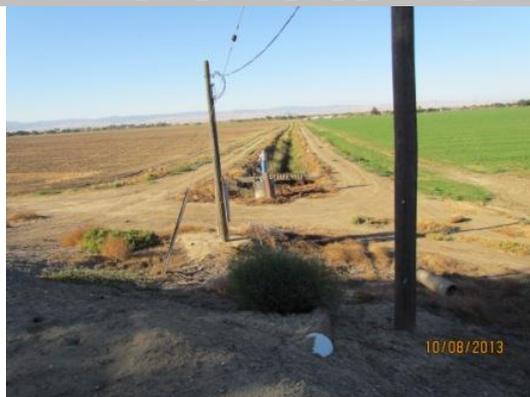
Photo 1 of 2 : FA_2014_RD2095_322_5_20141001_00006.jpg

LM Start	0.35	Rating **	A/W	Issue No.	5
LM End	0.35	Issue Type +	En	Location *	CR
Category	Earthen Levee		GPS Latitude/Longitude		
			Start	End	
Item	Encroachments		37.767822 °	37.767822 °	
			-121.322835 °	-121.322835 °	
DWR ID	DWR_RD2095_01_s_2012_5				
Action/Comments					
Pipe Inspector Comments: No closure devices or flap gate on discharge pipe. Pipe penetrates freeboard of levee.

View of pipe day lighting at landside levee slope.

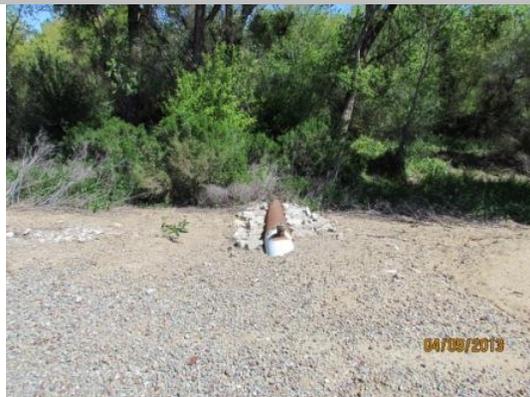
Photo 2 of 2 : FA_2014_RD2095_322_5_20141001_00007.jpg

LM Start	0.35	Rating **	A/W	Issue No.	5 (cont)
LM End	0.35	Issue Type +	En	Location *	CR

View of the pipe penetrating waterside levee slope.

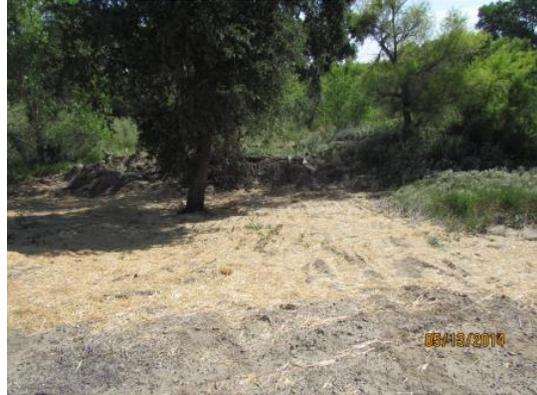
Photo 1 of 1 : FA_2014_RD2095_322_13_20141001_00009.jpg

LM Start	0.42	Rating **	A/W	Issue No.	13
LM End	0.42	Issue Type +	Ma	Location *	WS
Category	Earthen Levee		GPS Latitude/Longitude		
			Start	End	
Item	Slope Stability		37.766917 °	37.766917 °	
			-121.322267 °	-121.322267 °	
DWR ID	DWR_RD2095_01_s_2013_13				
Action/Comments					
Repair the levee slope damaged by vehicle traffic and prevent access where possible. Inspector Comments: LMA is actively controlling the slope instability.

View of the repaired waterside levee slope.

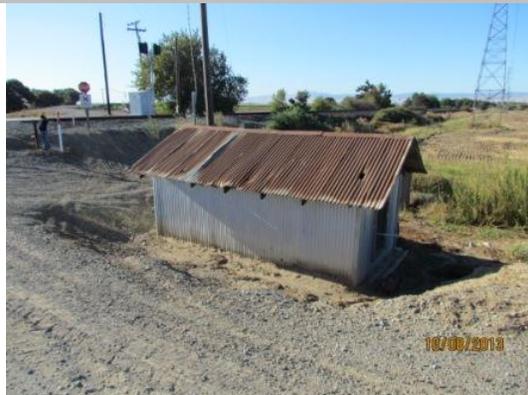
Photo 1 of 1 : FA_2014_RD2095_322_11_20141001_00008.jpg

LM Start	0.70	Rating **	M	Issue No.	11
LM End	0.70	Issue Type +	En	Location *	LS
Category	Earthen Levee		GPS Latitude/Longitude		
			Start	End	
Item	Encroachments		37.763630 °	37.763630 °	
			-121.319045 °	-121.319045 °	
DWR ID	DWR_RD2095_01_s_2012_11				
Action/Comments					
Building Inspector Comments: Pump house near RR.

View of building at the landside levee toe.

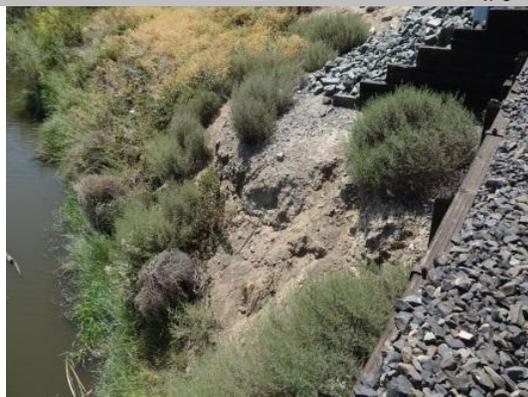
Photo 1 of 1 : SJR2014_RD2095U01RM6.74_1.jpg

LM Start	0.73	Rating **	M	Issue No.	1
LM End	0.74	Issue Type +	Ma	Location *	WS
Category	Supplemental		GPS Latitude/Longitude		
			Start	End	
Item	DWR Erosion Survey		37.763630 °	37.763630 °	
			-121.319000 °	-121.319000 °	
DWR ID					
Action/Comments					
Inspector Comments: 08/26/2014: No significant change observed. 08/28/2013: No significant change observed. 07/18/2012: No significant change observed. 09/02/2011: No significant change observed. 09/22/2010: No significant change observed. There is now considerable vegetation at the water line and along the lower berm slope. However, the erosion on the lower berm slope is still present and has not been corrected. 08/06/2010: Recommended for local maintenance issue, per CLRO. 07/29/2009: No major change since last visit; noticeable vegetation growth; erosion is on berm, but if left untreated, it will eventually erode into levee prism; site is recommended for annual assessment and monitoring of the site, per CLRO CES 2008 Report; Site # is the same as RM6.80,LM0.73; previously rated "U". 07/22/2008: Downstream of WPRR near siphon pipe & pump; sandy levee; visited by Jeff Van Gilder and LRO in 2008 for repair assessment; scouring downstream of RR crossing, possibly caused by eddy effects. 03/13/2007: Site visited on 03/13/2007. [2014 Site ID:RD2095U01RM6.74]

Direct view of the erosion upstream of Railroad bridge.

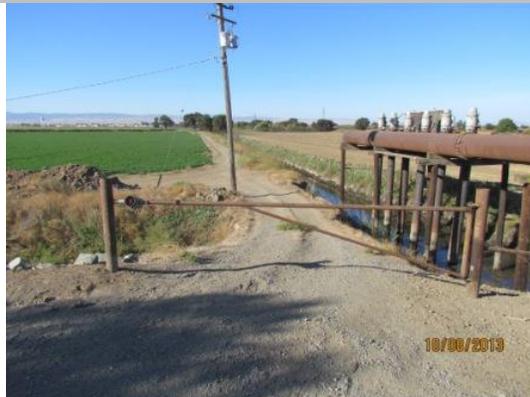
Photo 1 of 1 : FA_2014_RD2095_322_4_20141001_00005.jpg

LM Start	0.87	Rating **	A/W	Issue No.	4
LM End	0.87	Issue Type +	En	Location *	LS
Category	Earthen Levee		GPS Latitude/Longitude		
			Start	End	
Item	Encroachments		37.761475 °	37.761475 °	
			-121.317804 °	-121.317804 °	
DWR ID	DWR_RD2095_01_f_2013_4				
Action/Comments					
Fence Inspector Comments: Permitted gate across landside levee ramp. A key was provided to the DWR inspector.

View of the new gate at landside levee hinge.

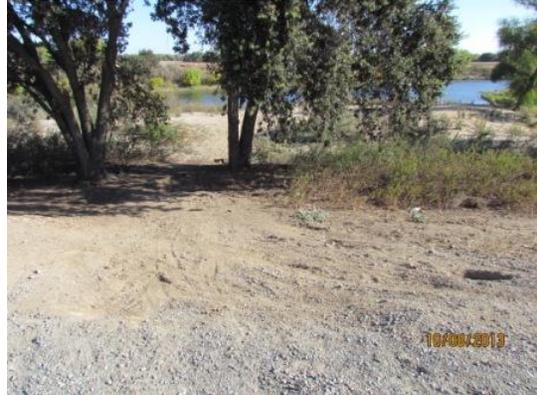
Photo 1 of 1 : FA_2014_RD2095_323_9_20141001_00005.jpg

LM Start	0.03	Rating **	A/W	Issue No.	9
LM End	0.03	Issue Type +	Ma	Location *	WS
Category	Earthen Levee		GPS Latitude/Longitude		
			Start	End	
Item	Slope Stability		37.758986 °	37.758986 °	
			-121.307854 °	-121.307854 °	
DWR ID	DWR_RD2095_02_s_2013_9				
Action/Comments					
Repair the levee slope damaged by vehicle traffic and prevent access where possible.

View of the vehicle tire ruts on waterside levee slope.

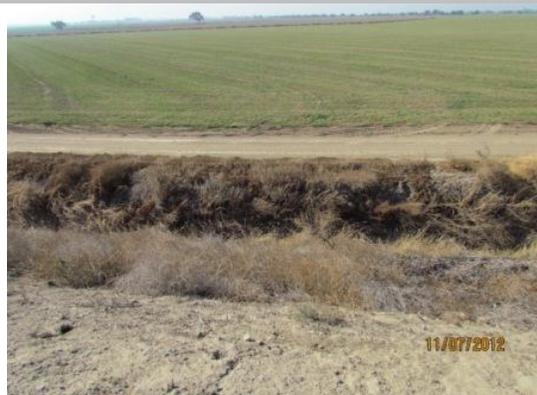
Photo 1 of 1 : FA_2014_RD2095_323_5_20141001_00003.jpg

LM Start	0.36	Rating **	M	Issue No.	5
LM End	0.85	Issue Type +	En	Location *	LS
Category	Earthen Levee		GPS Latitude/Longitude		
			Start	End	
Item	Encroachments		37.754952 °	37.749645 °	
			-121.305880 °	-121.301977 °	
DWR ID	DWR_RD2095_02_f_2012_5				
Action/Comments					
Ditch

View of a ditch along the landside toe.

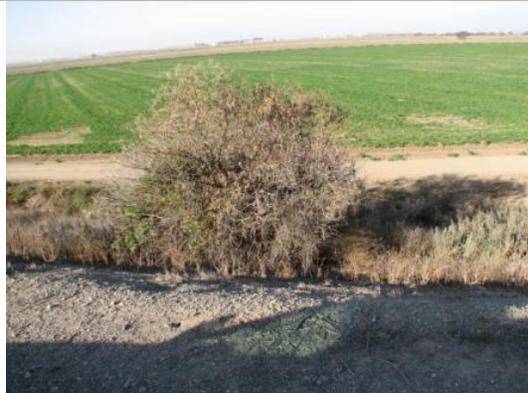
Photo 1 of 1 : FA_2014_RD2095_323_6_20141001_00004.jpg

LM Start	0.62	Rating **	A/W	Issue No.	6
LM End	0.62	Issue Type +	Ma	Location *	LS
Category	Earthen Levee		GPS Latitude/Longitude		
			Start	End	
Item	Vegetation		37.751668 °	37.751668 °	
			-121.304302 °	-121.304302 °	
DWR ID	DWR_RD2095_02_s_2012_6				
Action/Comments					
Elderberries are blocking visibility and flood fight capability.

11/01/2011 Elderberry bush at landside toe.

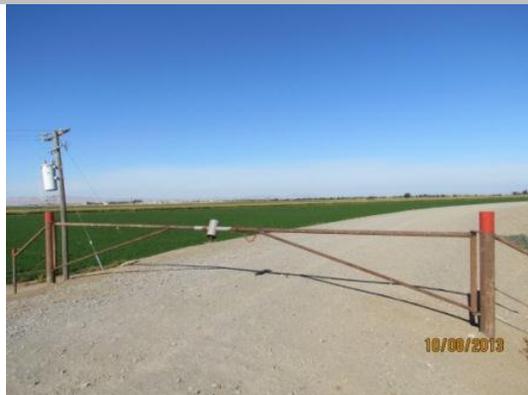
Photo 1 of 1 : FA_2014_RD2095_323_14_20141001_00007.jpg

LM Start	0.75	Rating **	A/W	Issue No.	14
LM End	0.75	Issue Type +	En	Location *	LS
Category	Earthen Levee		GPS Latitude/Longitude		
			Start	End	
Item	Encroachments		37.749916 °	37.749916 °	
			-121.303312 °	-121.303312 °	
DWR ID	DWR_RD2095_02_f_2013_14				
Action/Comments					
Fence Inspector Comments: Permitted gate across levee crown. A key was provided to the DWR inspector.

View of new gate across levee crown.

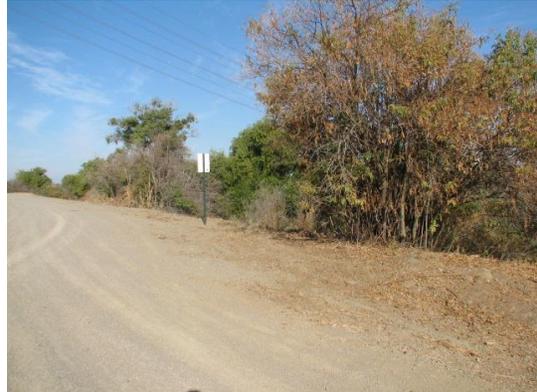
Photo 1 of 1 : FA_2014_RD2095_323_941_20141001_00013.jpg

LM Start	0.98	Rating **	U	Issue No.	941
LM End	0.98	Issue Type +	Ma	Location *	WS
Category	Earthen Levee		GPS Latitude/Longitude		
			Start	End	
Item	Vegetation		37.749706 °	37.749706 °	
			-121.299237 °	-121.299237 °	
DWR ID	DWR_RD2095_02_s_2012_941				
Action/Comments					
Elderberries are blocking visibility and flood fight capability. Inspector Comments: Dense bush within 20' of crown on waterside slope.

Elderberry blocks visibility of levee slope.

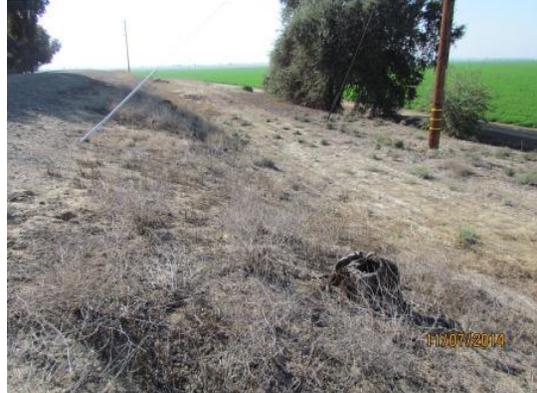
Photo 1 of 1 : FA_2014_RD2095_323_3_20141110_00016.jpg

LM Start	1.10	Rating **	N	Issue No.	3
LM End	1.10	Issue Type +	Ma	Location *	LS
Category	Earthen Levee		GPS Latitude/Longitude		
			Start	End	
Item	Trim / Thin Trees		37.748184 °	37.748184 °	
			-121.298995 °	-121.298995 °	
DWR ID	DWR_RD2095_02_s_2012_3				
Action/Comments					
Tree stumps. Inspector Comments: 4 stumps

View of the tree stumps on the landside levee slope..

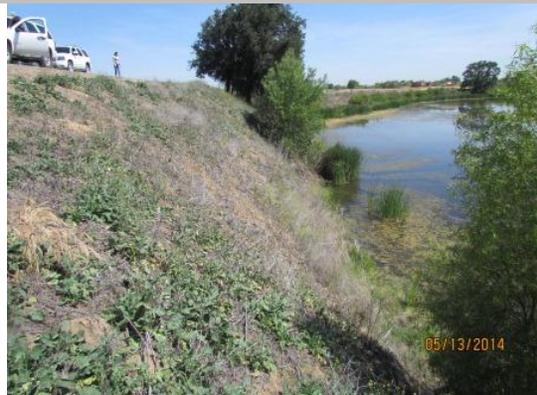
Photo 1 of 1 : FA_2014_RD2095_323_195_20141001_00011.jpg

LM Start	1.35	Rating **	A/W	Issue No.	195
LM End	1.35	Issue Type +	Ma	Location *	WS
Category	Earthen Levee		GPS Latitude/Longitude		
			Start	End	
Item	Erosion / Bank Caving		37.744746 °	37.744746 °	
			-121.297695 °	-121.297695 °	
DWR ID	DWR_RD2095_02_s_2014_195				
Action/Comments					
Note and monitor erosion site.

View of the erosion on the waterside levee slope possibly eroding into the levee prism.

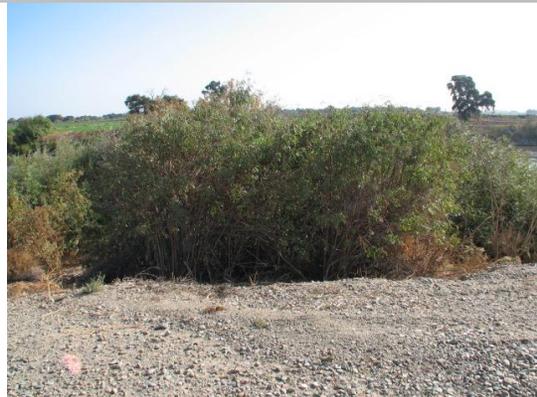
Photo 1 of 1 : FA_2014_RD2095_323_20_20141001_00010.jpg

LM Start	2.14	Rating **	M	Issue No.	20
LM End	2.14	Issue Type +	Ma	Location *	WS
Category	Earthen Levee			GPS Latitude/Longitude	
				Start	End
Item	Vegetation			37.734858 °	37.734858 °
				-121.297758 °	-121.297758 °
DWR ID	DWR_RD2095_02_s_2012_20				
Action/Comments					
Elderberries are blocking visibility and flood fight capability.

Vegetation on waterside slope obstructs access and visibility.
