**Flood Control Project Maintenance
Levee Inspections**

Maintenance Issue Types Only, Levee Inspection Report By Mile - Spring 2015

Reclamation District No. 2095 Paradise Cut

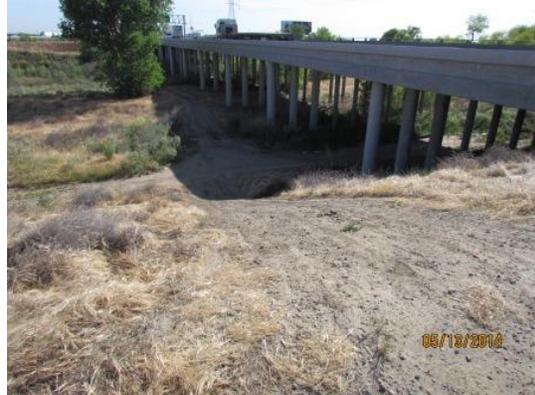
Photo 1 of 1 : SP_2015_RD2095_322_134_20150317_00008.jpg

LM Start	0.11	Rating **	A/W	Issue No.	134
LM End	0.11	Issue Type +	Ma	Location *	WS
Category	Earthen Levee		GPS Latitude/Longitude		
			Start	End	
Item	Slope Stability		37.770212 °	37.770212 °	
			-121.325675 °	-121.325675 °	
DWR ID	DWR_RD2095_01_s_2014_134				
Action/Comments					
Repair the levee slope damaged by vehicle traffic and prevent access where possible.

View of the vehicle access on the waterside levee slope.

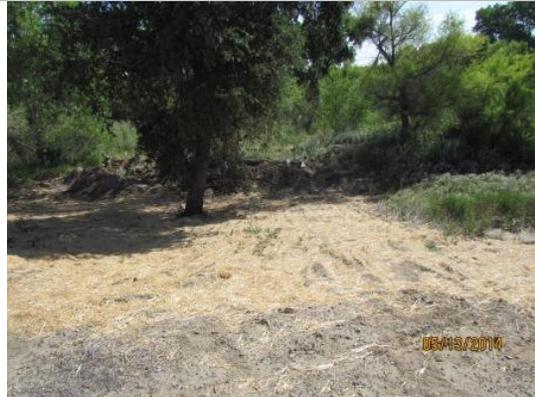
Photo 1 of 1 : SP_2015_RD2095_322_13_20150317_00007.jpg

LM Start	0.42	Rating **	A/W	Issue No.	13
LM End	0.42	Issue Type +	Ma	Location *	WS
Category	Earthen Levee		GPS Latitude/Longitude		
			Start	End	
Item	Slope Stability		37.766917 °	37.766917 °	
			-121.322267 °	-121.322267 °	
DWR ID	DWR_RD2095_01_s_2013_13				
Action/Comments					
Repair the levee slope damaged by vehicle traffic and prevent access where possible. Inspector Comments: LMA is actively controlling the slope instability.

View of the repaired waterside levee slope.

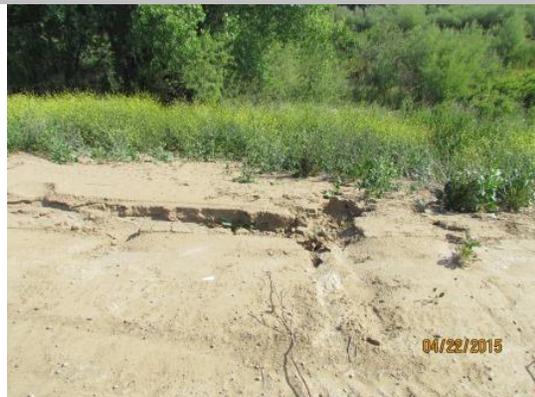
Photo 1 of 1 : SP_2015_RD2095_322_242_20150424_00321.jpg

LM Start	0.68	Rating **	M	Issue No.	242
LM End	0.68	Issue Type +	Ma	Location *	WS
Category	Earthen Levee		GPS Latitude/Longitude		
			Start	End	
Item	Erosion / Bank Caving		37.763991 °	37.763991 °	
			-121.319334 °	-121.319334 °	
DWR ID	DWR_RD2095_01_s_2015_242				
Action/Comments					
Schedule repair of erosion site prior to the next inspection.

View of the erosion on the waterside levee hinge.

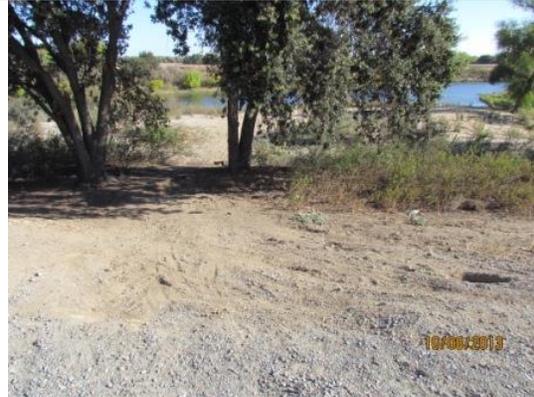
Photo 1 of 1 : SP_2015_RD2095_323_9_20150317_00006.jpg

LM Start	0.03	Rating **	A/W	Issue No.	9
LM End	0.03	Issue Type +	Ma	Location *	WS
Category	Earthen Levee		GPS Latitude/Longitude		
			Start	End	
Item	Slope Stability		37.758986 °	37.758986 °	
			-121.307854 °	-121.307854 °	
DWR ID	DWR_RD2095_02_s_2013_9				
Action/Comments					
Repair the levee slope damaged by vehicle traffic and prevent access where possible.

View of the vehicle tire ruts on waterside levee slope.

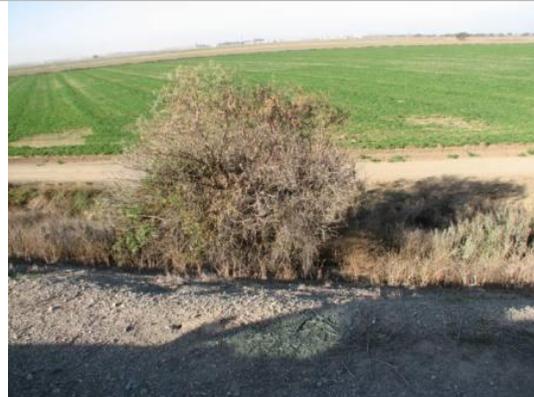
Photo 1 of 1 : SP_2015_RD2095_323_6_20150317_00005.jpg

LM Start	0.60	Rating **	A/W	Issue No.	6
LM End	0.60	Issue Type +	Ma	Location *	LS
Category	Earthen Levee		GPS Latitude/Longitude		
			Start	End	
Item	Vegetation		37.751668 °	37.751668 °	
			-121.304302 °	-121.304302 °	
DWR ID	DWR_RD2095_02_s_2012_6				
Action/Comments					
Elderberries are blocking visibility and flood fight capability.

11/01/2011 Elderberry bush at landside toe.

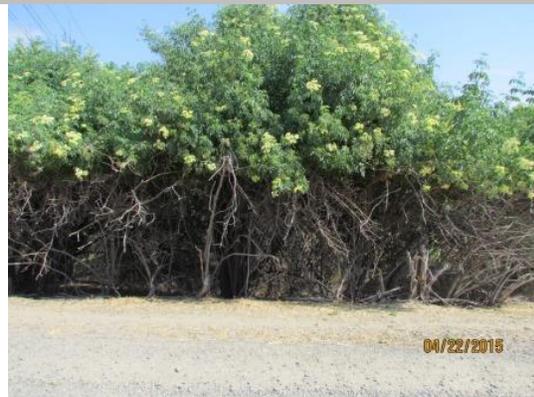
Photo 1 of 2 : SP_2015_RD2095_323_941_20150424_00553.jpg

LM Start	0.97	Rating **	A/W	Issue No.	941
LM End	0.97	Issue Type +	Ma	Location *	WS
Category	Earthen Levee		GPS Latitude/Longitude		
			Start	End	
Item	Vegetation		37.749706 °	37.749706 °	
			-121.299237 °	-121.299237 °	
DWR ID	DWR_RD2095_02_s_2012_941				
Action/Comments					
Elderberries are blocking visibility and flood fight capability. Inspector Comments: Dense bush within 20' of crown on waterside slope.

View of the elderberry shrubs at the waterside levee hinge.

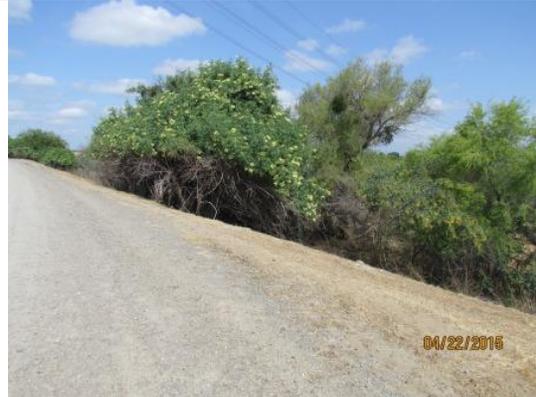
Photo 2 of 2 : SP_2015_RD2095_323_941_20150424_00554.jpg

LM Start	0.97	Rating **	A/W	Issue No.	941 (cont)
LM End	0.97	Issue Type +	Ma	Location *	WS
Category	Earthen Levee			GPS Latitude/Longitude	
				Start	End
Item	Vegetation			37.749706 °	37.749706 °
				-121.299237 °	-121.299237 °
DWR ID	DWR_RD2095_02_s_2012_941				
Action/Comments					
Elderberries are blocking visibility and flood fight capability. Inspector Comments: Dense bush within 20' of crown on waterside slope.

View of the elderberry shrubs on the waterside levee slope.

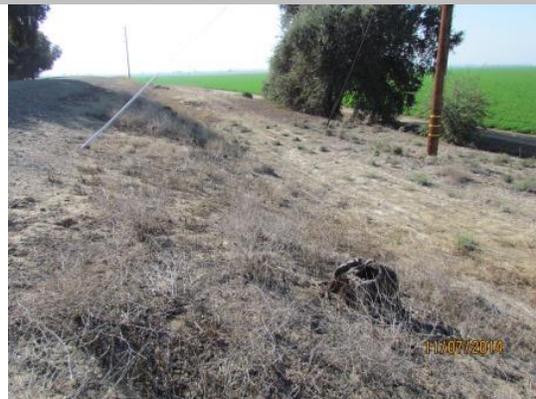
Photo 1 of 1 : SP_2015_RD2095_323_3_20150317_00003.jpg

LM Start	1.09	Rating **	N	Issue No.	3
LM End	1.09	Issue Type +	Ma	Location *	LS
Category	Earthen Levee			GPS Latitude/Longitude	
				Start	End
Item	Trim / Thin Trees			37.748184 °	37.748184 °
				-121.298995 °	-121.298995 °
DWR ID	DWR_RD2095_02_s_2012_3				
Action/Comments					
Tree stumps. Inspector Comments: 4 stumps

View of the tree stumps on the landside levee slope..

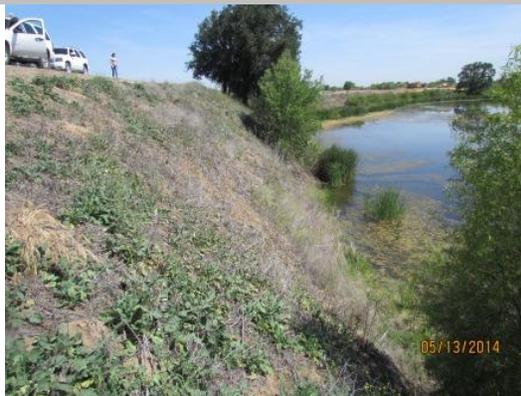
Photo 1 of 1 : SP_2015_RD2095_323_195_20150317_00009.jpg

LM Start	1.35	Rating **	A/W	Issue No.	195
LM End	1.35	Issue Type +	Ma	Location *	WS
Category	Earthen Levee		GPS Latitude/Longitude		
			Start	End	
Item	Erosion / Bank Caving		37.744746 °	37.744746 °	
			-121.297695 °	-121.297695 °	
DWR ID	DWR_RD2095_02_s_2014_195				
Action/Comments					
Note and monitor erosion site.

View of the erosion on the waterside levee slope possibly eroding into the levee prism.

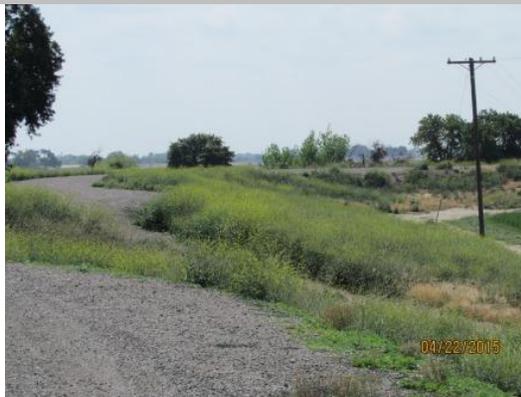
Photo 1 of 1 : SP_2015_RD2095_323_365_20150424_00555.jpg

LM Start	1.51	Rating **	U	Issue No.	365
LM End	1.51	Issue Type +	Ma	Location *	LS
Category	Earthen Levee		GPS Latitude/Longitude		
			Start	End	
Item	Vegetation		37.742866 °	37.742866 °	
			-121.297274 °	-121.297274 °	
DWR ID	DWR_RD2095_02_s_2015_365				
Action/Comments					
Control annual grass and weeds on the levee slopes and easements. Inspector Comments: Dense vegetation on levee slope.

View of the annual vegetation on the landside levee slope.

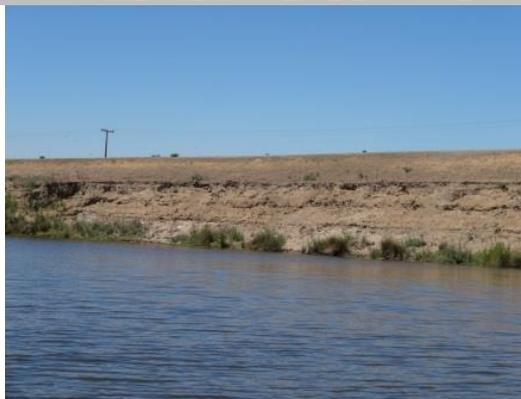
Photo 1 of 1 : SP_2015_RD2095_323_1_20150317_00001.jpg

LM Start	1.75	Rating **	M	Issue No.	1
LM End	1.75	Issue Type +	Ma	Location *	WS
Category	Supplemental		GPS Latitude/Longitude		
			Start	End	
Item	DWR Erosion Survey		37.740196 °	37.740196 °	
			-121.297662 °	-121.297662 °	
DWR ID	DWR_RD2095_02_s_2015_1				
Action/Comments					
Inspector Comments: 7/02/2014: No significant change observed. 08/28/2013: No significant change observed. 09/13/2012: The site has been visited by land survey. The vegetation on the site shows the erosion has not developed significantly from the last survey. The site was not visited by boat survey due to the limitation of navigable waterway. 08/23/2011: No significant change observed. 9/22/2010: No significant change observed. There is moderate vegetation growth on the berm. Despite the erosion occurring on the berm, corrective action should be taken before the issue becomes severe. 9/29/2009: Site is immediately downstream of a section of existing rip rap; there is a 20-foot berm remaining; berm will continue to erode unless erosion is mitigated; Site# is the same as RM62.6, LM1.87; recommended for annual assessment, per CES Evaluation 2008 Report 2006: Visited 10/20/06 [2014 Site ID:RD2095U02RM60.62]

View of the erosion.
