**Flood Control Project Maintenance
Levee Inspections**

Fall 2009 Levee Maintenance Deficiency Summary Report

Reclamation District No. 2096 Wetherbee Lake

Levee Inspection Report By Mile - Fall 2009

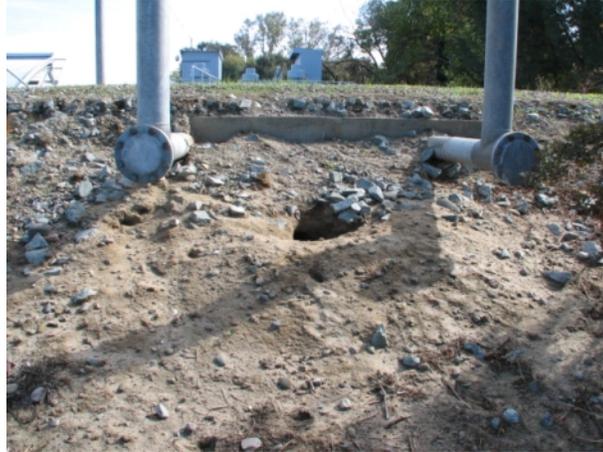
Levee Mile Report Line	1
Start Levee Mile	0.03
End Levee Mile	0.03
Location	Water Side
Category	Earthen Levee
Item	Animal Control
Two active animal burrows exist on the waterside slope near the navigation gate.	
jpaasch_20091105_179.jpg

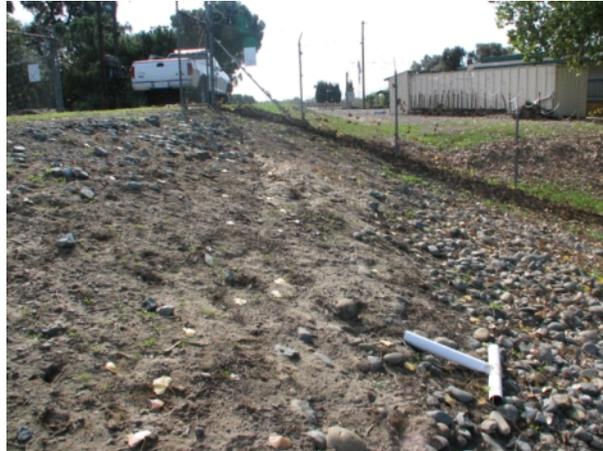
Levee Mile Report Line	1
Start Levee Mile	0.03
End Levee Mile	0.03
Location	Water Side
Category	Earthen Levee
Item	Animal Control
Though numerous bait stations have been placed, animal burrows remain on the waterside slope near the navigation gate.	
jpaasch_20091105_180.jpg

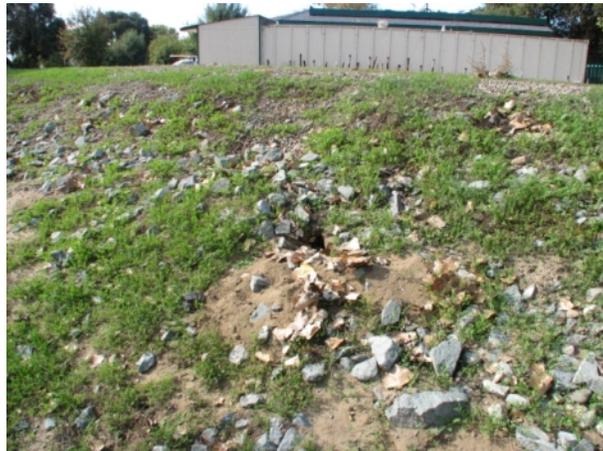
Levee Mile Report Line	3
Start Levee Mile	0.05
End Levee Mile	0.05
Location	Land Side
Category	Earthen Levee
Item	Animal Control
An active animal burrow on the landside slope.	
jpaasch_20091105_181.jpg

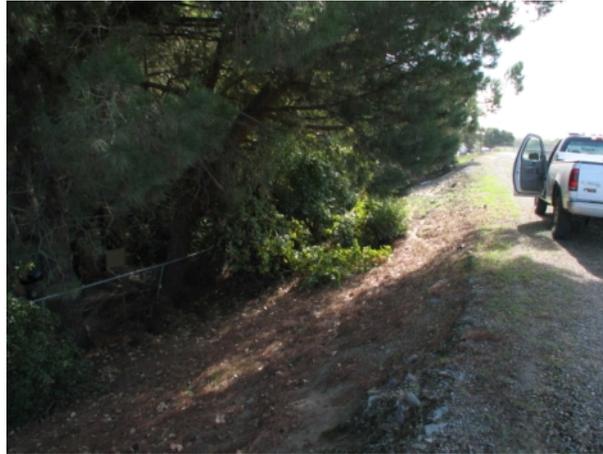
Levee Mile Report Line	4
Start Levee Mile	0.05
End Levee Mile	0.06
Location	Land Side
Category	Earthen Levee
Item	Vegetation
Condition unchanged. Vines and branches on the landward slope limit access.	
jpaasch_20091105_182.jpg

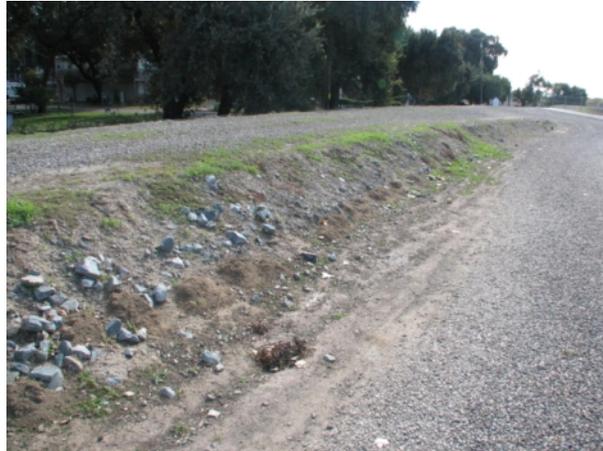
Levee Mile Report Line	6
Start Levee Mile	0.07
End Levee Mile	0.08
Location	Water Side
Category	Earthen Levee
Item	Animal Control
Several animal burrows are on the waterside slope.	
jpaasch_20091105_184.jpg

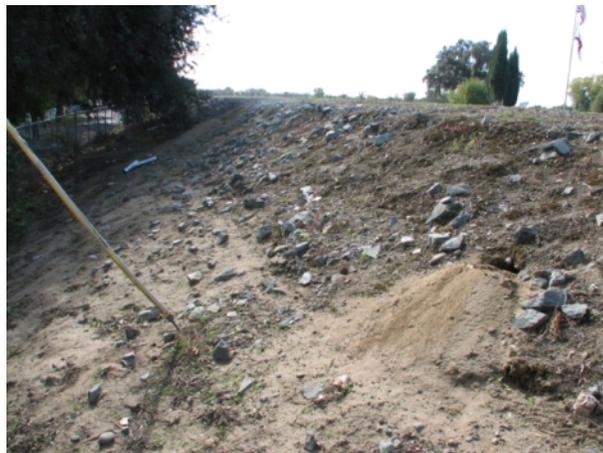
Levee Mile Report Line	7
Start Levee Mile	0.07
End Levee Mile	0.08
Location	Land Side
Category	Earthen Levee
Item	Animal Control
Though several bait stations have been placed and previous holes have been grouted, active rodent holes persist.	
jpaasch_20091105_185.jpg

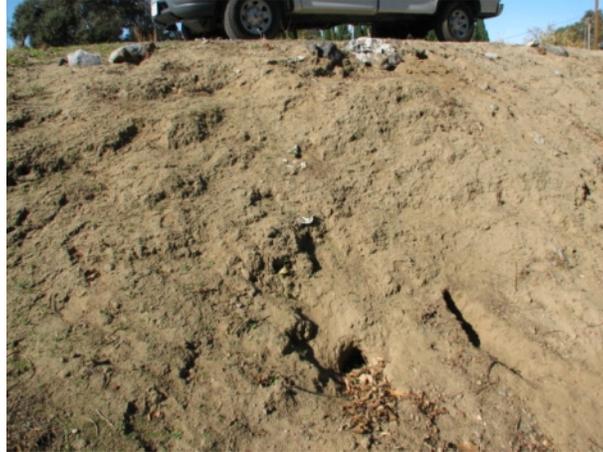
Levee Mile Report Line	8
Start Levee Mile	0.10
End Levee Mile	0.10
Location	Land Side
Category	Earthen Levee
Item	Animal Control
Photo of damaged waterward slope due to rodent burrows.	
jpaasch_20091105_186.jpg
