**Flood Control Project Maintenance
Levee Inspections**

Fall 2010 Levee Maintenance Deficiency Summary Report

San Joaquin River Basin

Reclamation District No. 2096 Wetherbee Lake

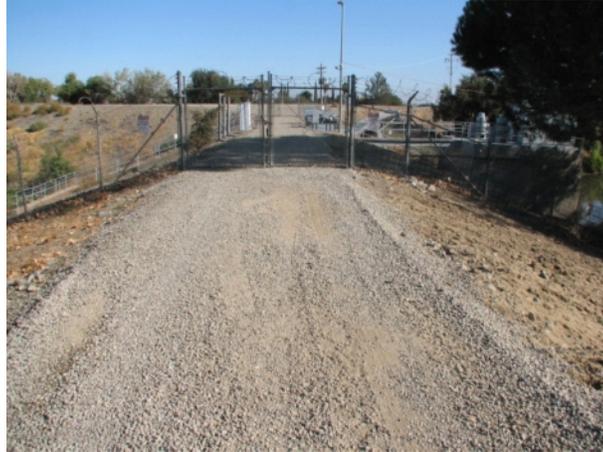
Levee Mile Report Line	1
Start Levee Mile	0.00
End Levee Mile	0.17
Location	Crown
Category	Earthen Levee
Item	Crown Surface / Depressions / Rutting
Gravel added to crown roadway.	
jpaasch_f_20101004_476.jpg

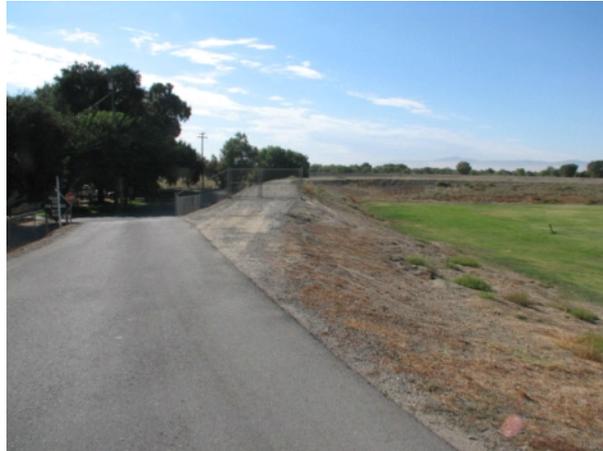
Levee Mile Report Line	1
Start Levee Mile	0.00
End Levee Mile	0.17
Location	Crown
Category	Earthen Levee
Item	Crown Surface / Depressions / Rutting
Levee crown roadway looking upstream.	
jpaasch_f_20101004_477.jpg

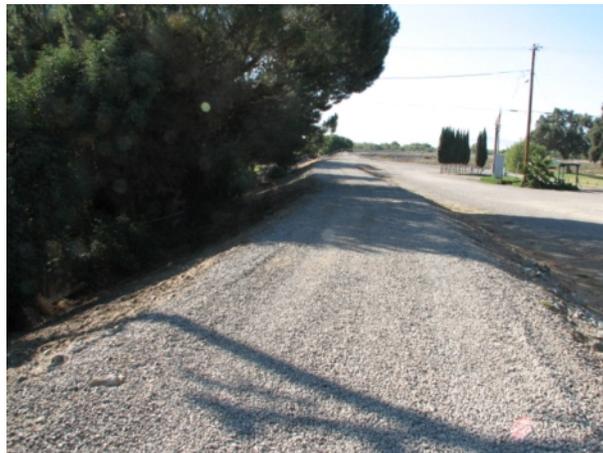
Levee Mile Report Line	5
Start Levee Mile	0.05
End Levee Mile	0.06
Location	Land Side
Category	Earthen Levee
Item	Vegetation
Vegetation on landside slope and toe (left) needst o be trimmed up 5' for access and visibility.	
jpaasch_f_20101004_472.jpg

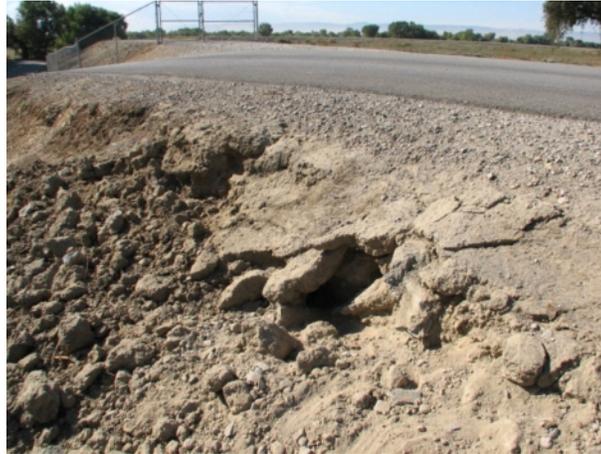
jpaasch_f_20101004_475.jpg

Levee Mile Report Line	8
Start Levee Mile	0.10
End Levee Mile	0.10
Location	Land Side
Category	Earthen Levee
Item	Animal Control

Levee slope was recompacted and rodents have reestablished their den at this location.
