**Flood Control Project Maintenance  
Levee Inspections**

**Fall 2012 Levee Maintenance Deficiency Summary Report  
Overall LMA & Unit Ratings, including DWR Erosion Survey**

**Reclamation District No. 2096 Wetherbee Lake**

**Levee Inspection Report By Mile - Fall 2012**

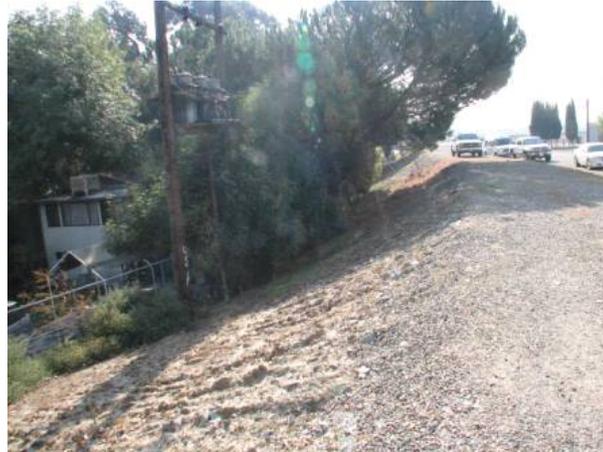
Levee Mile Report Line	4
Start Levee Mile	0.04
End Levee Mile	0.17
Location	Land Side
Category	Earthen Levee
Item	Encroachments
11/09/2011 Fence at toe of levee.	
mkhashch_f_20120927_345.jpg

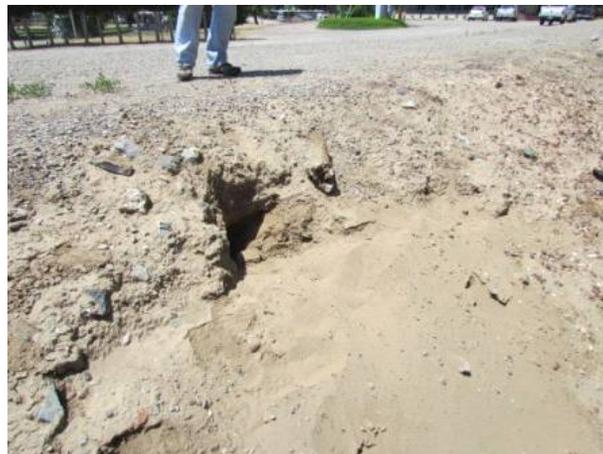
Levee Mile Report Line	5
Start Levee Mile	0.08
End Levee Mile	0.08
Location	Land Side
Category	Earthen Levee
Item	Animal Control
View of large burrow hole in landside slope. Grout plug did not work as it was removed by squirrels and is visible next to the hole on the right. 05/24/2012	
mkhashch_f_20120927_348.jpg

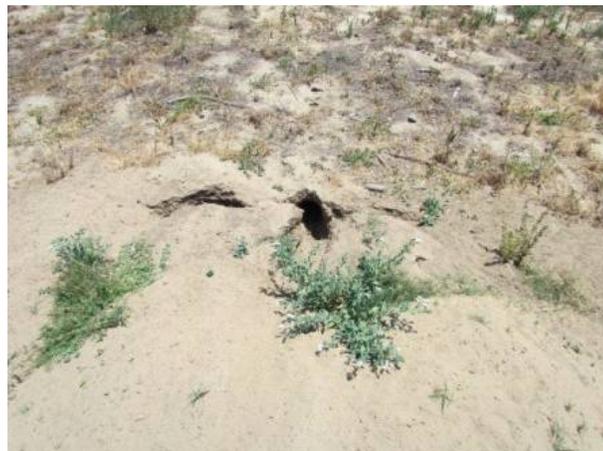
Levee Mile Report Line	6
Start Levee Mile	0.12
End Levee Mile	0.12
Location	Water Side
Category	Earthen Levee
Item	Animal Control
View of large burrow holes at waterside toe. 05/24/2012	
mkhashch_f_20120927_346.jpg

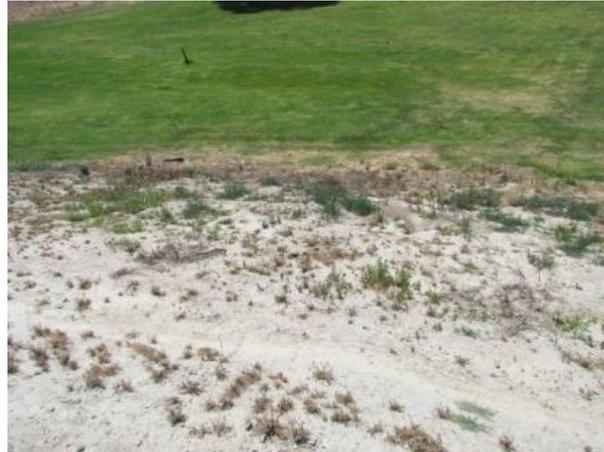
Levee Mile Report Line	6
Start Levee Mile	0.12
End Levee Mile	0.12
Location	Water Side
Category	Earthen Levee
Item	Animal Control

View of active burrow holes at waterside toe.  
05/24/2012

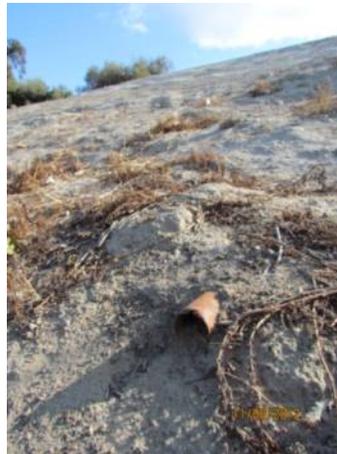
Levee Mile Report Line	7
Start Levee Mile	0.12
End Levee Mile	0.12
Location	Water Side
Category	Earthen Levee
Item	Encroachments

DWR ID: DWR_RD2096_01_s_2012_5		
7	0.12	0.12	Earthen Levee	Encroachments	WS	U Ma	PI : Pipe Inspector Comments: Exposed 2" steel pipe on waterside slope.	37.772477 ° -121.298383 °	37.772477 ° -121.298383 °	7 Y
								DWR ID: DWR_RD2096_01_f_2012_7

View of the exposed open two inch pipe on the waterside slope near the toe.
