**Flood Control Project Maintenance  
Levee Inspections**

**Fall 2014 Levee Maintenance Deficiency Summary Report  
Overall LMA & Unit Ratings, including DWR Erosion Survey**

**Reclamation District No. 2096 Wetherbee Lake**

**Levee Inspection Report By Mile - Fall 2014**

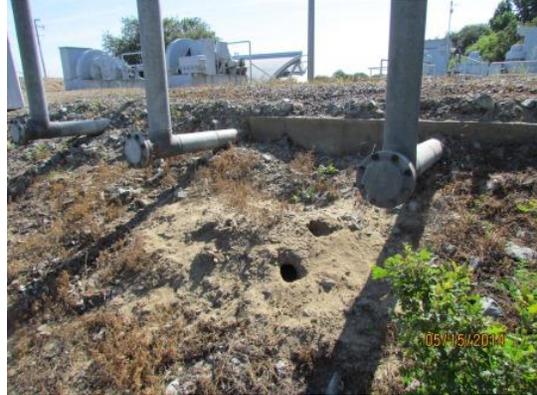
Photo 1 of 1 : FA\_2014\_RD2096\_117\_10\_20141001\_00006.jpg

LM Start	<b>0.02</b>	Rating **	M	Issue No.	<b>10</b>
LM End	<b>0.02</b>	Issue Type +	Ma	Location *	WS
Category	Earthen Levee		GPS Latitude/Longitude		
			Start	End	
Item	Animal Control		37.773901 °	37.773901 °	
			-121.298399 °	-121.298399 °	
DWR ID	DWR_RD2096_01_s_2013_10				
Action/Comments					
Exterminate rodents and backfill and compact or grout burrows. Inspector Comments: LMA grouted the hole and another one appeared just below the original hole.

View of the rodent burrow on the waterside levee slope.

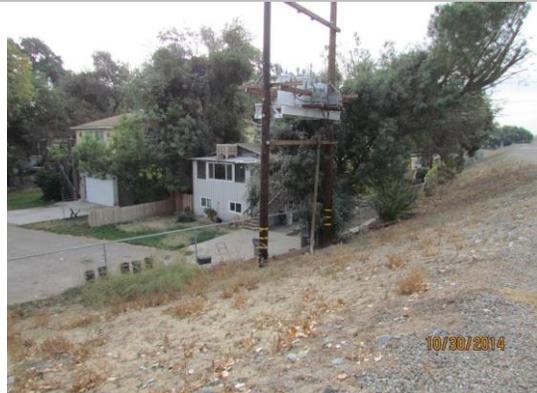
Photo 1 of 1 : FA\_2014\_RD2096\_117\_3\_20141030\_00010.jpg

LM Start	<b>0.04</b>	Rating **	M	Issue No.	<b>3</b>
LM End	<b>0.17</b>	Issue Type +	En	Location *	LS
Category	Earthen Levee		GPS Latitude/Longitude		
			Start	End	
Item	Encroachments		37.773495 °	37.772722 °	
			-121.298411 °	-121.298436 °	
DWR ID	DWR_RD2096_01_s_2012_3				
Action/Comments					
Fence Inspector Comments: Fence at toe of levee obstructs access.

View of the fence at the landside levee toe.

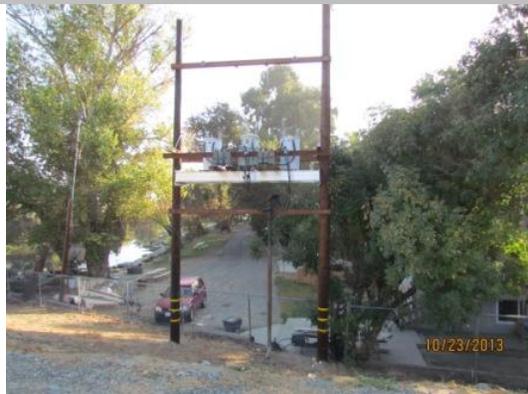
Photo 1 of 1 : FA\_2014\_RD2096\_117\_8\_20141001\_00004.jpg

LM Start	<b>0.05</b>	Rating **	A/W	Issue No.	<b>8</b>
LM End	<b>0.05</b>	Issue Type +	En	Location *	LS
Category	Earthen Levee		GPS Latitude/Longitude		
			Start	End	
Item	Encroachments		37.773479 °	37.773479 °	
			-121.298486 °	-121.298486 °	
DWR ID	DWR_RD2096_01_f_2013_8				
Action/Comments					
Pole Inspector Comments: Two telephone poles at landside levee toe.

View of the telephone poles at the landside levee toe.

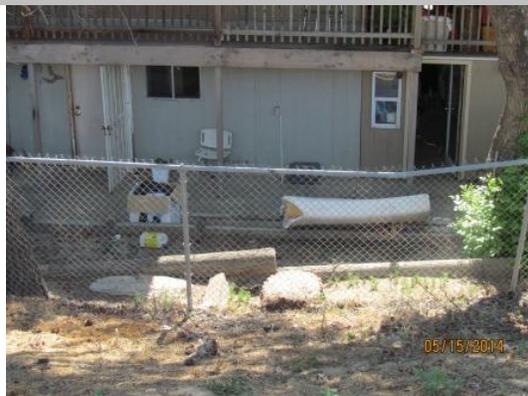
Photo 1 of 1 : FA\_2014\_RD2096\_117\_9\_20141001\_00005.jpg

LM Start	<b>0.06</b>	Rating **	N	Issue No.	<b>9</b>
LM End	<b>0.06</b>	Issue Type +	Ma	Location *	LS
Category	Earthen Levee		GPS Latitude/Longitude		
			Start	End	
Item	Trim / Thin Trees		37.773348 °	37.773348 °	
			-121.298475 °	-121.298475 °	
DWR ID	DWR_RD2096_01_s_2014_9				
Action/Comments					
Tree stumps. Inspector Comments: Pine tree stump at levee toe.

View of the tree stump at the landside levee toe.

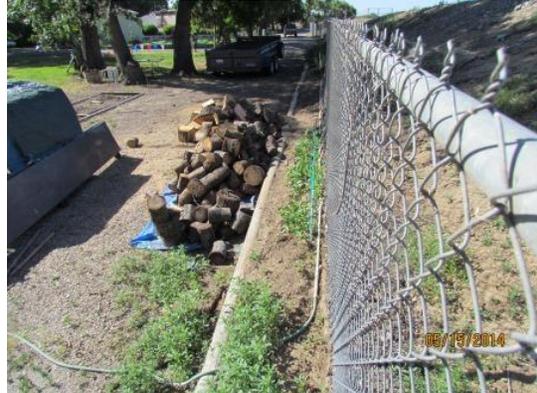
Photo 1 of 1 : FA\_2014\_RD2096\_117\_13\_20141001\_00008.jpg

LM Start	<b>0.08</b>	Rating **	M	Issue No.	<b>13</b>
LM End	<b>0.08</b>	Issue Type +	En	Location *	LS
Category	Earthen Levee		GPS Latitude/Longitude		
			Start	End	
Item	Encroachments		37.773021 °	37.773021 °	
			-121.298430 °	-121.298430 °	
DWR ID	DWR_RD2096_01_s_2014_13				
Action/Comments					
Retaining Wall Inspector Comments: Abut 1 foot by 50 feet retaining wall at levee toe with irrigation and landscaping.

View of the retaining wall at the landside levee toe.

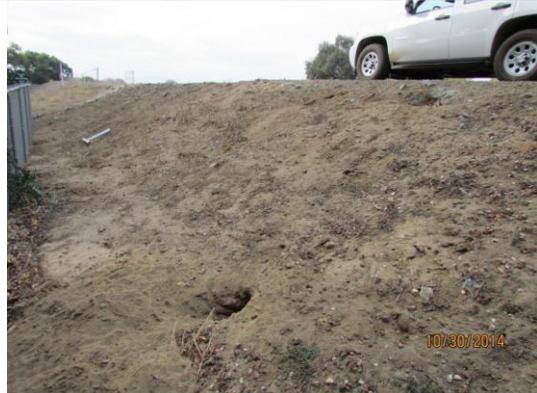
Photo 1 of 1 : FA\_2014\_RD2096\_117\_6\_20141030\_00011.jpg

LM Start	<b>0.09</b>	Rating **	M	Issue No.	<b>6</b>
LM End	<b>0.09</b>	Issue Type +	Ma	Location *	LS
Category	Earthen Levee		GPS Latitude/Longitude		
			Start	End	
Item	Animal Control		37.772909 °	37.772909 °	
			-121.298445 °	-121.298445 °	
DWR ID	DWR_RD2096_01_s_2012_6				
Action/Comments					
No rodents visible, but rodent burrows visible; need to backfill and compact or grout burrows.

View of the rodent burrow on the landside levee toe.

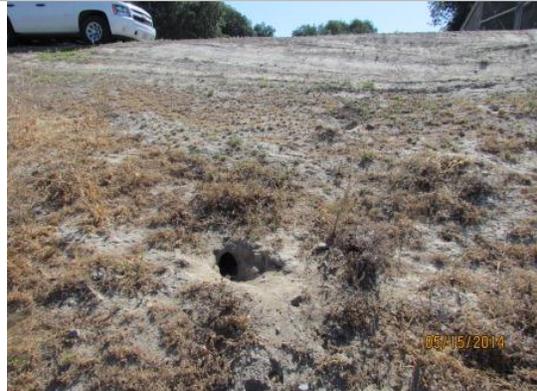
Photo 1 of 1 : FA\_2014\_RD2096\_117\_5\_20141001\_00002.jpg

LM Start	<b>0.12</b>	Rating **	M	Issue No.	<b>5</b>
LM End	<b>0.12</b>	Issue Type +	Ma	Location *	WS
Category	Earthen Levee		GPS Latitude/Longitude		
			Start	End	
Item	Animal Control		37.772485 °	37.772485 °	
			-121.298463 °	-121.298463 °	
DWR ID	DWR_RD2096_01_s_2012_5				
Action/Comments					
No rodents visible, but rodent burrows visible; need to backfill and compact or grout burrows. Inspector Comments: LMA is actively managing rodent infestation. Recently completed grouting.

View of the multiple rodent burrows recently grouted on the waterside levee slope. Monitor and exterminate any remaining rodents in the area.
