**Flood Control Project Maintenance
Levee Inspections**

Fall 2015 Levee Maintenance Deficiency Summary Report

Reclamation District No. 2096 Wetherbee Lake

Levee Inspection Report By Mile - Fall 2015

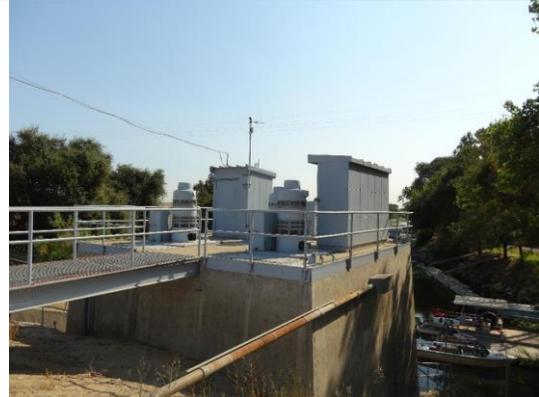
Photo 1 of 2 : UCIP_FA_2015_2276.jpg

LM Start	0.03	Rating **	M	Issue No.	14
LM End	0.03	Issue Type +	En	Location *	N/A
Category	Supplemental			GPS Latitude/Longitude	
				Start	End
Item	DWR UCIP Field Study			37.773800 °	37.773800 °
				-121.298428 °	-121.298428 °
DWR ID					
Action/Comments					
Inspector Comments: FS_ID:21506 DS_ID:24666 EP_NO: N/A FS_HLM: 0.027 Repair Type: Non-Urgent Crossing Status: Found UCIP Comments: - more information needs to be find from LMA/DWR Inspector for this crossing. - needs to find whether this pipe passes through the levee. FIELD_STRUCT_DESC: A 4-inch steel pipe through the levee and to pump platform, 3 ft. below the crown. It is a element of pumping plant. Field study discovered utility crossing. FS Date: 09/10/2013

LS view: closer view of 4-inch steel pipe (left) through the levee and to pump platform.

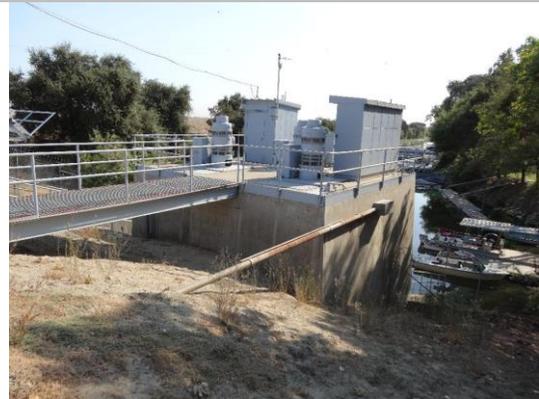
Photo 2 of 2 : UCIP_FA_2015_2277.jpg

LS view: 4-inch steel pipe (right) through the levee and to pump platform.

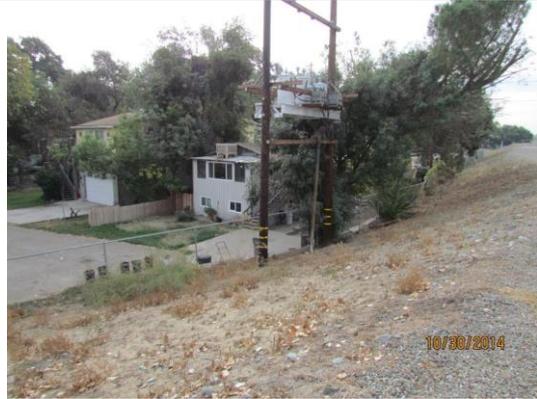
Photo 1 of 1 : FA_2015_RD2096_117_3_20150910_00001.jpg

LM Start	0.05	Rating **	M	Issue No.	3
LM End	0.10	Issue Type +	En	Location *	LS
Category	Earthen Levee		GPS Latitude/Longitude		
			Start	End	
Item	Encroachments		37.773495 °	37.772722 °	
			-121.298411 °	-121.298436 °	
DWR ID	DWR_RD2096_01_s_2012_3				
Action/Comments					
Fence Inspector Comments: Fence at toe of levee obstructs access.

View of the fence at the landside levee toe.

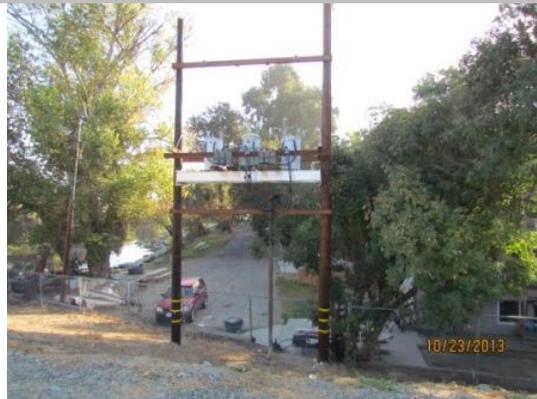
Photo 1 of 1 : FA_2015_RD2096_117_8_20150910_00004.jpg

LM Start	0.05	Rating **	A/W	Issue No.	8
LM End	0.05	Issue Type +	En	Location *	LS
Category	Earthen Levee		GPS Latitude/Longitude		
			Start	End	
Item	Encroachments		37.773479 °	37.773479 °	
			-121.298486 °	-121.298486 °	
DWR ID	DWR_RD2096_01_f_2013_8				
Action/Comments					
Pole Inspector Comments: Two telephone poles at landside levee toe.

View of the telephone poles at the landside levee toe.

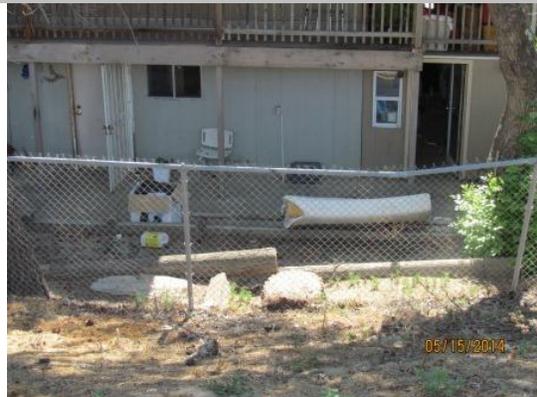
Photo 1 of 1 : FA_2015_RD2096_117_9_20150910_00005.jpg

LM Start	0.06	Rating **	N	Issue No.	9
LM End	0.06	Issue Type +	Ma	Location *	LS
Category	Earthen Levee		GPS Latitude/Longitude		
			Start	End	
Item	Trim / Thin Trees		37.773348 °	37.773348 °	
			-121.298475 °	-121.298475 °	
DWR ID	DWR_RD2096_01_s_2014_9				
Action/Comments					
Tree stumps. Inspector Comments: Pine tree stump at levee toe.

View of the tree stump at the landside levee toe.

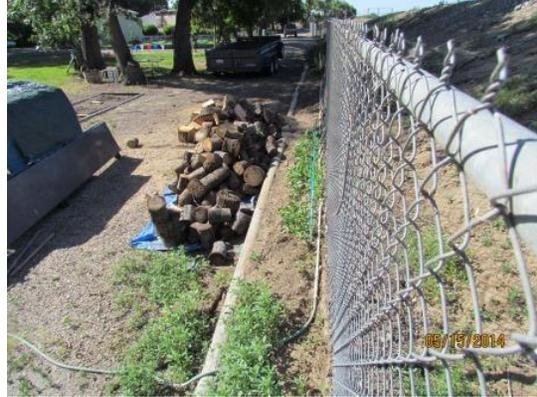
Photo 1 of 1 : FA_2015_RD2096_117_13_20150910_00007.jpg

LM Start	0.08	Rating **	M	Issue No.	13
LM End	0.08	Issue Type +	En	Location *	LS
Category	Earthen Levee		GPS Latitude/Longitude		
			Start	End	
Item	Encroachments		37.773021 °	37.773021 °	
			-121.298430 °	-121.298430 °	
DWR ID	DWR_RD2096_01_s_2014_13				
Action/Comments					
Retaining Wall Inspector Comments: Abut 1 foot by 50 feet retaining wall at levee toe with irrigation and landscaping.

View of the retaining wall at the landside levee toe.

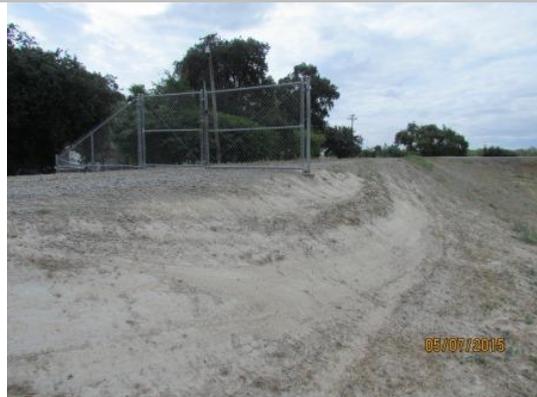
Photo 1 of 2 : FA_2015_RD2096_117_11_20150910_00006.jpg

View of the vehicle tracks eroding the waterside levee slope.

LM Start	0.12	Rating **	M	Issue No.	11
LM End	0.12	Issue Type +	Ma	Location *	WS
Category	Earthen Levee		GPS Latitude/Longitude		
			Start	End	
Item	Slope Stability		37.772434 °	37.772434 °	
			-121.298433 °	-121.298433 °	
DWR ID	DWR_RD2096_01_s_2015_11				
Action/Comments					
Repair the levee slope damaged by vehicle traffic and prevent access where possible.

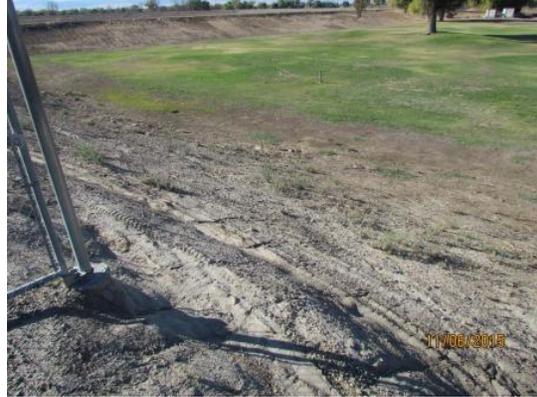
Photo 2 of 2 : FA_2015_RD2096_117_11_20151112_00009.jpg

Another view of the vehicle tracks on the waterside levee slope.

LM Start	0.12	Rating **	M	Issue No.	11 (cont)
LM End	0.12	Issue Type +	Ma	Location *	WS
Category	Earthen Levee			GPS Latitude/Longitude	
				Start	End
Item	Slope Stability			37.772434 °	37.772434 °
				-121.298433 °	-121.298433 °
DWR ID	DWR_RD2096_01_s_2015_11				
Action/Comments					
Repair the levee slope damaged by vehicle traffic and prevent access where possible.
