**Flood Control Project Maintenance
Levee Inspections**
LMA District Cover Sheet
Spring 2014 Levee Inspection Results

Reclamation District No. 2096 Wetherbee Lake

Spring 2014 Levee Inspection Results

Waterway	Bank	Unit Miles
Unit No. 01 San Joaquin River	Right	0.17

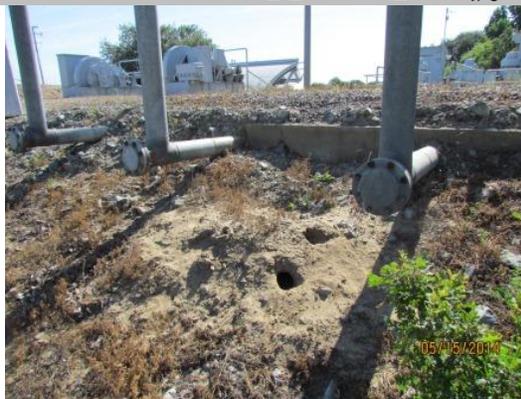
Photo 1 of 1 : mkhashch_s_20140519_01033.jpg

LM Start	0.02	Rating **	M	Issue No.	10
LM End	0.02	Issue Type +	Ma	Location *	WS
Category	Earthen Levee			GPS Latitude/Longitude	
				Start	End
Item	Animal Control			37.773901 °	37.773901 °
				-121.298399 °	-121.298399 °
DWR ID	DWR_RD2096_01_s_2013_10				
Action/Comments					
Exterminate rodents and backfill and compact or grout burrows. Inspector Comments: LMA grouted the hole and another one appeared just below the original hole.

View of the rodent burrow on the waterside levee slope.

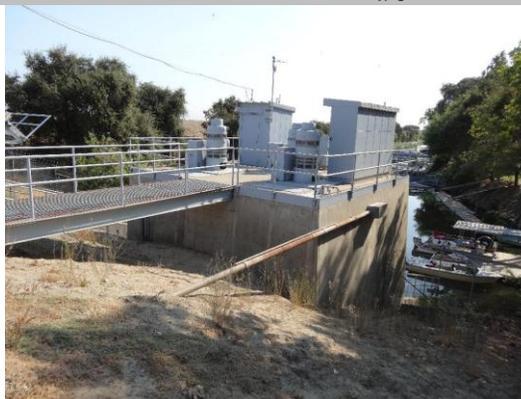
Photo 1 of 1 : UCIP_2504.jpg

LM Start	0.03	Rating **	M	Issue No.	7
LM End	0.03	Issue Type +	En	Location *	WS
Category	Supplemental			GPS Latitude/Longitude	
				Start	End
Item	DWR UCIP Field Study			37.773800 °	37.773800 °
				-121.298428 °	-121.298428 °
DWR ID	DWR_RD2096_01_s_2014_7				
Action/Comments					
Inspector Comments: FS_ID:21506 EP_NO: N/A Repair Type: Crossing Status: UCIP Comments: - more information needs to be find from LMA/DWR Inspector for this crossing. needs to find whether this pipe passes through the levee. FIELD_STRUCT_DESC: A 4-inch steel pipe through the levee and to pump platform, 3 ft. below the crown. It is a element of pumping plant. Field study discovered utility crossing. FS Date: 9/10/2013

LS view: 4-inch steel pipe (right) through the levee and to pump platform.

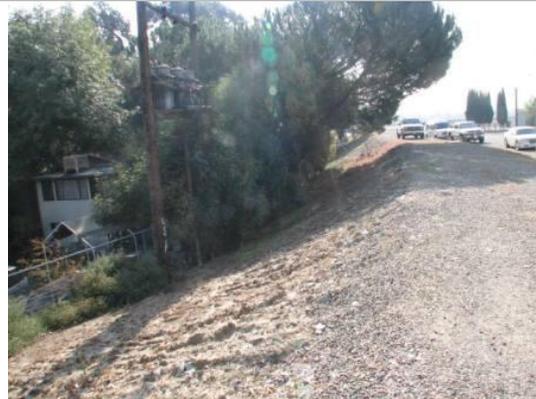
Photo 1 of 1 : mkhashch_s_20140428_00814.jpg

LM Start	0.04	Rating **	M	Issue No.	3
LM End	0.17	Issue Type +	En	Location *	LS
Category	Earthen Levee		GPS Latitude/Longitude		
			Start	End	
Item	Encroachments		37.773495 °	37.772722 °	
			-121.298411 °	-121.298436 °	
DWR ID	DWR_RD2096_01_s_2012_3				
Action/Comments					
Fence Inspector Comments: Fence at toe of levee obstructs access.

11/09/2011 Fence at the toe of the levee.

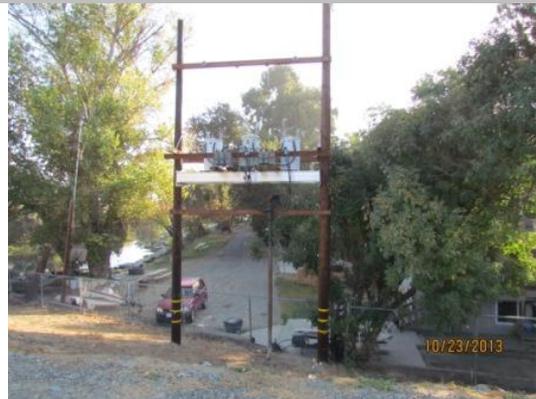
Photo 1 of 1 : mkhashch_s_20140428_00817.jpg

LM Start	0.05	Rating **	A/W	Issue No.	8
LM End	0.05	Issue Type +	En	Location *	LS
Category	Earthen Levee		GPS Latitude/Longitude		
			Start	End	
Item	Encroachments		37.773479 °	37.773479 °	
			-121.298486 °	-121.298486 °	
DWR ID	DWR_RD2096_01_f_2013_8				
Action/Comments					
Pole Inspector Comments: Two telephone poles at landside levee toe.

View of the telephone poles at the landside levee toe.

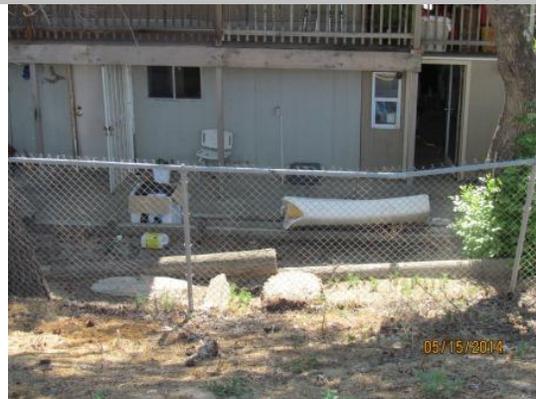
Photo 1 of 1 : mkhashch_s_20140519_01034.jpg

LM Start	0.06	Rating **	N	Issue No.	9
LM End	0.06	Issue Type +	Ma	Location *	LS
Category	Earthen Levee		GPS Latitude/Longitude		
			Start	End	
Item	Trim / Thin Trees		37.773348 °	37.773348 °	
			-121.298475 °	-121.298475 °	
DWR ID	DWR_RD2096_01_s_2014_9				
Action/Comments					
Tree stumps. Inspector Comments: Pine tree stump at levee toe.

View of the tree stump at the landside levee toe.

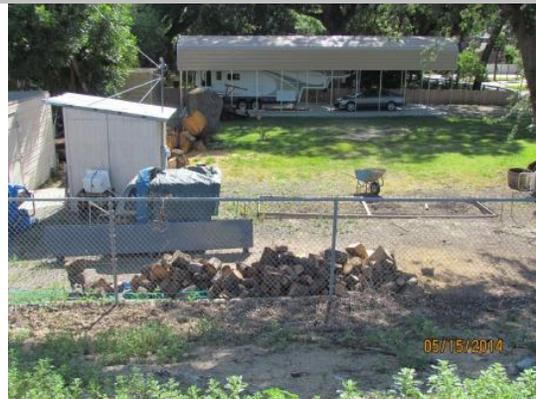
Photo 1 of 1 : mkhashch_s_20140519_01035.jpg

LM Start	0.08	Rating **	M	Issue No.	12
LM End	0.08	Issue Type +	En	Location *	LS
Category	Earthen Levee		GPS Latitude/Longitude		
			Start	End	
Item	Encroachments		37.773120 °	37.773120 °	
			-121.298439 °	-121.298439 °	
DWR ID	DWR_RD2096_01_s_2014_12				
Action/Comments					
Firewood Inspector Comments: Firewood at levee toe obstructing visibility. Move the stockpile at least 15 feet away from levee toe.

View of the firewood stored at the landside levee toe.

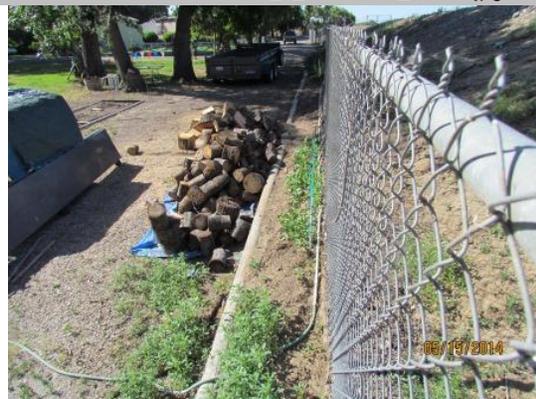
Photo 1 of 1 : mkhashch_s_20140519_01036.jpg

LM Start	0.08	Rating **	M	Issue No.	13
LM End	0.08	Issue Type +	En	Location *	LS
Category	Earthen Levee		GPS Latitude/Longitude		
			Start	End	
Item	Encroachments		37.773021 °	37.773021 °	
			-121.298430 °	-121.298430 °	
DWR ID	DWR_RD2096_01_s_2014_13				
Action/Comments					
Retaining Wall Inspector Comments: Abut 1 foot by 50 feet retaining wall at levee toe with irrigation and landscaping.

View of the retaining wall at the landside levee toe.

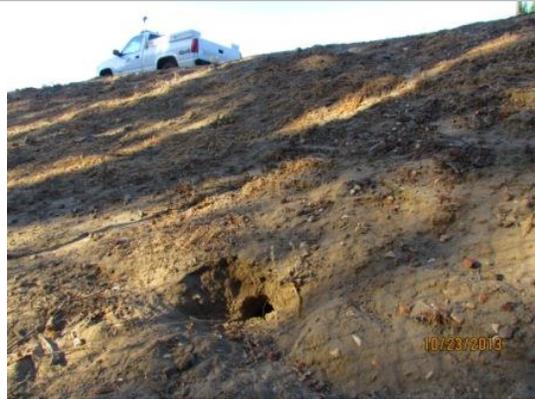
Photo 1 of 1 : mkhashch_s_20140428_00816.jpg

LM Start	0.09	Rating **	M	Issue No.	6
LM End	0.09	Issue Type +	Ma	Location *	LS
Category	Earthen Levee		GPS Latitude/Longitude		
			Start	End	
Item	Animal Control		37.772909 °	37.772909 °	
			-121.298445 °	-121.298445 °	
DWR ID	DWR_RD2096_01_s_2012_6				
Action/Comments					
No rodents visible, but rodent burrows visible; need to backfill and compact or grout burrows.

View of the rodent burrow on the landside levee toe.

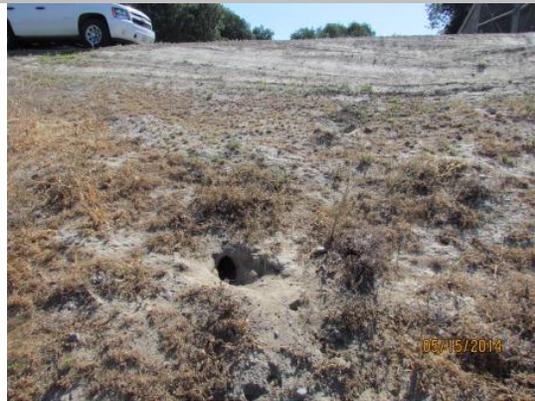
Photo 1 of 1 : mkhashch_s_20140519_01037.jpg

LM Start	0.12	Rating **	M	Issue No.	5
LM End	0.12	Issue Type +	Ma	Location *	WS
Category	Earthen Levee		GPS Latitude/Longitude		
			Start	End	
Item	Animal Control		37.772485 °	37.772485 °	
			-121.298463 °	-121.298463 °	
DWR ID	DWR_RD2096_01_s_2012_5				
Action/Comments					
No rodents visible, but rodent burrows visible; need to backfill and compact or grout burrows. Inspector Comments: LMA is actively managing rodent infestation. Recently completed grouting.

View of the multiple rodent burrows recently grouted on the waterside levee slope. Monitor and exterminate any remaining rodents in the area.
