**Flood Control Project Maintenance  
Levee Inspections**  
**LMA District Cover Sheet**  
**Spring 2015 Levee Inspection Results**

**Reclamation District No. 2096 Wetherbee Lake**

**Levee Inspection Report By Mile - Spring 2015**

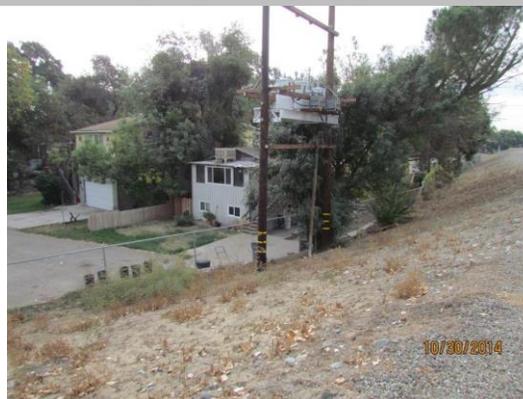
Photo 1 of 1 : SP\_2015\_RD2096\_117\_3\_20150317\_00001.jpg

LM Start	<b>0.05</b>	Rating **	M	Issue No.	<b>3</b>
LM End	<b>0.10</b>	Issue Type +	En	Location *	LS
Category	Earthen Levee		GPS Latitude/Longitude		
			Start	End	
Item	Encroachments		37.773495 °	37.772722 °	
			-121.298411 °	-121.298436 °	
DWR ID	DWR_RD2096_01_s_2012_3				
Action/Comments					
Fence Inspector Comments: Fence at toe of levee obstructs access.

View of the fence at the landside levee toe.

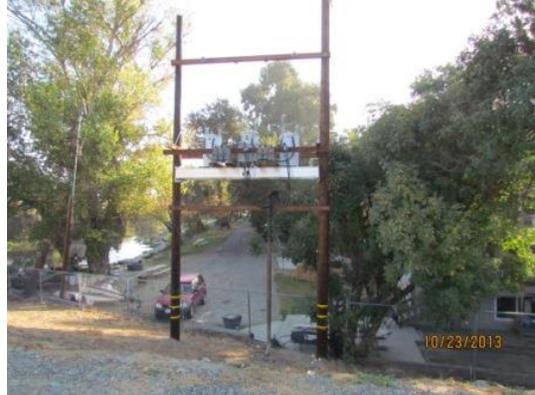
Photo 1 of 1 : SP\_2015\_RD2096\_117\_8\_20150317\_00004.jpg

LM Start	<b>0.05</b>	Rating **	A/W	Issue No.	<b>8</b>
LM End	<b>0.05</b>	Issue Type +	En	Location *	LS
Category	Earthen Levee			GPS Latitude/Longitude	
				Start	End
Item	Encroachments			37.773479 °	37.773479 °
				-121.298486 °	-121.298486 °
DWR ID	DWR_RD2096_01_f_2013_8				
Action/Comments					
Pole Inspector Comments: Two telephone poles at landside levee toe.

View of the telephone poles at the landside levee toe.

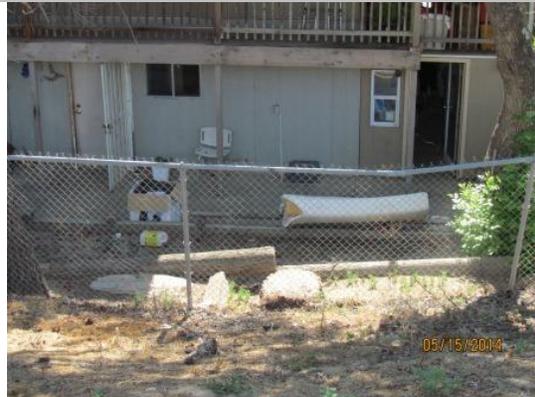
Photo 1 of 1 : SP\_2015\_RD2096\_117\_9\_20150317\_00005.jpg

LM Start	<b>0.06</b>	Rating **	N	Issue No.	<b>9</b>
LM End	<b>0.06</b>	Issue Type +	Ma	Location *	LS
Category	Earthen Levee			GPS Latitude/Longitude	
				Start	End
Item	Trim / Thin Trees			37.773348 °	37.773348 °
				-121.298475 °	-121.298475 °
DWR ID	DWR_RD2096_01_s_2014_9				
Action/Comments					
Tree stumps. Inspector Comments: Pine tree stump at levee toe.

View of the tree stump at the landside levee toe.

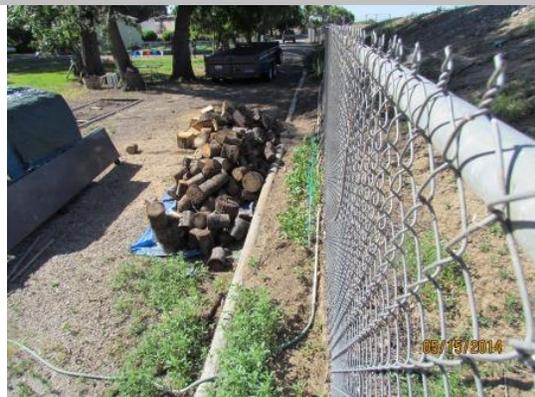
Photo 1 of 1 : SP\_2015\_RD2096\_117\_13\_20150317\_00007.jpg

LM Start	<b>0.08</b>	Rating **	M	Issue No.	<b>13</b>
LM End	<b>0.08</b>	Issue Type +	En	Location *	LS
Category	Earthen Levee			GPS Latitude/Longitude	
				Start	End
Item	Encroachments			37.773021 °	37.773021 °
				-121.298430 °	-121.298430 °
DWR ID	DWR_RD2096_01_s_2014_13				
Action/Comments					
Retaining Wall Inspector Comments: Abut 1 foot by 50 feet retaining wall at levee toe with irrigation and landscaping.

View of the retaining wall at the landside levee toe.
