**Flood Control Project Maintenance  
Levee Inspections**  
**LMA District Cover Sheet**  
**Spring 2016 Levee Inspection Results**

**Reclamation District No. 2096 Wetherbee Lake**

**Levee Inspection Report By Mile - Spring 2016**

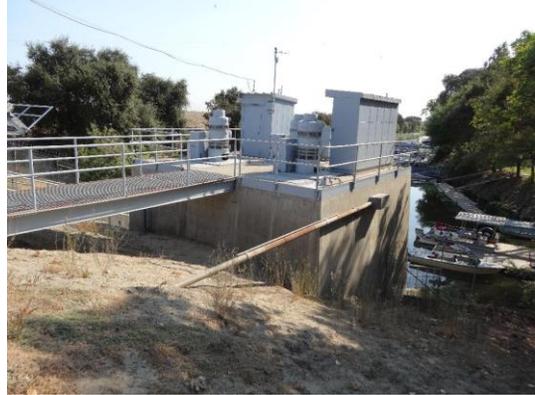
Photo 1 of 2 : UCIP\_SP\_2016\_21506\_36453.jpg

| FS_ID:21506<br>DS_ID:24666<br>EP_NO: N/A<br>Repair Type: Non-Urgent<br>Crossing Status: Found<br>UCIP Comments: - more information needs to be find from LMA/DWR Inspector for this crossing. - needs to find whether this pipe passes through the levee.<br>FIELD_STRUCT_DESC: A 4-inch steel pipe through the levee and to pump platform, 3 ft. below the crown. It is a element of pumping plant.<br>Field study discovered utility crossing.<br>FS Date: 9/10/2013 | | | | | |

LS view: 4-inch steel pipe (right) through the levee and to pump platform.

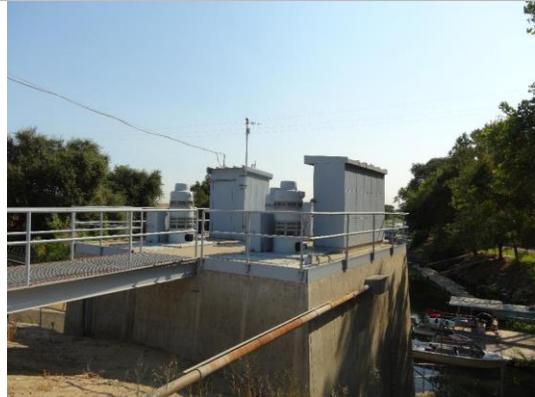
Photo 2 of 2 : UCIP\_SP\_2016\_21506\_36452.jpg

LS view: closer view of 4-inch steel pipe (left) through the levee and to pump platform.

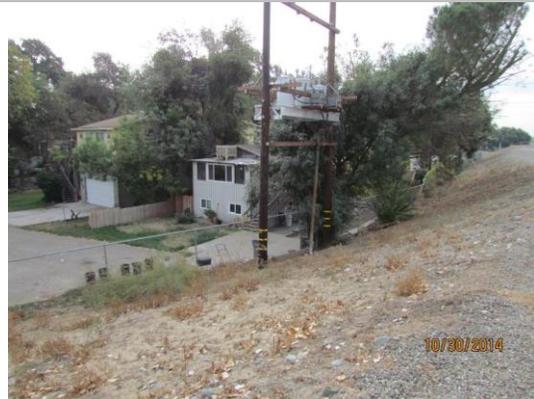
Photo 1 of 1 : SP\_2016\_RD2096\_117\_3\_20160229\_00001.jpg

| Fence at toe of levee obstructs access. | | | | | |

View of the fence at the landside levee toe.

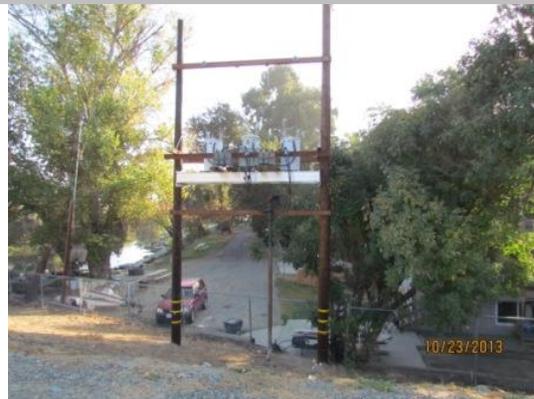
Photo 1 of 1 : SP\_2016\_RD2096\_117\_8\_20160229\_00002.jpg

| Two telephone poles at landside levee toe. | | | | | |

View of the telephone poles at the landside levee toe.

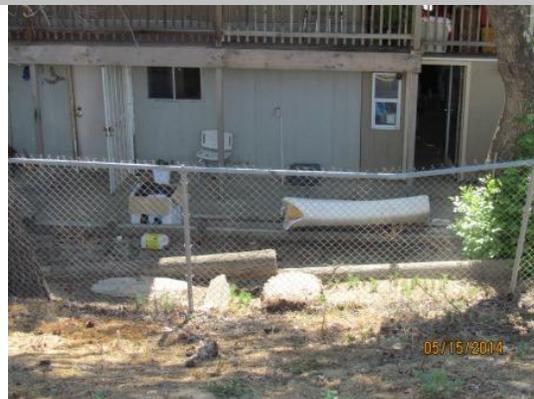
Photo 1 of 1 : SP\_2016\_RD2096\_117\_9\_20160229\_00003.jpg

| Pine tree stump at levee toe. | | | | | |

View of the tree stump at the landside levee toe.

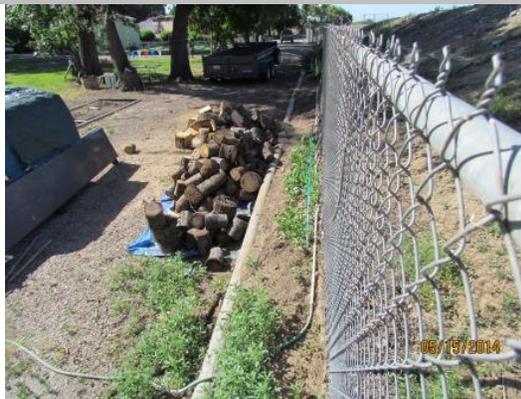
Photo 1 of 1 : SP\_2016\_RD2096\_117\_13\_20160229\_00006.jpg

| Abut 1 foot by 50 feet retaining wall at levee toe with irrigation and landscaping. | | | | | |

View of the retaining wall at the landside levee toe.

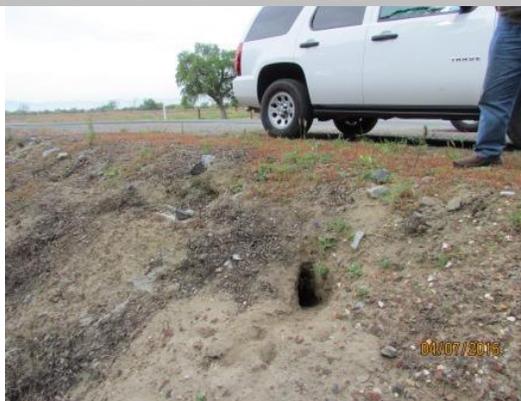
Photo 1 of 1 : SP\_2016\_RD2096\_117\_6\_20160412\_00009.jpg

| A3 : No rodents visible, but rodent burrows visible; need to backfill and compact or grout burrows. | | | | | |

View of the rodent hole on the landside levee slope.

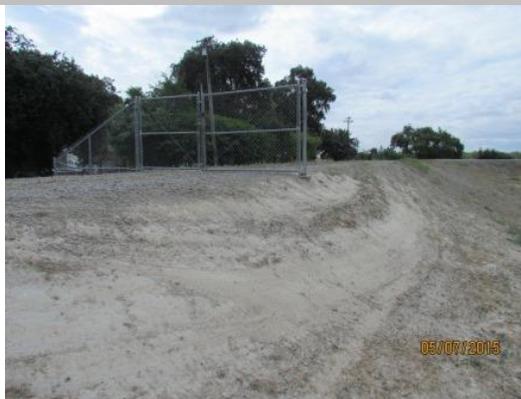
Photo 1 of 2 : SP\_2016\_RD2096\_117\_11\_20160229\_00004.jpg

View of the vehicle tracks eroding the waterside levee slope.

| S3 : Repair the levee slope damaged by vehicle traffic and prevent access where possible. | | | | | |

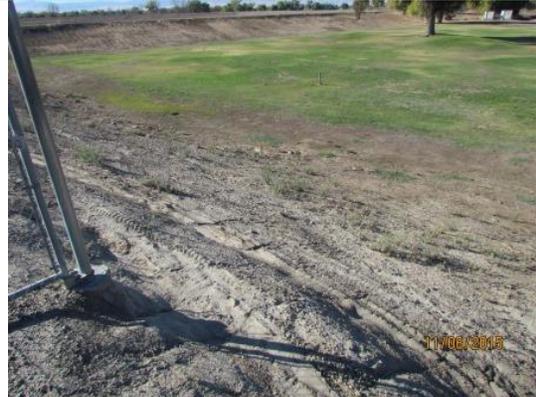
Photo 2 of 2 : SP\_2016\_RD2096\_117\_11\_20160229\_00005.jpg

Another view of the vehicle tracks on the waterside levee slope.

| S3 : Repair the levee slope damaged by vehicle traffic and prevent access where possible. | | | | | |
