**Flood Control Project Maintenance
Levee Inspections**

Maintenance Issue Types Only, Levee Inspection Report By Mile - Spring 2015

Reclamation District No. 2096 Wetherbee Lake

Waterway	Bank	Unit Miles	Inspection Start/End	Inspector
Unit No. 01 San Joaquin River	Right	0.16	05/07/2015 05/07/2015	Maksim Khashchuk

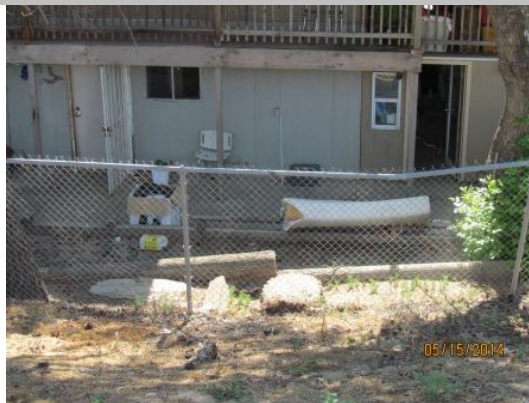
Photo 1 of 1 : SP_2015_RD2096_117_9_20150317_00005.jpg

LM Start	0.06	Rating **	N	Issue No.	9
LM End	0.06	Issue Type +	Ma	Location *	LS
Category	Earthen Levee			GPS Latitude/Longitude	
				Start	End
Item	Trim / Thin Trees			37.773348 °	37.773348 °
				-121.298475 °	-121.298475 °
DWR ID	DWR_RD2096_01_s _ 2014_9				
Action/Comments					
Tree stumps.					
Inspector Comments: Pine tree stump at levee toe.

View of the tree stump at the landside levee toe.

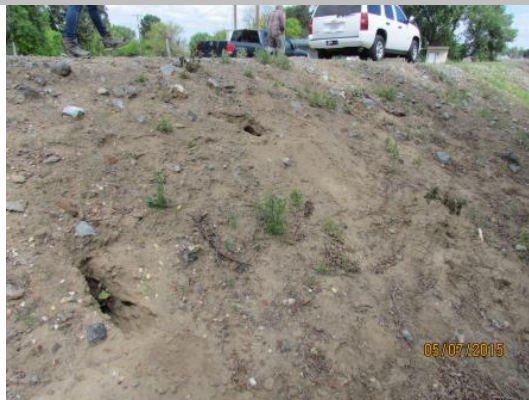
Photo 1 of 1 : SP_2015_RD2096_117_6_20150511_00009.jpg

LM Start	0.09	Rating **	M	Issue No.	6
LM End	0.09	Issue Type +	Ma	Location *	LS
Category	Earthen Levee			GPS Latitude/Longitude	
				Start	End
Item	Animal Control			37.772909 °	37.772909 °
				-121.298445 °	-121.298445 °
DWR ID	DWR_RD2096_01_s _ 2012_6				
Action/Comments					
No rodents visible, but rodent burrows visible; need to backfill and compact or grout burrows.

View of the rodent burrow on the landside levee slope.

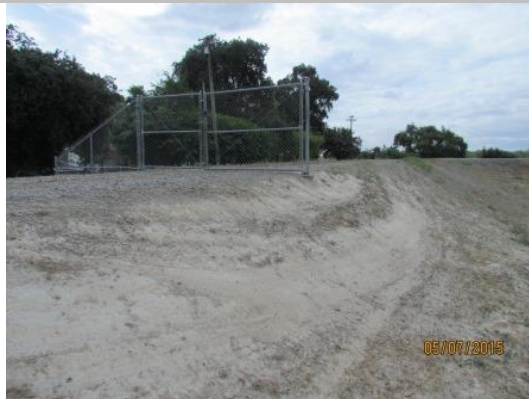
Photo 1 of 1 : SP_2015_RD2096_117_11_20150511_00011.jpg

LM Start	0.12	Rating **	M	Issue No.	11
LM End	0.12	Issue Type +	Ma	Location *	WS
Category	Earthen Levee			GPS Latitude/Longitude	
				Start	End
Item	Slope Stability			37.772434 °	37.772434 °
				-121.298433 °	-121.298433 °
DWR ID	DWR_RD2096_01_s_2015_11				
Action/Comments					
Repair the levee slope damaged by vehicle traffic and prevent access where possible.

View of the vehicle tracks eroding the waterside levee slope.

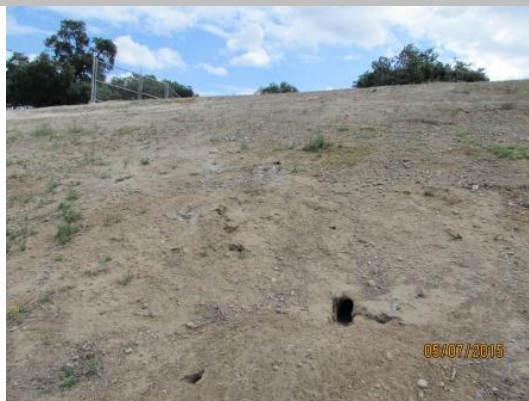
Photo 1 of 1 : SP_2015_RD2096_117_5_20150511_00010.jpg

LM Start	0.13	Rating **	M	Issue No.	5
LM End	0.13	Issue Type +	Ma	Location *	WS
Category	Earthen Levee			GPS Latitude/Longitude	
				Start	End
Item	Animal Control			37.772354 °	37.772354 °
				-121.298424 °	-121.298424 °
DWR ID	DWR_RD2096_01_s_2012_5				
Action/Comments					
No rodents visible, but rodent burrows visible; need to backfill and compact or grout burrows.					
Inspector Comments: LMA is actively managing rodent infestation.					
Recently completed grouting.

View of the multiple rodent burrows recently grouted on the waterside levee slope. Monitor and exterminate any remaining rodents in the area.
