**Flood Control Project Maintenance
Levee Inspections**

Maintenance Issue Types Only, Levee Inspection Report By Mile - Spring 2016

Reclamation District No. 2096 Wetherbee Lake

Waterway	Bank	Unit Miles	Inspection Start/End	Inspector
Unit No. 01 San Joaquin River	Right	0.16	04/07/2016 04/07/2016	Maksim Khashchuk

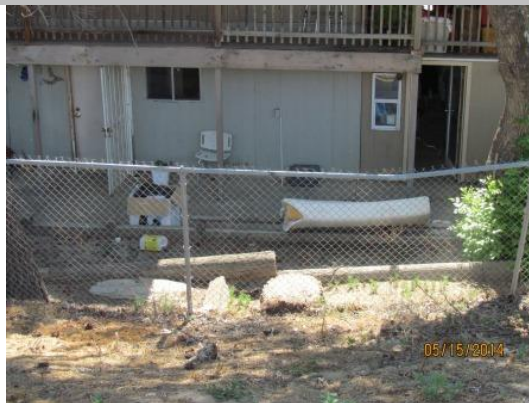
Photo 1 of 1 : SP_2016_RD2096_117_9_20160229_00003.jpg

LM Start	0.06	Rating **	N	Issue No.	9
LM End	0.06	Issue Type +	Ma	Location *	LS
Category	Earthen Levee			GPS Latitude/Longitude	
				Start	End
Item	Trim / Thin Trees			37.773348 °	37.773348 °
				-121.298475 °	-121.298475 °
DWR ID	DWR_RD2096_01_s_2014_9				
Comment Code					
T5 : Tree stumps.					
Inspector Comment					
Pine tree stump at levee toe.

View of the tree stump at the landside levee toe.

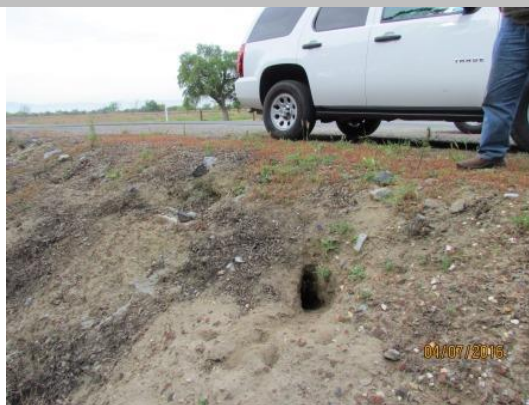
Photo 1 of 1 : SP_2016_RD2096_117_6_20160412_00009.jpg

LM Start	0.09	Rating **	M	Issue No.	6
LM End	0.09	Issue Type +	Ma	Location *	LS
Category	Earthen Levee			GPS Latitude/Longitude	
				Start	End
Item	Animal Control			37.772891 °	37.772891 °
				-121.298454 °	-121.298454 °
DWR ID	DWR_RD2096_01_s_2016_6				
Comment Code					
A3 : No rodents visible, but rodent burrows visible; need to backfill and compact or grout burrows.					
Inspector Comment

View of the rodent hole on the landside levee slope.

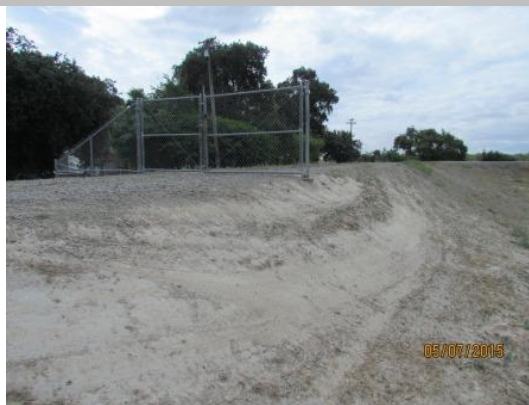
Photo 1 of 2 : SP_2016_RD2096_117_11_20160229_00004.jpg

LM Start	0.12	Rating **	M	Issue No.	11
LM End	0.12	Issue Type +	Ma	Location *	WS
Category	Earthen Levee			GPS Latitude/Longitude	
				Start	End
Item	Slope Stability			37.772434 °	37.772434 °
				-121.298433 °	-121.298433 °
DWR ID	DWR_RD2096_01_s_2015_11				
Comment Code					
S3 : Repair the levee slope damaged by vehicle traffic and prevent access where possible.					
Inspector Comment

View of the vehicle tracks eroding the waterside levee slope.

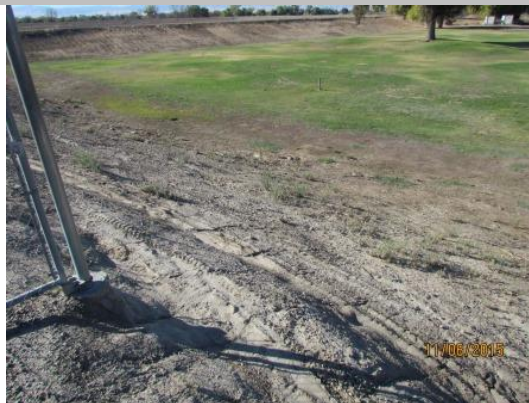
Photo 2 of 2 : SP_2016_RD2096_117_11_20160229_00005.jpg

LM Start	0.12	Rating **	M	Issue No.	11 (cont)	
LM End	0.12	Issue Type +	Ma	Location *	WS	
Category	Earthen Levee			GPS Latitude/Longitude		
				Start		End
Item	Slope Stability			37.772434 °		37.772434 °
				-121.298433 °		-121.298433 °
DWR ID	DWR_RD2096_01_s_2015_11					
Comment Code						
S3 : Repair the levee slope damaged by vehicle traffic and prevent access where possible.						
Inspector Comment

Another view of the vehicle tracks on the waterside levee slope.
