**Flood Control Project Maintenance
Levee Inspections**

Maintenance Issue Types Only, Levee Inspection Report By Mile - Spring 2017

Reclamation District No. 2096 Wetherbee Lake

Waterway	Bank	Unit Miles	Inspection Start/End	Inspector
Unit No. 01 San Joaquin River	Right	0.16	04/11/2017 04/11/2017	Maksim Khashchuk

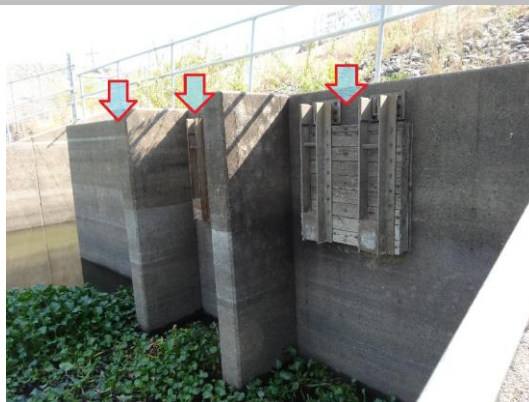
Photo 1 of 3 : UCIP_SP_2017_21505_36449.jpg

LM Start	0.02	Rating **	A/W	Issue No.	15
LM End	0.02	Issue Type +	Ma	Location *	N/A
Category	Supplemental		GPS Latitude/Longitude		
			Start	End	
Item	DWR UCIP LMA Responsibility		37.773852 °	37.773852 °	
			-121.298413 °	-121.298413 °	
DWR ID					
Comment Code					
Inspector Comment					
FS_ID:21505 DS_ID:22737 EP_NO: N/A Repair Type: No Action Needed Crossing Status: Found UCIP Comments: - steel walkway to pump platform. - pumping plant and navigation structure area is fenced with gates at north and south end. FIELD_STRUCT_DESC: 1 of 3. Three 36-inch pipes through levee, 3.5 feet below the crown. Automatic pumping plant and concrete sump on the landward side. Vent pipes on the waterward shoulder. Concrete headwall and spillbox on the waterward side. Flap gate on the waterward end. O&M Manual, December 1968. FS Date: 9/10/2013

WS view: three wooden flap gates for drainage pipes. Concrete headwall at levee slope end.

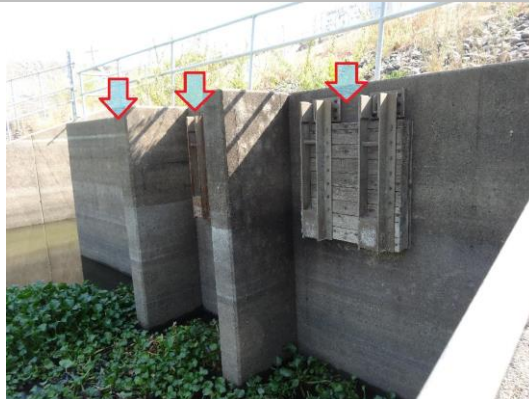
Photo 1 of 3 : UCIP_SP_2017_21507_36456.jpg

FS_ID:21507
DS_ID:22740
EP_NO: N/A
Repair Type: No Action Needed
Crossing Status: Found
UCIP Comments: - steel walkway to pump platform.- pumping plant and navigation structure area is fenced with gates at north and south end.
FIELD_STRUCT_DESC: 3 of 3. Three 36-inch pipes through levee, 3.5 feet below the crown. Automatic pumping plant and concrete sump on the landward side. Vent pipes on the waterward shoulder. Concrete headwall and spillbox on the waterward side. Flap gate on the waterward end. O&M Manual, December 1968.
FS Date: 9/10/2013

WS view: three wooden flap gates for drainage pipes. Concrete headwall at levee slope end.

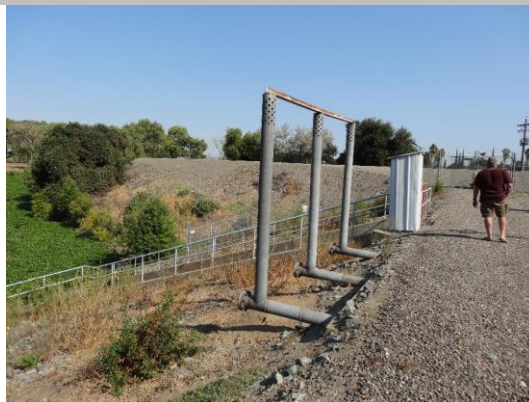
Photo 2 of 3 : UCIP_SP_2017_21507_36455.jpg

WS view: three air vents for three drainage pipes on levee shoulder.

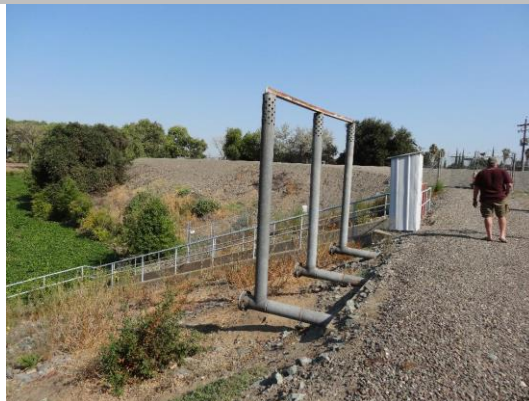
Photo 2 of 3 : UCIP_SP_2017_21508_36460.jpg

Comment Code					
Inspector Comment					
FS_ID:21508					
DS_ID:22739					
EP_NO: N/A					
Repair Type: No Action Needed					
Crossing Status: Found					
UCIP Comments: - steel walkway to pump platform.- pumping plant and navigation structure area is fenced with gates at north and south end.					
FIELD_STRUCT_DESC: 2 of 3. Three 36-inch pipes through levee, 3.5 feet below the crown, one concrete cutoff wall. Automatic pumping plant and concrete sump on the landward side. Vent pipes on the waterward shoulder. Concrete headwall and spillbox on the waterward side. Flap gate on the waterward end. O&M Manual, December 1968.					
FS Date: 9/10/2013

WS view: three air vents for three drainage pipes on levee shoulder.

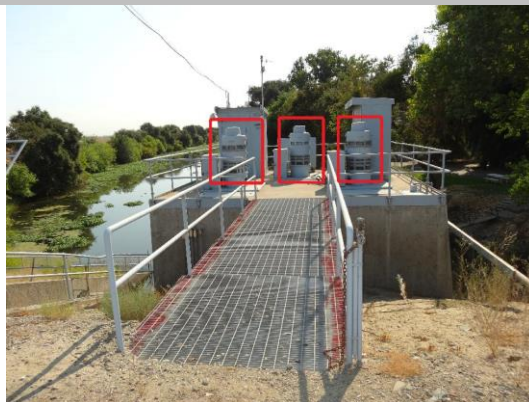
Photo 3 of 3 : UCIP_SP_2017_21508_36461.jpg

LS view: automatic pumping plant with three pumps. Steel walkway to pump platform.

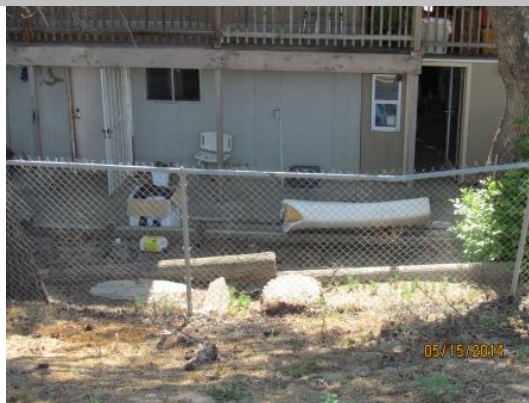
Photo 1 of 1 : SP_2017_RD2096_117_9_20170407_00004.jpg

LM Start	0.06	Rating **	N	Issue No.	9
LM End	0.06	Issue Type +	Ma	Location *	LS
Category	Earthen Levee			GPS Latitude/Longitude	
				Start	End
Item	Trim / Thin Trees			37.773348 °	37.773348 °
				-121.298475 °	-121.298475 °
DWR ID	DWR_RD2096_01_s_2014_9				
Comment Code					
T5 : Tree stumps.					
Inspector Comment					
Pine tree stump at levee toe.

View of the tree stump at the landside levee toe.

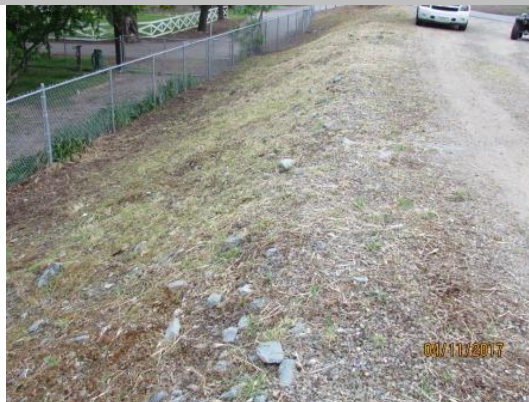
Photo 1 of 1 : SP_2017_RD2096_117_14_20170417_00020.jpg

LM Start	0.09	Rating **	A	Issue No.	14
LM End	0.09	Issue Type +	Ma	Location *	LS
Category	Earthen Levee			GPS Latitude/Longitude	
				Start	End
Item	Vegetation			37.772896 °	37.772896 °
				-121.298474 °	-121.298474 °
DWR ID	DWR_RD2096_01_s_2017_14				
Comment Code					
V1 : Control annual grass and weeds on the levee slopes and easements.					
Inspector Comment					
Acceptable vegetation control on the levee slope.

View of the acceptable vegetation on the levee slope.

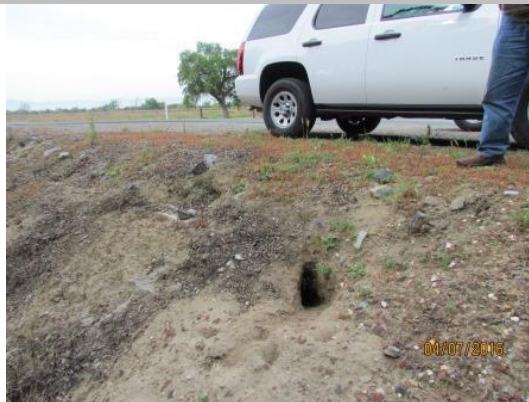
Photo 1 of 1 : SP_2017_RD2096_117_6_20170407_00002.jpg

LM Start	0.09	Rating **	A/W	Issue No.	6
LM End	0.09	Issue Type +	Ma	Location *	LS
Category	Earthen Levee			GPS Latitude/Longitude	
				Start	End
Item	Animal Control			37.772891 °	37.772891 °
				-121.298454 °	-121.298454 °
DWR ID	DWR_RD2096_01_s_2016_6				
Comment Code					
A3 : No rodents visible, but rodent burrows visible; need to backfill and compact or grout burrows.					
Inspector Comment					
LMA has effective rodent control program. Monitor this location for possible future activity.

View of the rodent hole on the landside levee slope.

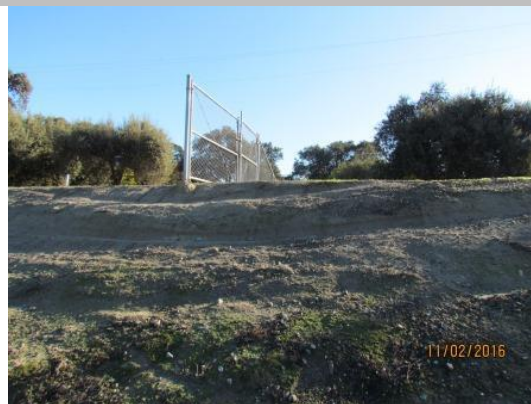
Photo 1 of 3 : SP_2017_RD2096_117_11_20170407_00005.jpg

LM Start	0.12	Rating **	M	Issue No.	11
LM End	0.12	Issue Type +	Ma	Location *	WS
Category	Earthen Levee			GPS Latitude/Longitude	
				Start	End
Item	Slope Stability			37.772434 °	37.772434 °
				-121.298433 °	-121.298433 °
DWR ID	DWR_RD2096_01_s_2015_11				
Comment Code					
S3 : Repair the levee slope damaged by vehicle traffic and prevent access where possible.					
Inspector Comment					
Regrade and re-compact damaged waterside levee slope.

View of the waterside slope damaged by vehicle.

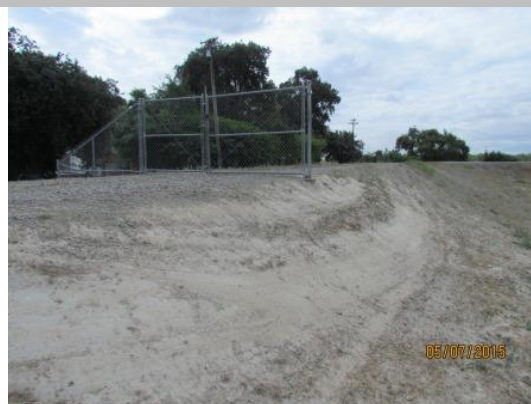
Photo 2 of 3 : SP_2017_RD2096_117_11_20170407_00006.jpg

View of the vehicle tracks eroding the waterside levee slope.

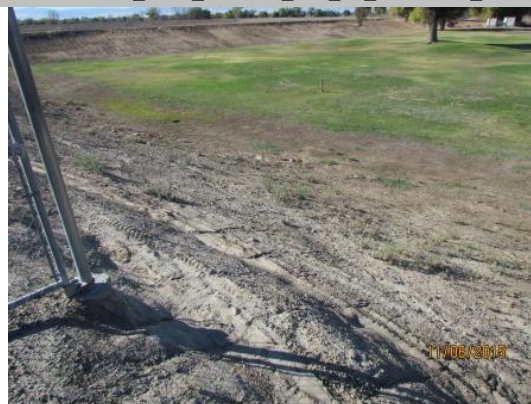
Photo 3 of 3 : SP_2017_RD2096_117_11_20170407_00007.jpg

Another view of the vehicle tracks on the waterside levee slope.
