**Flood Control Project Maintenance
Levee Inspections**

Maintenance Issue Types Only, Levee Inspection Report By Mile - Spring 2018

Reclamation District No. 2096 Wetherbee Lake

Waterway	Bank	Unit Miles	Inspection Start/End	Inspector
Unit No. 01 San Joaquin River	Right	0.16	03/13/2018 03/13/2018	Maksim Khashchuk

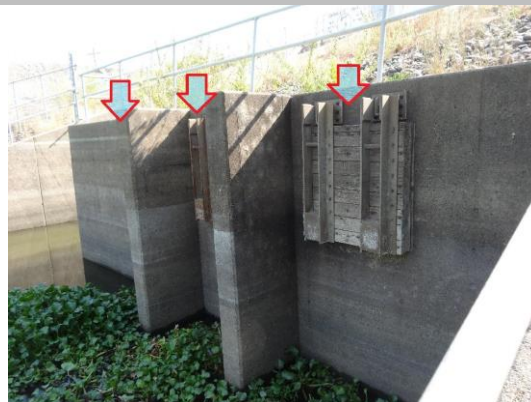
Photo 1 of 3 : UCIP_SP_2018_21505_36449.jpg

Comment Code					
Inspector Comment					
FS_ID:21505 DS_ID:22737 EP_NO: N/A Repair Type: No Action Needed Crossing Status: Found UCIP Comments: - steel walkway to pump platform.- pumping plant and navigation structure area is fenced with gates at north and south end. FIELD_STRUCT_DESC: 1 of 3: 36-inch drainage discharge pipe of an unknown material through the levee, 3.5 feet below the crown. One concrete cutoff wall. Automatic pumping plant and concrete sump on the landside (LS). Vent pipes on the waterside (WS) shoulder. Concrete headwall and spill box on the WS. Flap gate on the WS end. [Additional Reference(s): DWR Levee Log, 2005. USACE San Joaquin O&M Manual 3, December 1968, (HLM 0.03)]. FS Date: 9/10/2013

WS view: three wooden flap gates for drainage pipes. Concrete headwall at levee slope end.

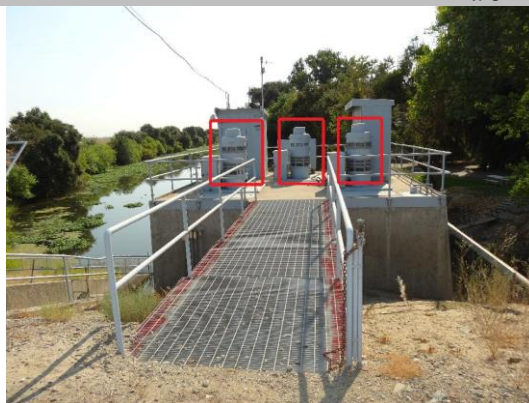
Photo 3 of 3 : UCIP_SP_2018_21505_36447.jpg

LS view: automatic pumping plant with three pumps. Steel walkway to pump platform.

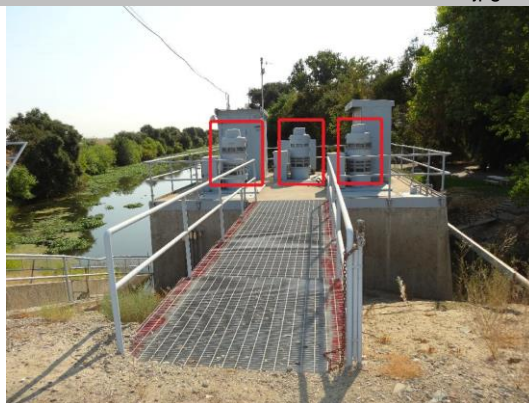
Photo 3 of 3 : UCIP_SP_2018_21507_36454.jpg

Comment Code						
Inspector Comment						
FS_ID:21507						
DS_ID:22740						
EP_NO: N/A						
Repair Type: No Action Needed						
Crossing Status: Found						
UCIP Comments: - steel walkway to pump platform.- pumping plant and navigation structure area is fenced with gates at north and south end.						
FIELD_STRUCT_DESC: 2 of 3: 36-inch drainage discharge pipe of an unknown material through the levee, 3.5 feet below the crown. One concrete cutoff wall. Automatic pumping plant and concrete sump on the landside (LS). Vent pipes on the waterside (WS) shoulder. Concrete headwall and spill box on the WS. Flap gate on the WS end. [Additional Reference(s): DWR Levee Log, 2005. USACE San Joaquin O&M Manual 3, December 1968, (HLM 0.03)].						
FS Date: 9/10/2013

LS view: automatic pumping plant with three pumps. Steel walkway to pump platform.

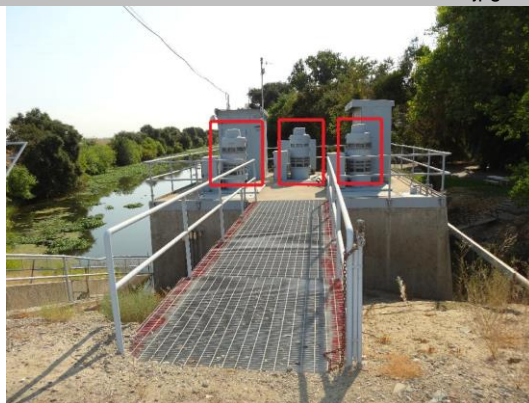
Photo 3 of 3 : UCIP_SP_2018_21508_36461.jpg

Comment Code						
Inspector Comment						
FS_ID:21508 DS_ID:22739 EP_NO: N/A Repair Type: No Action Needed Crossing Status: Found UCIP Comments: - steel walkway to pump platform.- pumping plant and navigation structure area is fenced with gates at north and south end. FIELD_STRUCT_DESC: 3 of 3: 36-inch drainage discharge pipe of an unknown material through the levee, 3.5 feet below the crown. One concrete cutoff wall. Automatic pumping plant and concrete sump on the landside (LS). Vent pipes on the waterside (WS) shoulder. Concrete headwall and spill box on the WS. Flap gate on the WS end. [Additional Reference(s): DWR Levee Log, 2005. USACE San Joaquin O&M Manual 3, December 1968, (HLM 0.03)]. FS Date: 9/10/2013

LS view: automatic pumping plant with three pumps. Steel walkway to pump platform.

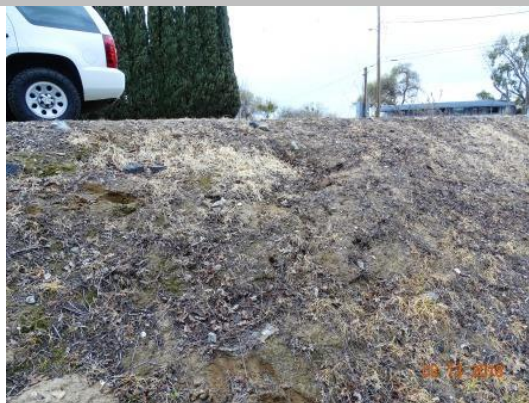
Photo 1 of 1 : SP_2018_RD2096_117_6_20180314_00019.jpg

LM Start	0.09	Rating **	A/W	Issue No.	6
LM End	0.09	Issue Type +	Ma	Location *	LS
Category	Earthen Levee			GPS Latitude/Longitude	
				Start	End
Item	Animal Control			37.772891 °	37.772891 °
				-121.298454 °	-121.298454 °
DWR ID	DWR_RD2096_01_s_2016_6				
Comment Code					
A3 : No rodents visible, but rodent burrows visible; need to backfill and compact or grout burrows.					
Inspector Comment					
LMA has effective rodent control program. Monitor this location for possible future activity.

View of the previously rodent infested area on the landside levee slope.

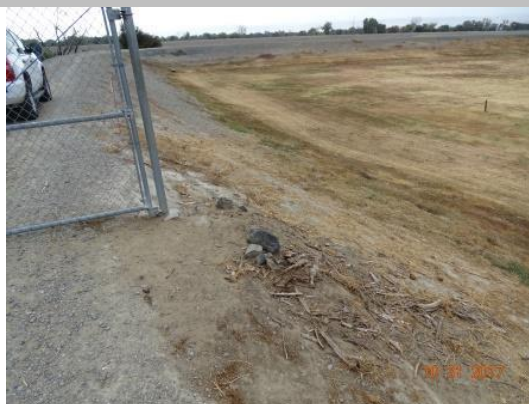
Photo 1 of 3 : SP_2018_RD2096_117_11_20180305_00004.jpg

LM Start	0.12	Rating **	M	Issue No.	11
LM End	0.12	Issue Type +	Ma	Location *	WS
Category	Earthen Levee			GPS Latitude/Longitude	
				Start	End
Item	Slope Stability			37.772434 °	37.772434 °
				-121.298433 °	-121.298433 °
DWR ID	DWR_RD2096_01_s_2015_11				
Comment Code					
S3 : Repair the levee slope damaged by vehicle traffic and prevent access where possible.					
Inspector Comment					
LMA restricted access but still a regrade and re-compaction of damaged waterside levee slope is required.

View of the material placed to prevent vehicles from driving around the gate.

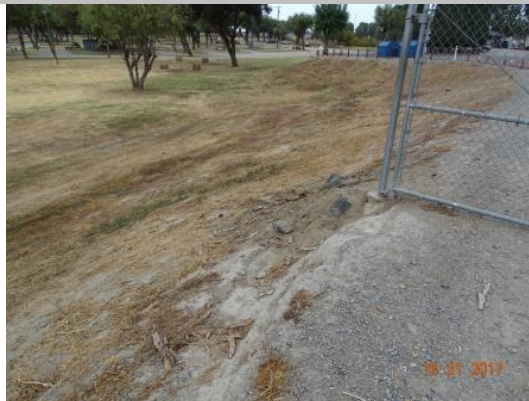
Photo 2 of 3 : SP_2018_RD2096_117_11_20180305_00005.jpg

LM Start	0.12	Rating **	M	Issue No.	11 (cont)	
LM End	0.12	Issue Type +	Ma	Location *	WS	
Category	Earthen Levee			GPS Latitude/Longitude		
				Start	End	
Item	Slope Stability			37.772434 °	37.772434 °	
				-121.298433 °	-121.298433 °	
DWR ID	DWR_RD2096_01_s_2015_11					
Comment Code						
S3 : Repair the levee slope damaged by vehicle traffic and prevent access where possible.						
Inspector Comment						
LMA restricted access but still a regrade and re-compaction of damaged waterside levee slope is required.

Another view of the material placed to prevent vehicles from driving around the gate. Looking downstream.

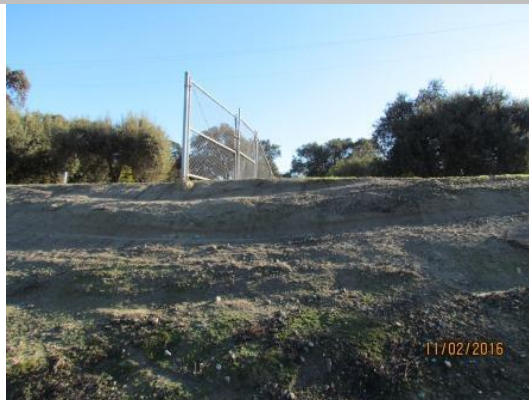
Photo 3 of 3 : SP_2018_RD2096_117_11_20180305_00006.jpg

View of the waterside slope damaged by vehicle.
