**Flood Control Project Maintenance
Levee Inspections**

Maintenance Issue Types Only, Levee Inspection Report By Mile - Spring 2019

Reclamation District No. 2096 Wetherbee Lake

Waterway	Bank	Unit Miles	Inspection Start/End	Inspector
Unit No. 01 San Joaquin River	Right	0.16	05/01/2019 05/01/2019	Alberto De Leon

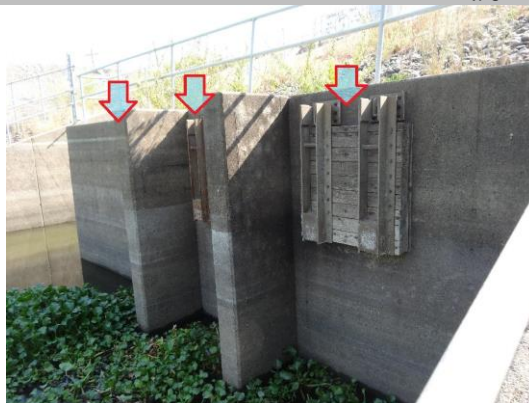
Photo 1 of 3 : UCIP_SP_2019_21505_36449.jpg

LM Start	0.02	Rating **	A/W	Issue No.	14
LM End	0.02	Issue Type +	Ma	Location *	
Category	Supplemental			GPS Latitude/Longitude	
				Start	End
Item	DWR UCIP LMA Responsibility			37.773852 °	37.773852 °
				-121.298413 °	-121.298413 °
DWR ID	22737

WS view: three wooden flap gates for drainage pipes. Concrete headwall at levee slope end.

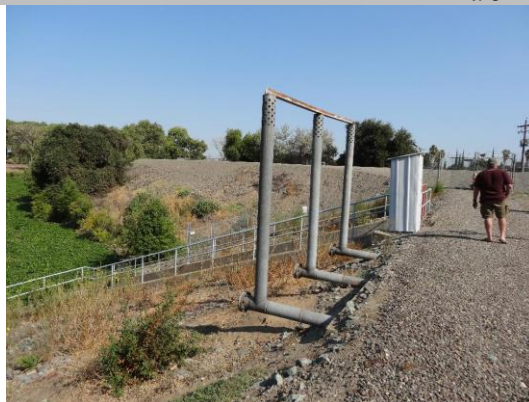
Photo 2 of 3 : UCIP_SP_2019_21505_36448.jpg

WS view: three air vents for three drainage pipes on levee shoulder.

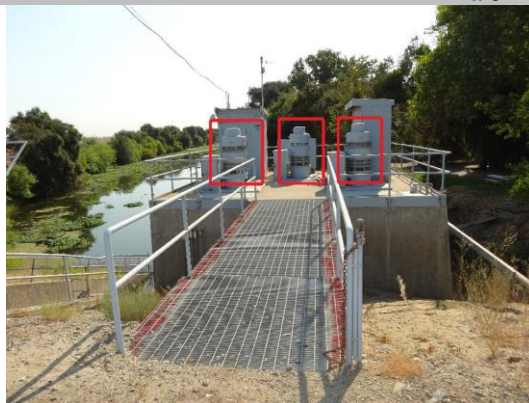
Photo 3 of 3 : UCIP_SP_2019_21505_36447.jpg

LS view: automatic pumping plant with three pumps. Steel walkway to pump platform.

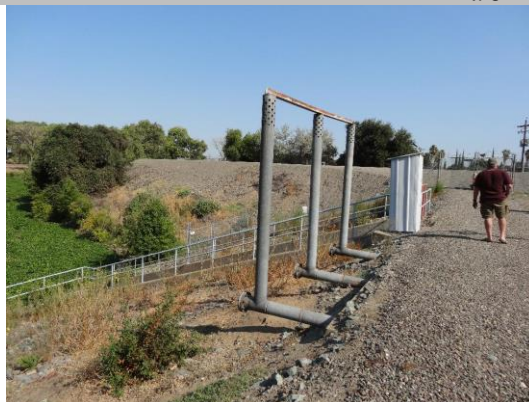
Photo 2 of 3 : UCIP_SP_2019_21507_36455.jpg

WS view: three air vents for three drainage pipes on levee shoulder.

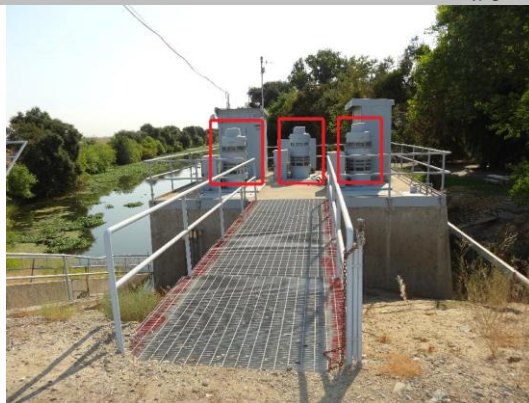
Photo 3 of 3 : UCIP_SP_2019_21507_36454.jpg

LS view: automatic pumping plant with three pumps. Steel walkway to pump platform.

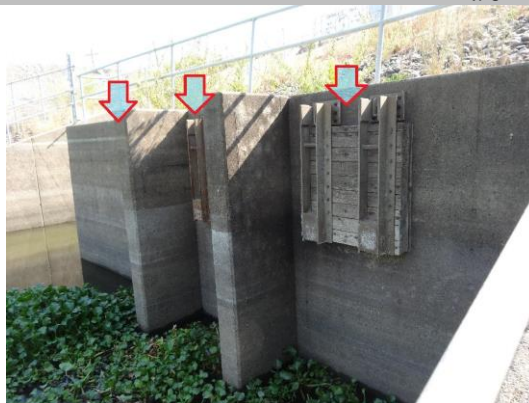
Photo 1 of 3 : UCIP_SP_2019_21508_36463.jpg

LM Start	0.03	Rating **	A/W	Issue No.	16	
LM End	0.03	Issue Type +	Ma	Location *		
Category	Supplemental			GPS Latitude/Longitude		
				Start		End
Item	DWR UCIP LMA Responsibility			37.773818 °	37.773818 °	
				-121.298423 °	-121.298423 °	
DWR ID	22739

WS view: three wooden flap gates for drainage pipes. Concrete headwall at levee slope end.

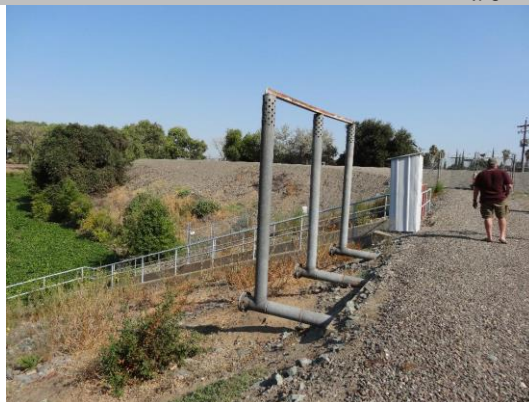
Photo 2 of 3 : UCIP_SP_2019_21508_36460.jpg

WS view: three air vents for three drainage pipes on levee shoulder.

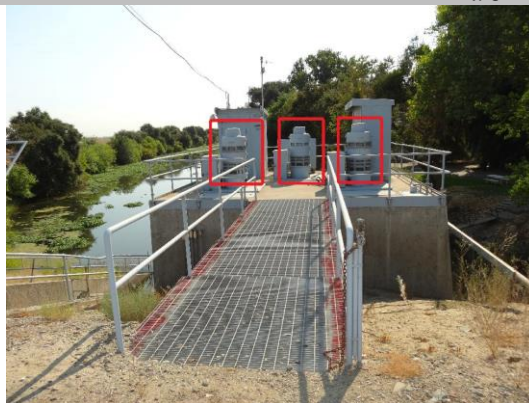
Photo 3 of 3 : UCIP_SP_2019_21508_36461.jpg

LS view: automatic pumping plant with three pumps. Steel walkway to pump platform.

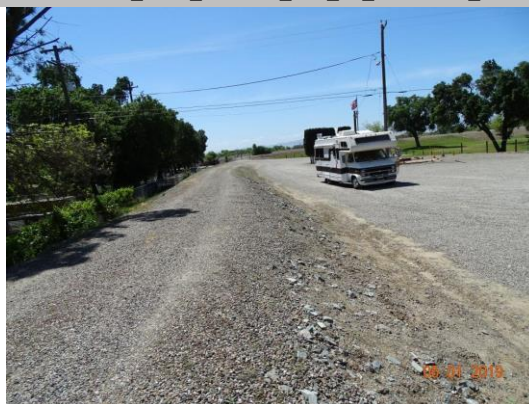
Photo 1 of 1 : SP_2019_RD2096_117_12_20190514_00018.jpg

LM Start	0.06	Rating **	A	Issue No.	12
LM End	0.16	Issue Type +	Ma	Location *	WS
Category	Earthen Levee			GPS Latitude/Longitude	
				Start	End
Item	Vegetation			37.773380 °	37.771824 °
				-121.298704 °	-121.298403 °
DWR ID	DWR_RD2096_01_s_2019_12				
Comment Code					
V1 : Control annual grass and weeds on the levee slopes and easements.					
Inspector Comment					
Annual vegetation is well maintained.

Typical view of vegetation on waterside slope. (Spring 2019)

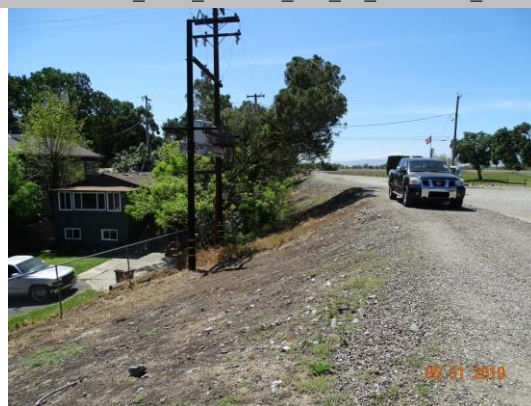
Photo 1 of 1 : SP_2019_RD2096_117_10_20190514_00019.jpg

LM Start	0.06	Rating **	A	Issue No.	10
LM End	0.16	Issue Type +	Ma	Location *	LS
Category	Earthen Levee			GPS Latitude/Longitude	
				Start	End
Item	Vegetation			37.773375 °	37.771824 °
				-121.298721 °	-121.298403 °
DWR ID	DWR_RD2096_01_s_2019_10				
Comment Code					
V1 : Control annual grass and weeds on the levee slopes and easements.					
Inspector Comment					
Annual vegetation is well maintained.

Typical view of vegetation on landside slope. (Spring 2019)

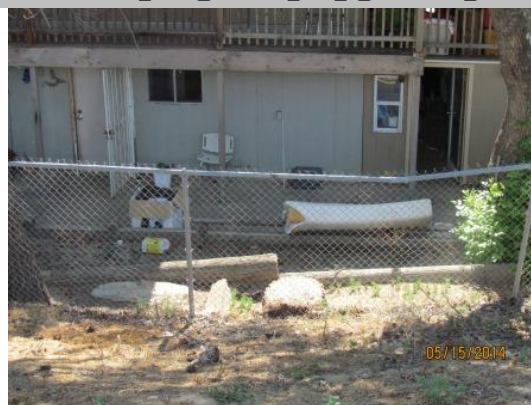
Photo 1 of 1 : SP_2019_RD2096_117_9_20190313_00002.jpg

LM Start	0.06	Rating **	N	Issue No.	9
LM End	0.06	Issue Type +	Ma	Location *	LS
Category	Earthen Levee			GPS Latitude/Longitude	
				Start	End
Item	Trim / Thin Trees			37.773348 °	37.773348 °
				-121.298475 °	-121.298475 °
DWR ID	DWR_RD2096_01_s_2014_9				
Comment Code					
T5 : Tree stumps.					
Inspector Comment					
There is a pine tree stump at the levee toe.

View of the tree stump at the landside levee toe.

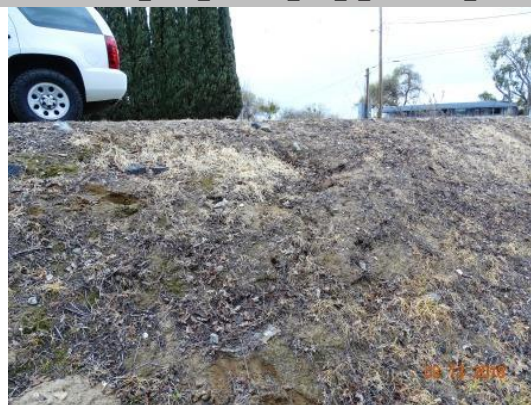
Photo 1 of 1 : SP_2019_RD2096_117_6_20190313_00001.jpg

LM Start	0.09	Rating **	A/W	Issue No.	6
LM End	0.09	Issue Type +	Ma	Location *	LS
Category	Earthen Levee			GPS Latitude/Longitude	
				Start	End
Item	Animal Control			37.772891 °	37.772891 °
				-121.298454 °	-121.298454 °
DWR ID	DWR_RD2096_01_s_2016_6				
Comment Code					
A3 : No rodents visible, but rodent burrows visible; need to backfill and compact or grout burrows.					
Inspector Comment					
The LMA has an effective rodent control program. Monitor this location for possible future activity.

View of the previously rodent infested area on the landside levee slope.

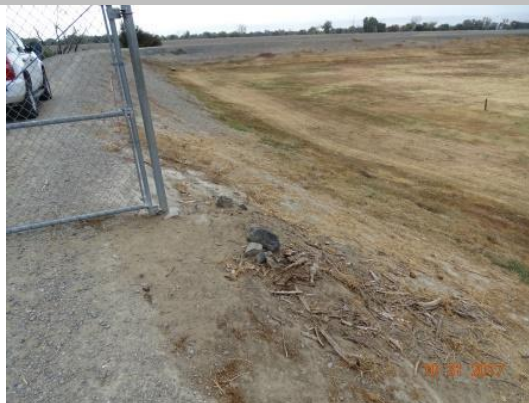
Photo 1 of 3 : SP_2019_RD2096_117_11_20190313_00003.jpg

LM Start	0.12	Rating **	M	Issue No.	11
LM End	0.12	Issue Type +	Ma	Location *	WS
Category	Earthen Levee			GPS Latitude/Longitude	
				Start	End
Item	Slope Stability			37.772434 °	37.772434 °
				-121.298433 °	-121.298433 °
DWR ID	DWR_RD2096_01_s_2015_11				
Comment Code					
S3 : Repair the levee slope damaged by vehicle traffic and prevent access where possible.					
Inspector Comment					
The LMA restricted access but still a regrade and re-compaction of the damaged waterside levee slope is required.

View of the material placed to prevent vehicles from driving around the gate.

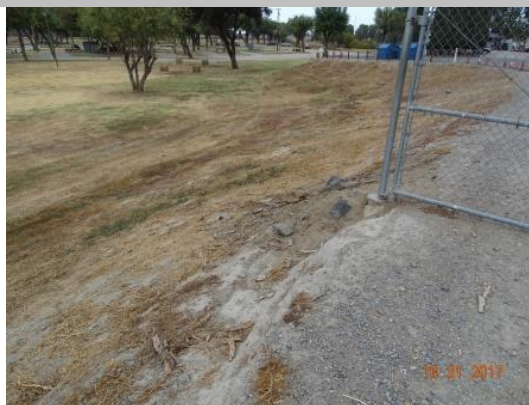
Photo 2 of 3 : SP_2019_RD2096_117_11_20190313_00004.jpg

Another view of the material placed to prevent vehicles from driving around the gate. Looking downstream.

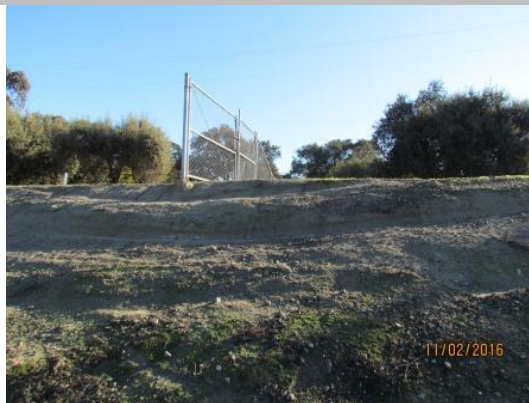
Photo 3 of 3 : SP_2019_RD2096_117_11_20190313_00005.jpg

View of the waterside slope damaged by vehicles.
